Vermillion River Watershed Joint Powers Organization  
**Empire Drainages Geomorphic Assessment, Dakota  
County, MN: Final Report**

April 30, 2013

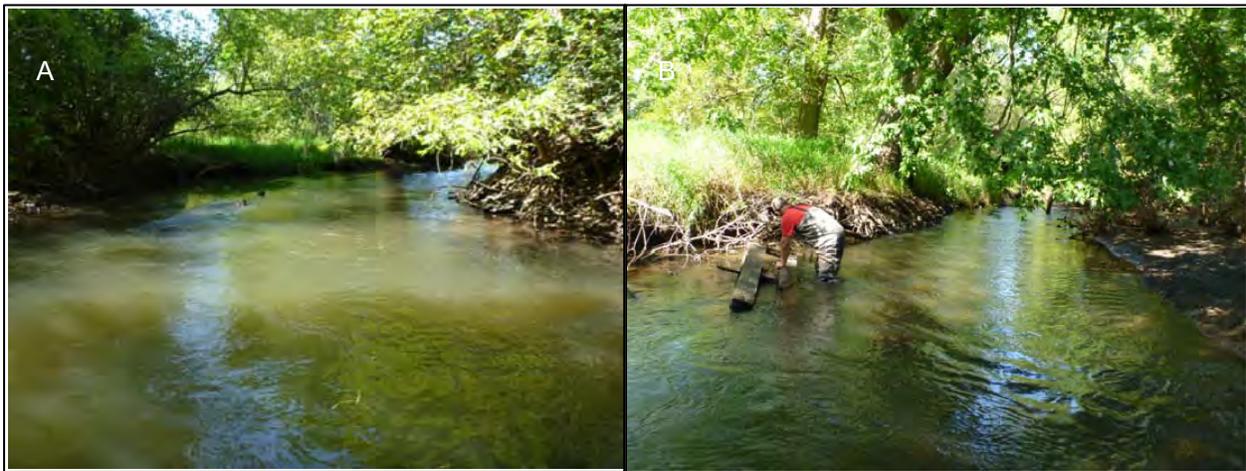
Figure C-6, Reach 6: A) Looking upstream at Station 47,800 towards a typical section within this reach showing good overstory, deep water, shade and channel meandering. B) Taken at Station 50,450 looking at a misaligned and damaged luncker.

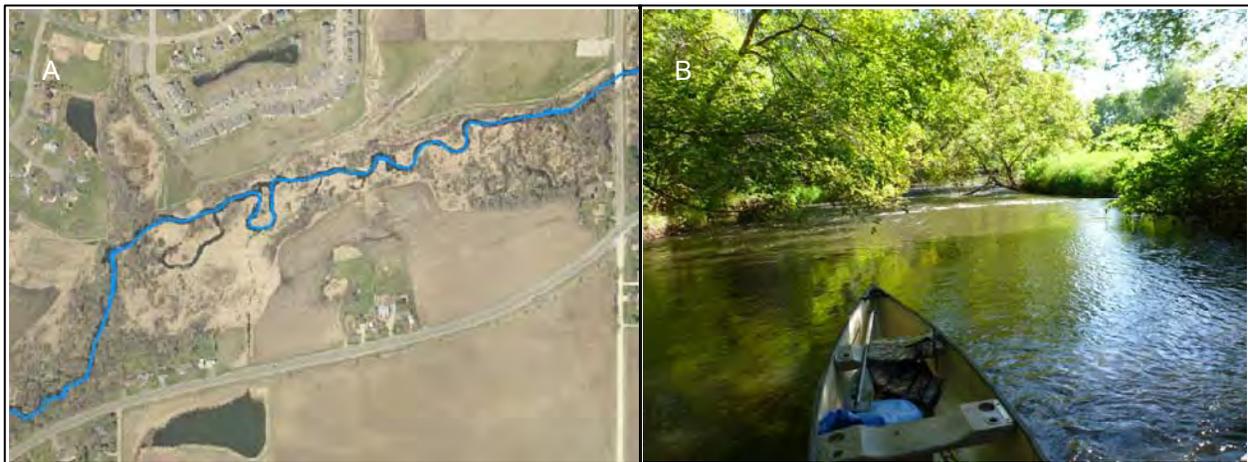
Figure C-7, Reach 7: A) Shows the lack of sinuosity within this reach. B) Looking downstream at a natural gravel and cobble riffle (Station 55,100).

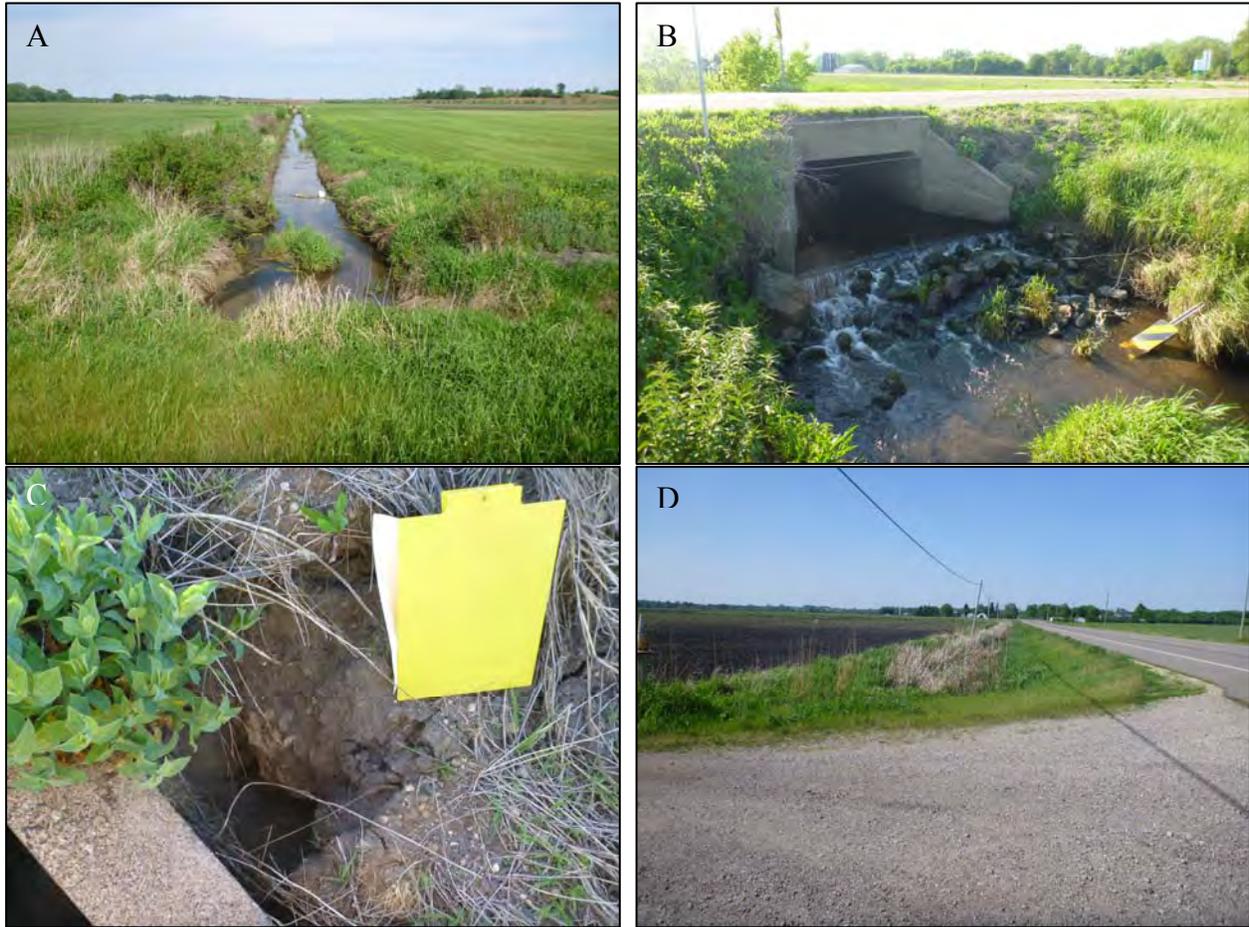
Figure C-12, Tributary 2, 2A: A) Tributary 2 looking downstream from Blaine Ave. B) looking upstream at perched culvert under Clayton Ave. C) hole developed between culvert and road at Clayton Ave. D) Tributary 2A looking downstream along Blaine Ave.

- Threats to infrastructure and safety
  - Tributary 2, PP36 (score: 38) - The concrete box culvert under Clayton Ave needs to be replaced as it is in disrepair and resulting in erosion between the culvert and the road and cracks in the road pavement. It is also a fish passage barrier so replacement with a larger bridge or culvert would improve passage.

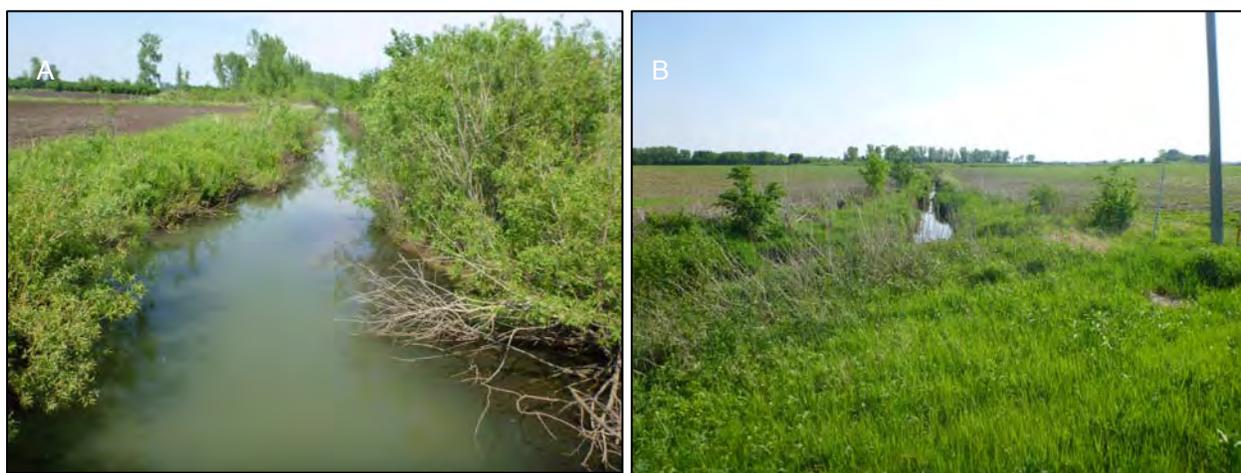
Figure C-16, Tributary 6: A) Looking downstream from 210th St W at straightened ditch. B) Looking upstream at the straightened ditch with minimal vegetated buffer. Note the poor water clarity.

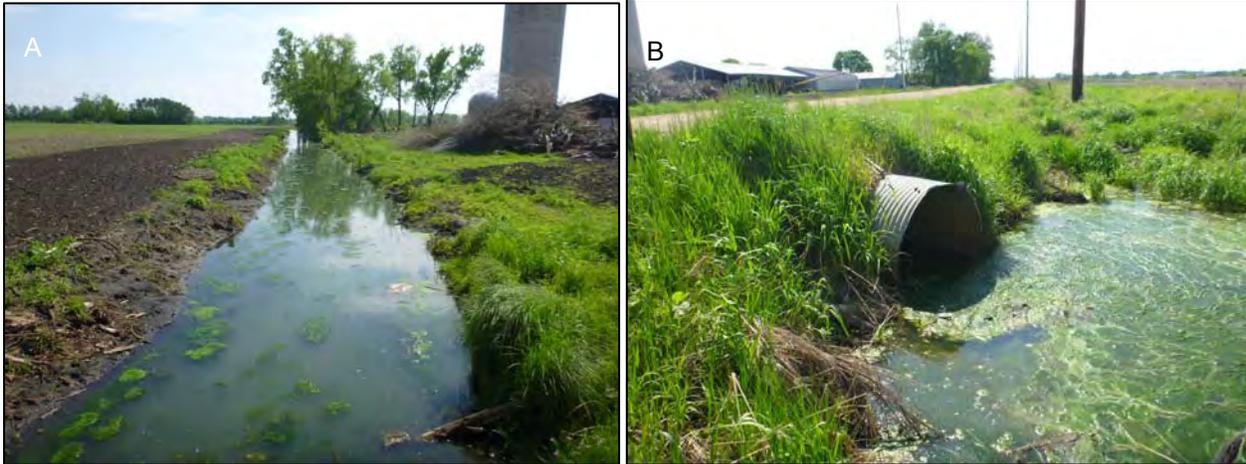
Figure C-17, Tributary 6A: A) Looking upstream from 210th St W at straightened ditch with no vegetated buffer. B) Looking upstream at the pool below 210th St W. Note the poor water clarity and quality.

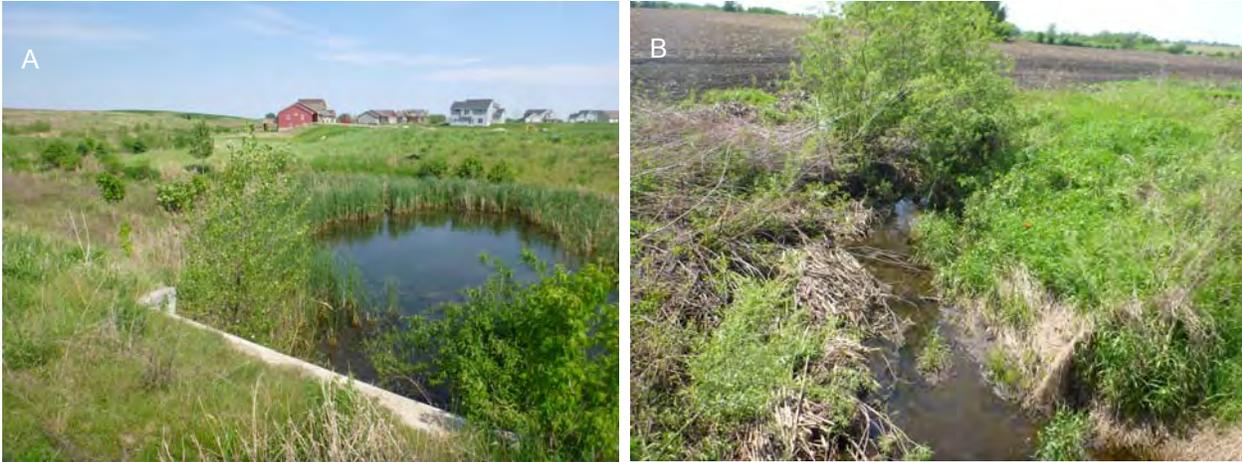
Figure C-19, Tributary 8: A) Looking downstream at recently constructed sinuous channel and stormwater basins near Cattail Lane. B) Looking upstream at straightened ditch with minimal buffer at Biscayne Ave.
