Vermillion River Watershed Joint Powers Organization
**Fluvial Geomorphic Assessment of Etter Creek and the
Ravenna Coulees, Dakota County, MN: Final Report**

February 25, 2011

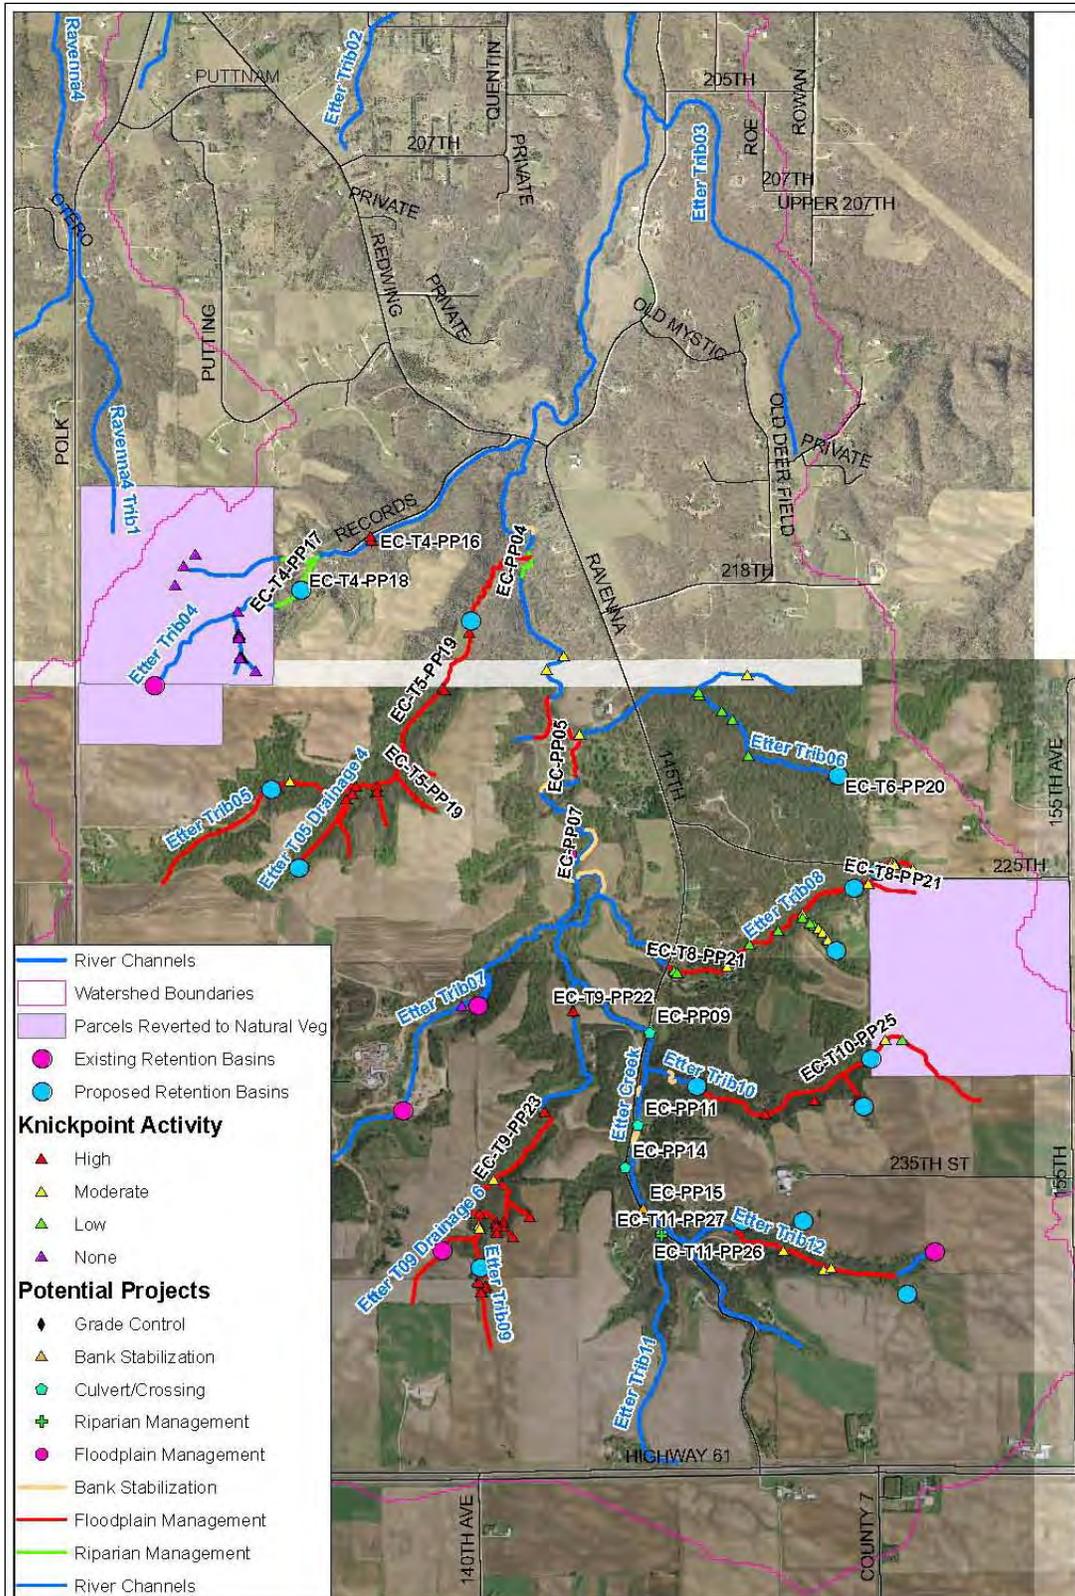
upper extremities of the Etter Creek subwatershed along Tributaries 4-12 (Figure 6). These knickpoints are indicative of vertical instability and suggest that the channel geometry is still adjusting to the increased hydrology due to changes in land use. As the knickpoints migrate upstream, sediment is carried downstream causing problems along Etter Creek. The incision results in over-steepened banks that subsequently fail and cause additional sedimentation.

Figure 6: The headwaters of Etter Creek showing the location and activity of knickpoints and the location of potential projects, existing and proposed retention basins, and parcels that have been converted to native vegetation.

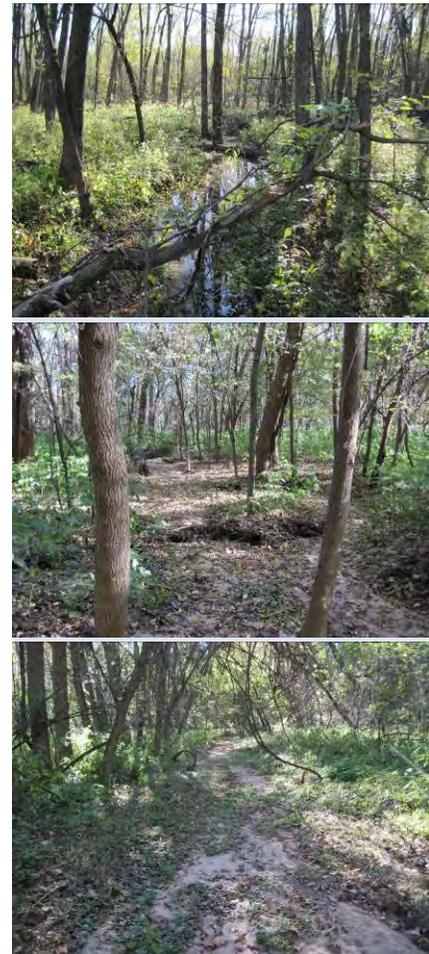
The channel substrate is predominantly sand, and the reach is aggradational as sand from higher gradient areas upstream is deposited. As the channel fills with deposited sand, water is forced onto the floodplain where it forms a new channel. This process probably causes frequent

Figure C-1: Etter Creek, Reach 1 (Top) Stn 650 looking downstream at Vermillion River backwater; (middle) Stn 1,400 looking downstream at newly created channel; (bottom) Stn 1,950 looking downstream at aggradational reach.

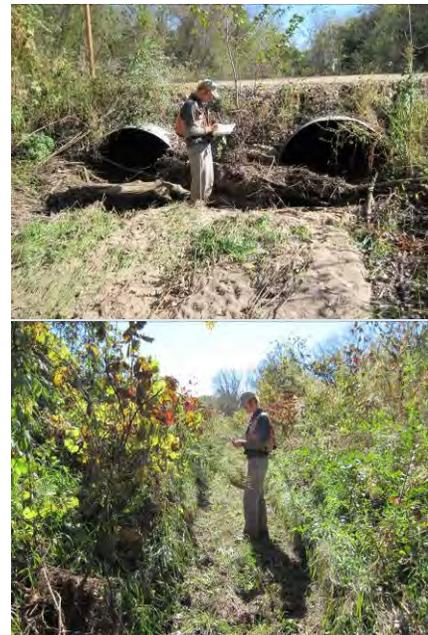
We observed evidence of past incision as the surface of the surrounding fields is up to 8ft higher than the channel bed (Figure C-2). The incision may be as much as 4ft, but we did not observe active incision (migrating knickpoints, headcuts, etc.) in this reach. There is gravel and cobbles on the stream bed in a number of locations, and incision may have slowed when this gravel layer was reached. Some active bank erosion is occurring on the outside of bends, but tree roots are attempting to stabilize in many of these locations.

Figure C-2: Etter Creek, Reach 2 (Top) Stn 4,050 looking downstream undersized culverts under Ravenna Trail; (bottom) Stn 5,500 looking upstream at straightened channel.

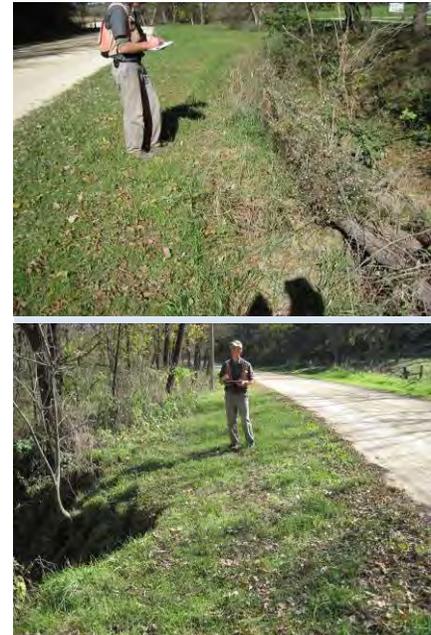
1) At station 26,950-27,050, the left bank is eroding and is now only 10ft from the edge of the road. No trees can grow on the banks to help stabilize it, and the concrete rip rap that was placed on the bank is falling into the channel. 2) At station 27,450, a 5ft corrugated metal pipe culvert is corroded and needs replacing. Downstream of the culvert, concrete, bricks, and other debris have been put on the left and right banks to help minimize erosion, but these may be exacerbating the problem because vegetation and their stabilizing roots cannot grow. 3) The

Figure C-5: Etter Creek, Reach 5 (Top) Stn 27,600 looking downstream at straightened channel with no riparian buffer; (bottom) Stn 28,850 looking upstream at eroding banks nearing the road.

- PP10 - 40 points - bank erosion on Etter Creek between Stn 26,950 and 27,050 that is within 10 ft of 145th Ave
- PP15 - 40 points - bank erosion on Etter Creek at Stn 28,650 that is within 8 ft of 145th Ave
- PP14 - 40 points - culvert under 145th Ave for a drainage that flows into Etter Creek at Stn 28,050; erosion around the culvert threatens the road
- PP11 - 33 points - culvert under a private driveway at Stn 27,450; the pipe is corroded and the concrete is severely cracked

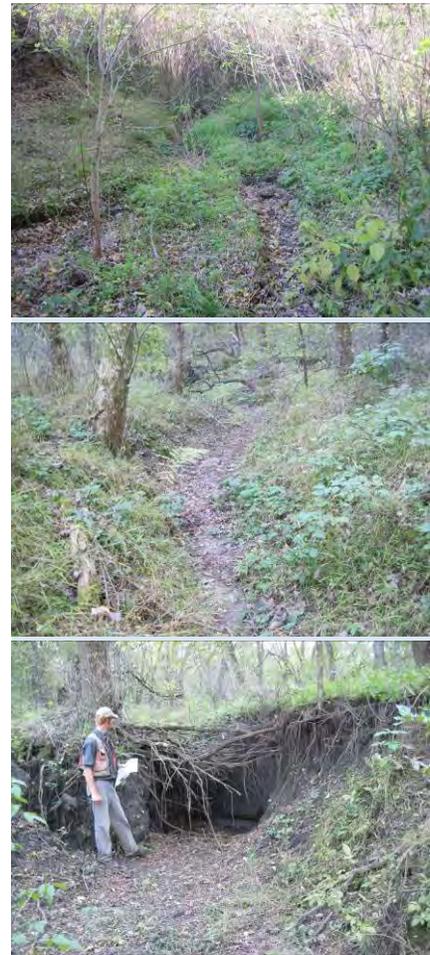
Figure C-10: Etter Creek, Tributary 5 (Top) Stn 1,650 looking downstream at channel after 10 ft of incision; (middle) Stn 4,750 looking upstream; (bottom) Stn 4800 looking upstream at knickpoint.

We recommend that this entire subwatershed be managed to control the actively migrating knickpoints and excessive erosion. The knickpoints may impact agriculture, and the incision and bank failure is the source of much of the sediment found in Etter Creek. Fixing individual knickpoints may temporarily halt incision, but long-term solutions should likely involve a combination of management practices: changes in farming practices, conversion of fields to native vegetation, construction of retention basins, stabilizing the channel and banks in select places.

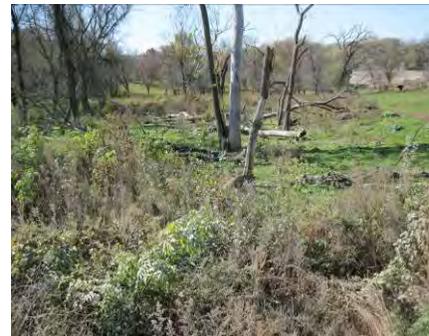
Upstream of station 2500, we observed low to moderately active knickpoints. At station 4500, 8-11 ft knickpoints are nearing open fields. Landowners have dumped woody debris into the channel here and have attempted to slow the incision by diverting the water, but

Figure C-11: Etter Creek, Tributary 6, Reach 1; Stn 950 looking downstream.

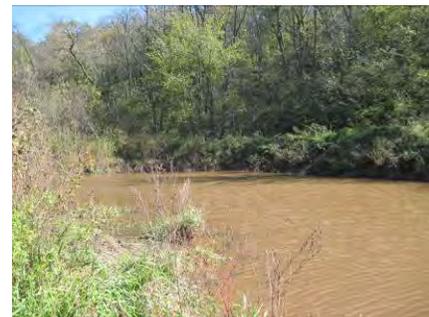
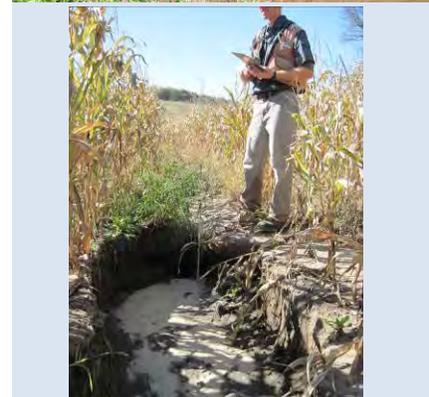
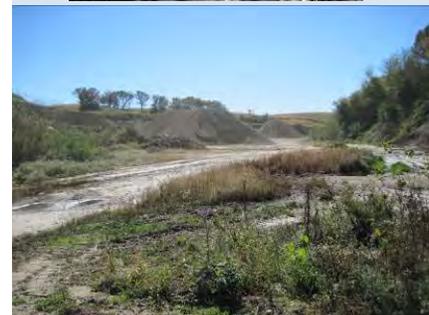
There is no aquatic or riparian habitat in reach 2. Where there is a vegetated corridor, it is up to 100ft wide and comprised completely of grasses and forbs. We did not investigate the channel upstream beyond the mining

Figure C-14: Etter Creek, Tributary 7, Reach 2; (Top) Stn 2,150 looking downstream at retention basin; (middle) Stn 2,500 looking upstream at incision in corn field; (bottom) Stn 2,750 looking upstream at mining operation.

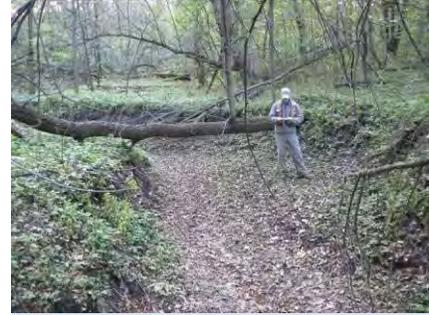
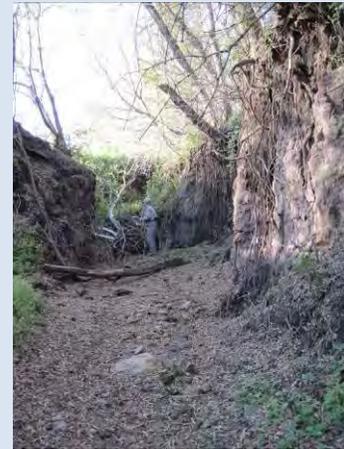
At station 2100, power lines cross the channel. There is a dirt road crossing and a 3ft knick point at station 2300. The knickpoint may continue to migrate upstream, which would further lower the base level elevations and increase incision and depth of knickpoints in the drainages. A small retention basin combined with a grassy swale between row crops along Drainage 6 has likely halted current and future incision through this drainage. In the mainstem and drainages surrounding this, however, incision continues, and we recommend subwatershed-scale management to decrease the amount of overland runoff and halt the incision and erosion. Row crops are actively falling into the knickpoints. A combination of using different farming

Figure C-17: Etter Creek, Tributary 9, Reach 2; (Top) Stn 4,700 looking downstream; (bottom) Stn 5,700 looking upstream at

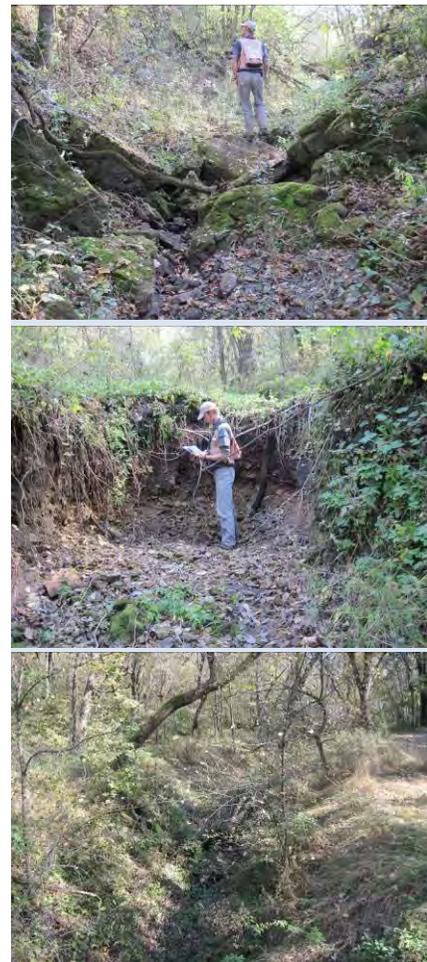
Figure C-18: Etter Creek, Tributary 10; (Top) Stn 100 looking upstream; (middle) Stn 1,900 looking upstream at knickpoint; (bottom) Stn 2,900 looking

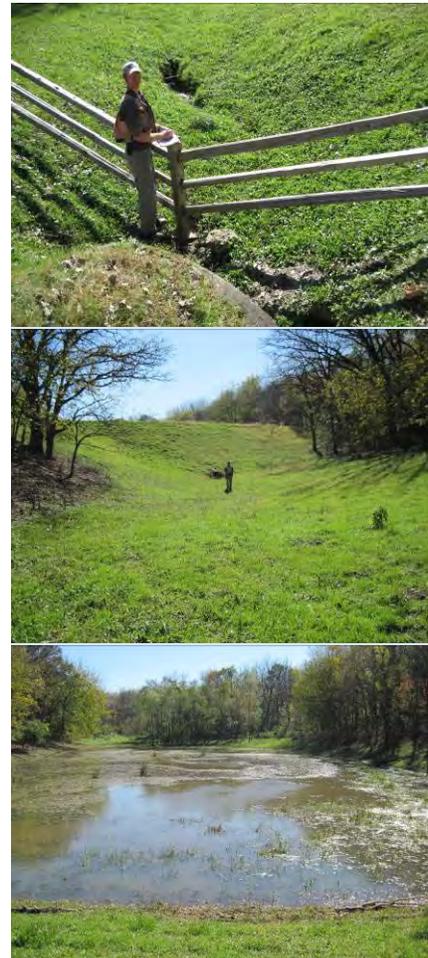
Figure C-19: Etter Creek, Tributary 11; (Top) Stn 100 looking upstream at minor erosion around post and in field; (middle) Stn 200 looking upstream to dam; (bottom) Stn 500 looking upstream at retention basin.

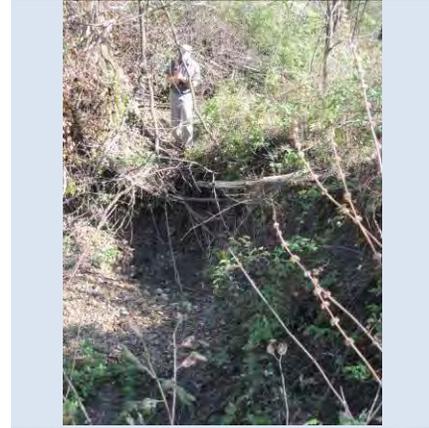
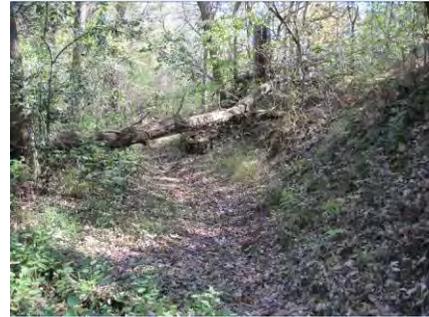
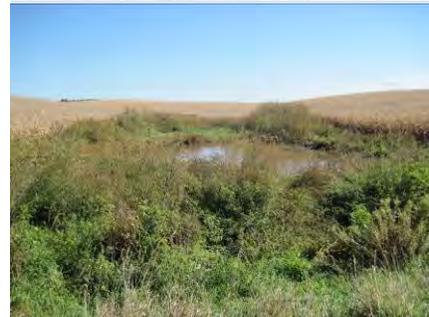
Figure C-20: Etter Creek, Reach 3 (Top) Stn 1,500 looking upstream at knickpoint; (middle) Stn 2,150 looking upstream; (bottom) Stn 3,900 looking upstream at retention basin.

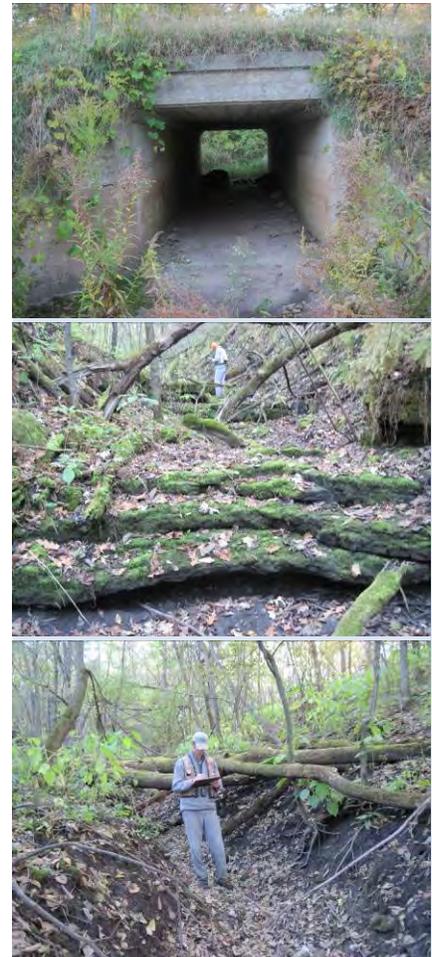
Figure C-21: Ravenna Coulee 1, (Top) East Drainage, Stn 600 looking upstream at Ravenna Trail crossing; (middle) East Drainage, Stn 1,300 looking upstream; (bottom) West Drainage, Stn 2,400 looking upstream.

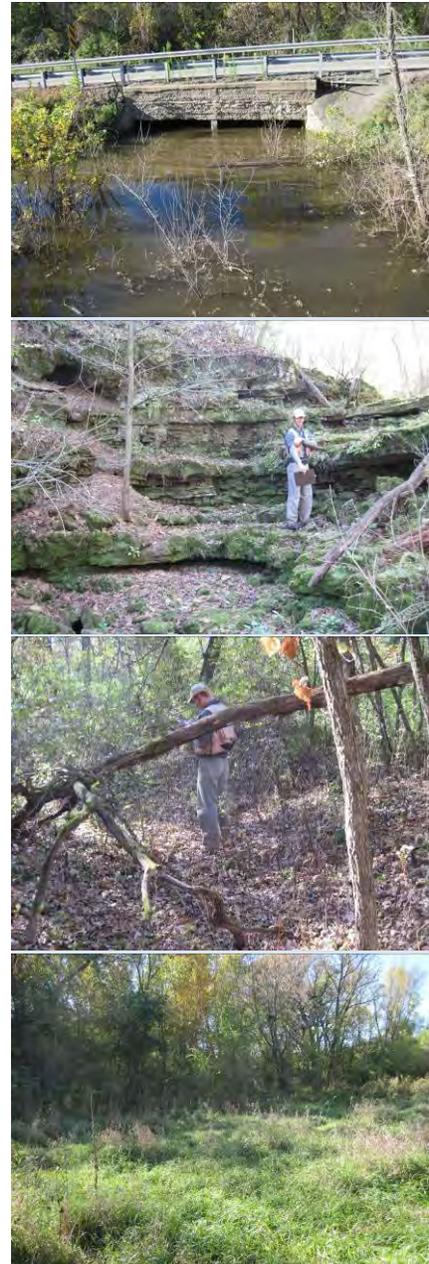
Figure C-22: Ravenna Coulee 2, Reach1 (top to bottom): Stn 300 looking upstream at Ravenna Trail crossing; Stn 2,100 looking upstream at bedrock ledge; Stn 2,850 looking upstream; Reach 2, Stn 4,600 looking upstream.

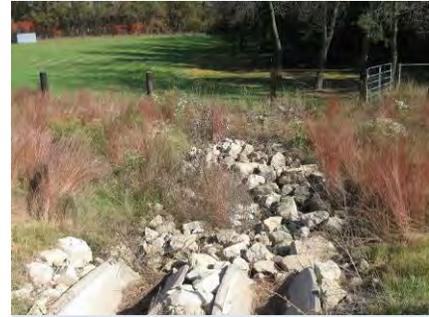
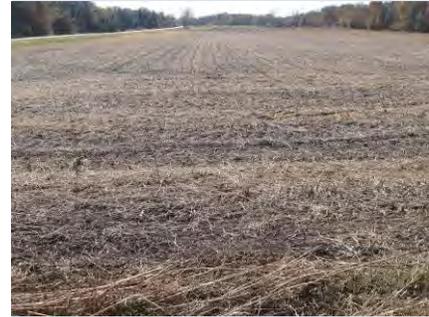
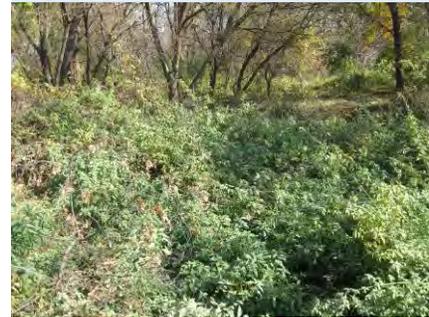
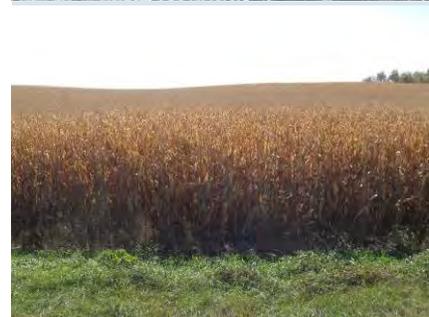
Figure C-24: Ravenna Coulee 3 (Top to bottom): Tributary 1, Stn 6,500 looking downstream; Tributary 2, Stn 6,550 looking upstream; Tributary 4, Stn 450 looking downstream; Tributary 5, Stn 3,800 looking upstream.

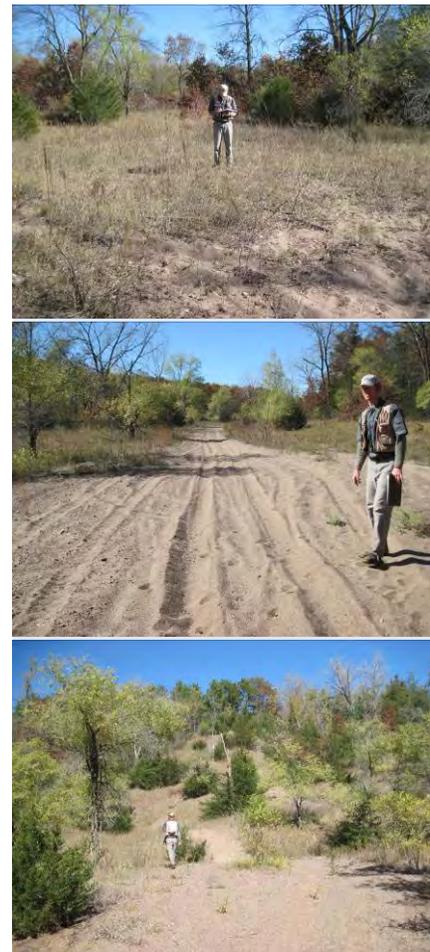
Figure C-25: Ravenna Coulee 4, Reach 1 (Top) Stn 2,750 looking downstream; (middle) Stn 3,700 looking upstream at channel/ATV path; (bottom) Stn 4,400 looking towards left valley wall.

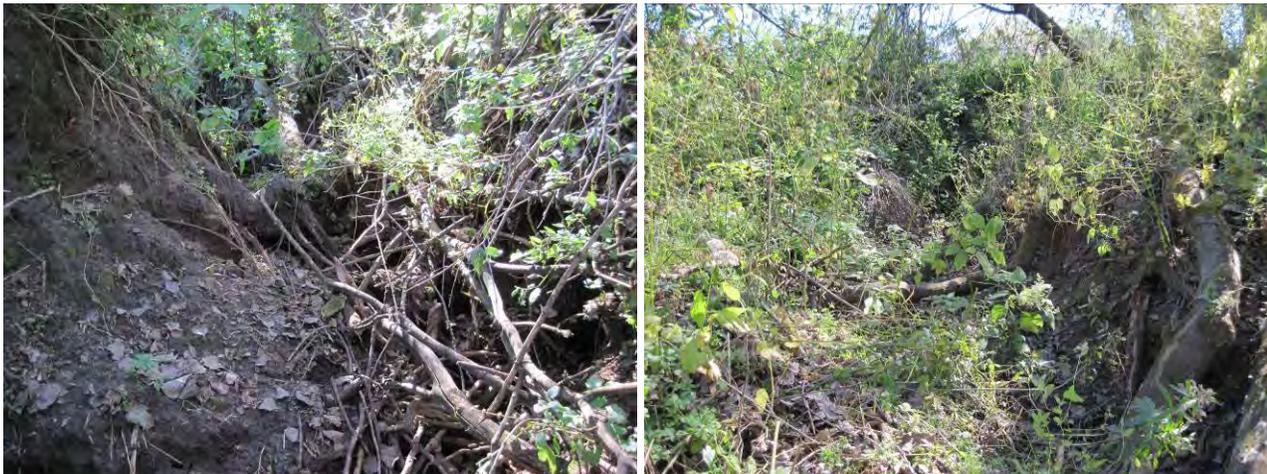
Stream: Etter Creek, Reach 3	Problem description: A bluff ~50 ft tall is actively eroding and slumping. This is natural and was seen elsewhere, but at this location paths are maintained to the edge of the bluff and a bench that has been cemented into the ground is about 6 ft from the edge of the bluff. Through channel migration, the channel has destabilized the toe of the bluff and seeps 30 ft above the channel destabilize the slope. Recent slumps were observed and the sediment lobes had pushed over small willow saplings on the banks of the channel.
Station: 15,600-15,750; right bank	
Solution: The cost effective approach would be to allow the bluff and channel come to an equilibrium: the slumping material will push the channel far enough away from the bluff that further erosion will be minimized. The lower slope will stabilize, revegetate, and the seeps will likely not cause further erosion of the upper slopes. This option would require that the bench be moved away from the eroding slope and that the top of the bluff be planted with shrubs and trees so the roots can help stabilize the slope. A second option is to actively stabilize the toe of the slope with rock or logs and plant vegetation along the slope. The scoring below is for the first option; costs and complexity would greatly increase for the second option.

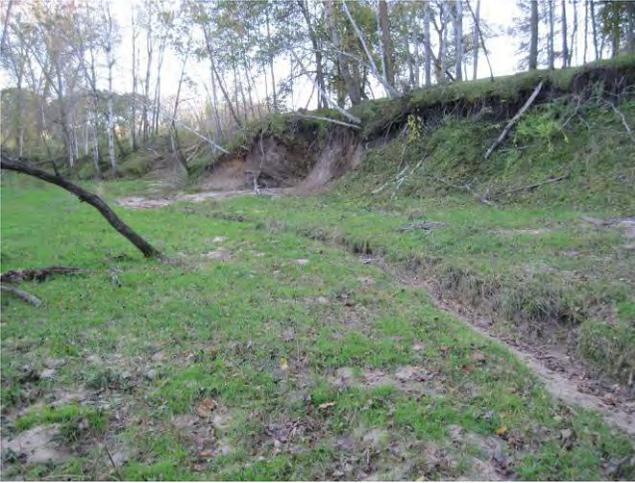
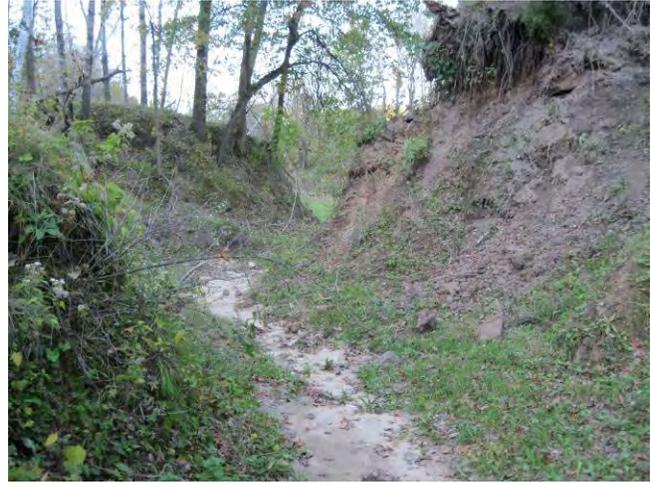
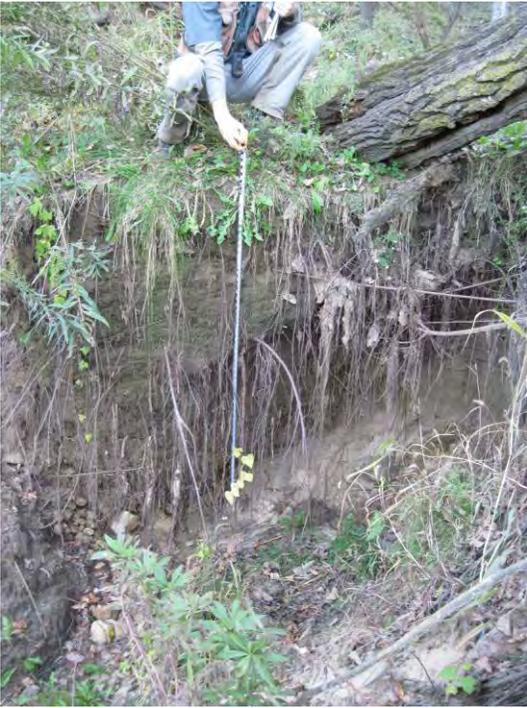
Clockwise from top left: Stn 18,750 looking upstream; Stn 100 of drainage entering Etter Creek at Stn 18,950 - looking downstream towards Etter Creek; Stn 350 of drainage - looking upstream at 7-ft knickpoint.

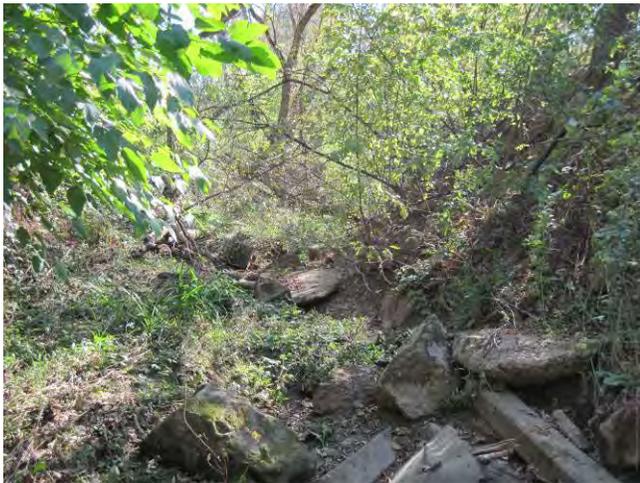
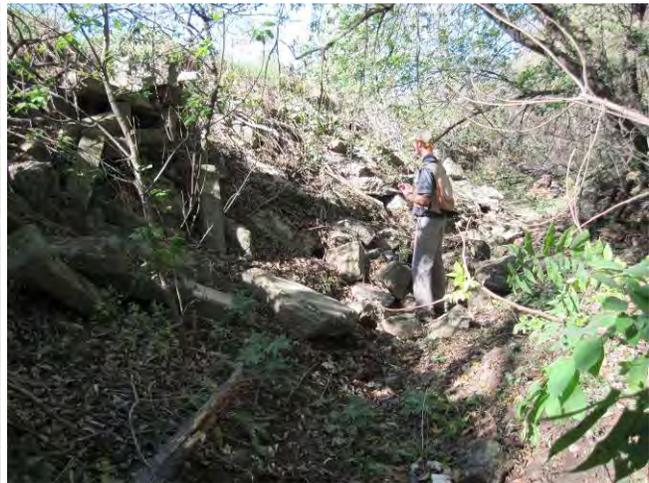
Stream: Etter Creek, Reach 5	Problem description: A 5-ft corrugated metal pipe encased in a concrete driveway is corroded through its base so that water flows through the holes in the metal and along the gravel bed under the culvert. Cracks in the concrete have already developed and continued erosion could further compromise the structural integrity of the culvert and driveway. In addition, concrete, bricks, and other debris have been placed on both banks immediately downstream of the culvert in an effort to minimize erosion. Some of this debris has fallen into the channel increasing instability and the debris on the banks prevents vegetation from stabilizing the banks.
Station: 27,450	
Solution: Replace the culvert with a larger culvert that will not result in a hydraulic jump on the downstream end. This would likely minimize the bank erosion on the downstream end; the debris could then be removed from the bed and the banks could be stabilized with native vegetation.

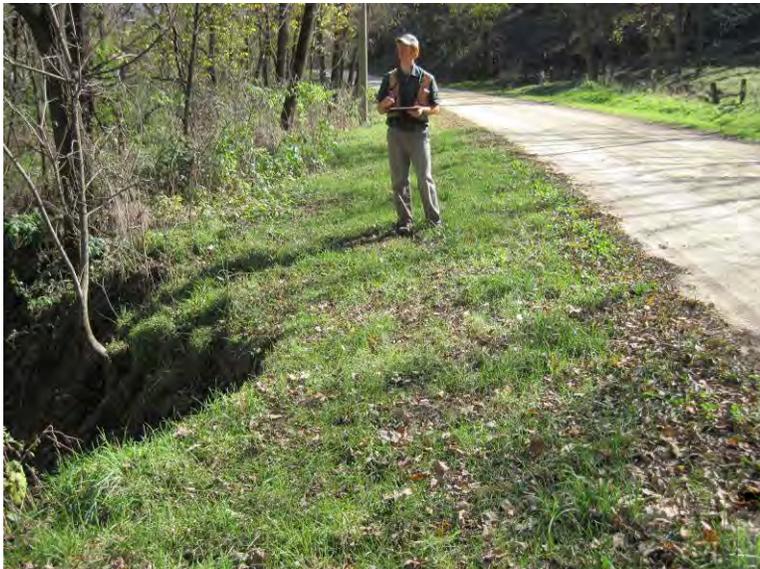
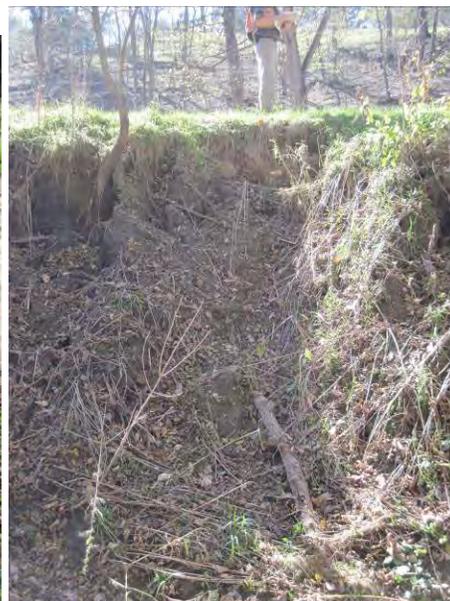
Stream: Etter Creek, Tributary 4	<p>Problem description: A 12-ft knickpoint is actively migrating upstream. A smaller, 3-ft knickpoint is about 10 ft from the edge of Records Trail. Migrating knickpoints can result in significant erosion and sedimentation of streams, damage to infrastructure, and damage to roads. Logs, concrete, and grass clippings have been dumped onto the knickpoints, but this only exacerbates the problem because this debris prevents native vegetative growth that could stabilize the banks. The knickpoints are likely the result of incision on Etter Creek migrating up the tributaries combined with increased water volumes due to land clearing.</p>
Station: 2600	
<p>Solution: A temporary solution (and the one that the scores below are based on) is to re-grade the channel into a series of grade controlling steps and energy-diffusing pools. The banks should also be re-graded to a gentler slope and planted with native riparian vegetation. The buffer between the road and the channel should be increased during this process and vegetation planted to increase infiltration and limit the amount of water draining directly off the road and into the channel. A more long-term solution is to increase the riparian buffer further upstream and incorporate stormwater retention practices to slow the flow of water downstream.</p>
