Vermillion River Watershed Joint Powers Organization  
**Fluvial Geomorphic Assessment of North Creek and  
Middle Creek, Dakota County, MN: Final Report**

January 6, 2012

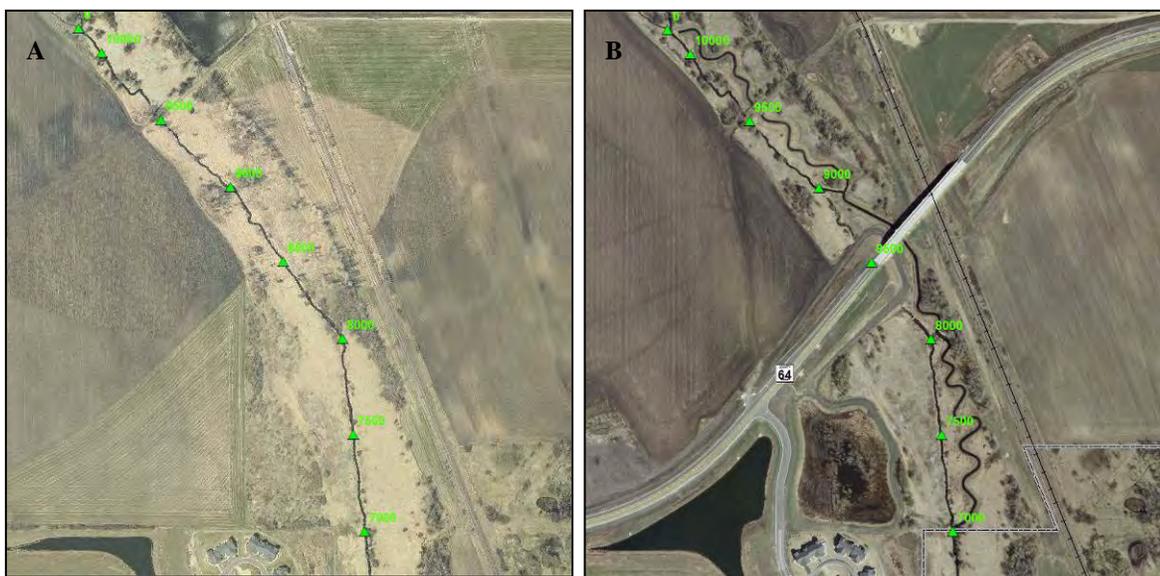
More than 3000 ft of sinuous channel was completed in 2009 along North Creek between Stns 7000 and 10,100 (Figure 9). In addition to increasing channel sinuosity, deep pools and point bars were constructed and native riparian vegetation was planted. A farm road at Stn 9500 was retained as the landowner would like to use it for potential future development to the east of the channel. Because this road and the culverts were not replaced, the restored channel between Stn 8900 and 10,100 was never activated, although the downstream ends of these channels are open and connected. Once this road can be removed or the culverts replaced with larger culverts, the restored channel should be activated as soon as possible.

Figure 9: North Creek (A) before restoration in 2008 and (B) after restoration in 2010.

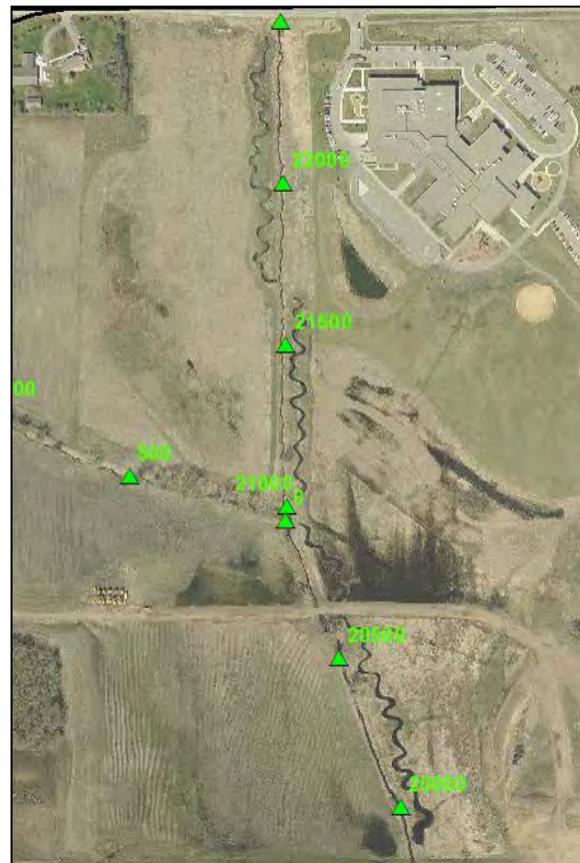
More than 2500 ft of sinuous channel was constructed on Middle Creek in 2006 to replace the straightened ditch between Stn 19,900 and 22,500 (Figure 10). The planform and channel dimensions appear well-designed and appropriate for the increased hydrology. The sinuosity is similar to the historic sinuosity, which is still apparent in downstream reaches of Middle Creek and in historic air photos. The channel is also wider to accommodate the larger flows that occur today. The channel bed elevation was built higher than the existing ditch elevation so that the floodplains could be activated. At the same time as the channel construction, the culverts under 195th St W were replaced to accommodate both the existing ditch elevation and the restored channel elevation. Concerns were raised, however, about the impact of the higher culvert and channel elevation on water elevations and the ability to drain fields upstream of the road. These concerns have not been resolved, so the restored channel has not been activated and remains dry except during large flood events. One possible solution could be to purchase the impacted land upstream of the road and modify the inlet to the culvert to create a stormwater basin. This could be a way to slow flows and trap sediment.

Figure 10: Middle Creek showing the sinuous restored channel that has not been activated. Water still flows through the straightened ditch. The large building in the upper right is the Farmington Elementary School.

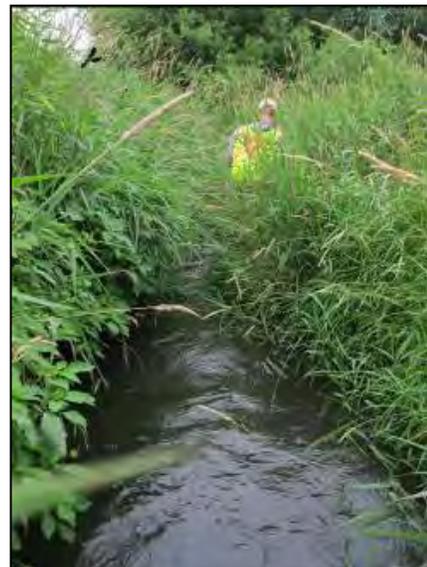
Reach 1 of North Creek Tributary 1 is 1,900ft long and consists of a narrow, straightened channel through a wide wetland on the left with an active farm within 50 ft of the right bank (Figure C-9). Water temperatures are warm (81° F during survey) as this channel is immediately downstream of Reach 2, which is essentially a series of in-stream stormwater basins for the adjacent developments. Because the channel was straightened into a deeper ditch, its interaction with the wetland is less frequent than it was in natural conditions. Restoration could include a more sinuous channel built just below the wetland surface, multiple side channels, and multiple channels that tap into cold groundwater would provide cold-water refugia and serve to cool down the main channels.

Figure C-9: North Creek, Tributary 1; Stn 250 looking upstream from within channel.

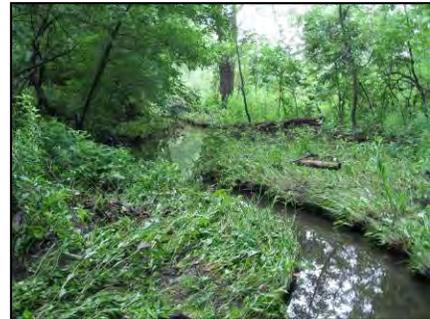
Figure C-14: North Creek, Tributary 5; (top) Stn 3,900 looking downstream.

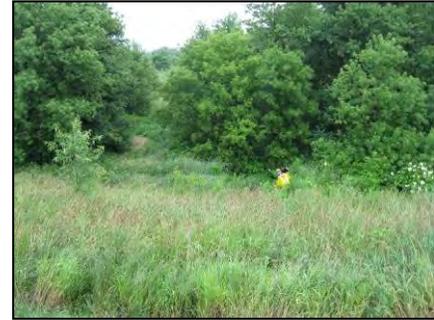
Figure C-21: Middle Creek, Tributary 5; Stn 4425 looking downstream from on top of Flagstaff Rd.

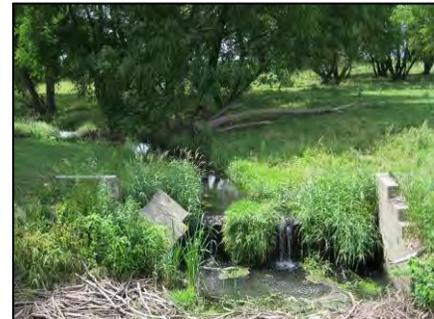
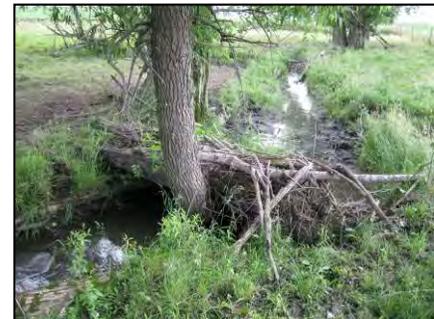
Figure C-22: Middle Creek, Tributary 6; (top) Stn 1350 looking upstream at broken weir; (bottom) Stn 2425 looking upstream at knickpoint.

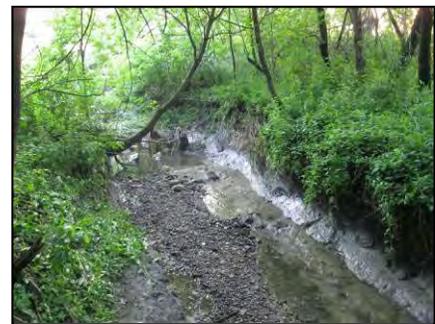
Figure C-28: Middle Creek, Tributary 9; Stn 2450 looking upstream at incision.

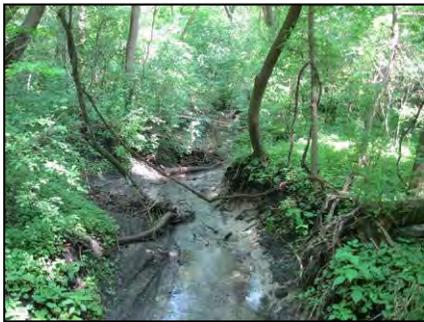
Figure C-29: Middle Creek, Tributary 9; Stn 5,700 looking upstream at active incision.

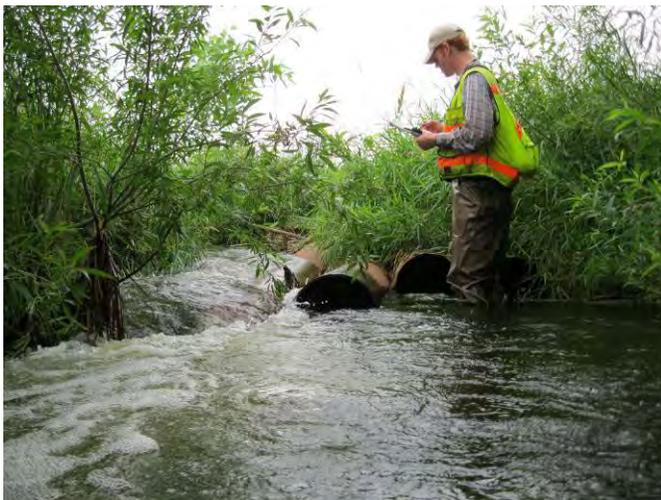
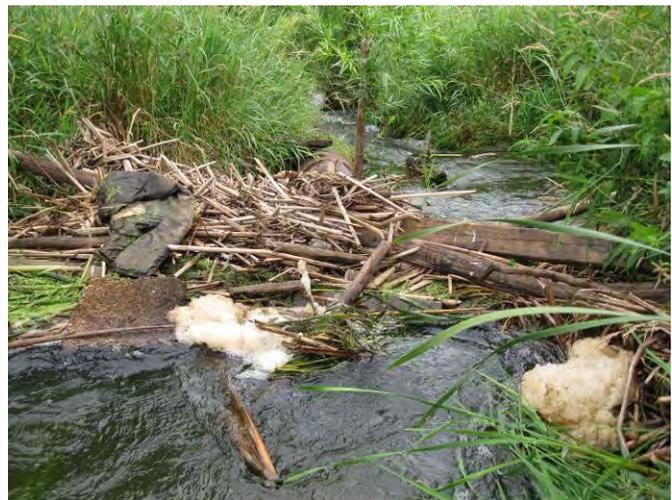
Stream: North Creek, Reach 2	Problem description: An old bridge that consists of 2 abutments and two I-beams remain in the channel. One of the I-beams has fallen and now lies submerged in the water. The earthen berm from the former bridge is cutting off floodplain and wetland connectivity. One I-beam crossing the channel may cause debris to accumulate.
Station: 16500	
Solution: Remove I-beams, concrete abutments and earthen berm.

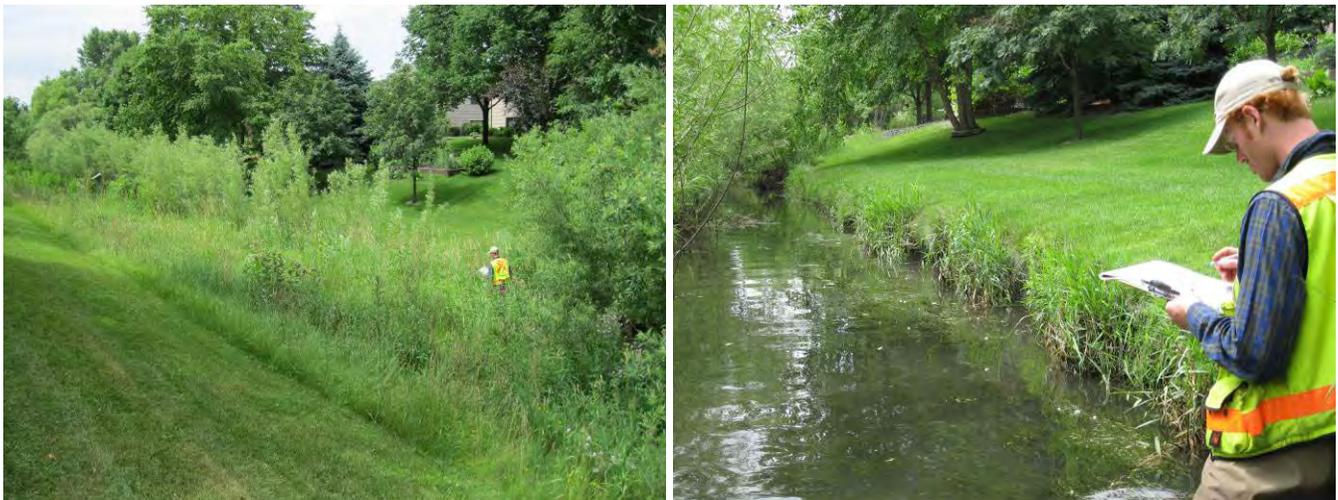
Stream: North Creek, Reach 3	Problem description: 30-ft long riprap cascade was likely built to protect culvert at Flagstaff Ave from a migrating knickpoint. Although there is always a low-flow channel, the gradient may present passage problems (velocity) for some species at certain flows. The channel drops ~4 ft in elevation over the length of the cascade.
Station: Stn 28,050	
Solution: There is room to lengthen the cascade, or build a more gradual riffle/pool sequence

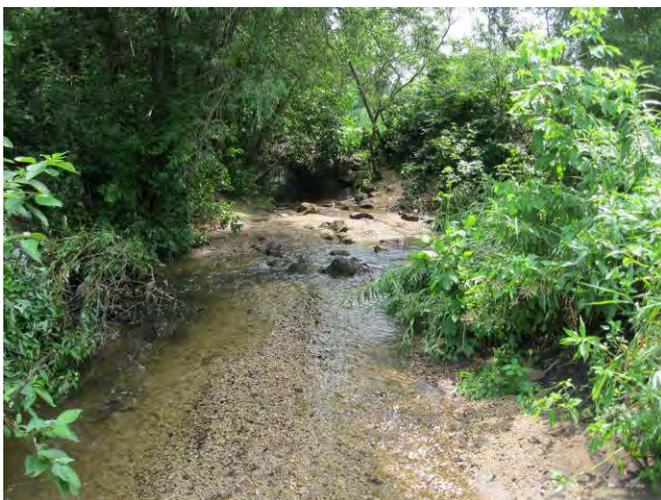
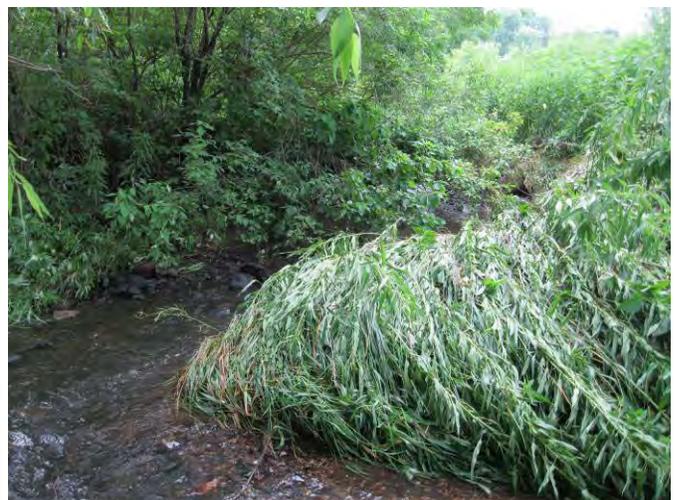
Stream: North Creek, Reach 4	Problem description: 4.5x3-ft corrugated metal pipe under 172nd St W. This is an undersized culvert that is perched 1 ft on the downstream end with a 3-ft scour hole. This presents a fish and aquatic organism passage barrier. In addition, a 1-ft <sup>2</sup> scour hole has developed under the pavement to the right of the pipe on the upstream side - this presents a safety risk due to potential road failure. The road did partially fail recently as repairs were observed and gravel deposits from the road were observed in the channel downstream.
Station: 42,350	
Solution: Replace culvert (and the culvert to the east from the stormwater basin) with larger box culverts or a bridge. This would provide passage during high and low flows and would allow the channel to adjust.

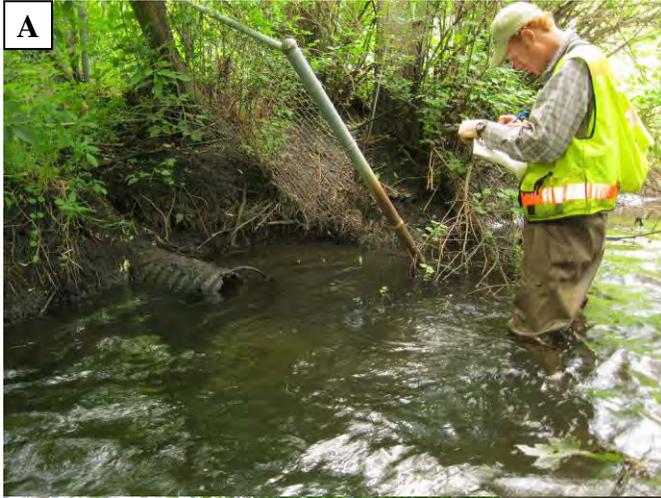
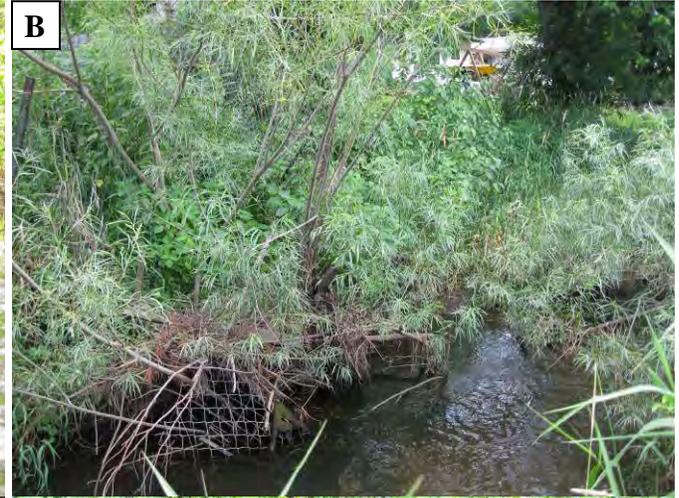
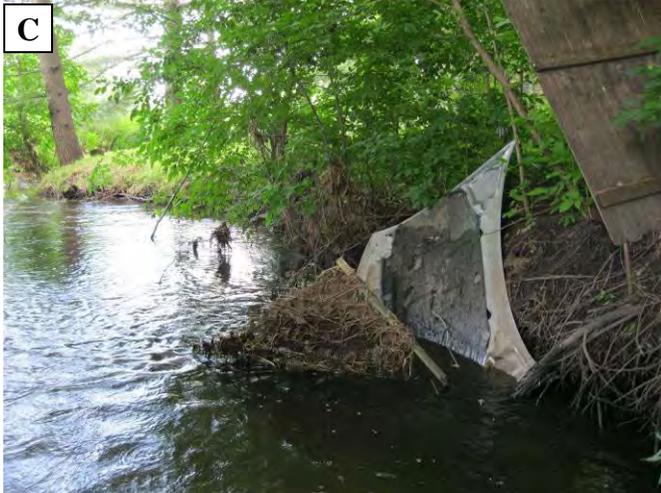
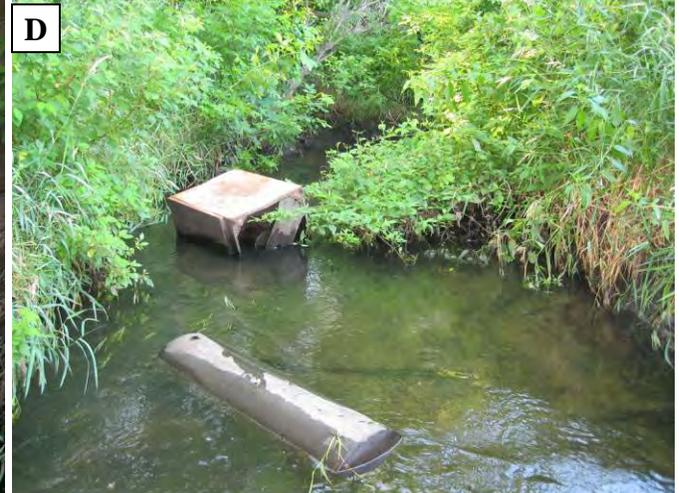
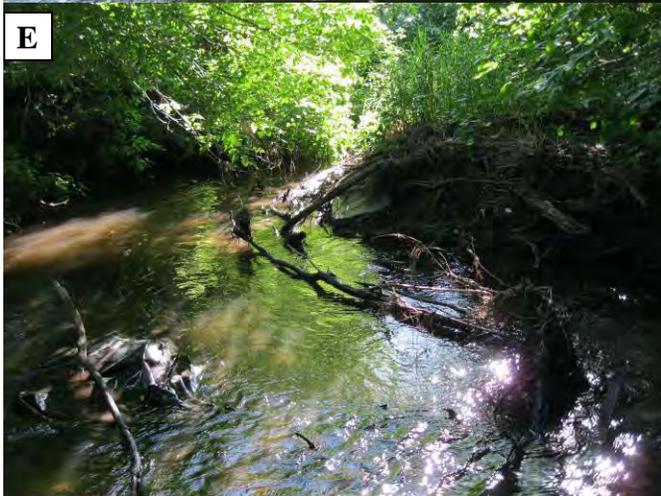
A) Stn 1550 looking upstream at exposed culvert & broken fence; B) Stn 1650 looking upstream at chain link fence and debris in water C) Stn 1850 looking downstream at fence and car hood in water, erosion under wood fence, and unprotected bank with lawn cut to edge further downstream; D) Stn 3100 looking upstream at garbage in water and much more exists on right bank; E) Stn 3600 looking downstream at garbage in the channel

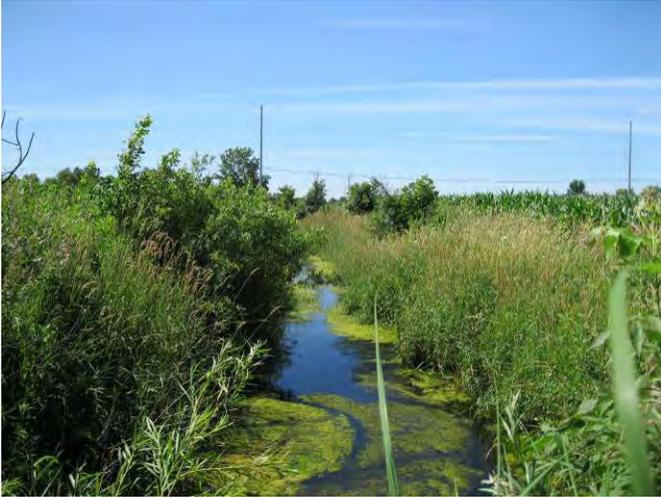
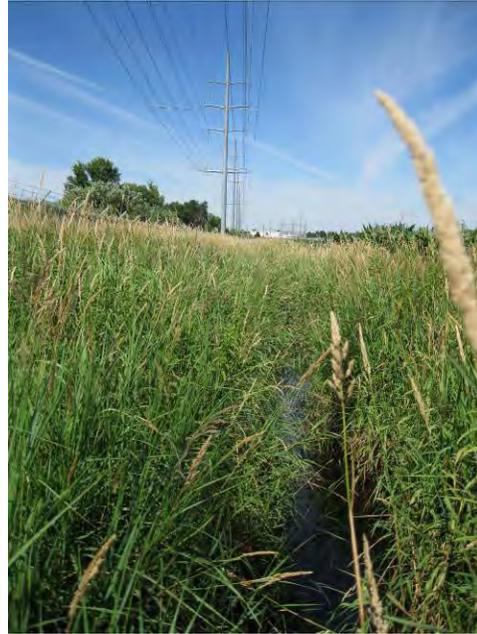
Stream: Middle Creek Trib 6, Reach 1	Problem description: Portions of this reach have little canopy cover, though grasses provide some in-channel shade. Trees planted on small benches between the channel and the ditch walls would provide stability, canopy cover, and geomorphic/habitat complexity as is found in a few locations with trees in this reach.
Station: 500-1200	
Solution: Plant native riparian trees and shrubs both within the ditch and between the row crops and the ditch.

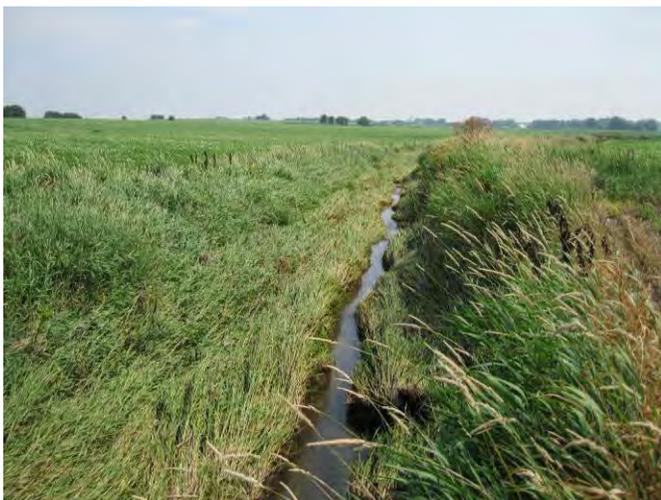
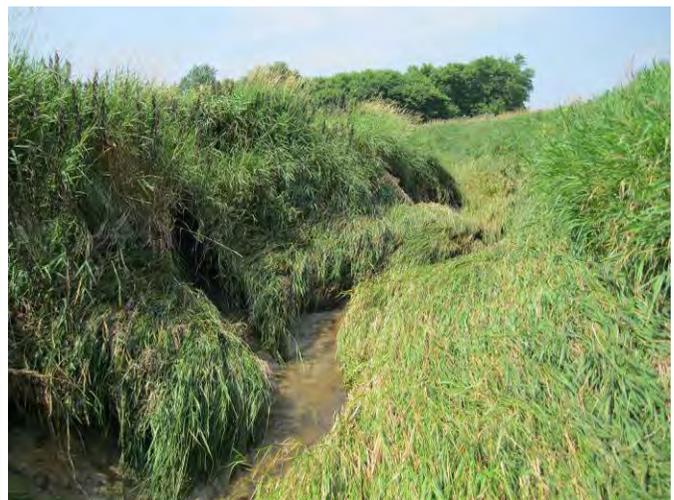
Stream: Middle Creek Trib 7A, Reach 1	Problem description: Incision has resulted in bank erosion and channel widening. Incision is continuing in drainages from fields and may impact field conditions in the future.
Station: 5750-5900	
Solution: Provide toe stabilization and grade control where necessary. Could be incorporated into downstream restoration. Monitor the incision near the fields.
