Vermillion River Watershed Joint Powers Organization
**South Creek Subwatershed Fluvial Geomorphic
Assessment Report**

January 15, 2010

1. Introduction

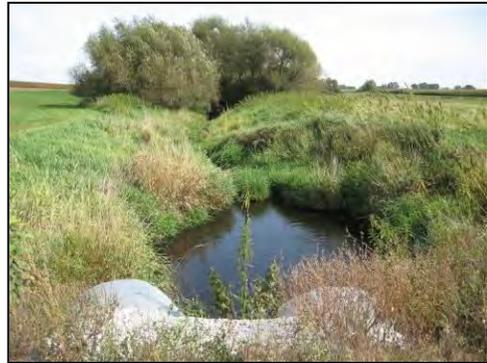
Figure 6: South Creek, Reach 1, station 5150, looking downstream.

Recommendations for management in reach 1 include increasing sinuosity along the entire reach. Between stations 1000-3000 and 4500 and 8300, creating a native riparian buffer with native forbs, grasses, shrubs and trees would improve riparian and in-stream habitat. At station 4600, a corrugated metal pipe on the left bank is perched above the bed and causing bank erosion and a scour pool. The corrugated metal pipes running beneath a dirt driveway at station 5150 are in good condition but are restricting flood flows. Woody debris is caught between the culverts and passage during high flows is likely difficult for fish species.

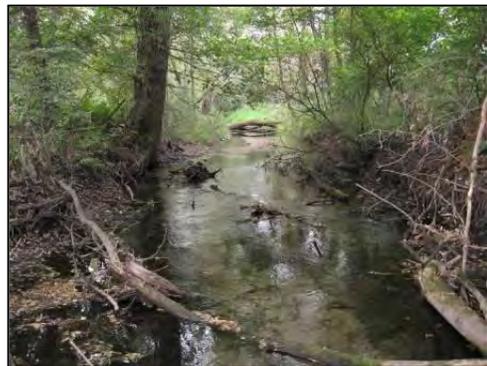
Figure 7: South Creek, Reach 2, station 8800, looking upstream. Downstream from Flagstaff Ave.

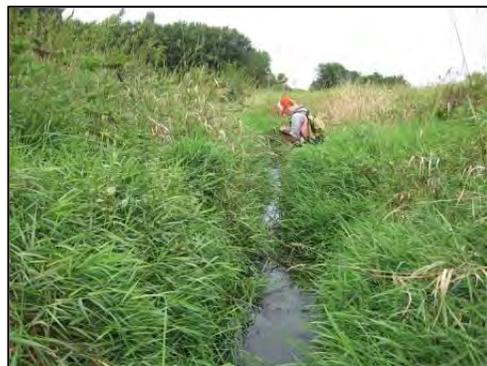
Figure 8: South Creek, Reach 2, station 10700, looking upstream. Upstream from Flagstaff Ave.

Recommendations for management focus on the section of reach 2 that is between stations 9500 and 14000. These recommendations include increasing sinuosity and channel complexity and creating a native riparian buffer. At station 13100, a vehicle crossing has resulted in some bank erosion and sedimentation.

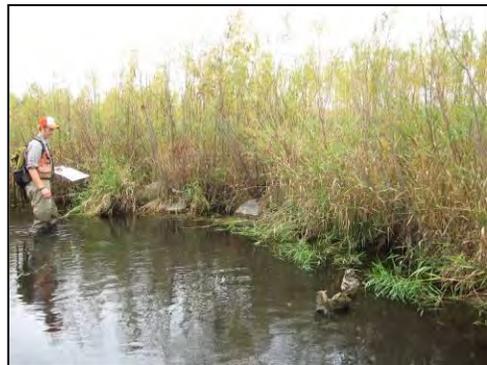
Figure 9: South Creek, Reach 3, station 14200, looking upstream; boulders and rootwads on outside of bend in pool.

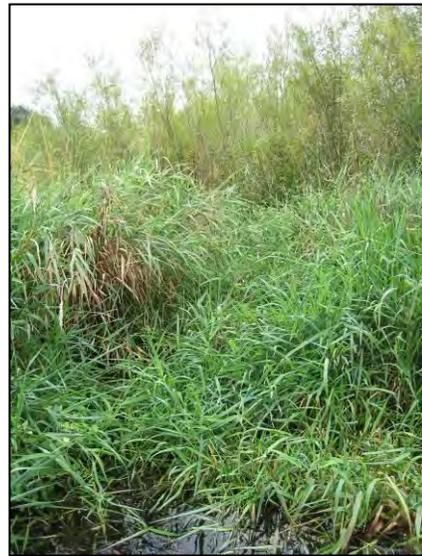
Figure 10: South Creek, Reach 3, station 15800, looking upstream; reed canary grass choking the channel.

Managing the reed canary grass in this reach will help the existing restoration fulfill its potential. Additionally, two petroleum pipes and one fiber optic line cross the channel at or below water line. The location of utility pipes in the channel may be a safety hazard and may be, or have the potential to be, negatively impacting water flow and water quality.

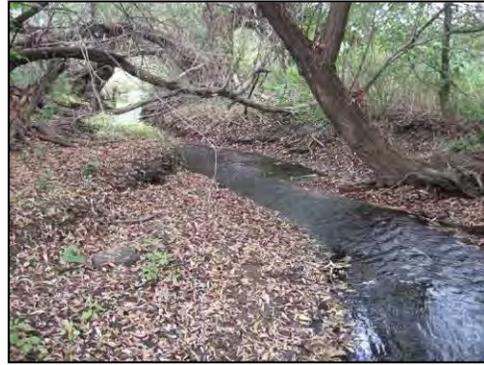
Figure 11: South Creek, Reach 4, station 20200, looking downstream.

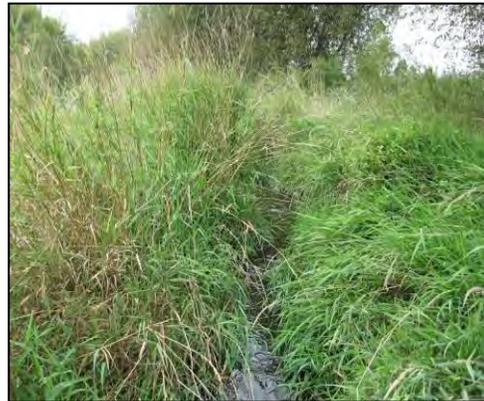
Figure 12: South Creek, Reach 4, station 20550, looking upstream.

Elsewhere downstream of station 21000 (Hamburg Ave crossing) the channel is narrow with vertical banks, reed canary grass overhangs most of the channel, the floodplain is narrow or non-existent and there is no canopy cover (Figure 12). There are some undercut banks and overhanging grasses that create in-stream cover. Upstream of station 21000, algae coated the water surface in pools and thick fine sediment covered the channel bed. When this sediment was disturbed, a gaseous and putrid odor was observed emanating from the water. Three grade control structures occur between the pools to prevent further incision or headcutting. These structures would likely not present passage problems to trout but may deter passage of other species. Even if passage was possible, there is little habitat available upstream as the natural channel is dry and the source of water comes through a long pipe from city runoff. Upstream of station 21000, the

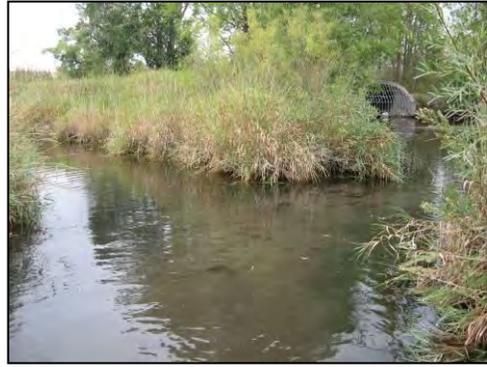
Figure 13: South Creek, Reach 4, station 22100, looking upstream. Main channel is on the left side of the figure, but the main water source is from city drainage through the pipe on the right.

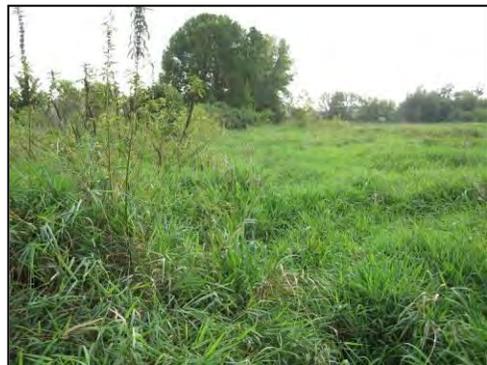
Figure 14: South Creek, Reach 5, station 23600, looking upstream at dry channel and open field.

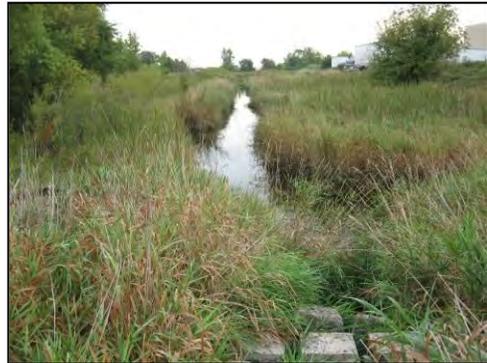
Figure 15: South Creek, Reach 5, station 22200, looking downstream with the levee and tiling in the foreground.

Many management projects would improve reach 5. Removal of the tiled levee across the channel at station 22200 would improve fish passage and channel connectivity. A fish-friendly grade control could be built to replace the levee. Increasing the sinuosity and native riparian vegetation throughout this reach will improve channel and habitat complexity. Because there is little room for restoration between station 24500 and 26700, the straightened channel could be changed to a more sinuous channel but still kept within the confines of the narrow valley walls.

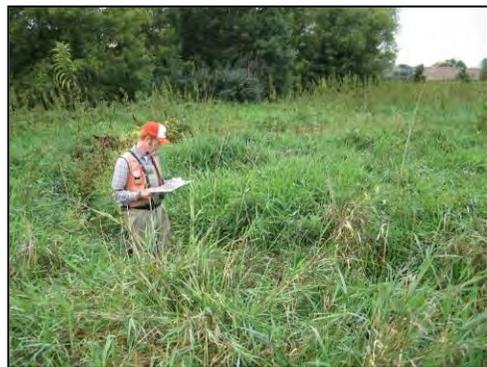
Reach 6, extending from station 27300 to 30600, is a restored reach with a highly sinuous planform (Figure 16). The tight bends in the channel are connected by narrower channels (6-8 ft bankfull width) with sand and gravel riffles. These riffles do not have any large gravel or cobbles for habitat, but the water depth is lower and these act as grade controls. The pools on the outside bends are deeper and contain about a foot of deposited fines on the bed. The banks here are stabilized by placed boulders and root wads and logs. Some of these have some erosion on the upstream end, but flows in this

Figure 16: South Creek, Reach 6, station 28600, looking upstream at sinuous channel.

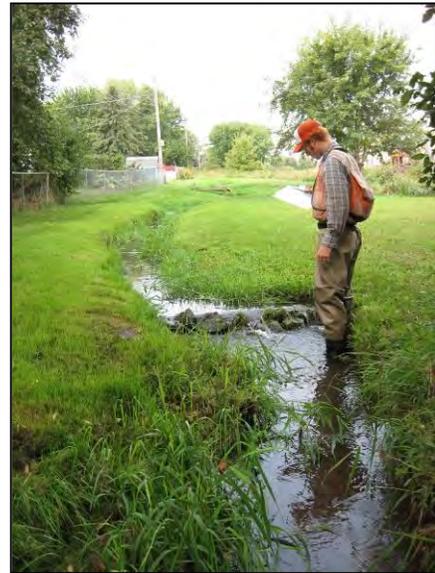
Figure 17: South Creek, Reach 7, station 31200, looking upstream at small check dam and mowed riparian area.

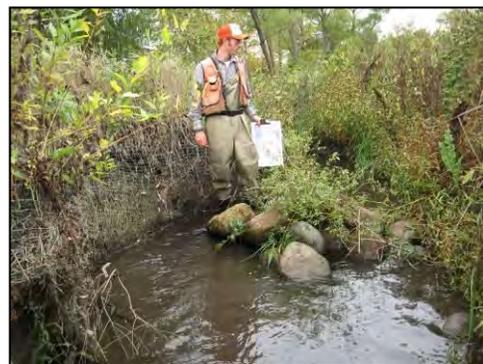
Figure 18: South Creek, Reach 7, station 32700, looking upstream at erosion around boulder grade control and fabric on banks.

There are a few cobble and boulder grade controls attached to the banks; excessive erosion has caused some of these structures to unravel, especially at station 32700 (Figure 18). Planted native riparian vegetation was noticeable, but reed canary grass is also abundant. The restoration in this section is not complete and it is likely some of the erosion and vegetation problems will be fixed during future stages of the project.

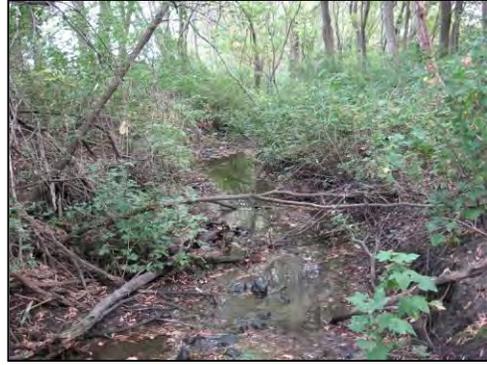
Figure 19: South Creek, Reach 7, station 41200, looking downstream.

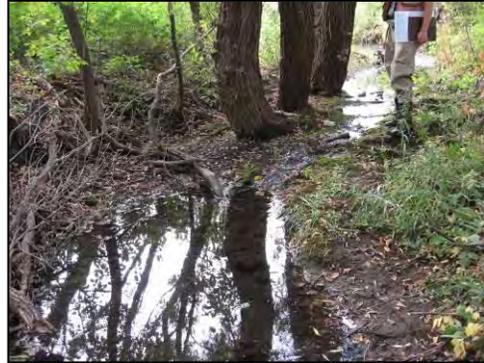
Figure 20: South Creek, Reach 7, station 41750, looking upstream at roots preventing further incision.

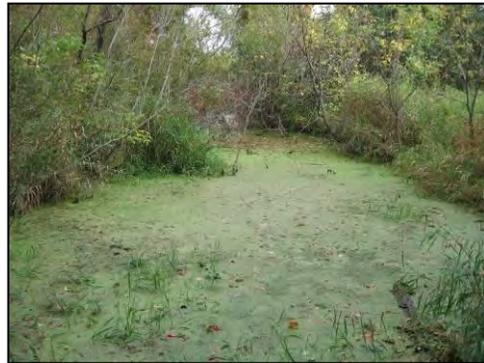
Figure 21: South Creek, Reach 7, station 42300, looking downstream at backwatered pool.

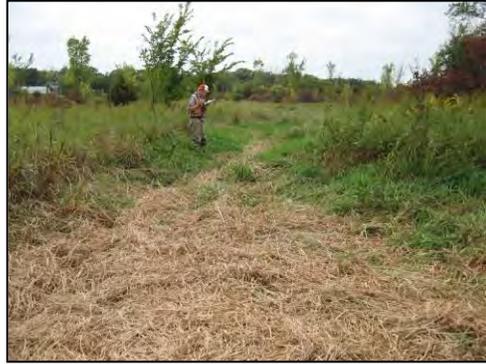
Figure 22: South Creek, Reach 8, station 43950, looking upstream at field with dry channel.

We do not recommend any restoration projects in this reach because of the lack of a defined channel and water for most of the year.

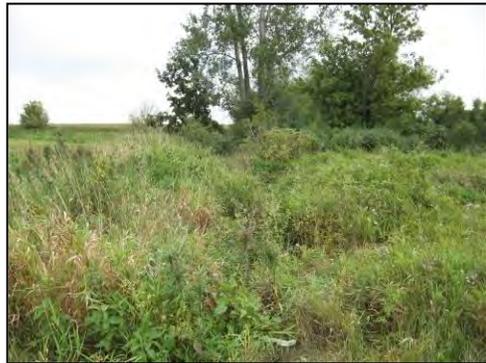
Figure 23: Tributary 1, Reach 1, station 150, looking downstream.

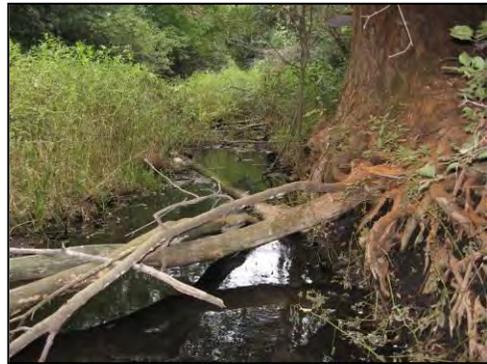
Figure 24: Tributary 2, Reach 1, station 600, looking downstream at active channel.

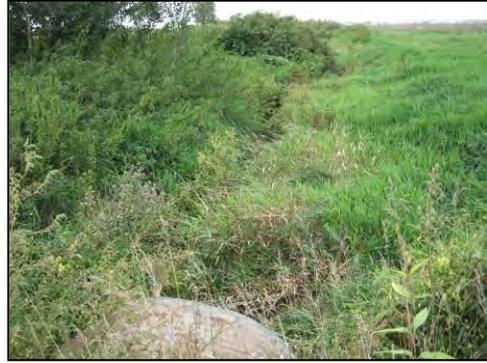
Figure 25: Tributary 2, Reach 1, station 1200, looking upstream at straightened channel.

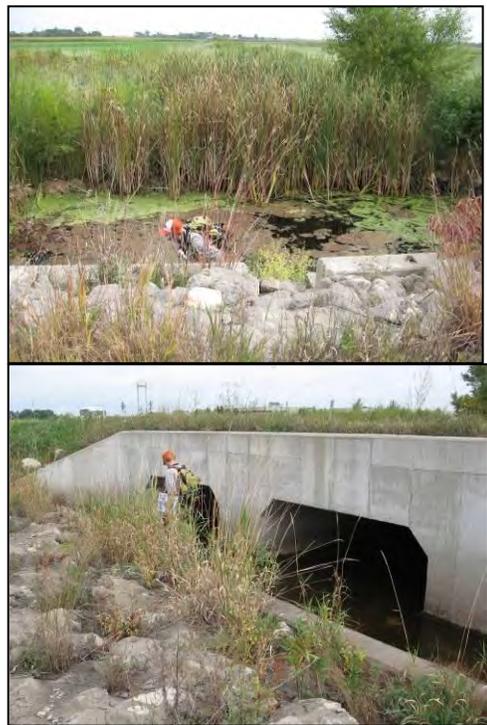
Figure 26: Tributary 2, Reach 1, station 6100 looking at riprap dam and pool downstream from culvert (top) and at concrete wall and riprap upstream from the culvert (bottom).

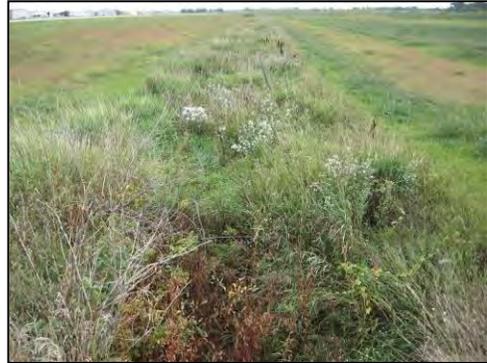
Figure 27: Tributary 2, Reach 2, station 11500, looking downstream at channel between runways.

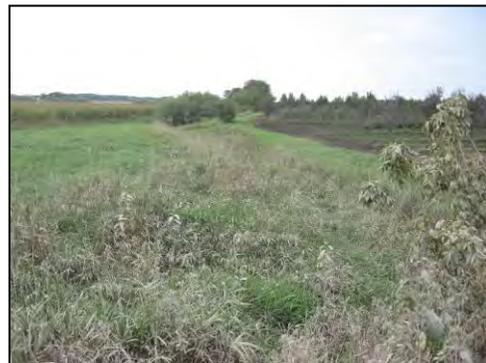
Figure 28: Tributary 2, Reach 3, station 12500, looking upstream at dry channel between row crops.

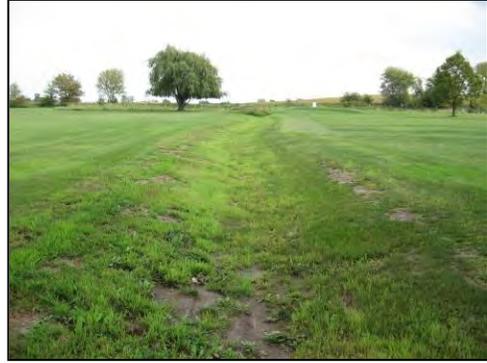
Figure 29: Tributary 2, Reach 3, station 18100, looking downstream at dry channel and mowed lawn in Frisbee golf course.

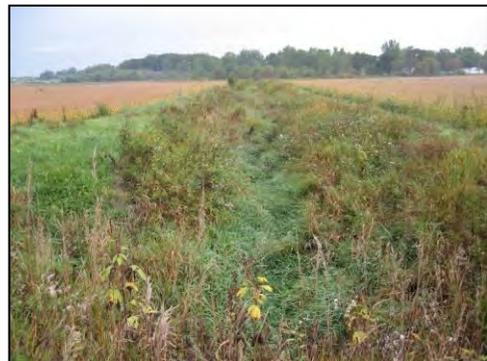
Figure 30: Tributary 3, Reach 1, station 2100, looking upstream.

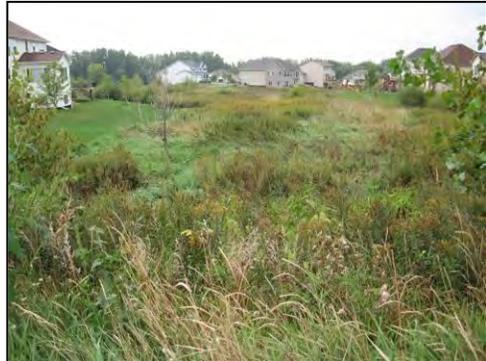
Figure 31: Tributary 3, Reach 2, station 7200, looking downstream towards wetlands in residential development.

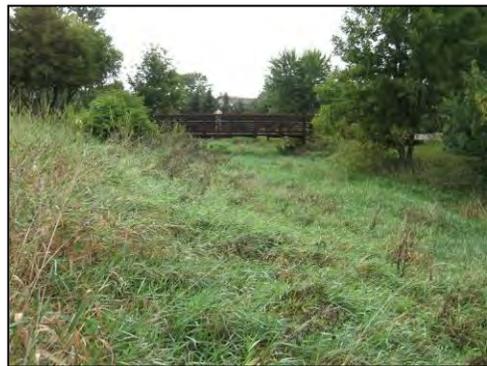
Figure 32: Tributary 4, Reach 1, station 3900, looking downstream at footbridge crossing the dry channel.

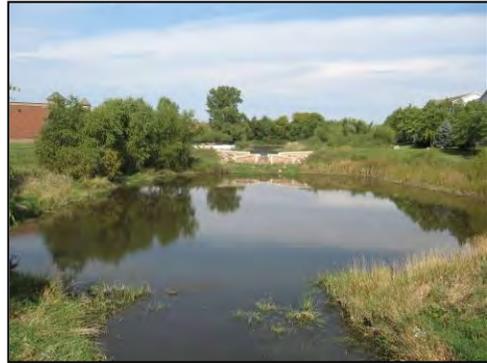
Figure 33: Tributary 4, Reach 2, station 9600, looking upstream at dam and detention basins in residential and commercial area.

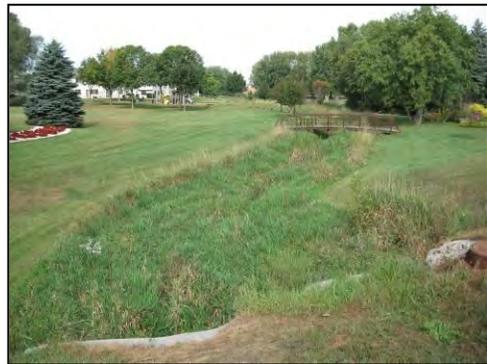
Figure 34: Tributary 4, Reach 2, station 7950 looking upstream at dry channel through James Jensen Park.

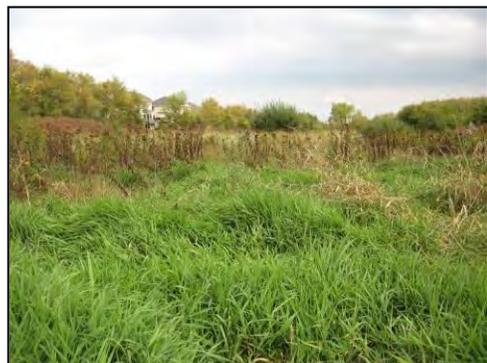
Figure 35: Tributary 4, Reach 2, station 18500 looking downstream at wetland in the headwaters of the tributary.

We do not recommend any channel restoration projects in this reach. There is not enough water in the system to provide continuous flow for fluvial species, so the created wetlands from dams and grade control structures are a good way to provide wetland and lacustrine habitat. We do recommend increased riparian buffer in James Jensen Park. Planting native shrubs and trees would provide additional canopy cover.
