October 24, 2018

CENTURY RIDGE TOWNHOME ASSOCIATION

STAGE II IRRIGATION AUDIT REPORT

WATER IN MOTION, INC.

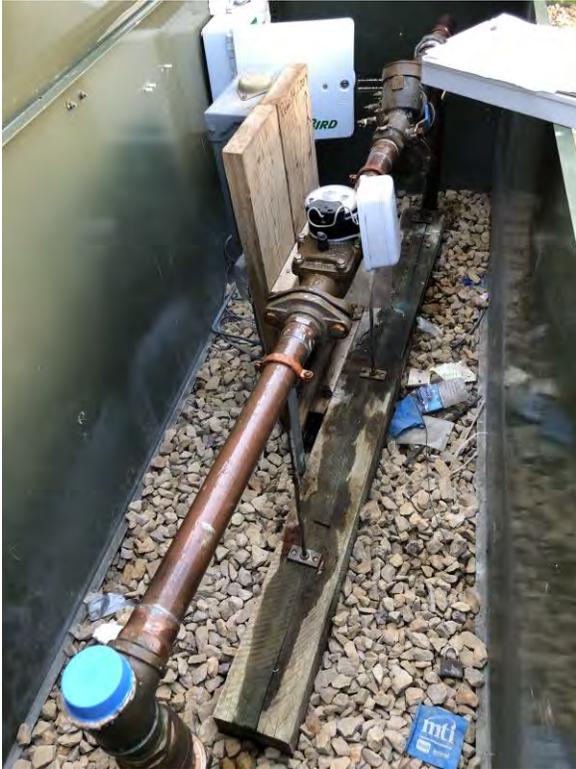
The water supply at 18800 Inca Avenue is assembled with copper and brass piping. This water supply cabinet also houses the irrigation controller and the electric supply. While the transformer is located inside a weather-proof box, wiring is exposed. See Figures 1 and 3.

Figure 1 (above): Irrigation water supply cabinet at 18800 Inca Avenue

- Remove the controller and electric connection from the water supply cabinet.
- Raise each valve box to final grade and remove debris.

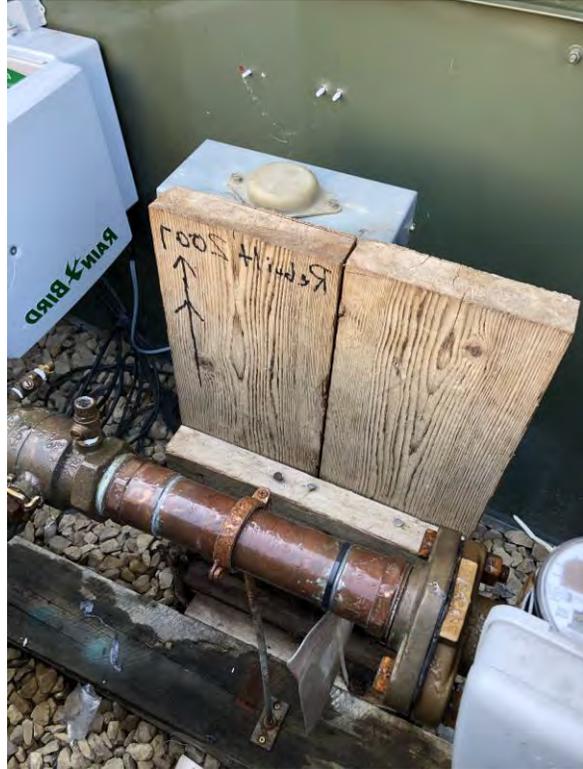
Figure 2 (above right): Electric supply in water supply cabinet at 18800 Inca Avenue

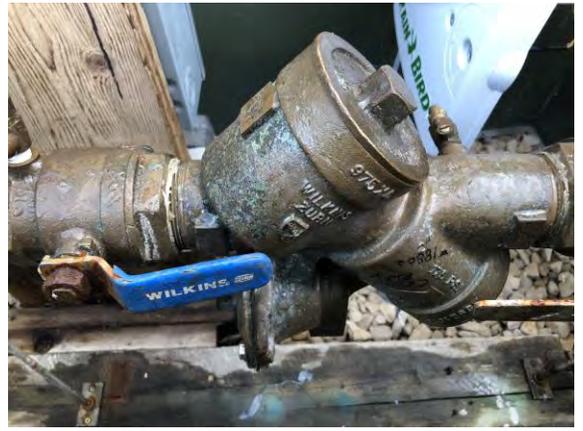
Figure 3 (right): Reduced pressure zone assembly (RPZ) in water supply cabinet at 18800 Inca Avenue

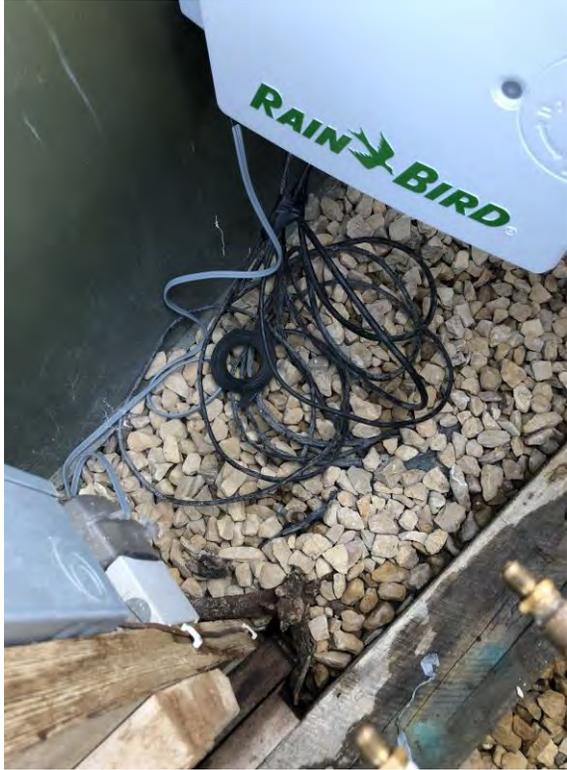
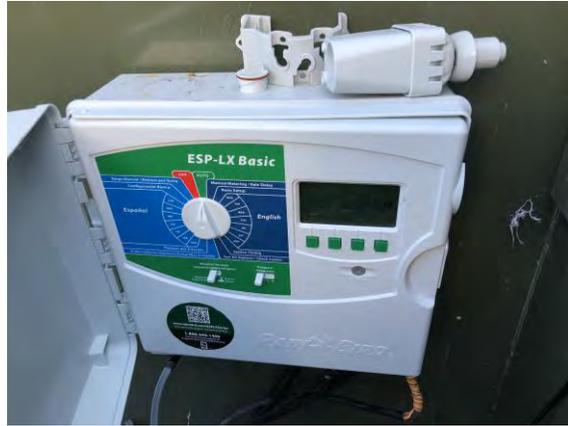
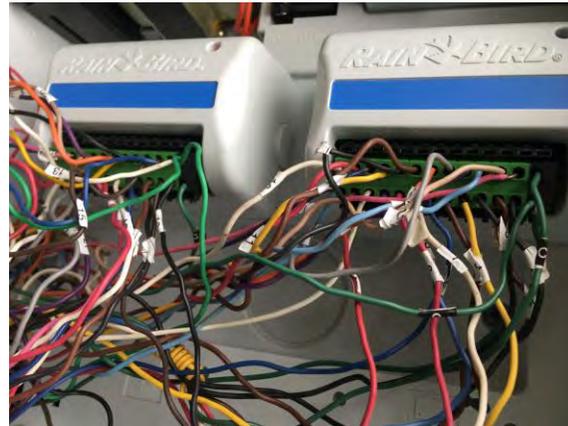
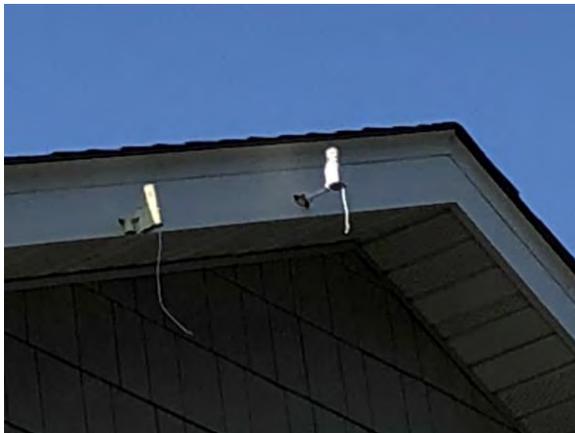
The controller is traditionally wired and contains two 12 station modules. Each module contains more than 12 field wires, hardwired to valves in the field, each operating one or more stations. See Figure 6. There are 24 programmed stations, the programmed irrigation schedule at the time of the audit is below.

On output ports of the irrigation controller where best practice is to hardwire a single station of irrigation, WiM found multiple stations of irrigation operating. The station map below indicates which stations operate together, indicated by "A", "B", and "C".

Figure 4 (above): Irrigation controller
Figure 5 (above right): Electric supply to irrigation controller
Figure 6 (right): Wiring in modules of irrigation controller
Figure 7 (below): Non-functional wireless rain sensors mounted at 18800 Inca Avenue

| F | High | Rewire controller to operate the 43 valves present on the site separately. Currently at Century Ridge there are stations operating alongside one or two other stations. WiM recommends installing two 12 station modules in the ESP-LX Basic controller. The 43 stations can then be operated separately after rewiring. | \$350 - \$450 | Assuming there are no field wiring issues |

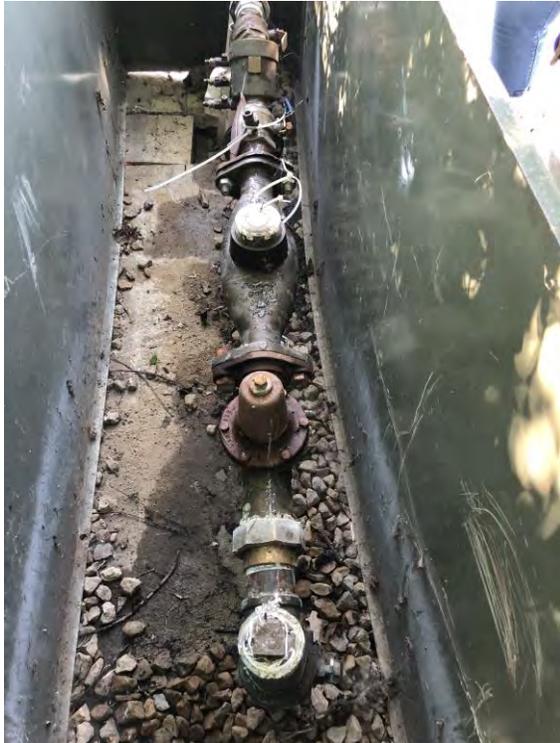
A portion of the water supply assembly piping at 18970 Inlet Road is PVC and includes a pressure reducing valve in the water supply cabinet. The remainder of the assembly is comprised of brass and copper. The water supply cabinet hood is broken. See Figures 8, 9 and 10.

Figure 8 (above): Water supply assembly at 18970 Inlet Avenue

| S | Low | Repair water supply cabinet hood at 18970 Inlet Road. | \$120 - \$300 | |

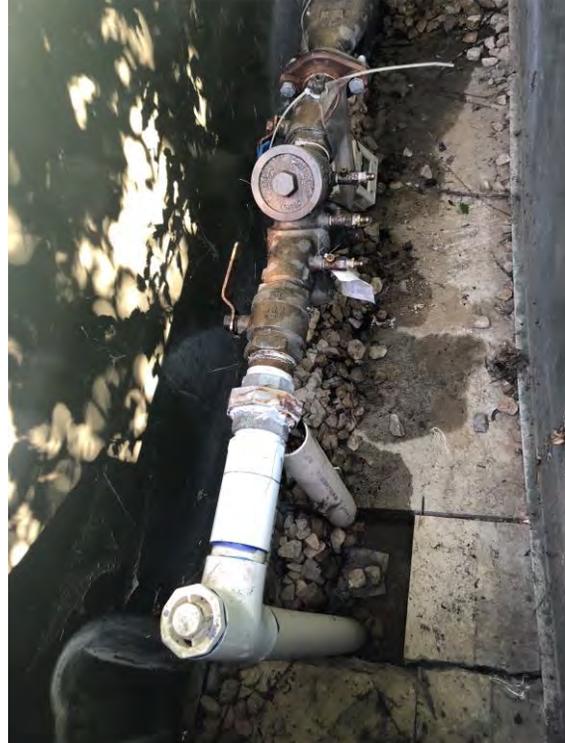
Figure 9 (above right): PVC product water pipe at 18970 Inlet Avenue

| J | Medium | Replace the water supply PVC pipe in the water supply closet at 18970 Inlet Road with copper or galvanized steel pipe. Both copper and galvanized steel are more durable than PVC pipe, which is more likely to break causing leaks and a repair to the water supply assembly. | \$500 - \$800 | |

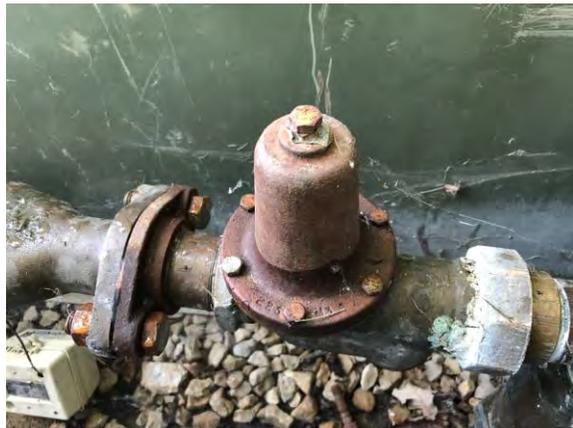
Figure 10 (right): Pressure reducing valve at 18970 Inlet Avenue

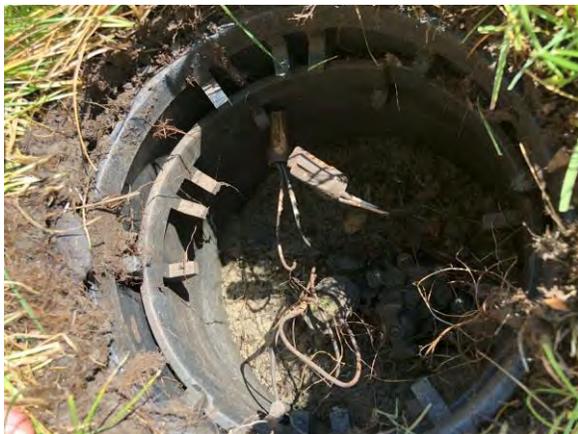
It was difficult or impossible to locate valve boxes. Nearly all valve boxes were sunken or overgrown with cool season turf. The valve boxes that were visible were oftentimes not flush with the landscape (Figure 18). The valve boxes that were inspected during the audit were oftentimes had debris such as soil, rock or water surrounding the valve (Figure 11).

Figure 11 (below): Typical valve box and field wiring

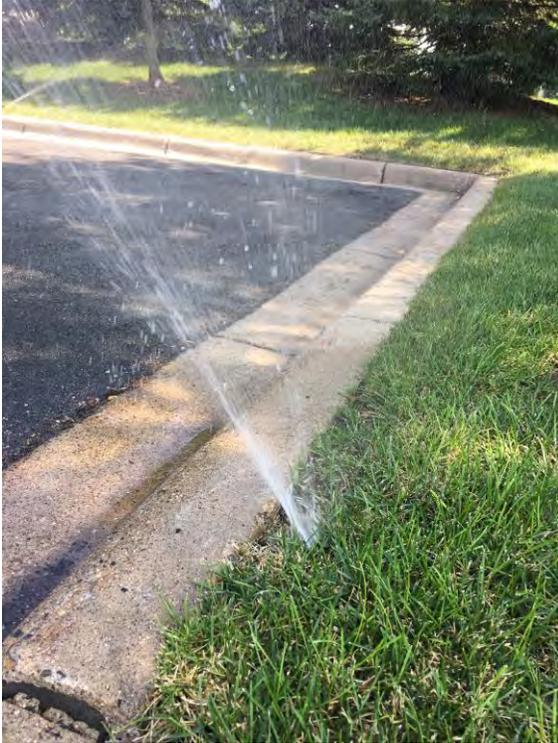
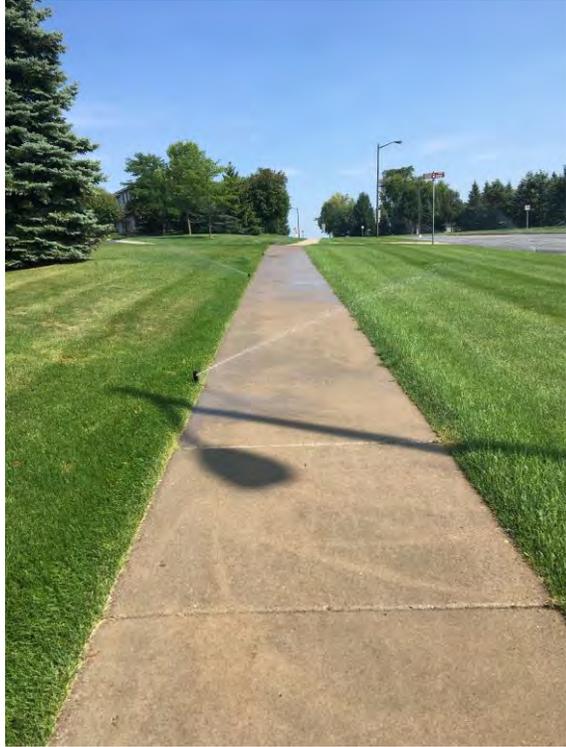
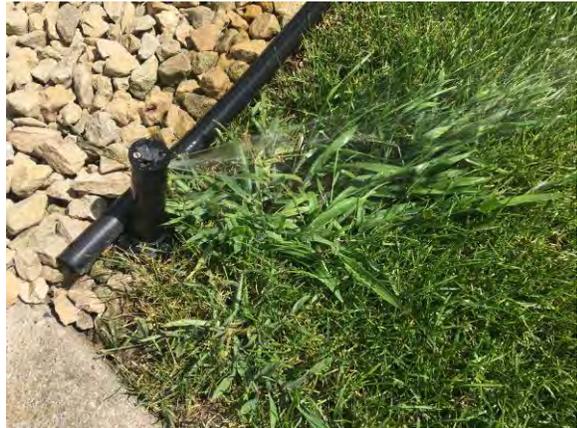
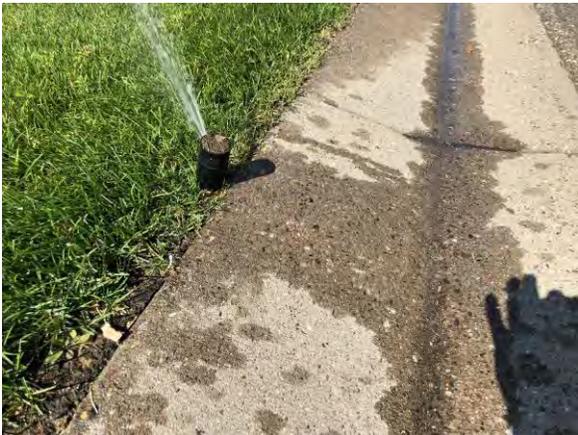
The nozzle of various rotors are not suitable to the landscape they were intended to irrigate. Most often, the arc angle is correct; however, the rotor should be adjusted. For example, a 180° nozzle is correct, but the arc causes the rotor to distribute water mostly on the pavement. See Figure 12. In some cases, the nozzle selection is incorrect and either does not irrigate the intended landscape or irrigates hardscape. For instance, a 180° nozzle is placed in a corner and is irrigating the landscape as well as the parking lot adjacent.

Figure 12 (above): Rotor spraying onto pavement
Figure 13 (above right): Rotor spraying over sidewalk
Figure 14 (right): Pitched rotor
Figure 15 (below): Pitched rotor

| ITEM | PRIORITY | DESCRIPTION | ESTIMATED COST | ADDITIONAL INFORMATION |
|---|---|--|---|--|
| A | High | Repair or replace sprinklers that are sunken, pitched, leaking, or clogged to improve performance. One broken sprinkler can waste hundreds of gallons per irrigation cycle, and up to thousands of gallons per week. | \$4,455 - \$5,245 | |

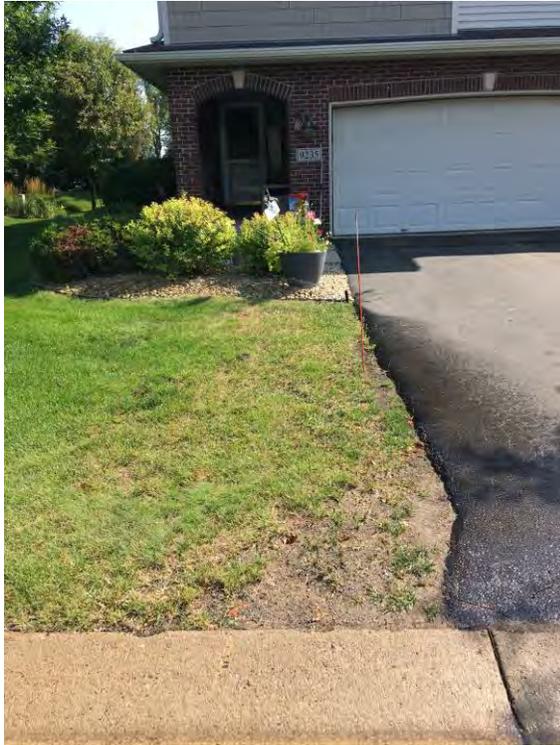
Figure 16 (above): Missing sprinkler in corner, dry spot evident

| L | Medium | Sprinkler to sprinkler coverage should be maintained in all areas of the irrigated property. Align sprinklers in such a way that the end of the spray of one sprinkler reaches the next sprinkler per best practice and manufacturer recommendations. Responsible addition of sprinklers on deficient stations may be a remedy to stations lacking proper performance. | \$1,200 - \$1,500 | Assuming addition of 20 sprinklers |

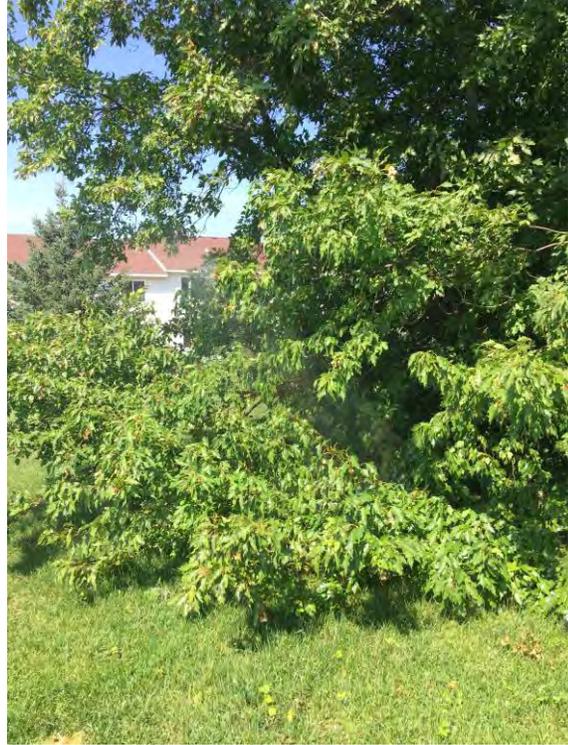
Each building at Century Ridge has one irrigation station surrounding the building. The additional stations irrigate cool season turf along roads or in between buildings. Rotors throwing into wooded areas is common, particularly on stations serving the greater landscape. See Figure 17. WiM also observed rotors throwing into conifers throughout the HOA (Figure 22). Damage to the conifers can be seen where the tree is hit by the stream of water.

Figure 17 (above right): Rotor now located in the woods, spraying into the woods

| H | Medium | Move or cap the sprinklers currently placed in wooded areas. The irrigation water applied to this landscape is unnecessary and could damage the trees. | \$450 - \$550 | Assuming 5% of sprinklers |

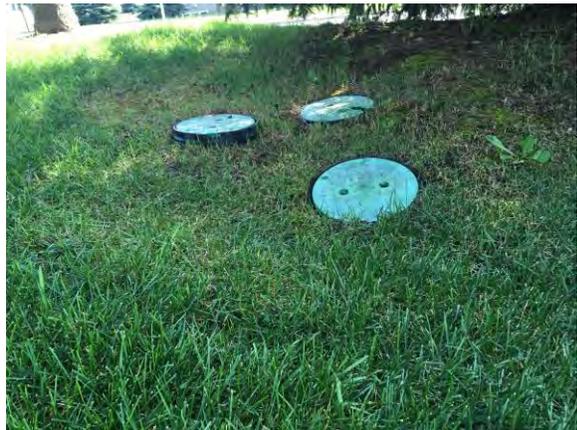
Figure 18 (right): Valve boxes sunken and askew

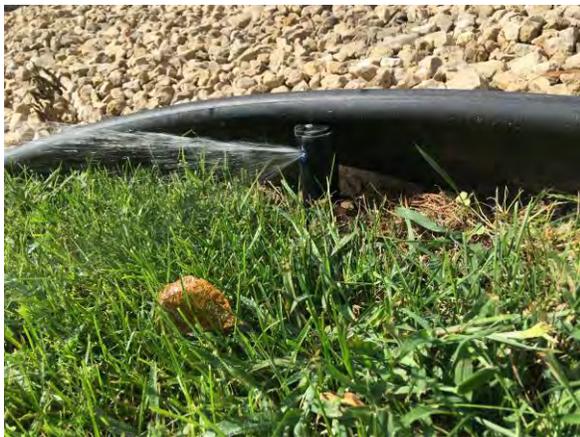
Figure 19 (below): Rotor unable to pop up due to landscaping

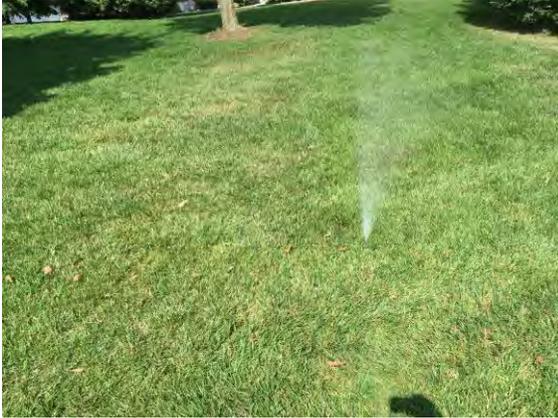
Figure 20 (above): Rotor not rotating, dry areas beginning to appear

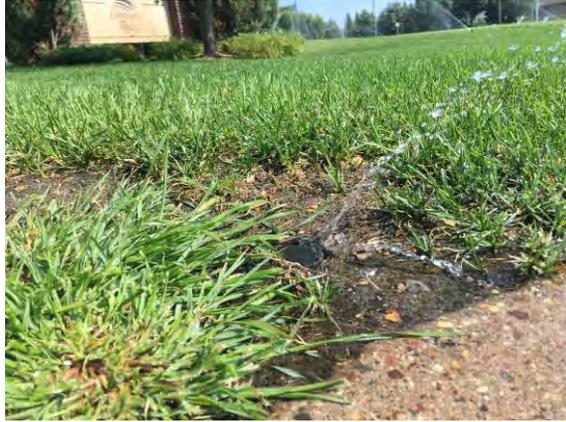
Figure 21 (above right): Broken rotor

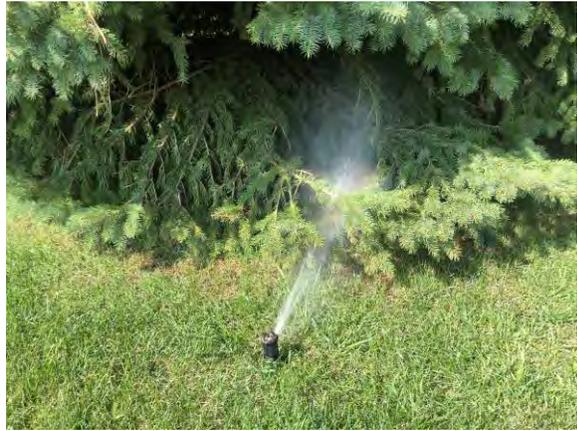
Figure 22 (right): Rotor spraying into conifer

| I | Medium | Adjust sprinklers so they are not spraying directly into conifers. The stream of water will oftentimes damage tree growth. | \$1,800 – \$2,400 | Assuming 5% of sprinklers |
