Lower Vermillion River Geomorphic Assessment

FINAL SUBMITTAL
December 2018

Vermillion River Watershed Joint Powers Organization
14955 Galaxie Ave.
Apple Valley, MN 55124

Inter-Fluve, Inc.
2121 Randolph Ave, Suite 200
St. Paul, MN 55105

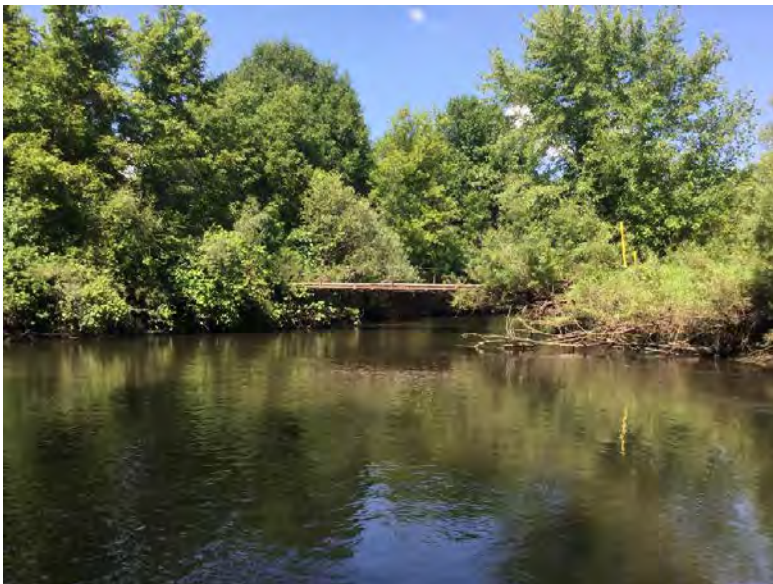
PP08

Stream: Lower Vermillion River	Problem description: Stream crossing made from railroad flat bed. Bottom of bridge is close to the water surface at low flow, so this likely restricts higher flows. Utilities run along the bridge.
Station: 56600, channel spanning Reach: 6	
Solution: Remove bridge if not needed and replace utilities.

Score	Notes
Pollutant loading	1	NA
In-stream ecological benefit	3	Small site
Project cost	3	Assumes utility relocate
Fish passage	1	NA
Riparian ecological benefit	1	NA
Infrastructure risk	5	Existing infrastructure need to be removed/replaced
Project complexity	5	Assumes utility relocate
Aesthetic impact	3	Improved aesthetic for paddlers
Property ownership	1	Private; though easement for utilities unknown
Public education	1	NA

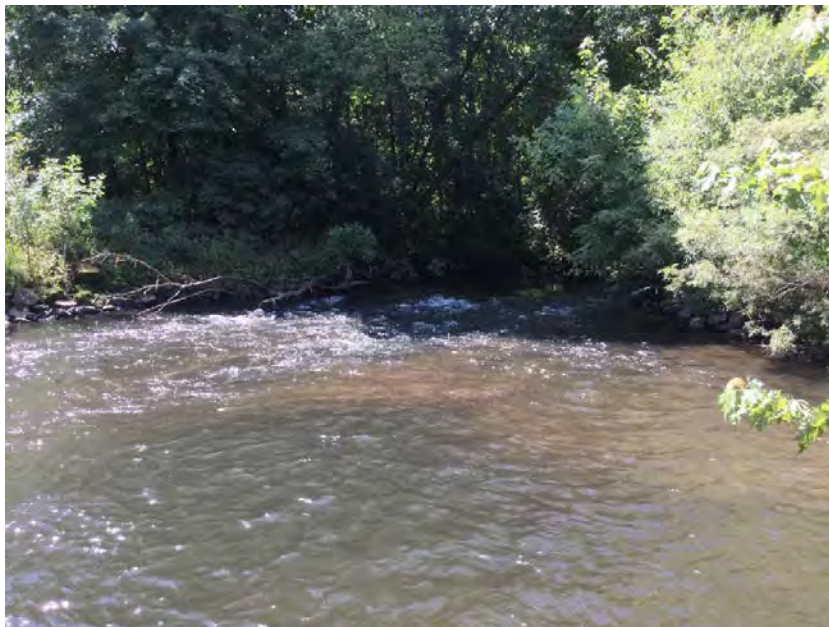
PP20

Stream: Lower Vermillion River	Problem description: Riprap from historic bridge constricts river causing erosion or river right and deposition on river left. This may exacerbate flooding and unstable conditions near the downstream bridge.
Station: 37500, channel spanning Reach: 4	
Solution: Model flood flows to determine if removal of remnant bridge pieces will reduce flooding potential or instability around the downstream bridge.

Score	Notes
Pollutant loading	1	Minimal pollutants under existing conditions
In-stream ecological benefit	1	Small site; no habitat work
Project cost	5	Could vary widely depending on model results and solution.
Fish passage	1	NA
Riparian ecological benefit	1	NA
Infrastructure risk	3	Minor – bridge is downstream
Project complexity	3	Could vary widely depending on model results and solution.
Aesthetic impact	1	No impact
Property ownership	1	Private, though not sure the exact boundary location between here and the bridge
Public education	1	NA
