Fieldstone Creek 2019 Irrigation Audit

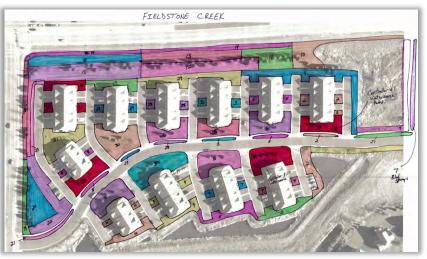
Figure 1. Mapped irrigation zones. Zone configuration did not take into account proximity to non-maintained vegetation in several areas.
