Claret Springs West Homeowner Association Rosemount, MN

Landscape Irrigation Assessment Report & Recommendations

AUGUST 23, 2023

Water in Motion, Inc. Authored by: Timothy Malooly, CLIA, US EPA WaterSense Partner

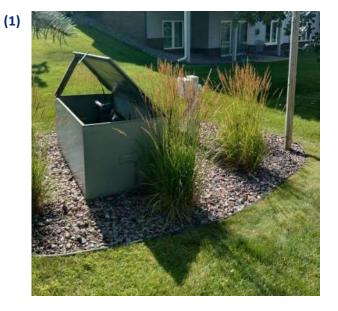
Controller and water supply behind 15118 Claret Circle. Top is held open with a wooden board due to failed gas struts. Recommend replacing gas struts for the hood, re-leveling the enclosure and placing on firm foundation.

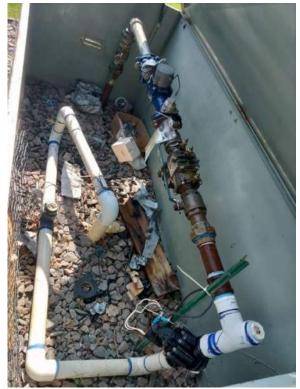
2" water supply 2" Febco 860 reduced pressure zone backflow prevention assembly (RPZ), 2" Rain Bird PgA as master valve, 2" Data Industrial paddle wheel flow sensor. System was formerly connected to full SMART remote central control. RPZ appears to have been tested and tagged May, 2023.

Recommend installing supports for the plumbing

equipment (currently resting on the PVC pipeline, change PVC pipe to metallic pipe.

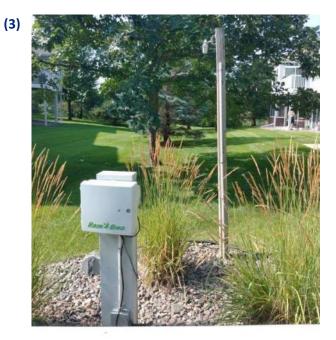
Rain Bird ESP-lx SMART ready controller w/24 stations of irrigation.

Rain Bird advanced rain sensor is connected and is in service.

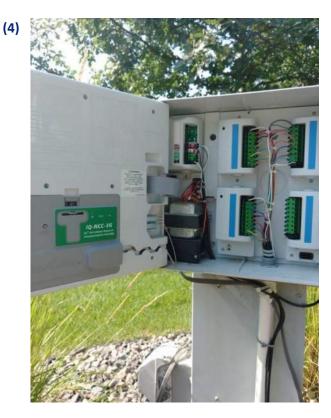
Controller interior is orderly. Controller has an expired (not in service) remote central control cellular card and functional but not-in-use flow sensor and master valve. This system was formerly on SMART and remote control service.

Database download reflects some SMART features was previously in place. If the owner chooses not to resubscribe to remote water management services, many water-efficient features are available as a stand-alone controller.

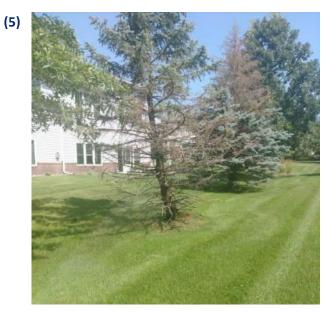
Claret Springs Station 1 illustration of sprinkler spray contributing to conifer damage over time.

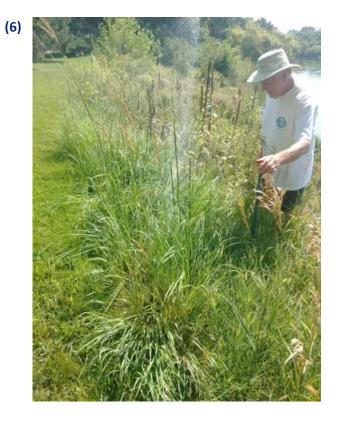
Claret Springs Station 2 example of a sprinkler blocked behind grass line. Sprinklers also need arc and throw adjustment.

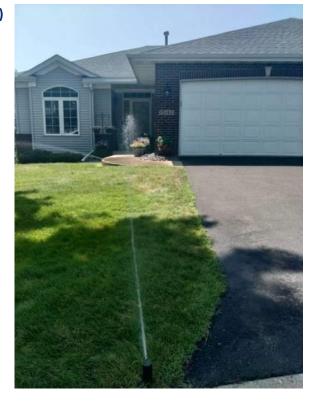
Claret Springs Station 3 front of 15142 Crestview Circle - example of arc adjustment needed and need to add an opposing sprinkler (at the top of driveway edge).

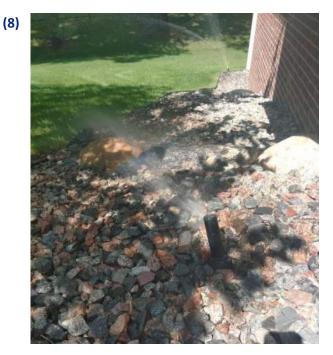
Claret Springs Station 4 example of a tilted sprinkler in need of maintenance and perhaps moving away from stone and into the lawn area.

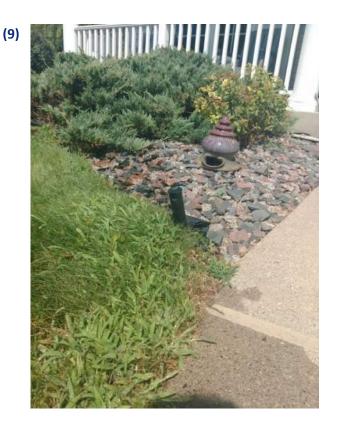
Claret Springs Station 4 front of 15123 Crestview Circle - example of a sprinkler tilted and stuck in the "up" position.

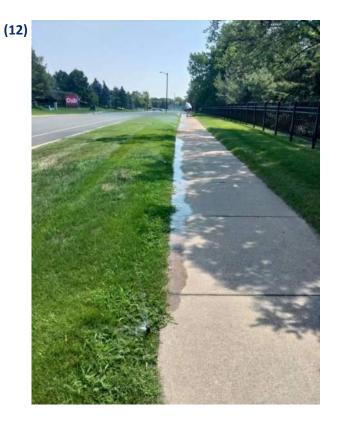
Claret Springs Station 8 sprays along 151st Street.

Several clogged, several sunken, 1 geyser.

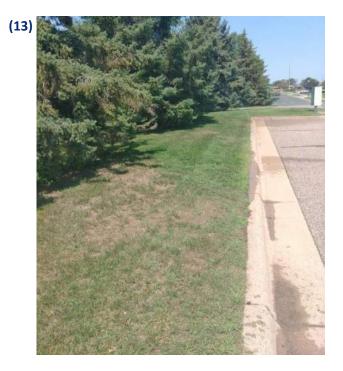
Claret Springs Station 10 island area needs maintenance.

At least one sprinkler is overgrown or perhaps root pinched and not operating at all, contributing to dry areas.

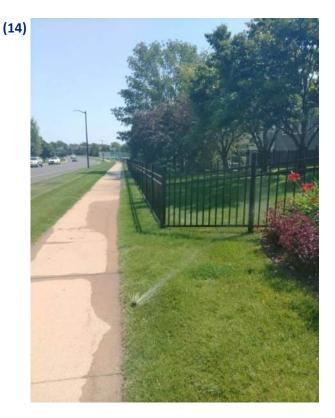
Total average depth of throw to cover is only about 12 feet. Existing sprinklers throw up to 30 feet and are throwing directly into the trees and are largely ineffective and damaging the trees.

Claret Springs Station 14 recommend the same remedy as station 10. Recommend changing rotor style sprinklers to short throw multi-stream, multitrajectory (MSMT) sprinklers and add as needed between sprinklers.

Changing sprinklers type will reduce waste and stress on mature conifers.

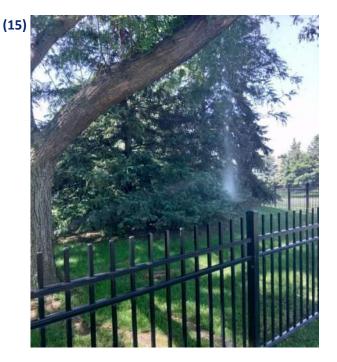
Claret Springs Station 17 several sprinklers blocked by conifers.

Recommend moving, adjusting and adding sprinklers as needed to avoid throwing water into conifers and maximizing coverage of lawn areas.

Shorter throw sprinklers such as MSMTs may be a better application for this area.

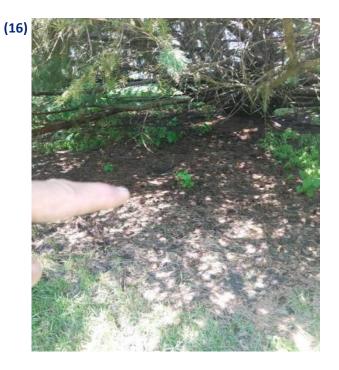
Claret Springs Station 19 pointing to a sprinkler directly under a conifer.

Recommend moving to another location or capping-off.

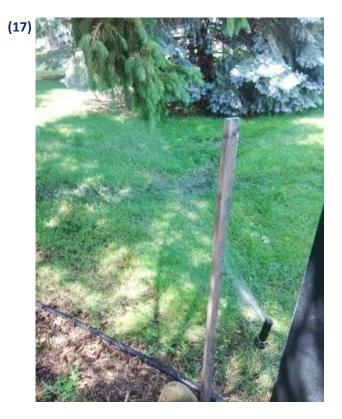
Claret Springs Station 24 -Heavy shade area in this photo.

Matched application rate nozzles (MARN) can help overcome the overwatered area shown while addressing underwatered/sunny areas elsewhere on this station.

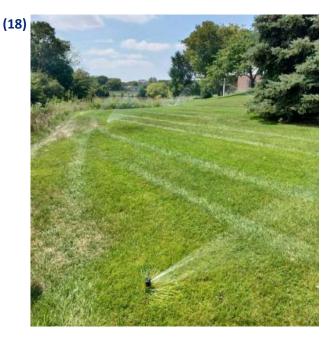
Claret Springs Station 23 several sprinklers blocked by vegitation. Recommend moving sprinklers into the managed lawn area, adjust as needed.
