GLENROSE Homeowner Association Rosemount, MN

Stage I Landscape Irrigation Assessment Report & Recommendations

OCTOBER 14, 2022

Water in Motion, Inc. Authored by: Timothy Malooly, CLIA, US EPA WaterSense Partner

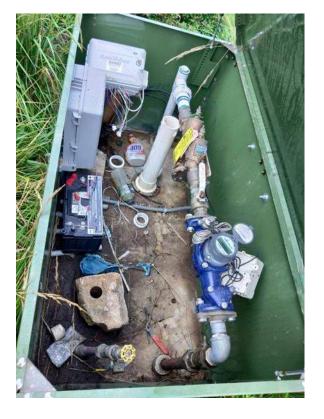
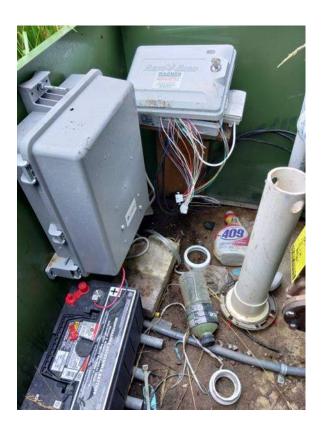
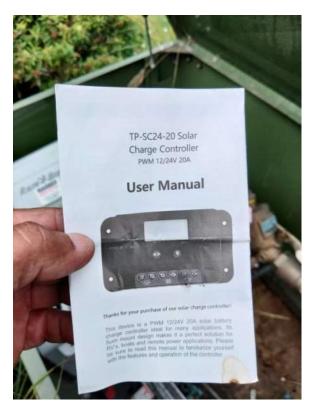
Sys 1 water supply and controller next to 14061 Burgundy Way.

1.5" water service, 1.5" Sensus brand water meter.

Apollo RPLF4A 1.5" reduced pressure zone backflow assembly with a recent test tag.

1.5" PVC feed pipe to system.

Plumbing support not in place.

Supply ball valve handle not in place. Suggest all-metallic pipe & fittings to below grade.

- A. Add support posts and brace brackets under the plumbing equipment to relieve stress on fittings
- B. Replace plastic (PVC) pipe and fittings with metallic pipe until below grade
- C. See Item F in the Controller section

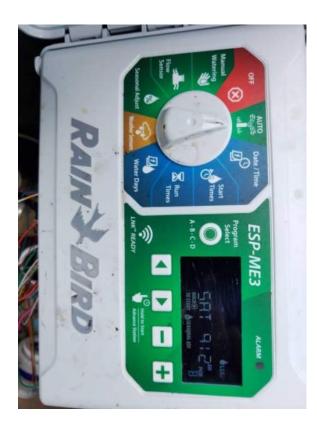
Inside the water supply cabinet.

Solar power equipment is installed in a wet environment.

Garbage inside.

Solar power user manual.

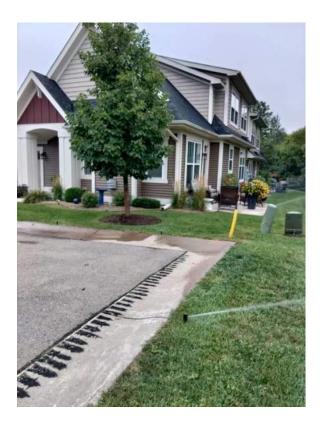
Sta 4 - front & side of 14097.

Fixed spray-type sprinklers on Hunter basic spray bodies.

Several clogged, pitched

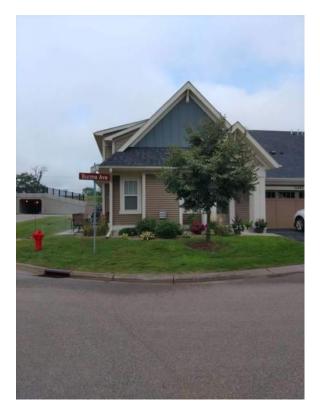
Sta6 - front & side of 14105.

Fixed spray-type sprinklers on Hunter basic spray bodies.

Several clogged, pitched

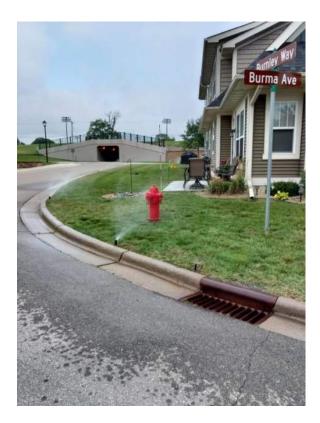
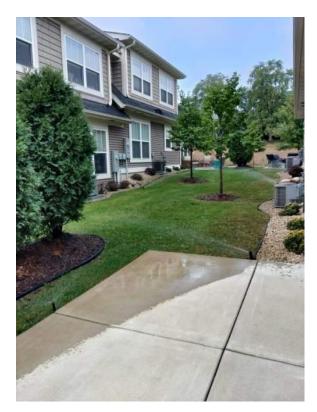
Sta 8 - front and side of 14063.

Hunter brand MSMT on basic Hunter sprinkler bodies and 5004 turf rotors throwing away from foundation

Suggest matched appl rate nozzles

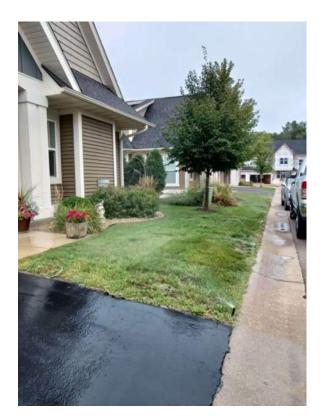
Sta10 - center courtyard 14068/59/64/55.

Hunter brand MSMT on basic Hunter sprinkler bodies and 5004 turf rotors

Pitched, imbalanced application rate nozzles. Add sprinklers to overcome poor coverage.

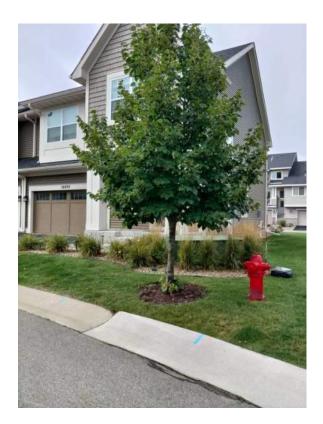
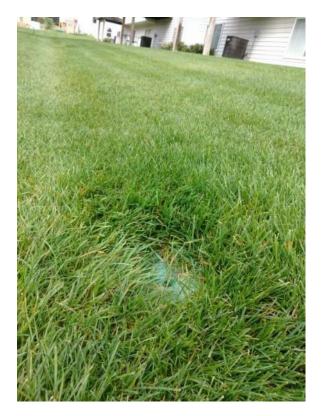
Sys2 water supply next to 14039.

This system is overwatering and mow heights too low.

Service boxes need maintenance (see next image.)

Sys2 sample of service box being grown over.

Suggest maintenance.

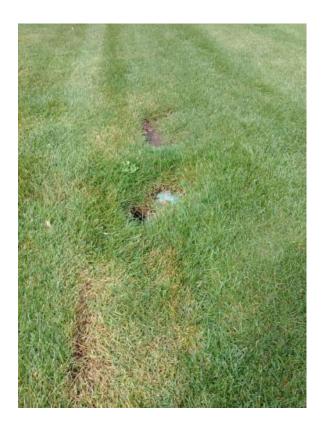
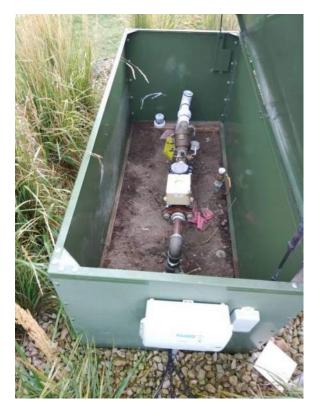
Sys2 service boxes sunken and resulting mow scalping

Sys2 water supply 72psi static before plumbing equip.

1.5" service to 1.5" Sensus brand water meter

1.5" Wilkins 975xl reduced pressure zone backflow preventer with a recent inspection tag.

Recommend replacing PVC plumbing w/metal pipe to below grade and adding plumbing equipment supports on a firm base.

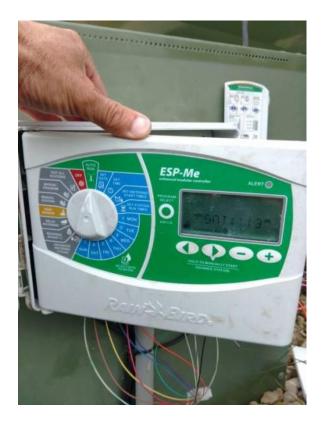
Sys2 controller - Rain Bird ESP-Me (early version) w/advanced rain sensor that is set to "bypass".

Key is broken inside the controller door lock.

11 stations. Irrigation begins at midnight, odd days. Seasonal adj is at 90%. 1,2,3,4,6,7 = 40 mins 5,8,9,10,11 = 35 mins. Lots of extra station wire to split or add future stations

Suggest adding SMART control technology.

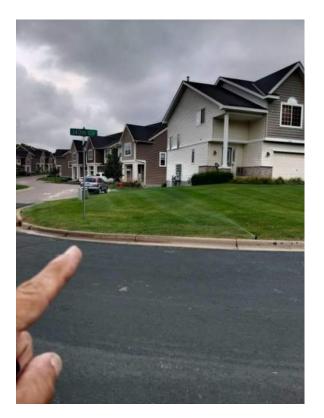
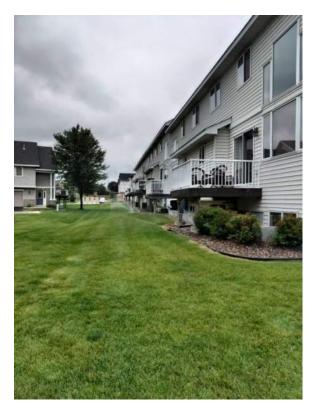
Sta1a - front of 2940.

Pointing to rotor sprinklers blocked by plants. Suggest moving sprinklers.

Hunter PGP rotors. Several w/blown seals. Several pitched sprinklers.

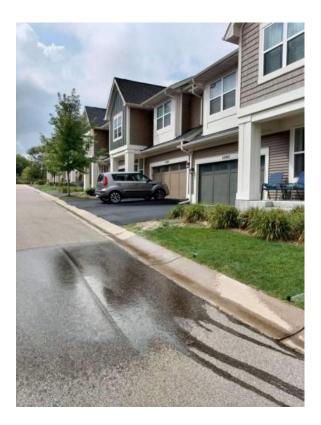
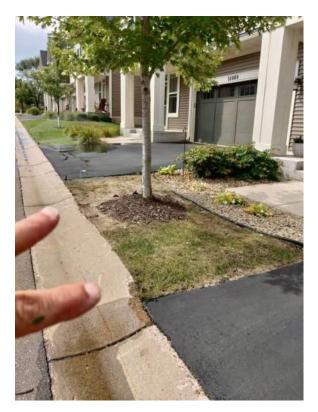
Sta5c – mix of MSMT, spray and small turf rotors. Suggest all MSMT sprinklers in small areas.

Sta5c – broken and ineffective sprinklers.

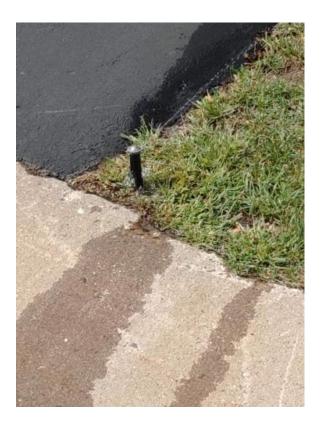
Sta7a - broken sprinkler front of 14093

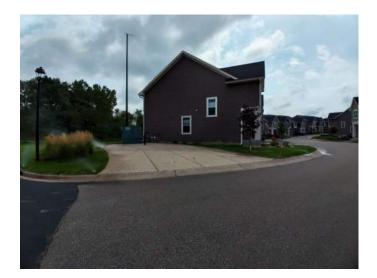
Sta11 - lift station and fronts of 14038,42,46.

Sprinklers in front of 14046 need maintenance.
