Rock Island Townhomes

Summary

BNR Irrigation Evaluation

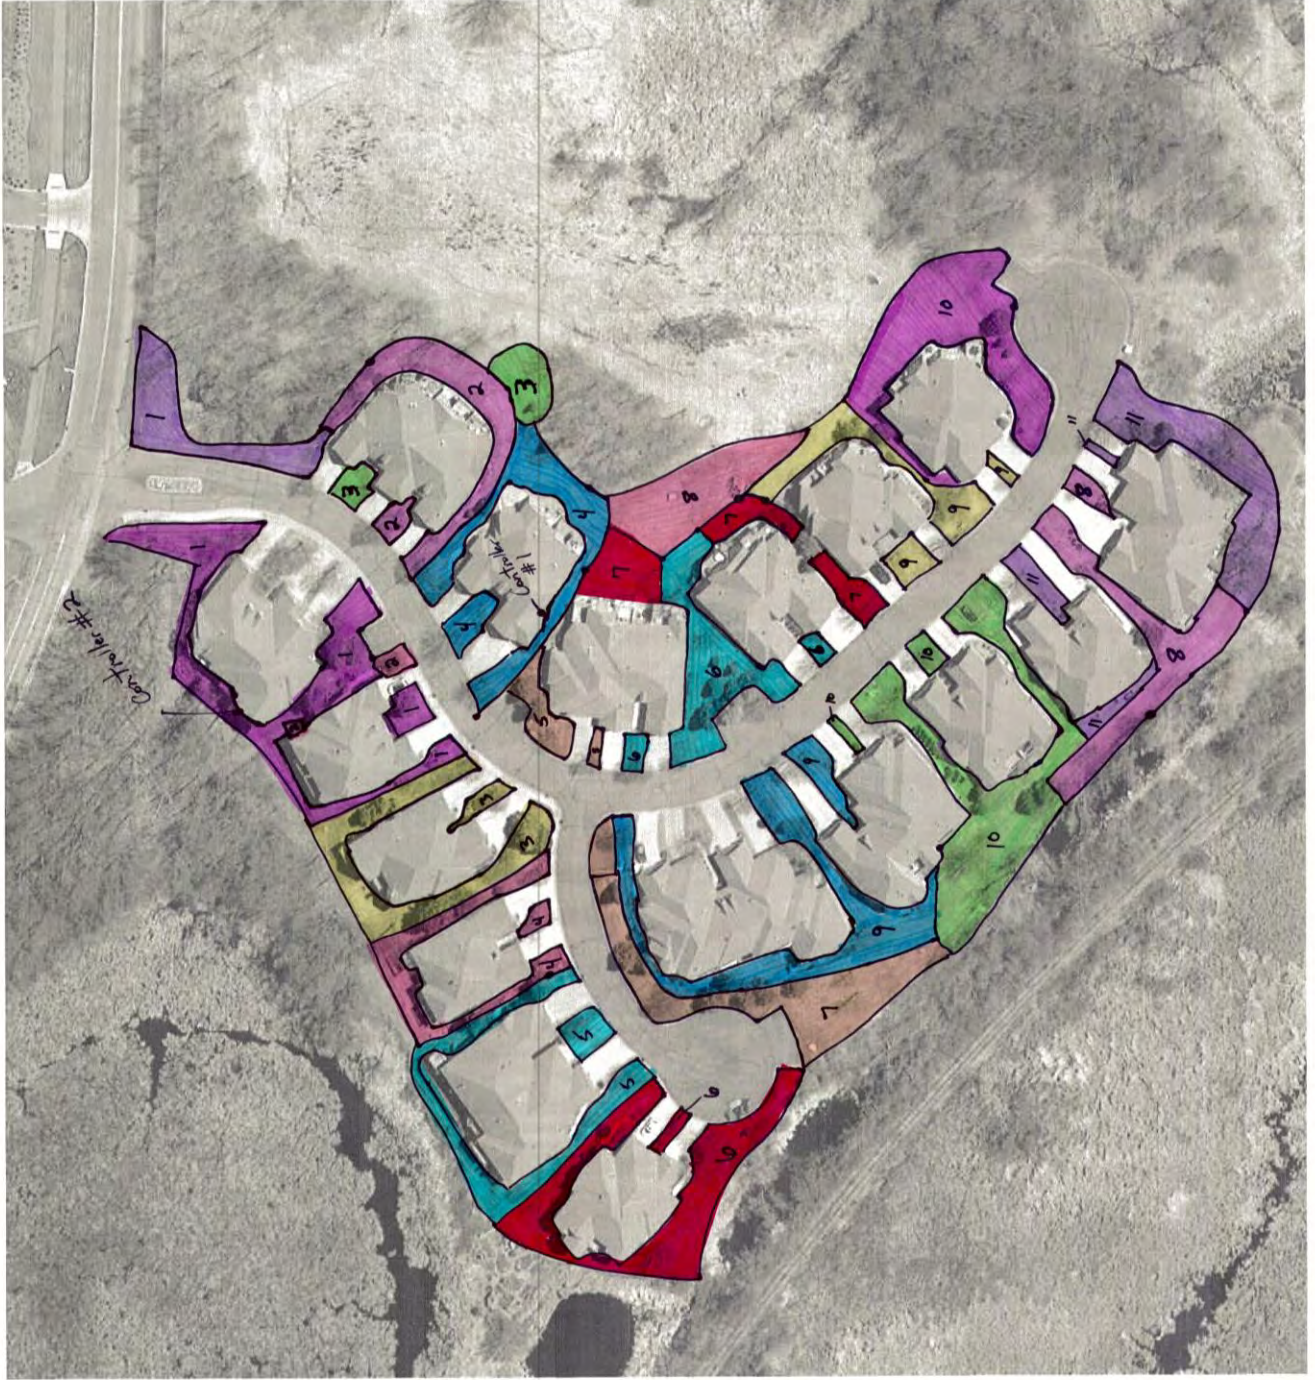
Rock Island

- A total of 21 irrigation zones
- Two controllers.
 1. Side of 16940 Kings Court
 2. Back patio of 16921
- There is a two-inch water source located at each of these addresses, one for each controller.
