Commercial Site Assessment™ Tier II

**Cedar
Landing**

20991 Goodhue Way
Lakeville, MN 55044

Commercial Site Assessment™

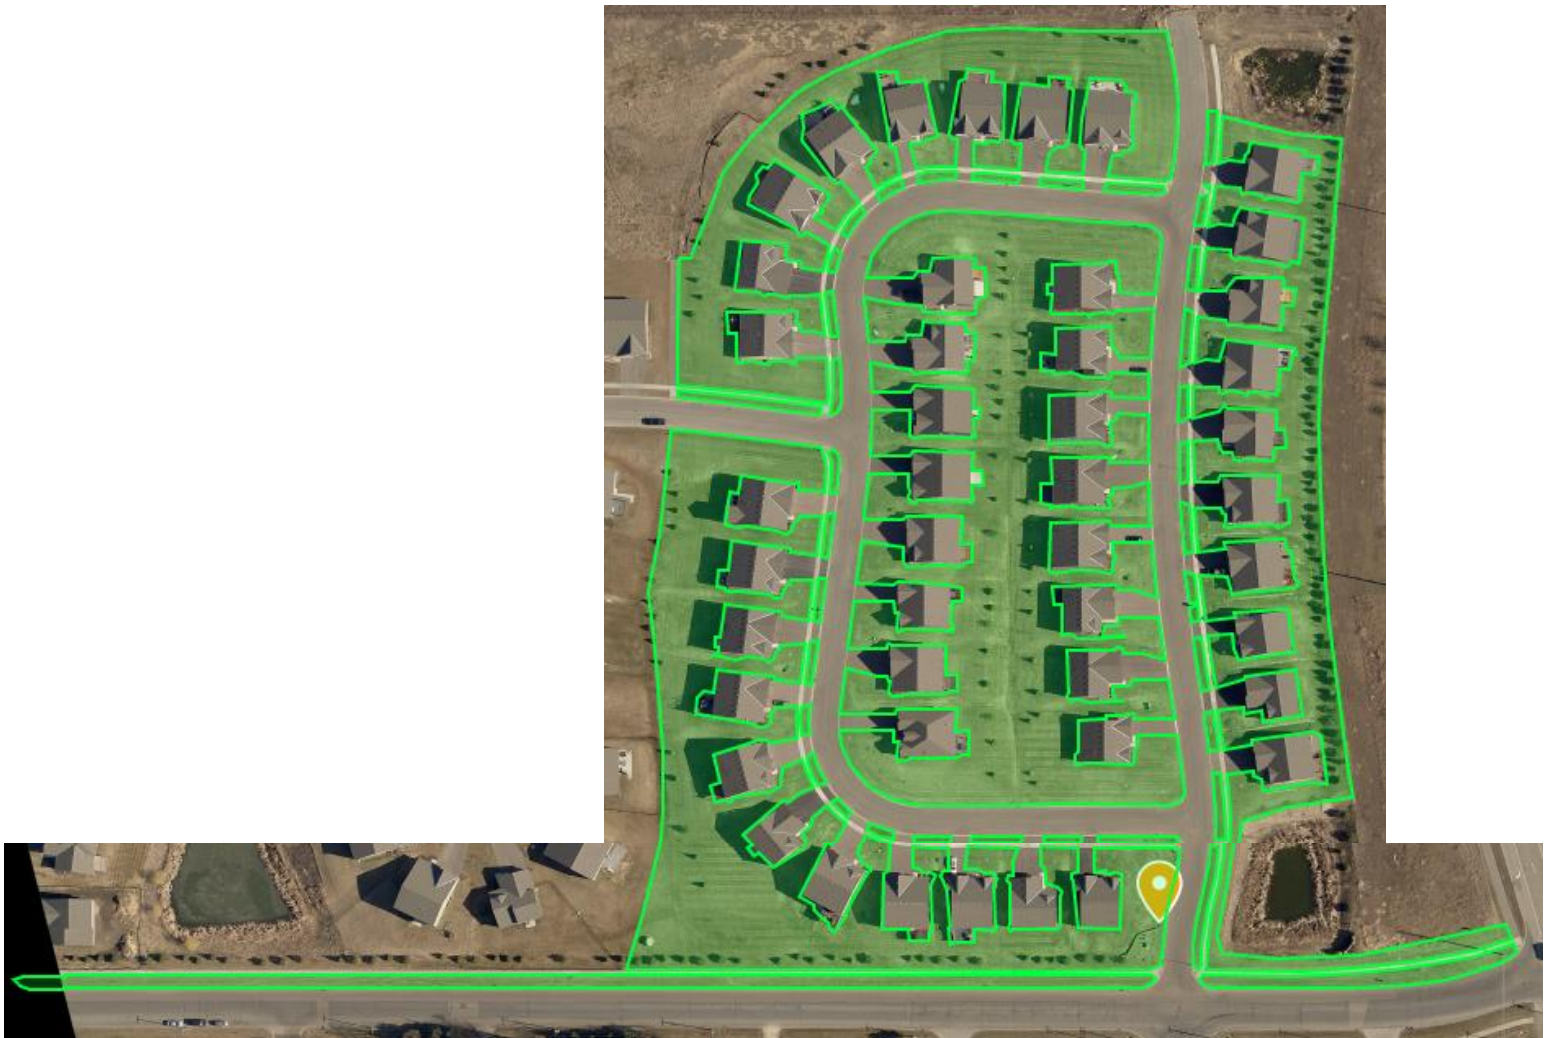
Cedar Landing Irrigated Area

Irrigated Acres: 8.24

Irrigated ft^2 : 358,762.27 ft^2
