Commercial
Site
Assessment™
Tier II

**Bellante
Townhome
HOA**

18348 Justice Way
Lakeville, MN 55044

Commercial Site Assessment™

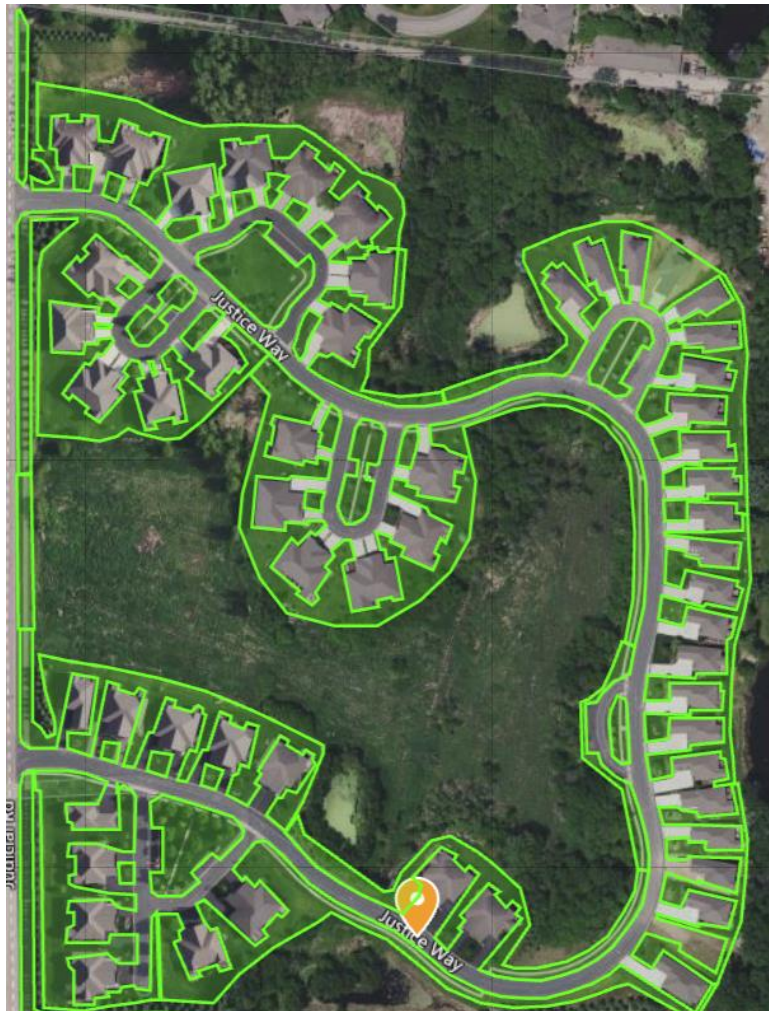
Irrigated Area

Irrigated Acres: 13.1

Irrigated *ft*²: 570,851 *ft*²

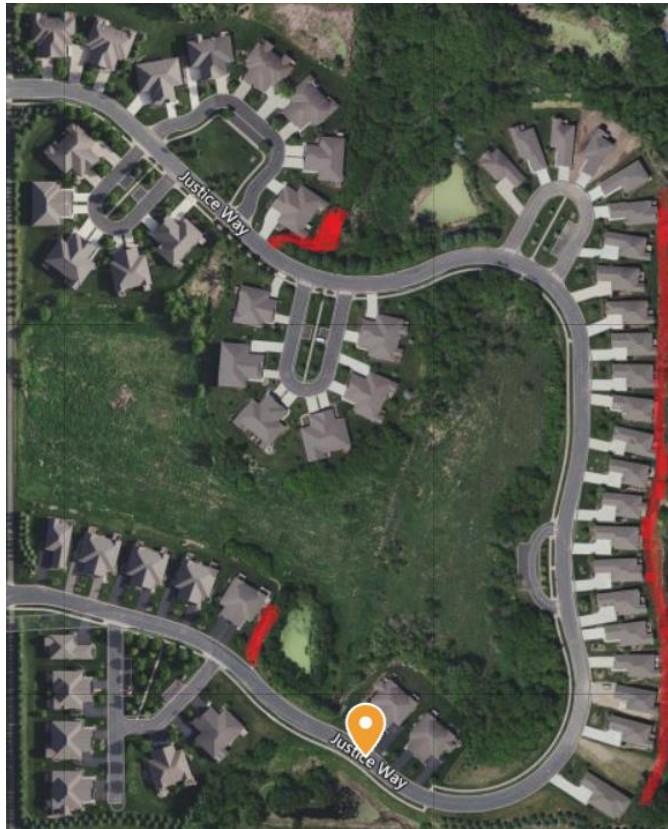
There were a few areas with minor design issues that need to be addressed. These areas either need heads added and/or moved for proper spacing and coverage. Many of the heads needing to be moved are in the prairie grass along the entire property.

There were many areas that could use a complete redesign. These areas are noted on the map below and would be addressed and estimates given upon consultation.

- Replace 250 rotors
- Raise 2 rotors
- Retrofit the remaining rotors with new heads and correct nozzle sizes and check valves
- Move 38 heads for proper spacing and coverage or move heads out of areas that don't require irrigation
- Add 51 heads for proper spacing and coverage
- Retrofit 16 spray nozzles with rotating nozzles (see mixed head types row of zone tables)

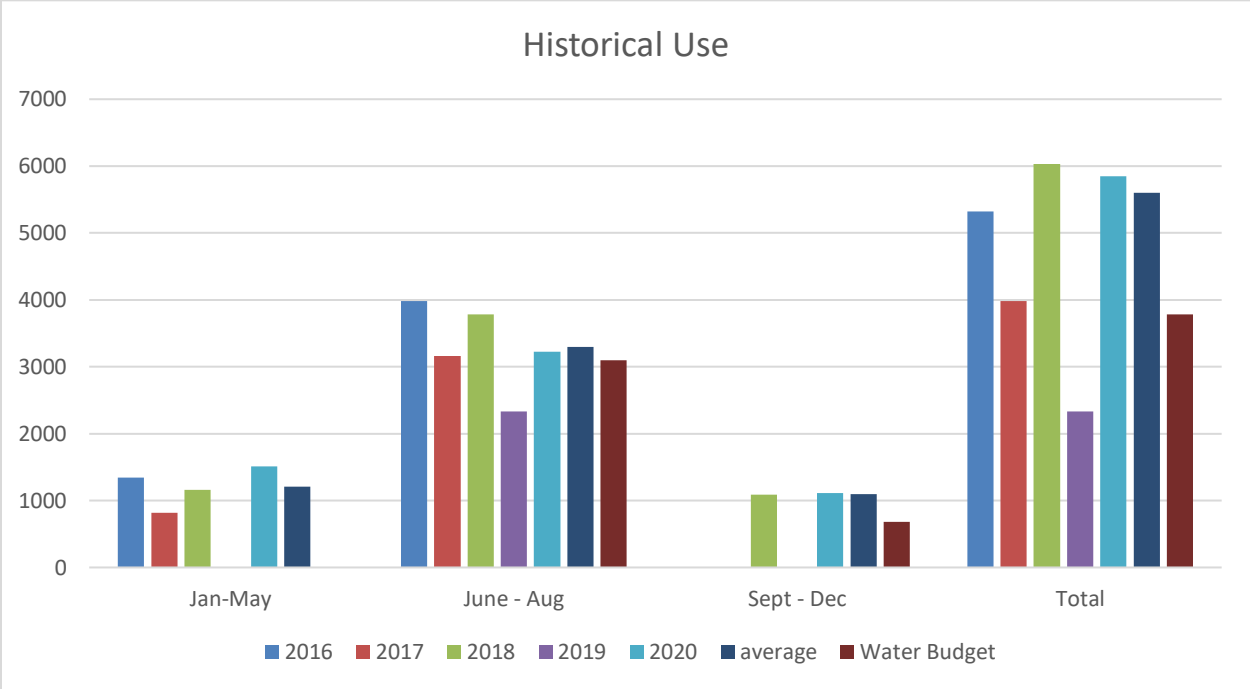
Water Budgeting

2016	2017	2018	2019	2020	average	Water Budget
Jan-May	1342	820	1161	0	1513	1209	0.00
June - Aug	3980	3163	3785	2331	3222	3296.2	3098.57
Sept - Dec	0	0	1088	0	1111	1099.5	683.78
Total	5322	3983	6034	2331	5846	5604.70	3782.35
