## Capital Improvement Project Lakeville: Middle Creek at Highview Avenue Channel Stabilization Project

### Reducing Erosion Results in a Healthier Middle Creek

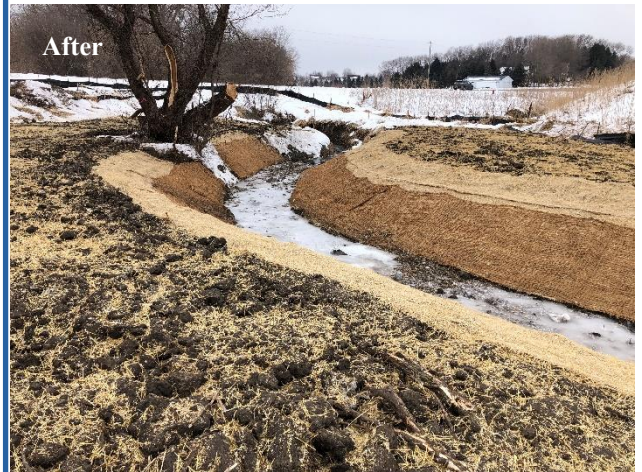
A variety of bank and channel bottom stabilization measures will result in significantly less erosion and cleaner water

- Poor quality trees were removed to provide sunlight to the understory
- Banks were gently sloped and stabilized
- Bends were added back into the channel where possible
- Rock structures were installed in the bottom and sides of the channel to stabilize slopes and protect nearby infrastructure
- Native plant, trees, and shrubs were planted
