## Capital Improvement Project

# Hastings: Hastings Industrial Park Ravine Stabilization and Restoration

## Reducing Sediment from Entering the Vermillion River

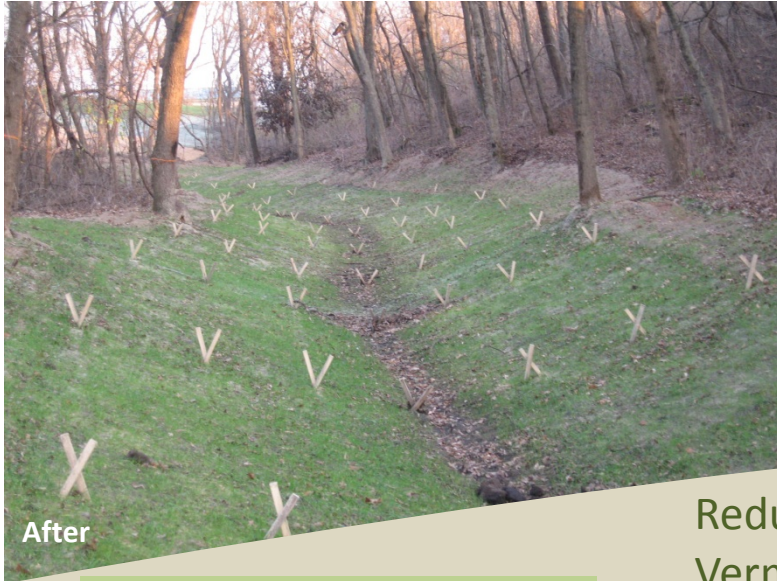
After

The Industrial Park Ravine in the City of Hastings was re-graded and stabilized using a turf reinforcement mat. A pond was constructed at the top of the ravine to control the flow rate in the ravine and provide settling of runoff sediment.

Cost-share funding from the Vermillion River Watershed Joint Powers Organization enabled the City of Hastings to re-grade and stabilize the ravine, prevent further erosion, build a treatment pond, and reduce sediment from entering the Vermillion River. The ravine was stabilized with a turf reinforcement mat to prevent erosion and promote the growth of grass and other vegetation in the ravine.

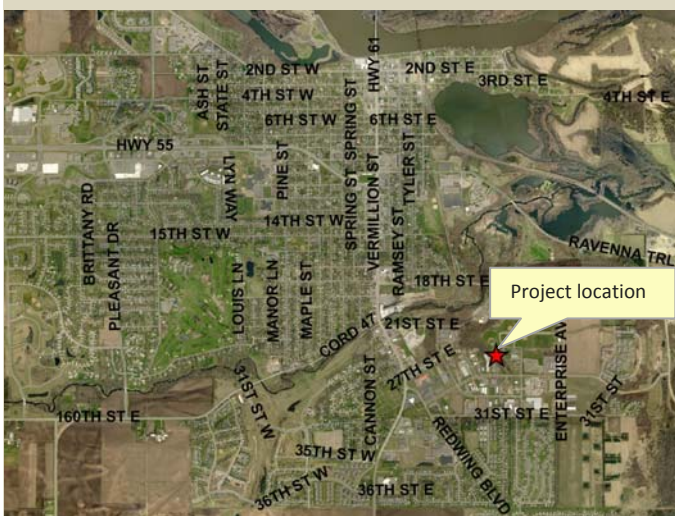
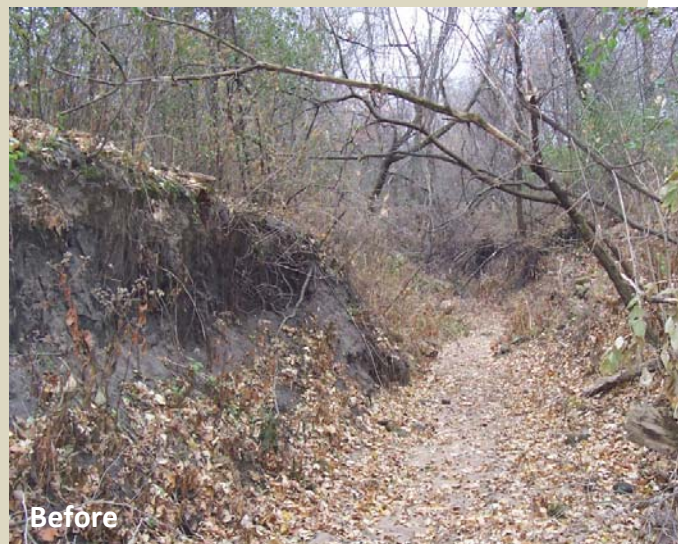
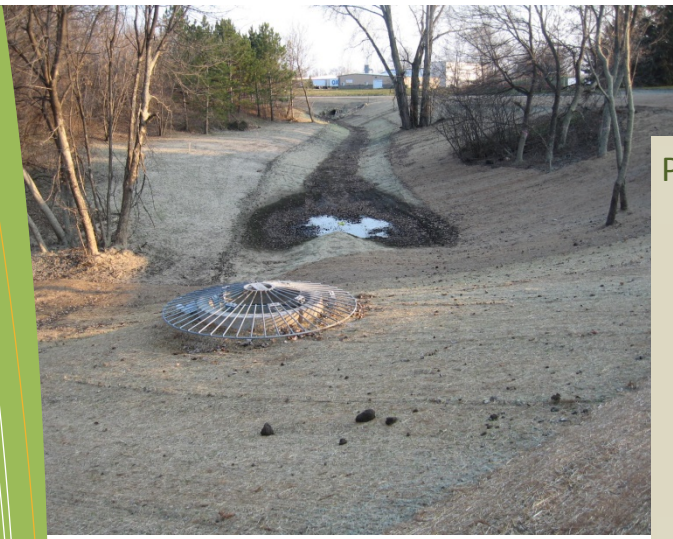
Before

Stormwater flow caused significant erosion, ten to 12 feet deep in places, in the 2,200-foot long ravine adjacent to Spiral Boulevard in Hastings. Sediment- and nutrient-laden waters drained into the Vermillion River. That reach of the Vermillion River is currently impaired for turbidity (cloudiness).
