Capital Improvement Project Sediment Basins on Almquist Property (Ravenna Township)

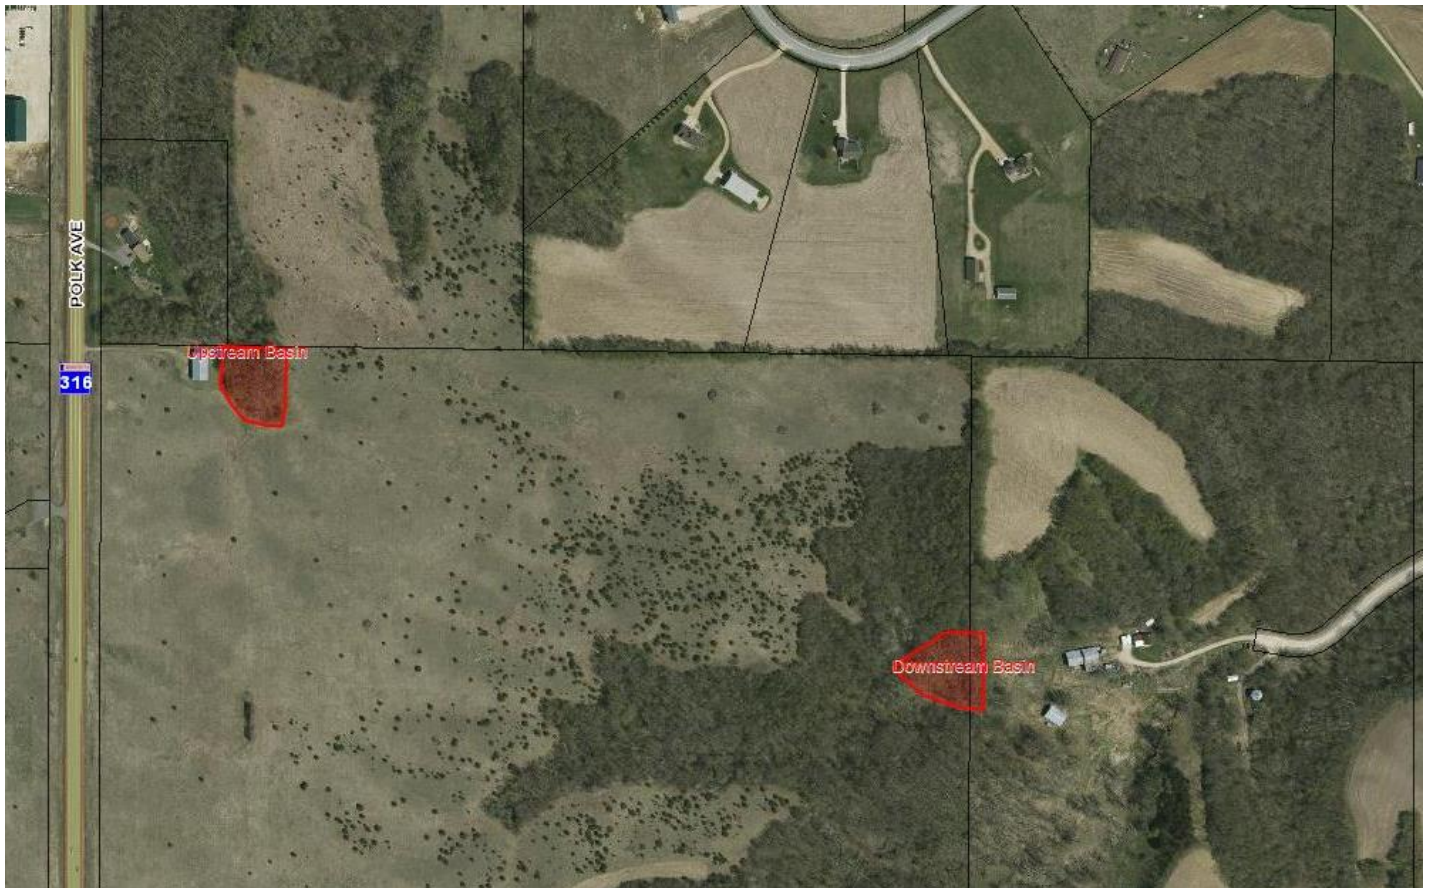
Figure 1. The locations of the sediment control basins on the Almquist property, in southern Ravenna Township.

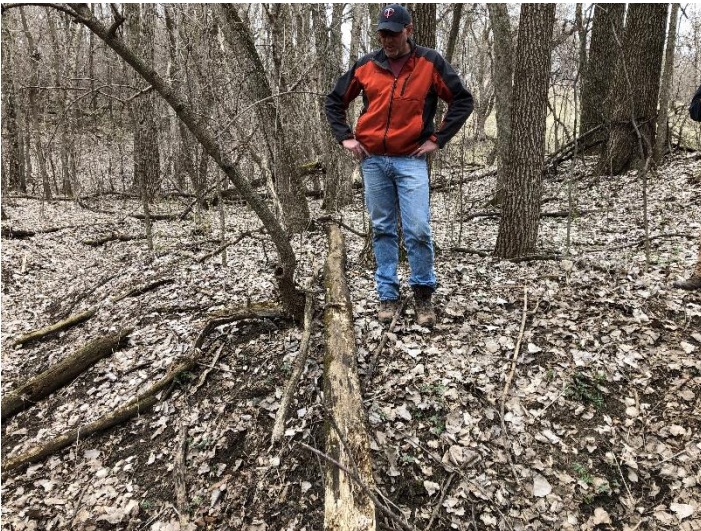
The Almquist family farm in Ravenna Township has sediment control basins on their property designed to keep sediment out of the Vermillion River. These basins were designed and constructed in the late 1960s and have filled with sediment to a level where they have limited function. Vermillion River Watershed Joint Powers Organization (VRWJPO) and Dakota County Soil and Water Conservation District (SWCD) staff agreed that a cleanout of both basins would be beneficial to their overall efforts, as some capacity in the basins can be restored to capture sediment and slow higher runoff flows that could cause erosion of the channels downstream.

Figure 2. Dakota County SWCD staff member Todd Matzke observes deposited sediment and volunteer tree growth in the downstream basin.

The repair project will consist of some tree removal to access the sites, excavating the basin pools, repairing an emergency spillway to the downstream channel, and seeding native vegetation for continued erosion control. This would complement VRWJPO's other efforts in Ravenna Township to decrease turbidity in the lower Vermillion River.

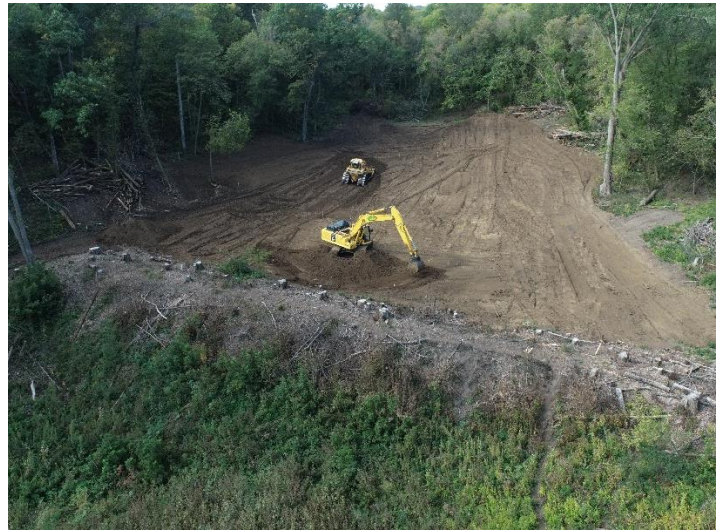
Figure 3. Eastern basin during the sediment cleanout process.

- The estimated pollution reduction is 5.5 tons/year of total suspended solids and 6.2 acre-feet/year volume reduction.
- The basins were cleaned out to a practical level to allow for future sediment capture during runoff events.
- Restoration of emergency overflows and restoring volume in the basin means that water only bypasses the basin in heavier rain events, dampening erosion from most flow events.
