Capital Improvement Project

Lakeville: 205th Street Channel Reconstruction Project-Phase 2

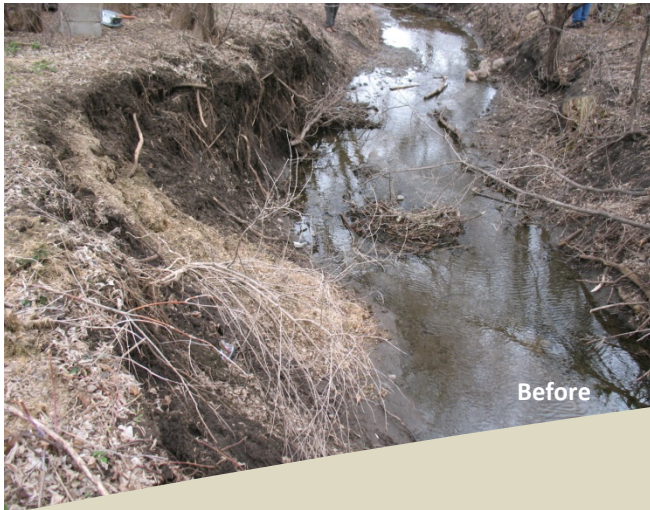
The 205th Street channel in the City of Lakeville was re-graded and stabilized using various forms of erosion-control and planted with native species.

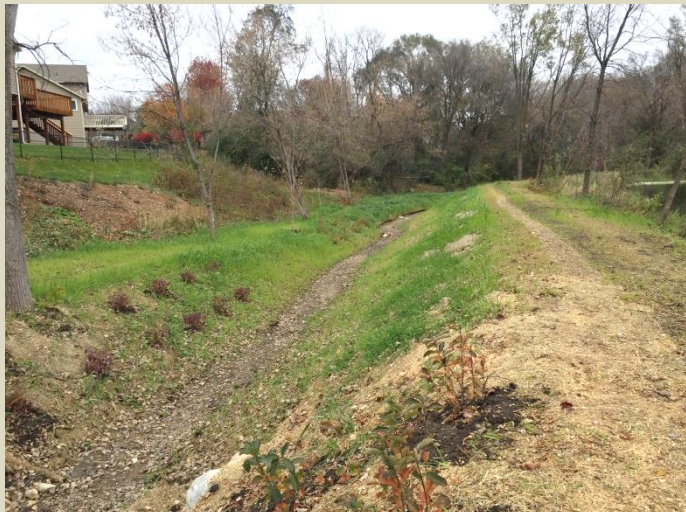
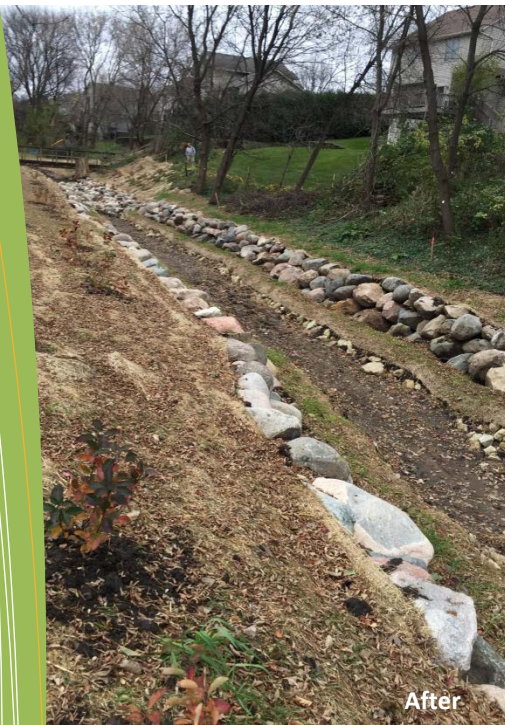
Stormwater flow caused erosion and bank failure and carved a six to eight foot deep ravine in the 1,000-foot long drainage channel at 205th Street in Lakeville. Sediment- and nutrient-laden waters from the channel drain into Lake Marion and create several water quality issues, such as cloudy water, algae blooms, and low dissolved oxygen. In 2009, the Vermillion River Watershed Joint Powers Organization (VRWJPO) provided financial assistance to the City of Lakeville to stabilize the first 600 feet of channel.

Financial assistance from the VRWJPO was provided to assist the City of Lakeville in designing and constructing phase 2. This included re-grading the channel, stabilizing banks with a combination of rock and native vegetation to prevent erosion, and reducing sediment and nutrients running into Lake Marion. The water quality improvements in Lake Marion will enhance year-round fishing and recreation. It will also protect Lake Marion from exceeding State water quality standards and becoming a nutrient-impaired Lake.

- Re-established natural channel shape and floodplain
- Used rock and native vegetation to stabilize and armor eroded slopes and channel so that it is able to slow water velocities and convey flows from the 531-acre watershed without excess sediment and nutrient transport
