Capital Improvement Project

Lakeville: North Creek at Highview Ave Channel Improvements

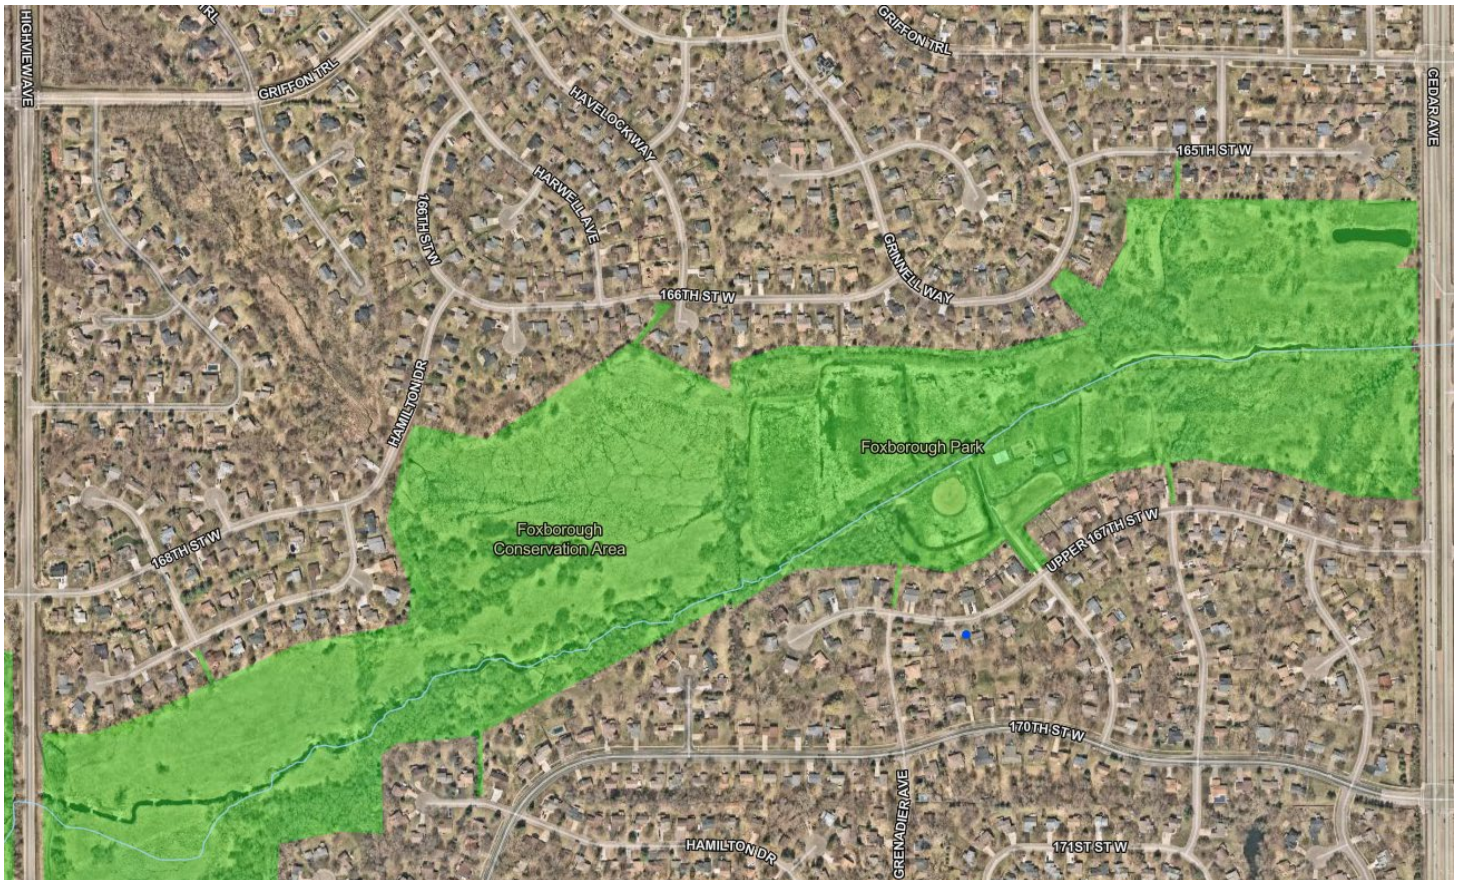
Figure 1. An aerial map of the North Creek channel improved during this project.

To address the problem, the Vermillion River Watershed Joint Powers Organization (VRWJPO) and the City of Lakeville collaborated to repair this eroded reach of North Creek between Highview Ave. and Cedar Ave. The project consisted of rock check dams, streambank stabilization grading, and removal of accumulated sediment that had deposited downstream over time. All the efforts will result in a healthier North Creek and Vermillion River, which are regionally significant resources for recreation and public use for the community.

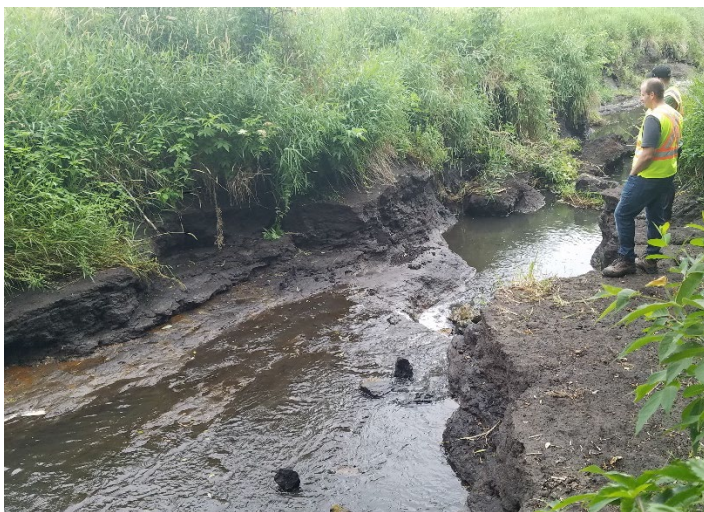
The North Creek Vermillion River subwatershed has undergone a lot of development over several decades, and unfortunately significant erosion of North Creek has come with it. The erosion resulted in the formation of vertical banks (head cuts) along the creek that reached six to eight feet height in areas. This section of the channel runs through a wetland where dark organic soils are present, which exacerbates the channel degradation because organic wetland soils are easily eroded and therefore deliver excessive sediment and nutrients downstream during storm events.

Figure 2. Overlooking the North Creek head cut before project.

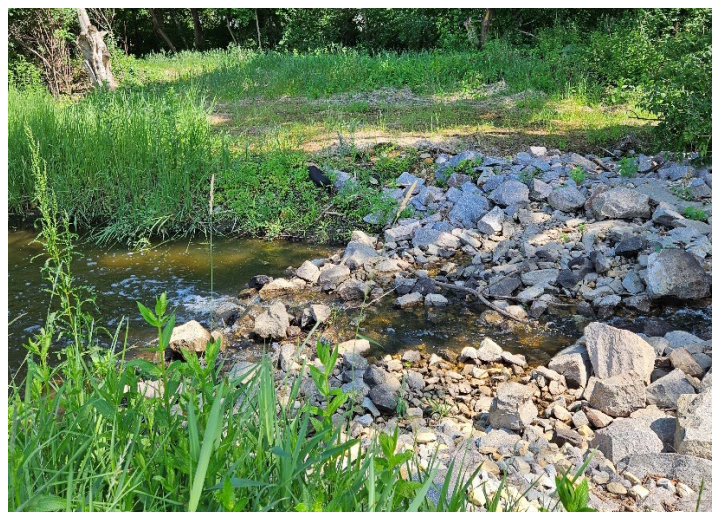
Figure 3. North Creek with rock checks installed.
