Vermillion River Monitoring Network 2023 Annual Report

*Prepared for the Vermillion River Watershed Joint Powers Organization
by the Dakota County Soil and Water Conservation District*

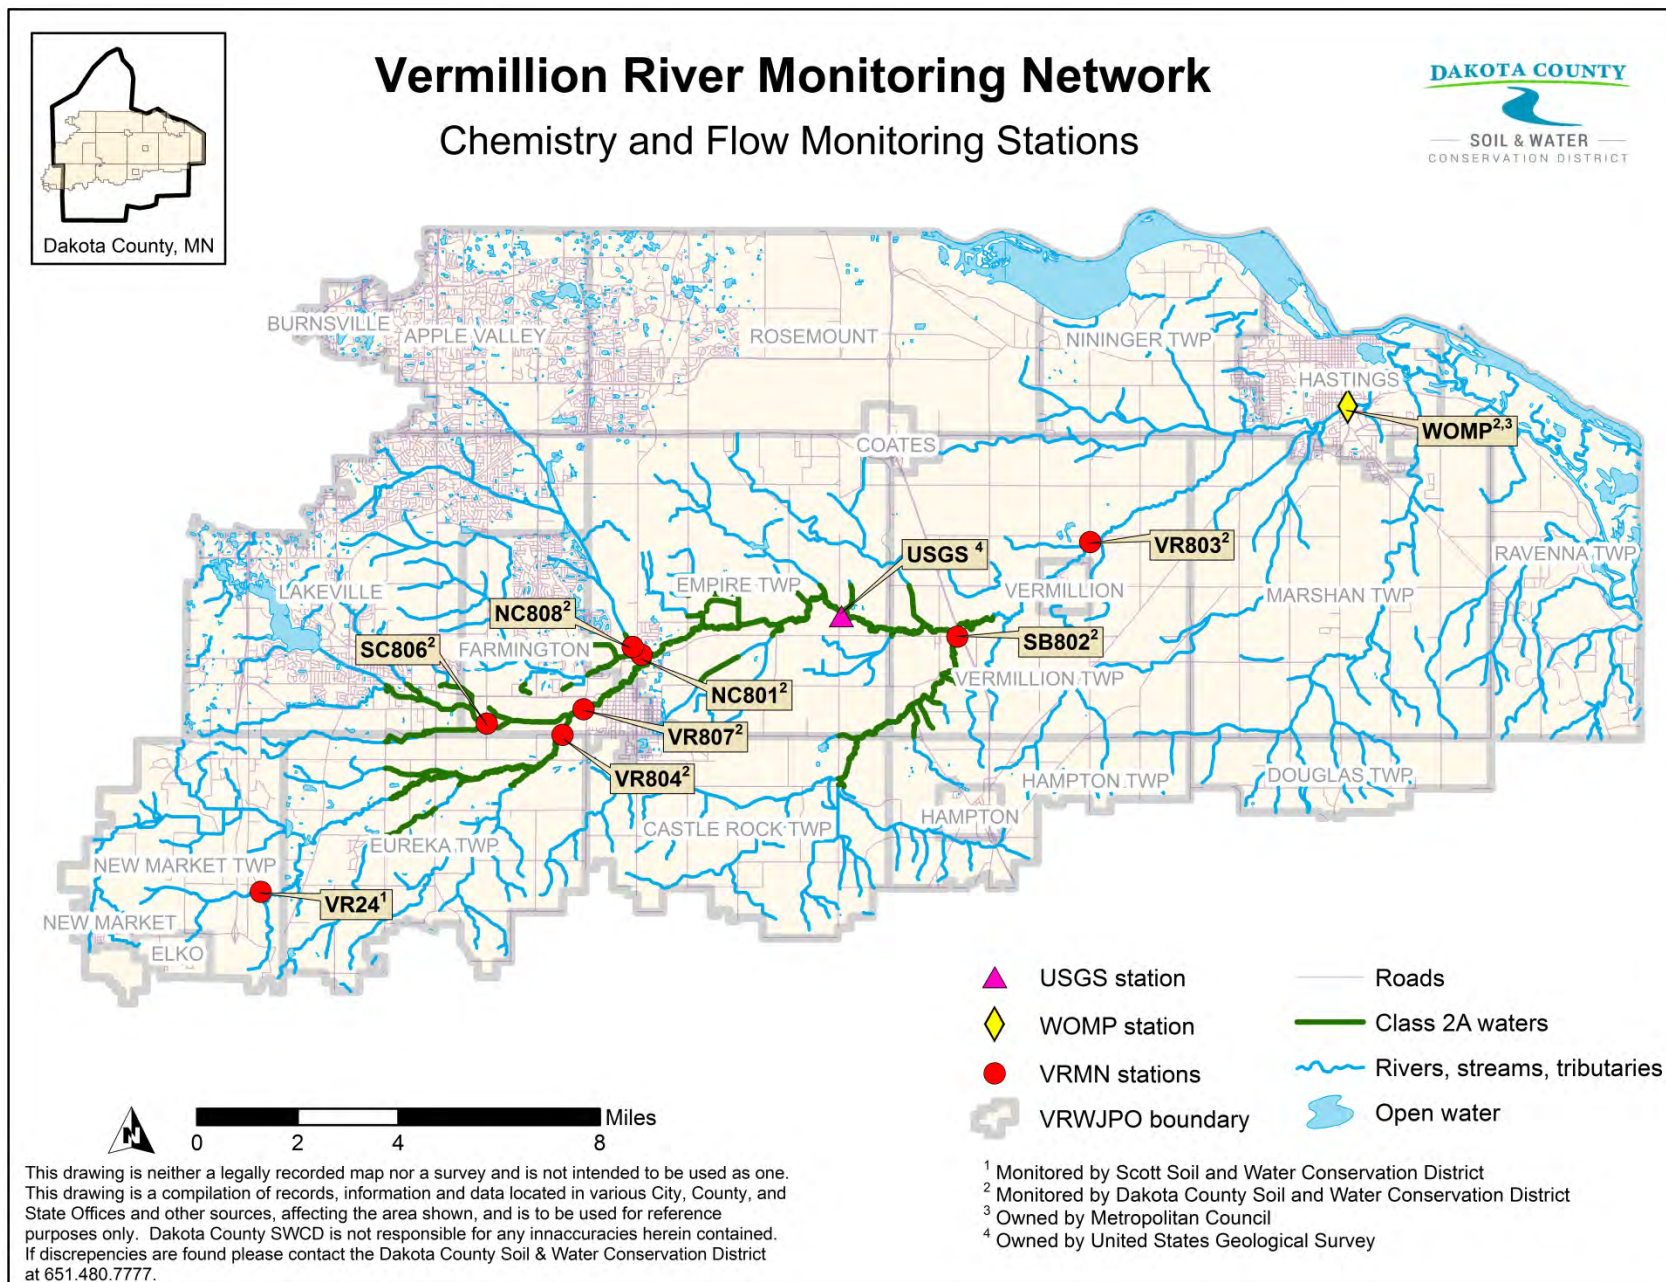
Figure 1. Vermillion River Monitoring Network (VRMN) chemistry and flow monitoring stations.

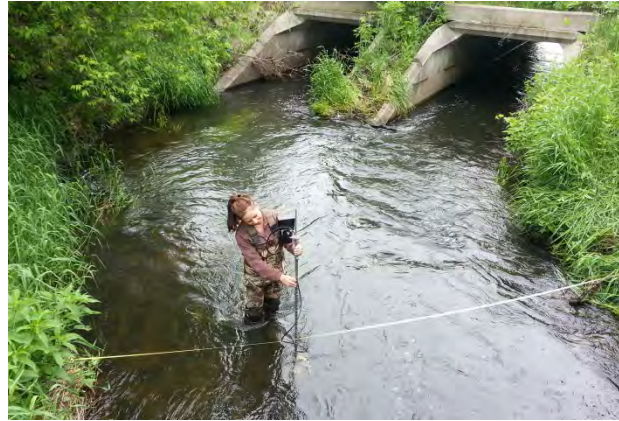
DCSWCD staff measuring flow at the NC808 monitoring site
Photo Credit – J. Van Der Werff Wilson

Flow is typically measured manually five to seven times per season at each site over a variety of flow regimes to develop a mathematical relationship in which flow can be estimated at any river level (stage). In doing so, DCSWCD staff follows United States Geological Survey (USGS) established protocols for measuring flow (Buchanan, 1969). Additionally, each station is equipped with automated data loggers which record continuous stage at fifteen minute intervals. With these two approaches, it is possible to get an accurate discharge rate at any water level.

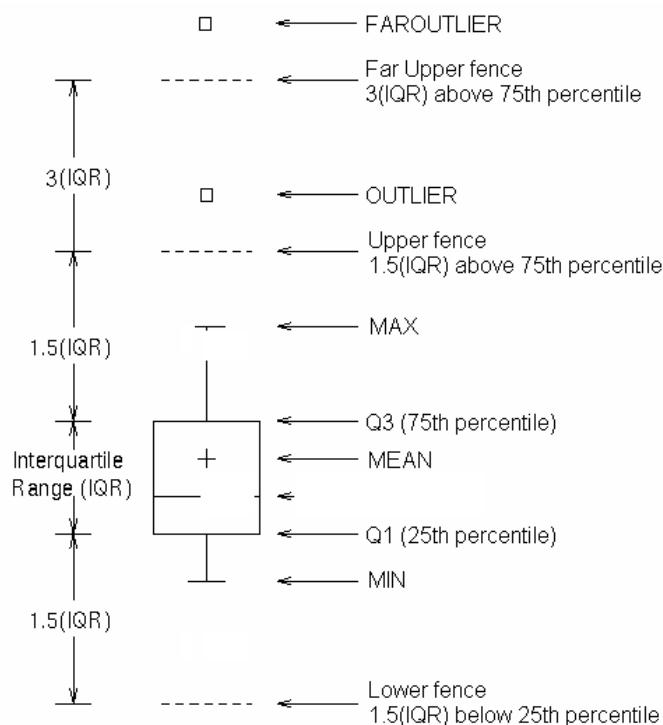
Figure 2. Vertical boxplot display key.

JMP 11 software was used to plot field and laboratory data. An explanation of box plot figures is shown in Figure 2. If outliers exist, lines are not drawn to the minimum and maximum but instead are drawn to 1.5 times the interquartile range (IQR) and outliers are shown as dots. The IQR effectively trims the highest and lowest 25% of values and represents the middle 50%. The median represents the value lying at the midpoint with an equal number of observed values above and below. N indicates sample size.

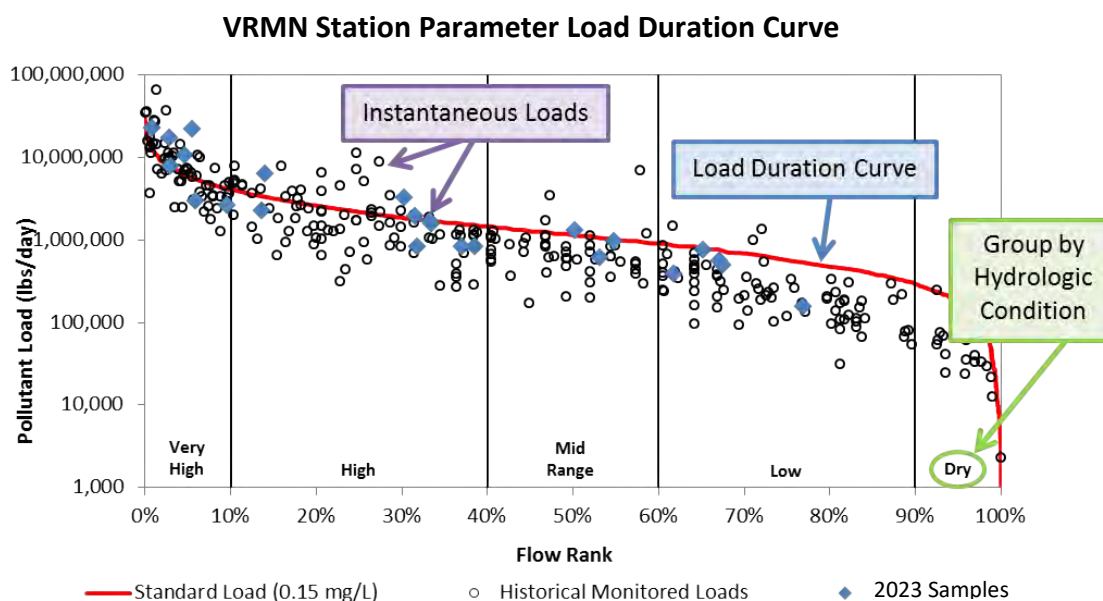
Figure 3. Example of a load duration curve

Parameter loads for *E. coli*, TP, and TSS displayed on the graph above the curve (calculated using the state standard) indicate a violation of the water quality standard, while those plotting below the load duration curve indicate that the standard is being met for that monitoring event. Conversely, dissolved oxygen readings that meet the standard are above the curve and those not meeting are below.

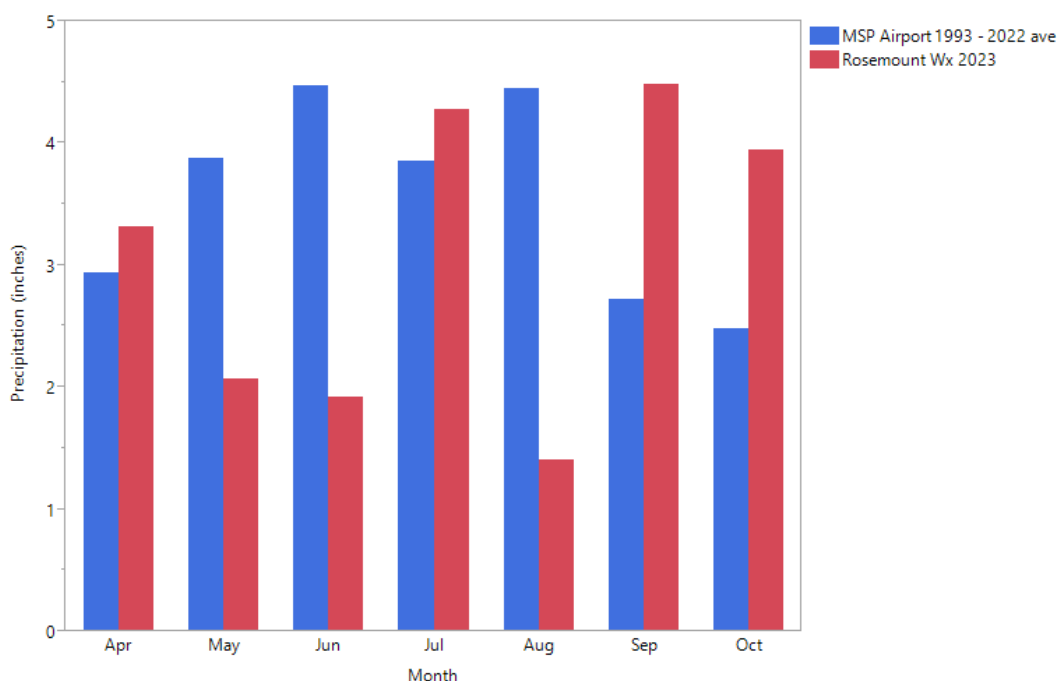
Figure 4. 30-year monthly average (1993-2022) precipitation at Minneapolis-St. Paul airport and 2023 monthly precipitation measured at the Rosemount weather station from April through October.

The 30-year average (1993-2022) for the April-October period at the MSP Airport is 24.79 inches and the total April through October 2023 precipitation data was 20.02 inches. For the third year in a row, drought conditions returned to the metro area due to record dryness in the late spring and early summer. Following a wetter July, dry conditions continued through August, resulting in most samples being collected during baseflow or low water level conditions. Large rainfall events occurred in both September and October, putting the monthly totals a few inches above the historical averages.

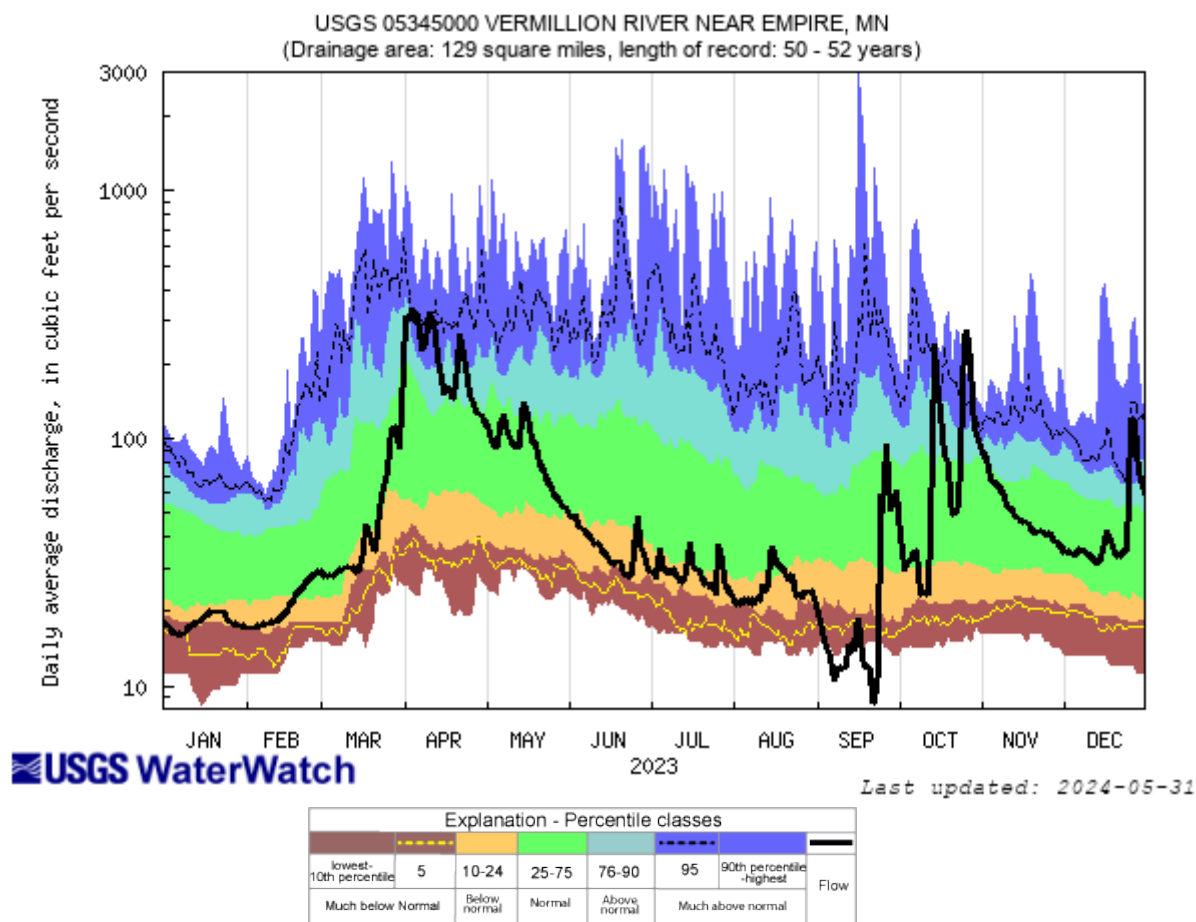
Figure 5. Daily average discharge (cfs) for the USGS station at Blaine Avenue in 2023.

Limited precipitation during July and August resulted in drought conditions setting in once again. River discharge dropped “below normal” or “much below normal” and remained there for much of the remainder of the season. September and October rain events helped bring water levels back to normal levels by the end of the year.

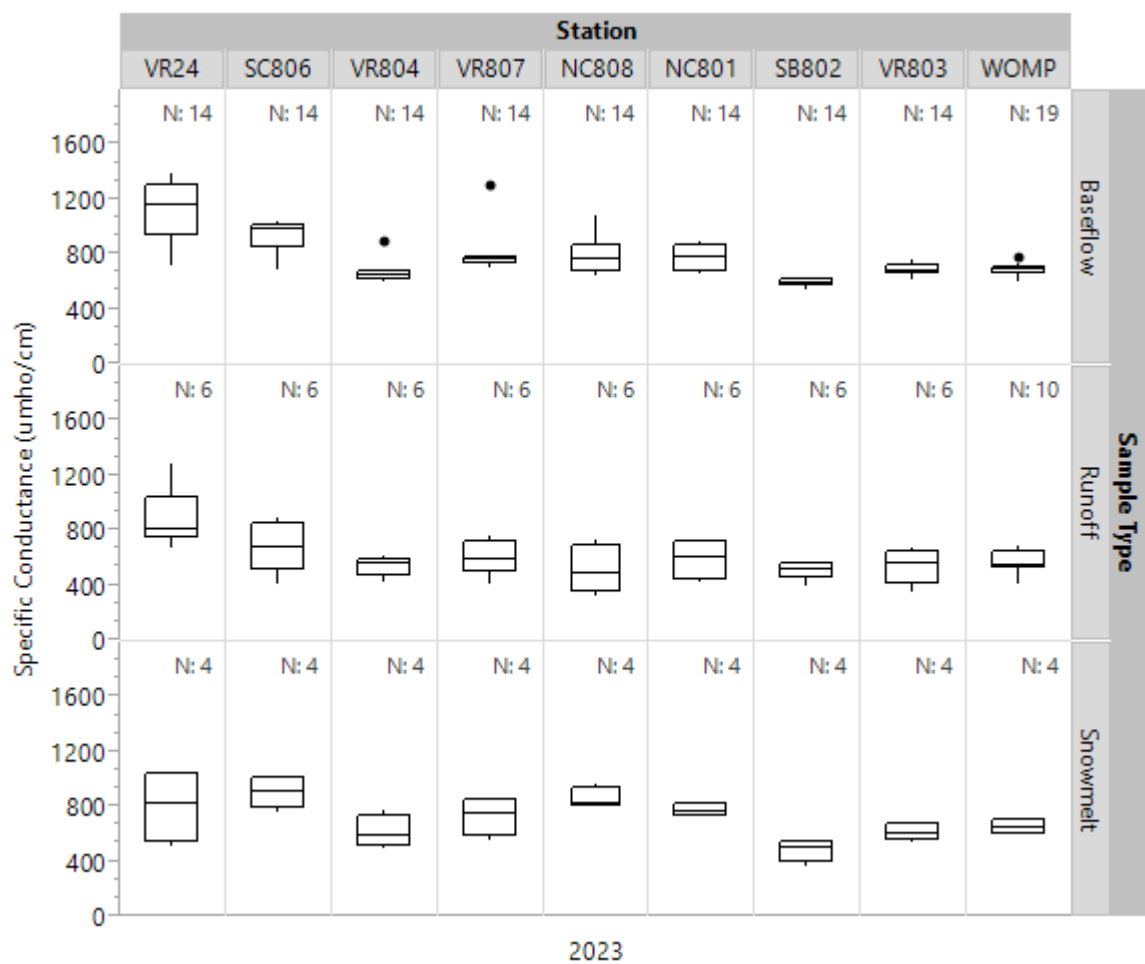
Figure 6. Specific conductance for each station, categorized by sample type, for 2023.

In 2023, baseflow conductivity was higher than conductivity measurements collected during runoff events at all sites (Figure 6). Groundwater tends to have more dissolved ions from geologic sources and rainwater tends to have lower conductivity. Additionally, fields are often irrigated with groundwater during dry conditions. This high conductivity water then enters surface water through shallow groundwater discharge.

Like in past years, there does not appear to be major differences between most stations with regards to specific conductance in 2023. Median levels appear comparable throughout the watershed during baseflow and runoff conditions. Sample medians were highest at VR24 and SC806 and both sites also had the highest variability in sampling results. The two sites in the North Creek subwatershed also had increased variability compared to the four mainstem sites and the site at the outlet of the South Branch subwatershed. Four snowmelt samples were collected in 2023 and median levels were closer to runoff conditions than baseflow.

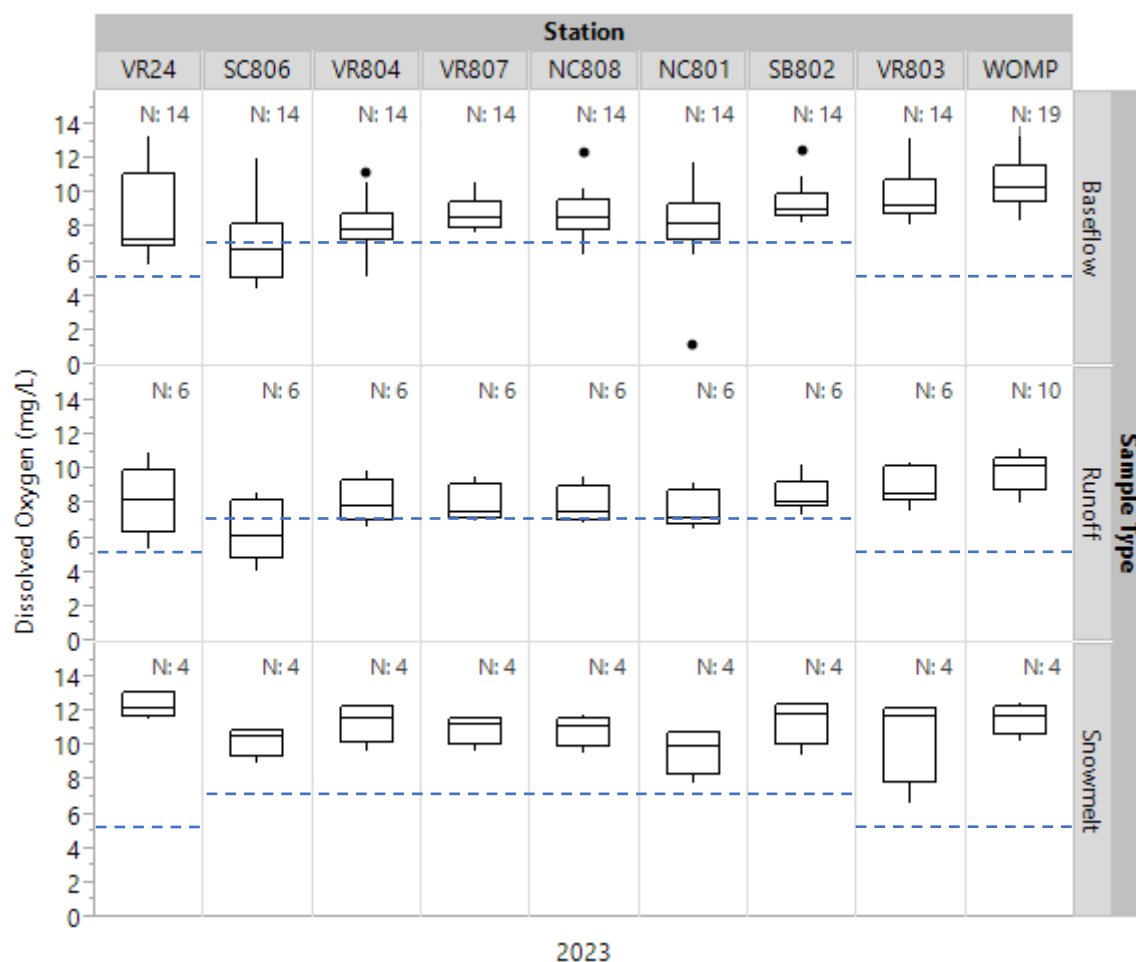
Figure 7. Dissolved oxygen for each station, categorized by sample type, for 2023.

In 2023, the median dissolved oxygen concentration was above the lower limit for all warm water (2B) streams (5.0 mg/L as daily minimum) and most of the cold water (2A) streams (7.0 mg/L as daily minimum) during baseflow conditions (dashed blue lines; Figure 7). The sample median for SC806 (coldwater site) was below the standard during baseflow conditions.

Median concentrations for runoff samples were above the threshold at most monitoring sites; SC806 had a median below the standard. Lower dissolved oxygen levels during or following runoff events could be the result of warmer water that is less capable of holding dissolved oxygen, flux of organic material which increases the biochemical oxygen demand, and/or flushing of warm ponded water or water draining directly from warm impervious surfaces from upstream. Snowmelt samples had relatively high dissolved oxygen medians at all stations. This is expected because the time of year is characterized by very cold water and minor biochemical oxygen demand.

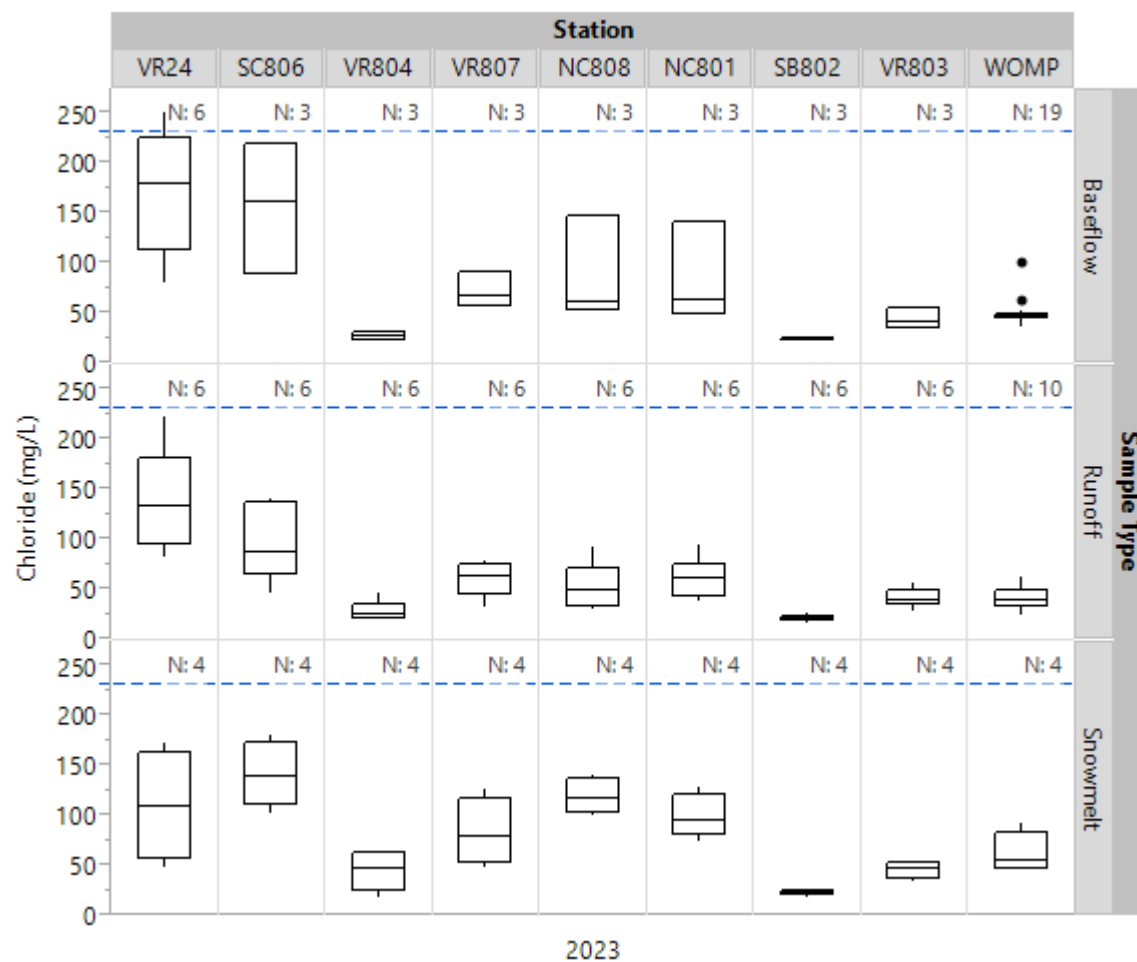
Figure 8. Chloride for each station, categorized by sample type, for 2023.

The VRWJPO began monitoring chloride in 2020. According to the MPCA, a stream, lake, or wetland is impaired for chloride if two or more samples exceed 230 mg/L within a three-year period; or, one sample exceeds 860 mg/L. Sampling in 2023 occurred during all conditions (Figure 8). At this time, no sample medians exceeded the chronic standard though VR24 had individual samples that did exceed. Higher levels during runoff events happen as stormwater runoff picks up debris from roads, sidewalks, and parking lots and transports into local waterbodies. Chloride levels are highest and most variable at VR24, possibly caused by several different sources including septic system discharge, agricultural runoff, livestock wading and/or defecating in streams, and resuspension of sediment in the sediment.

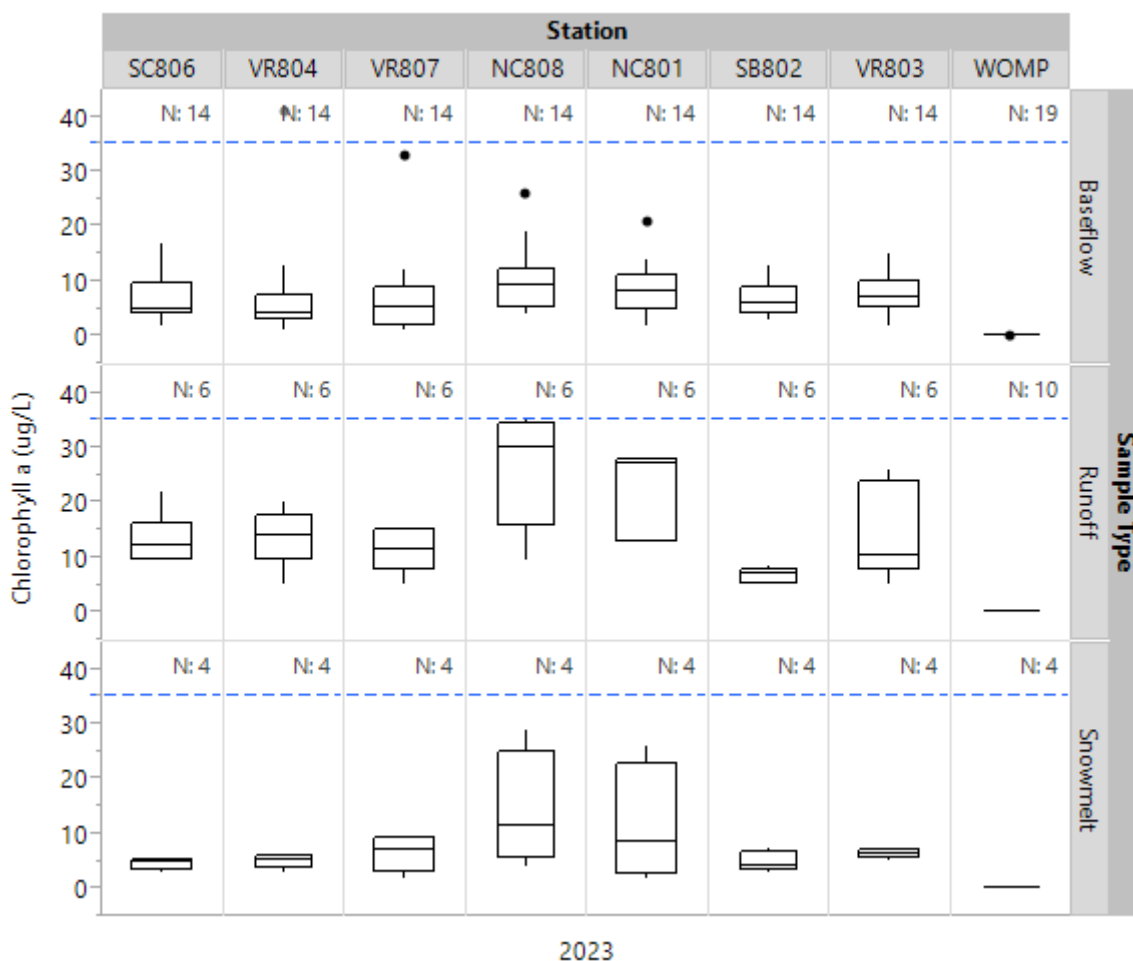
Figure 9. Chlorophyll *a* for each station, categorized by sample type, for 2023.

The sample median for all sites was below the state standard of ≤ 35 mg/L during all monitoring efforts (Figure 9). Individual sampling events at VR804 exceeded the standard during baseflow conditions. Variability and sample levels increased during runoff monitoring, but nothing exceeded the state standard. All snowmelt samples were below the standard. The two North Creek sites had highest variability during runoff and snowmelt conditions.

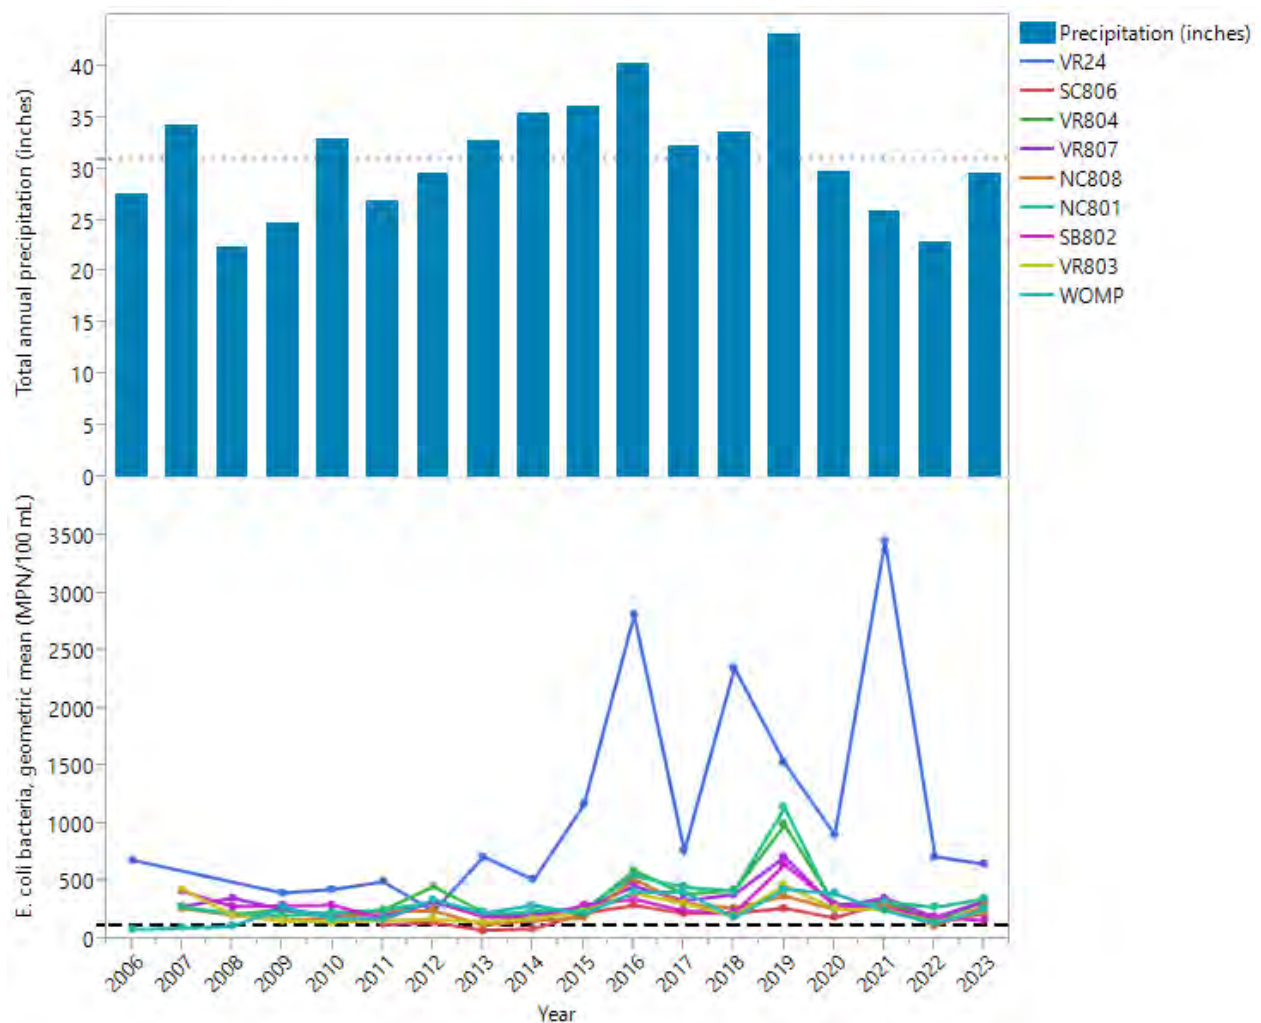
Figure 10. Annual geometric mean of *Escherichia coli* (*E. coli*) bacteria for all stations by year. MPN stands for most probable number of organisms. Black dashed line indicates the 30-day geometric mean standard (for data collected April through October) of ≤ 126 MPN/100 mL. Bars represent total annual precipitation for each year. Gray dotted line indicates the 30 year (1993-2022) total annual average precipitation at the Minneapolis – St. Paul airport weather station of 31 inches.

The total annual precipitation for each year is shown in Figure 10. A gray dotted line is drawn at 31 inches to indicate the 30 year (1993-2022) average total precipitation at the Minneapolis – St. Paul airport weather station. Before making conclusions regarding year-to-year variability, weather patterns should be considered. The Vermillion River watershed has been uncharacteristically dry the past few years, experiencing drought conditions for much of the monitoring season.

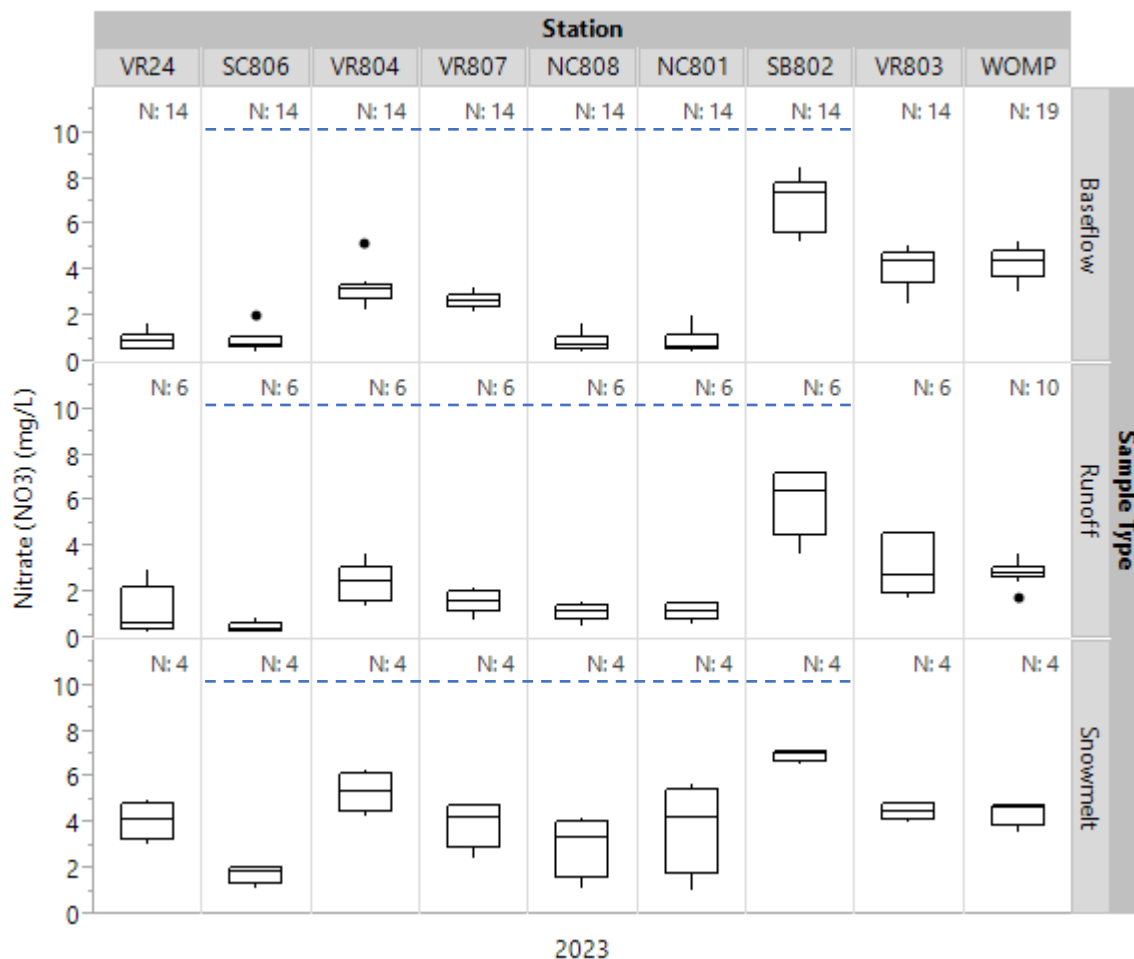
Figure 11. Nitrate nitrogen for each station, categorized by sample type, for 2023.

Waters that are used for domestic consumption (drinking water) have an approved nitrate standard not to exceed 10 mg/L. In Minnesota, cold water streams (2A streams) are protected as potential drinking water sources and are subject to the 10 mg/L standard. Figure 11 shows the nitrate nitrogen levels for each station, classified by sample type for the year 2023. The state standard is not applicable to warm water streams (2B streams) which include VR24, VR803, and WOMP. Sample medians for all sites are below the approved domestic consumption standard with Station SB802 having the highest median nitrate concentration in the watershed.

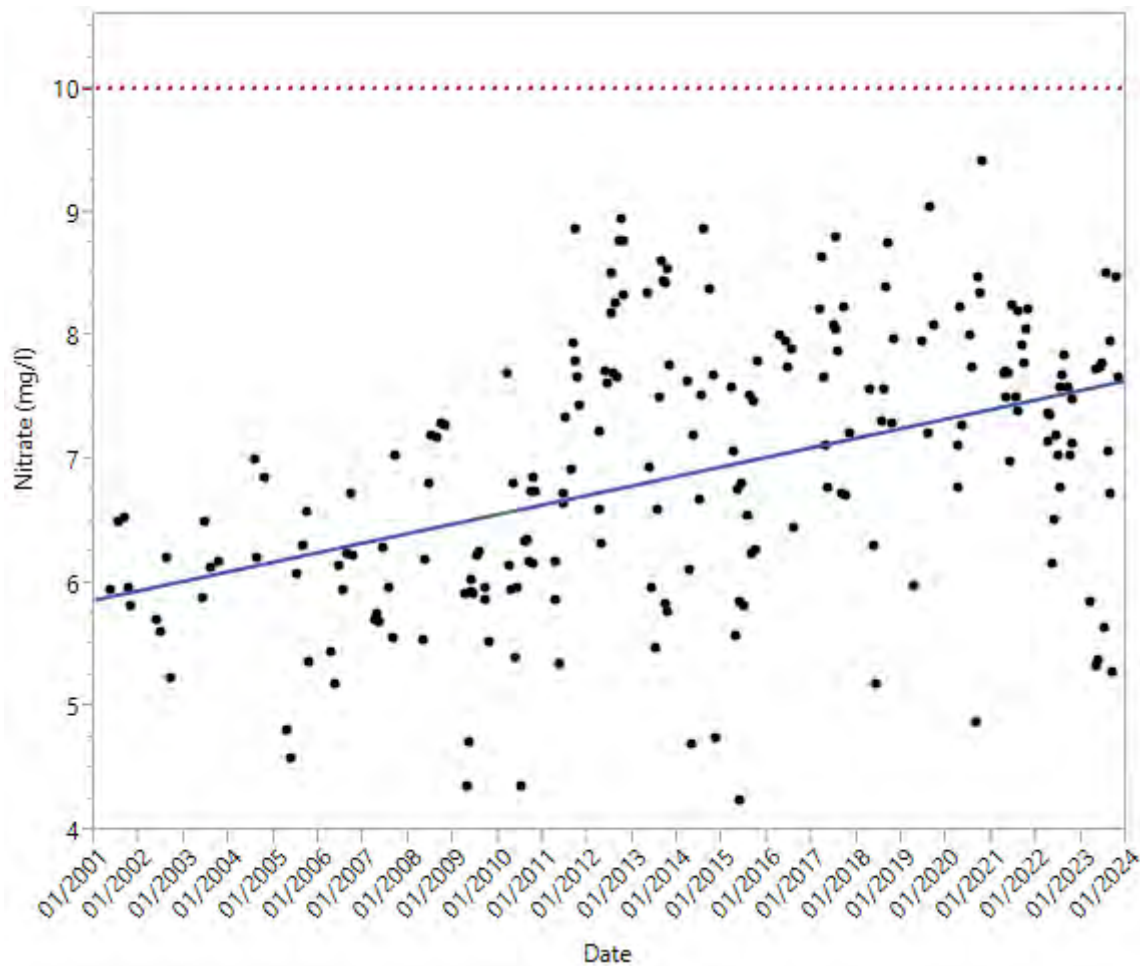
Figure 12. Baseflow nitrate concentration in South Branch Vermillion River, measured at 200th Street East near Highway 52, Dakota County.

Samples reflect surface water baseflow conditions (March – October) from 2001 - 2023. Blue solid line represents linear regression. Red dotted line indicates upper limit of state standard, 10 mg/L.

The baseflow nitrate values measured at SB802 appear to be increasing in recent years. By analyzing baseflow samples, changes attributed to weather patterns and background conditions can be ruled out with some confidence. A Kendall's tau (T) test was performed to determine if the apparent trend is statistically significant. Most generally, Kendall's tau (T) test is a test to determine whether measured nitrate concentrations tend to increase, decrease, or stay the same over time. For the entire period of record, baseflow nitrate at station SB802 seems to be increasing ($T=0.2996$, $P<0.0001$), as shown in Figure 12. The strong tau value suggests that this trend is statistically significant.

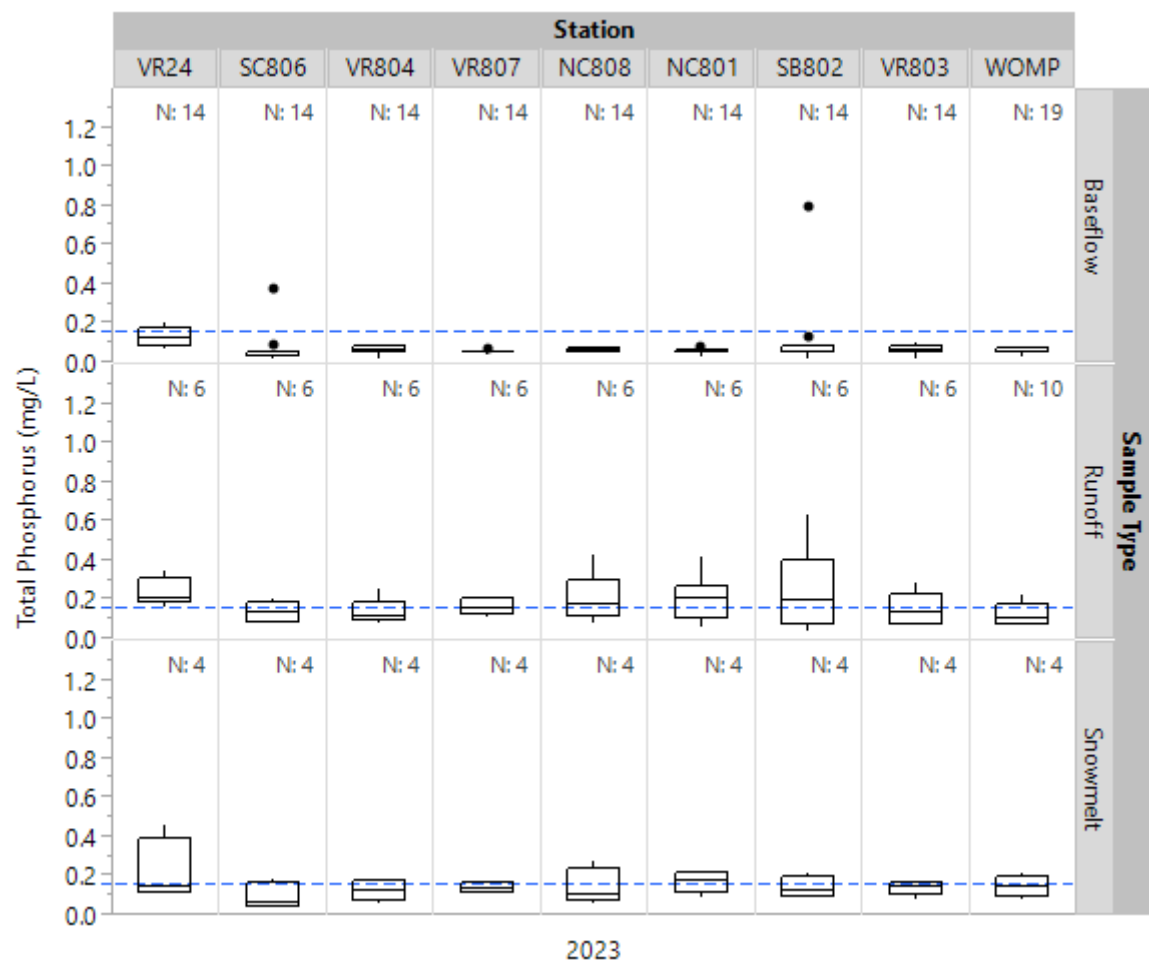
Figure 13. Total phosphorus (TP) for each station, categorized by sample type, for 2023.

Phosphorus levels during the four snowmelt events varied, with the median phosphorus level below the standard at most monitoring sites in the watershed except NC801. Individual samples exceeded the standard at all sites, but the medians remained below.

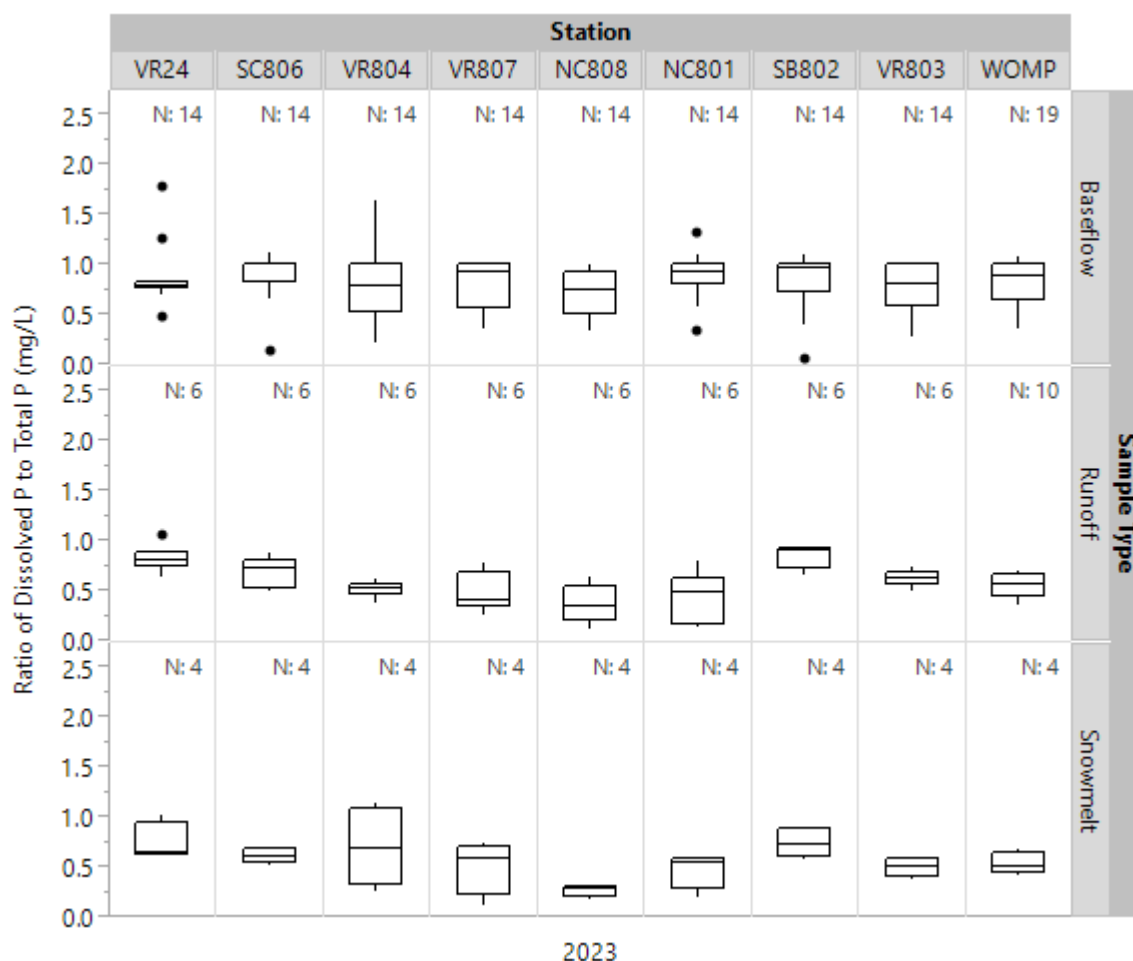
Figure 14. Ratio of dissolved phosphorus (TDP) to total phosphorus (TP) for each station, categorized by sample type, for 2023.

Figure 14 shows the TDP to TP ratio boxplots for each station, classified by sample type for the year 2023. In some cases, the sample ratios exceeded 1.0 which indicates a field collection or laboratory analysis error. Since TDP is a fraction of TP, it was concluded that either the TP value was underestimated or the TDP value was overestimated because of field or lab error. Nonetheless, the data provided here are useful and paint a good general picture of what is going on in the stream. There is no state approved or proposed standard nor is there a published benchmark value for evaluating TDP levels in Minnesota.

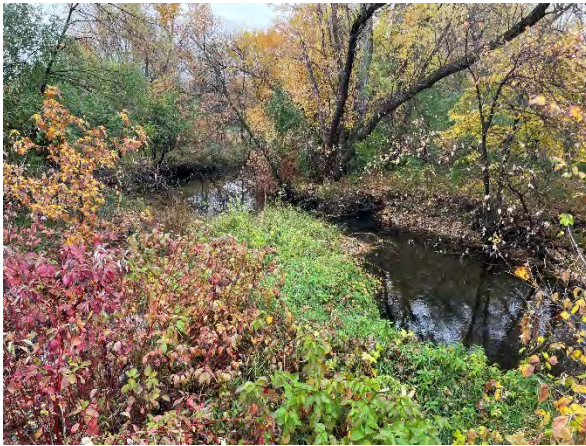
VR804 at *baseflow* conditions.

Water transparency is high.

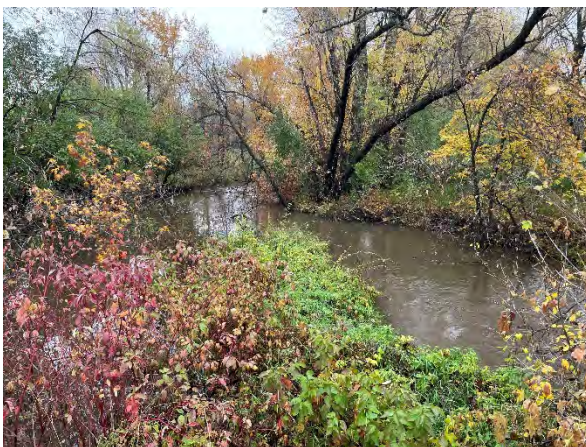
VR804 under *runoff* conditions.

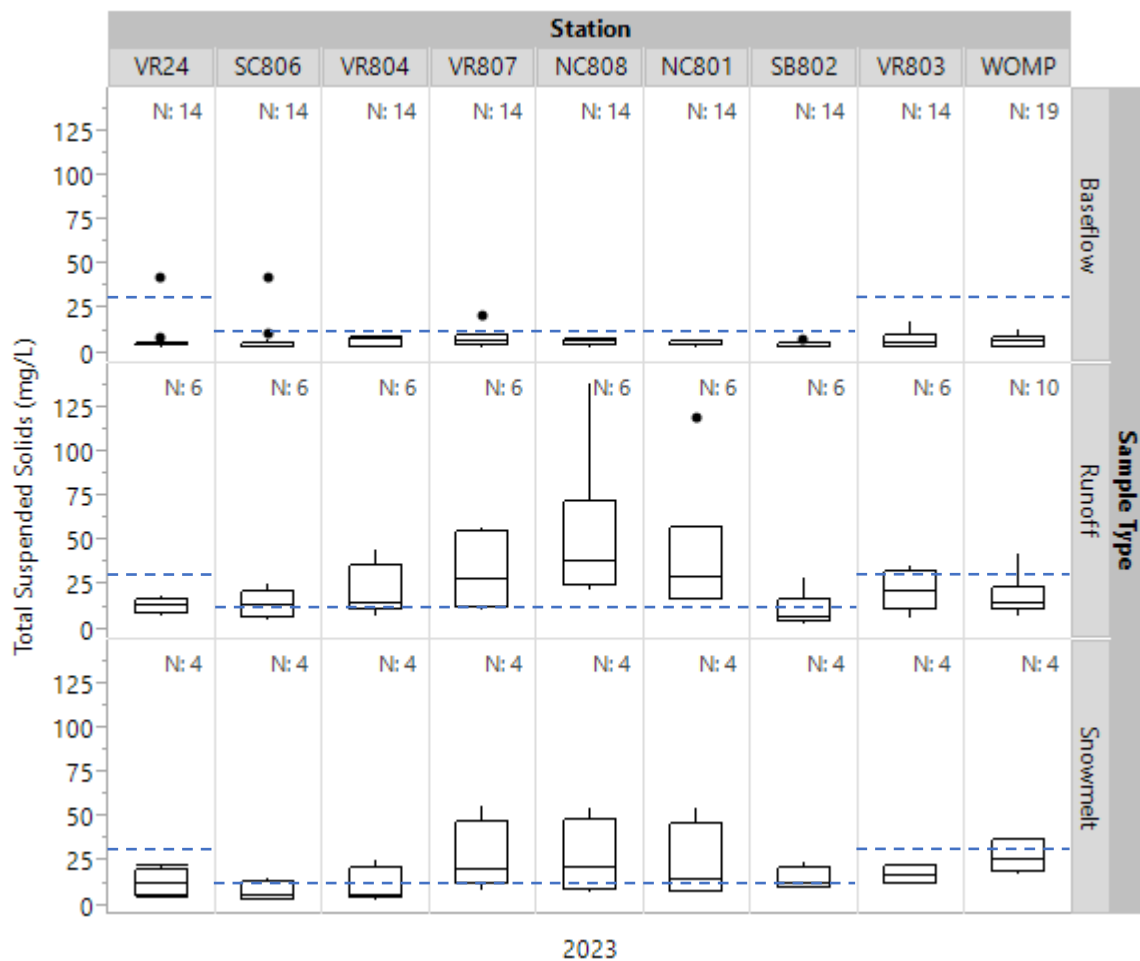
Figure 15. Total suspended solids categorized by sample type for 2023.

For cold water (2A) streams the standard is ≤ 10 mg/L and for warm water (2B) streams the standard is ≤ 30 mg/L (blue dashed line). These standards apply from April through September; however, data shown here includes the entire monitoring season which goes from snowmelt (mid-March) through November 1st (Figure 15). 2023 monitoring results mirror the historical results in that sample medians were at or below the state standard at all stations during baseflow conditions and at or above the standard during runoff monitoring. During snowmelt events in early spring, samples medians were above the standard for half of the cold water sites (warm water sites were all below).

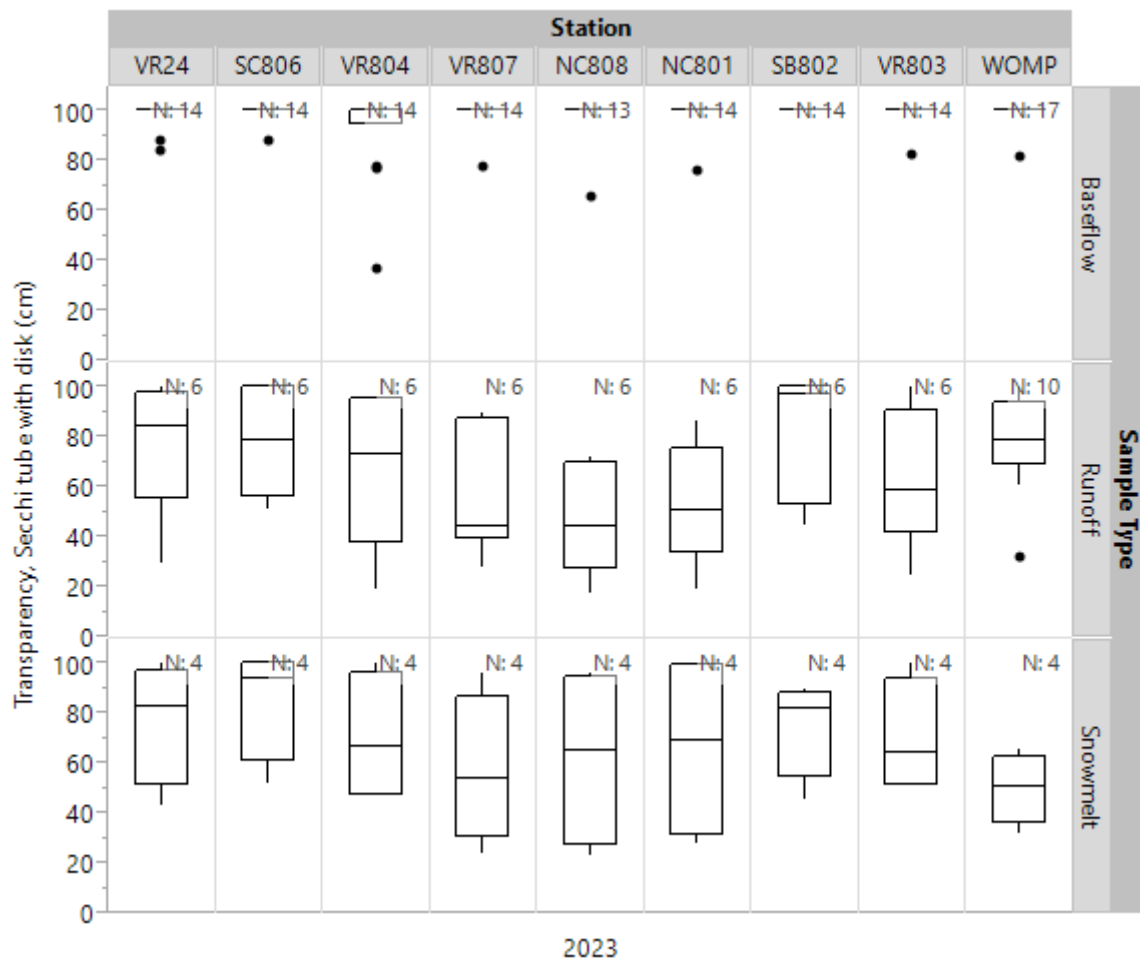
Figure 16. Transparency, categorized by sample type, for 2023.

Water is relatively clear during baseflow conditions at all stations (Figure 16). Station VR804 had the most variability in individual samples relative to the other monitoring sites in the watershed. Variability was high for both sample medians and individual samples during both runoff and snowmelt sampling efforts.
