Vermillion River Monitoring Network 2023 Annual Report

*Prepared for the Vermillion River Watershed Joint Powers Organization
by the Dakota County Soil and Water Conservation District*

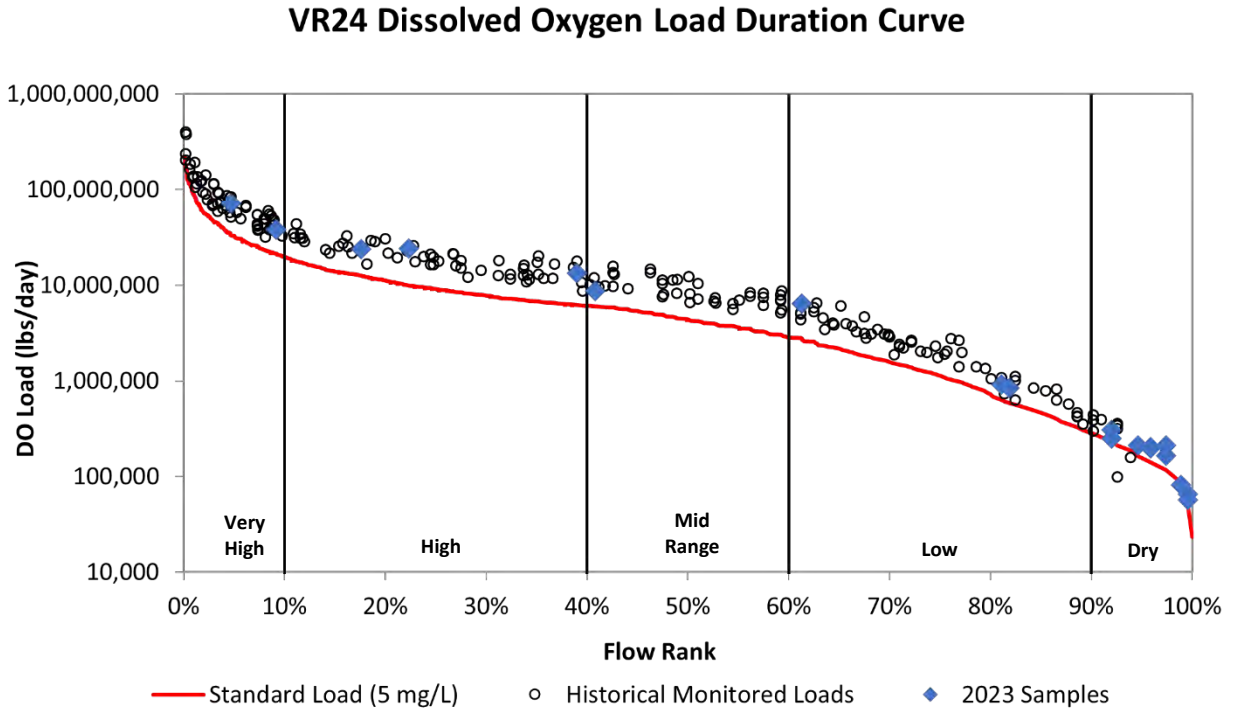
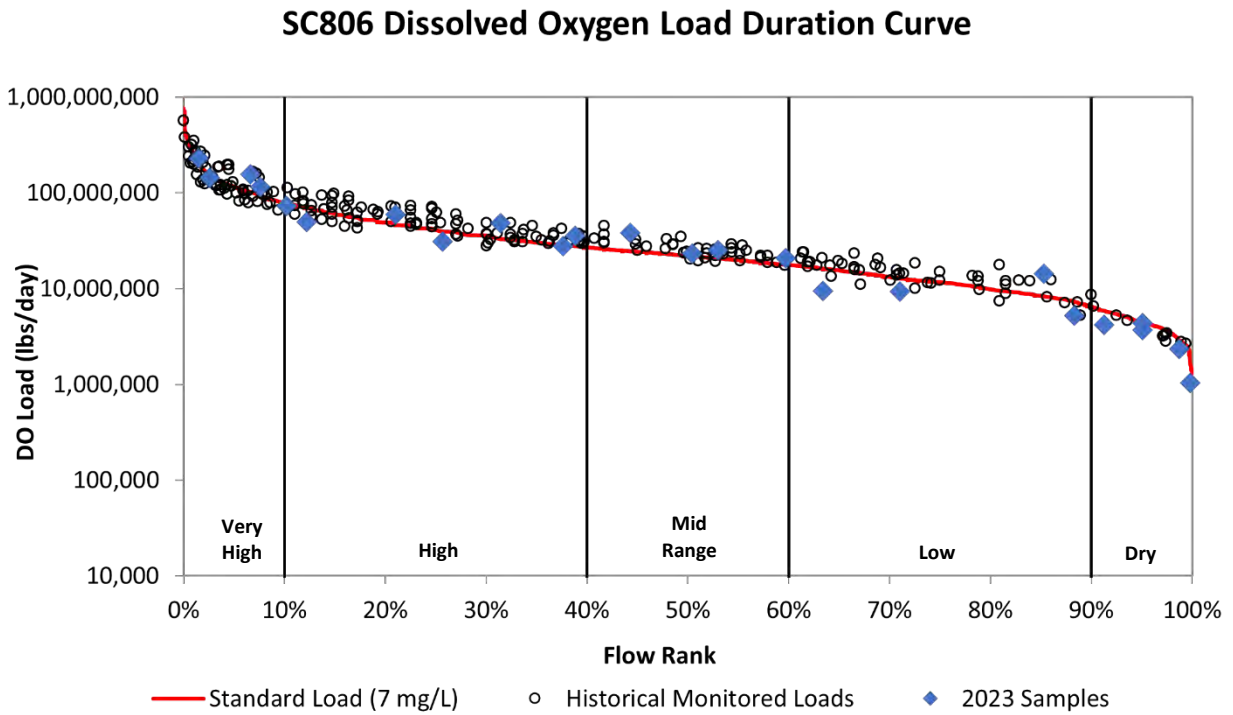
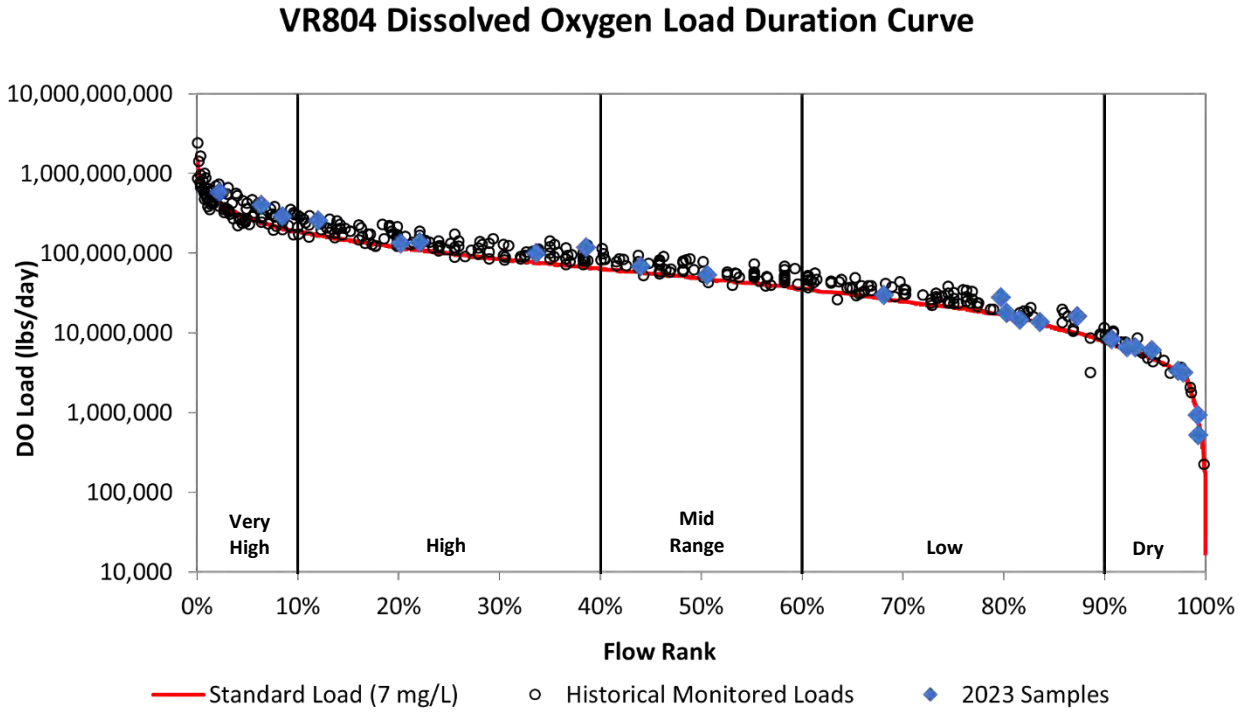
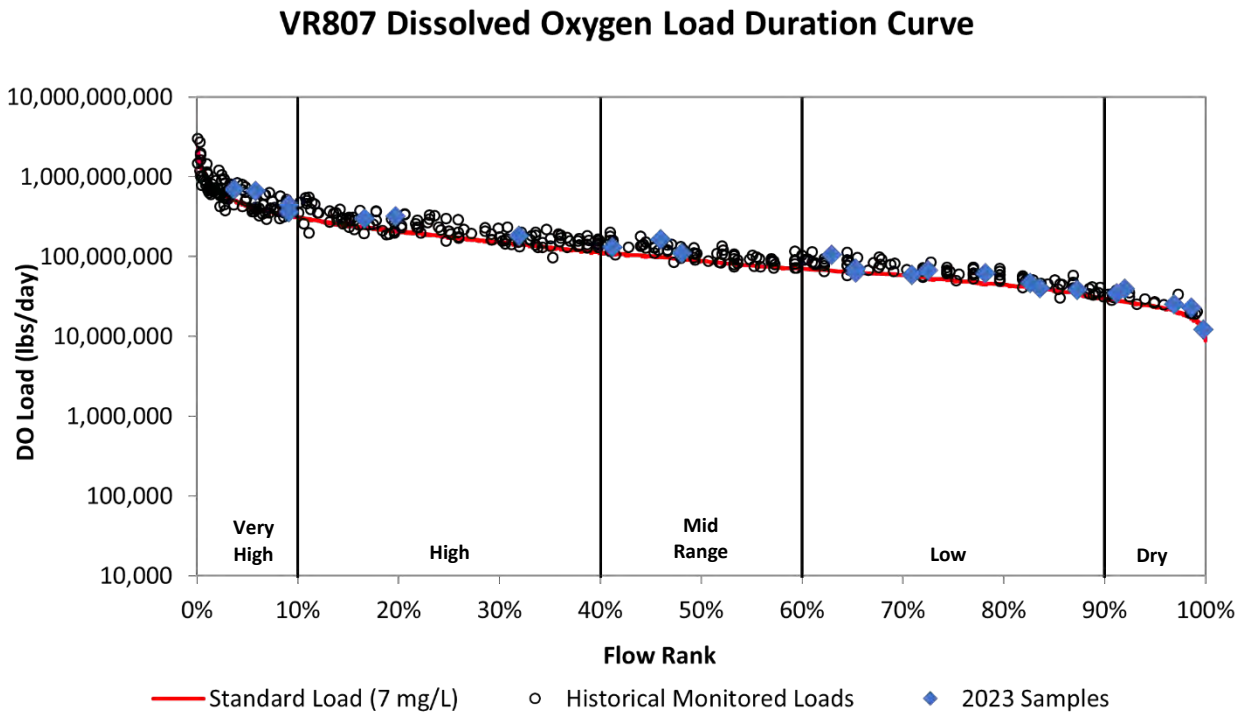
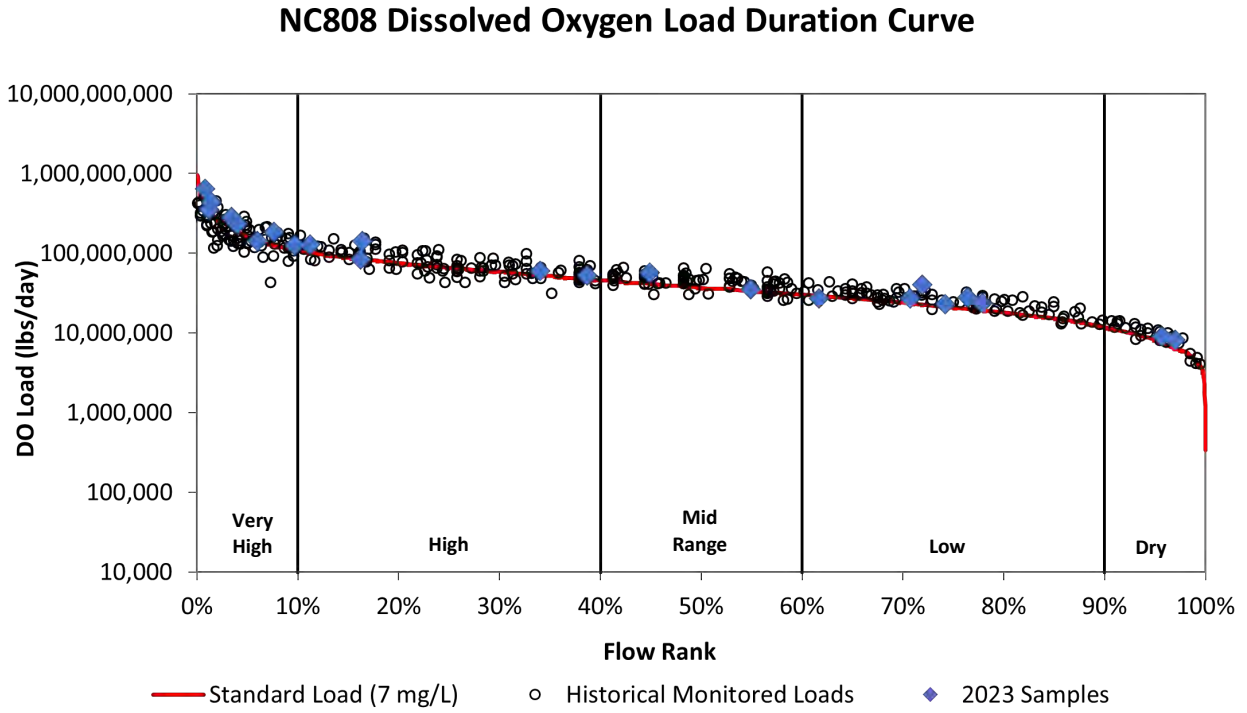
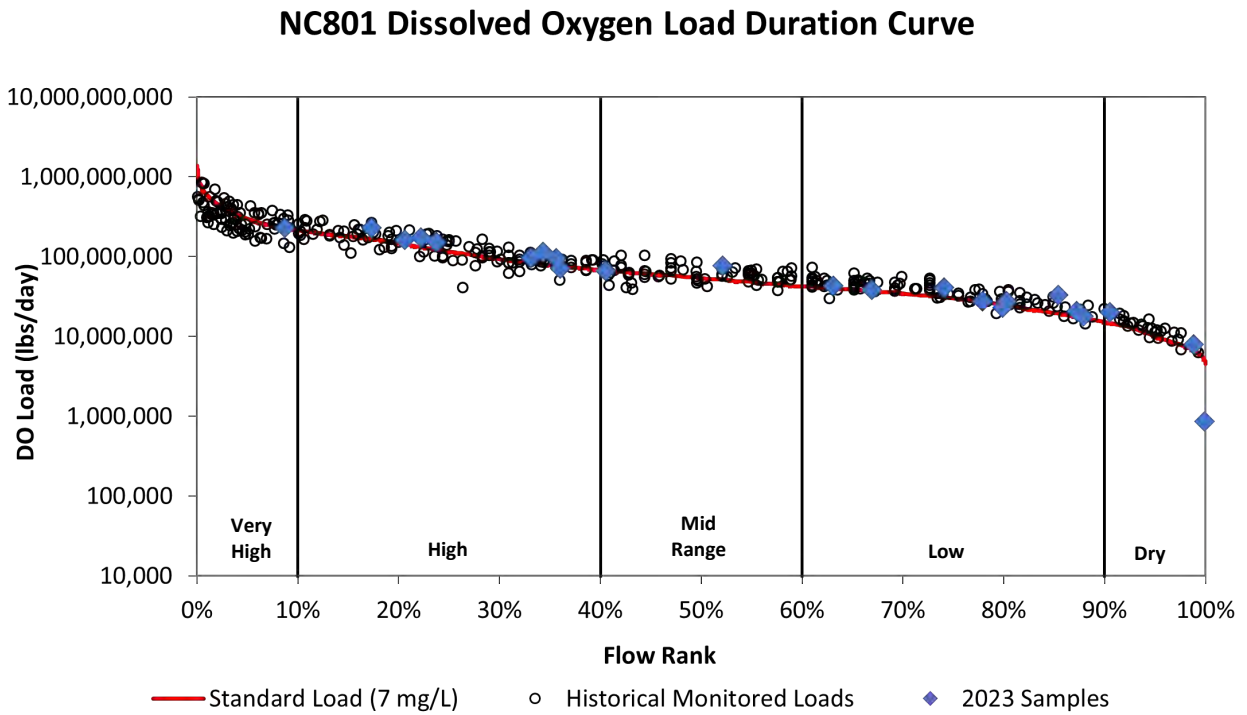
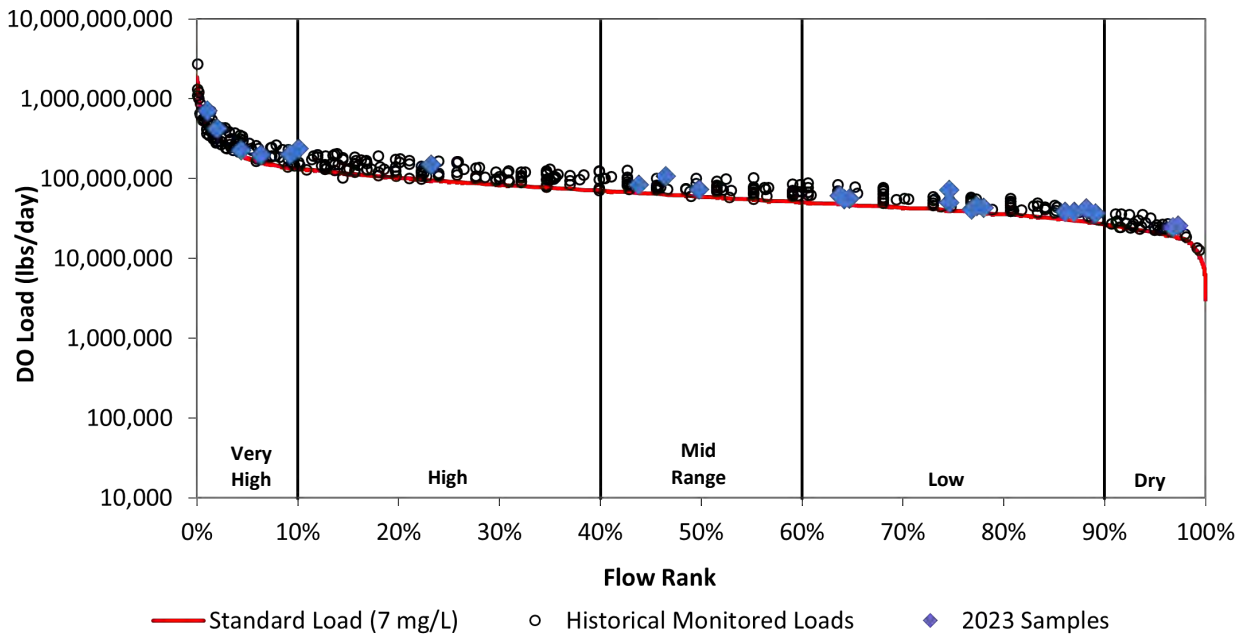
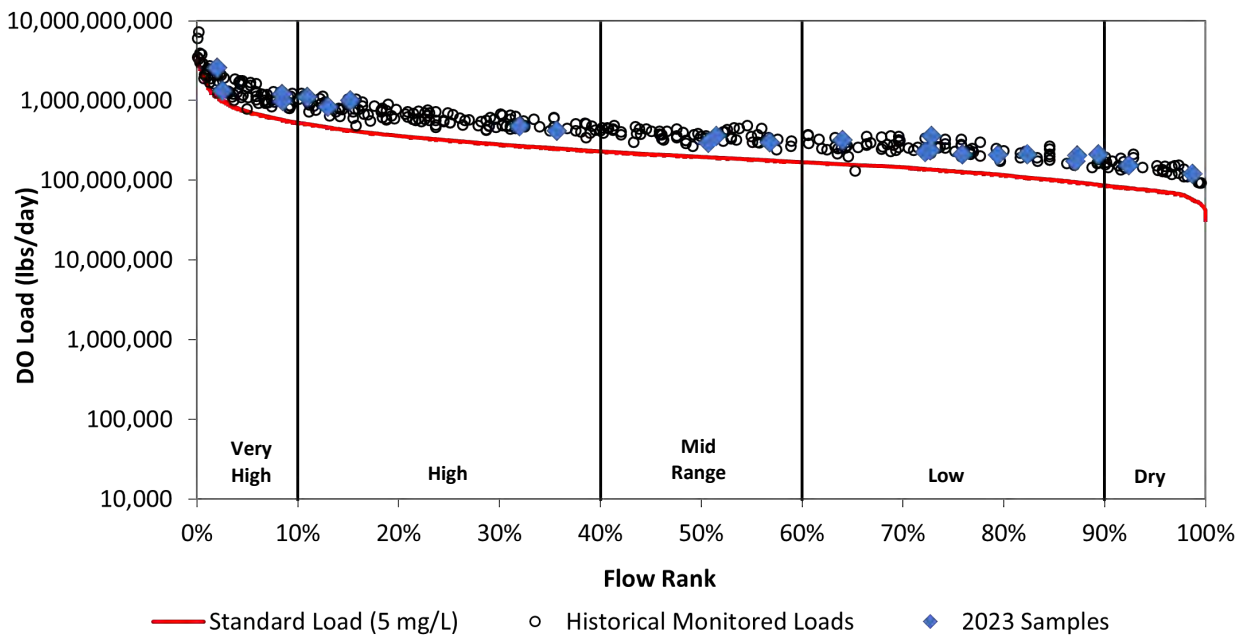
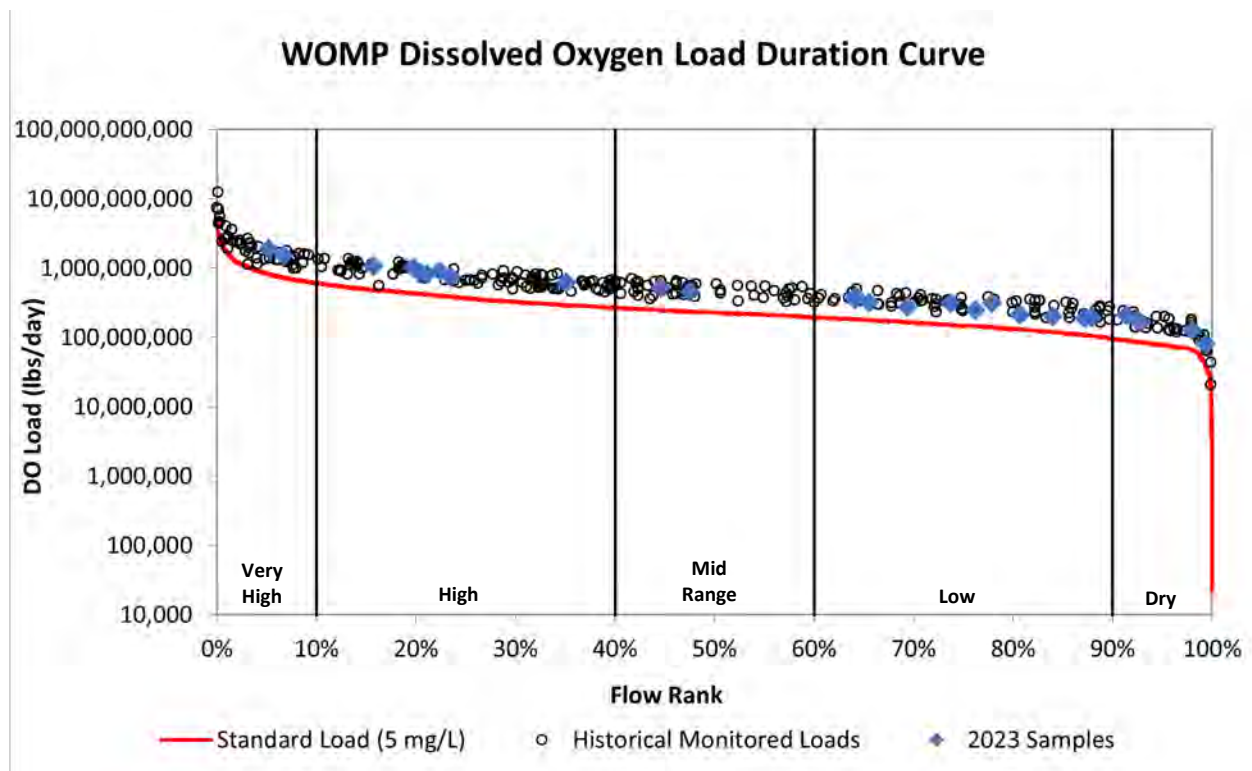
Figure 17a. Load duration curve for dissolved oxygen at VR24.

Figure 17b. Load duration curve for dissolved oxygen at SC806.

Figure 17c. Load duration curve for dissolved oxygen at VR804.

Figure 17d. Load duration curve for dissolved oxygen at VR807.

Figure 17e. Load duration curve for dissolved oxygen at NC808.

Figure 17f. Load duration curve for dissolved oxygen at NC801.

Figure 17g. Load duration curve for dissolved oxygen at SB802.

Figure 17h. Load duration curve for dissolved oxygen at VR803.

Figure 17i. Load duration curve for dissolved oxygen for WOMP.

In 2023, the dissolved oxygen standard was exceeded at all sites during all flow regimes (Figures 17a-i). One warmwater site (VR24; Figure 17a) and two coldwater sites (SC806 (Figure 17b) and VR804 (Figure 17c)) had samples that fell below their respective standard loads during dry conditions (90-100% flow rank). SC806 and the two sites in the North Creek subwatershed (NC808 (Figure 17e) and NC801 (Figure 17f)) had several samples with loads below the standard line during all other flow conditions as well.

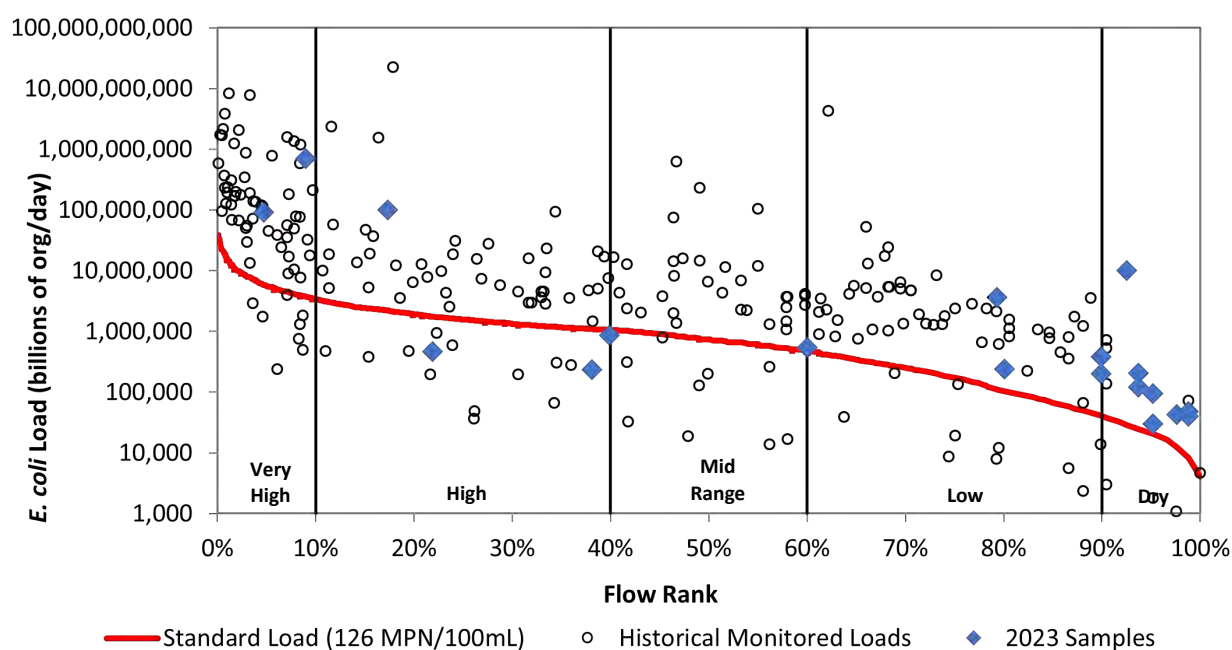
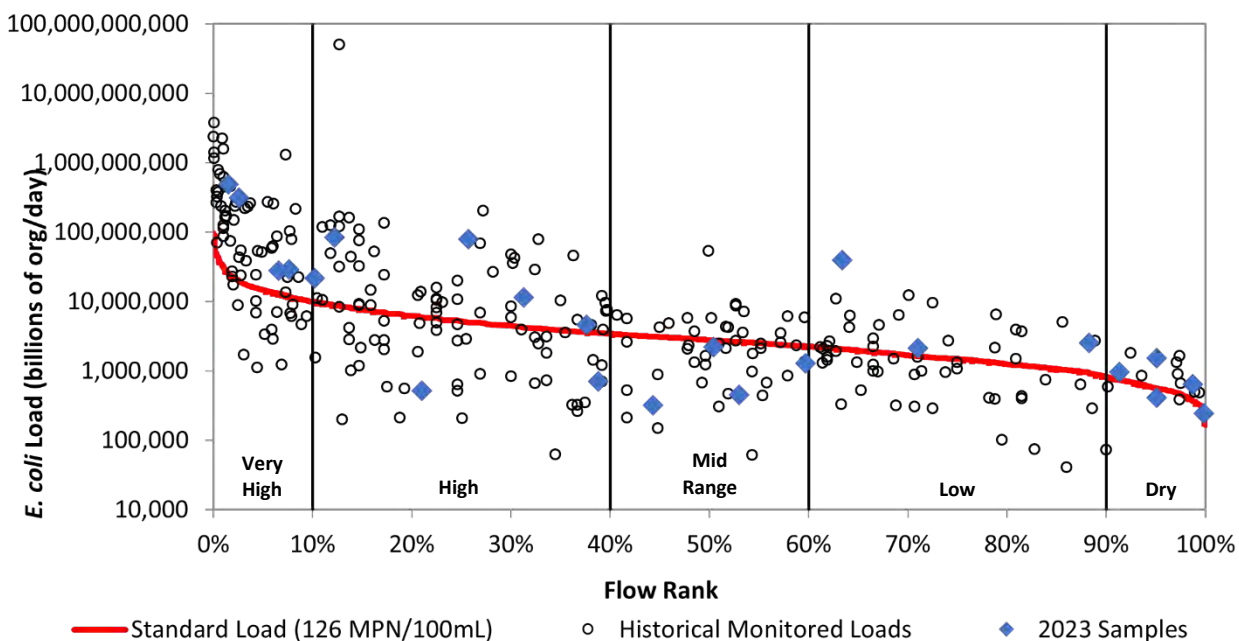
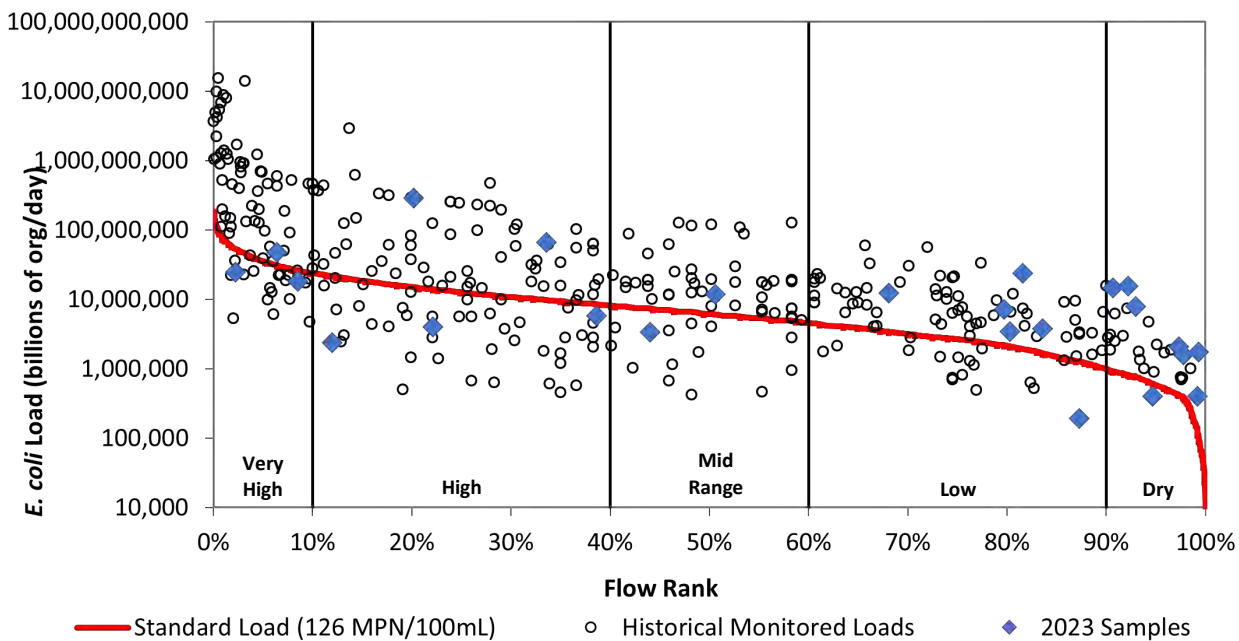
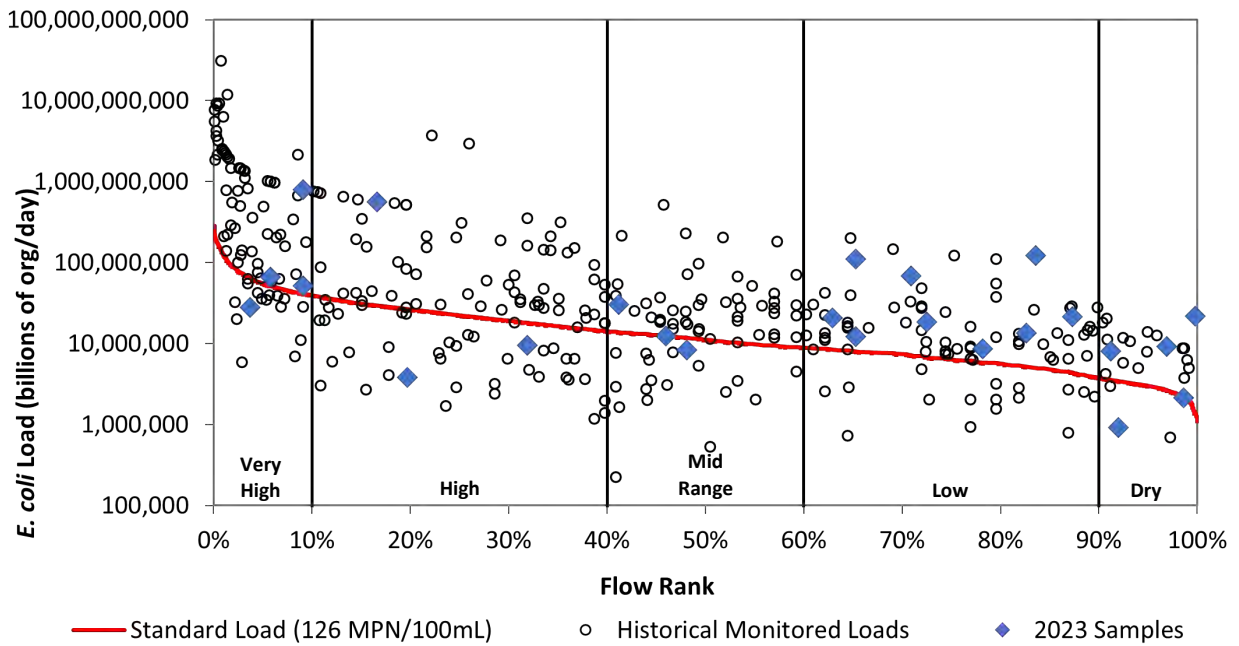
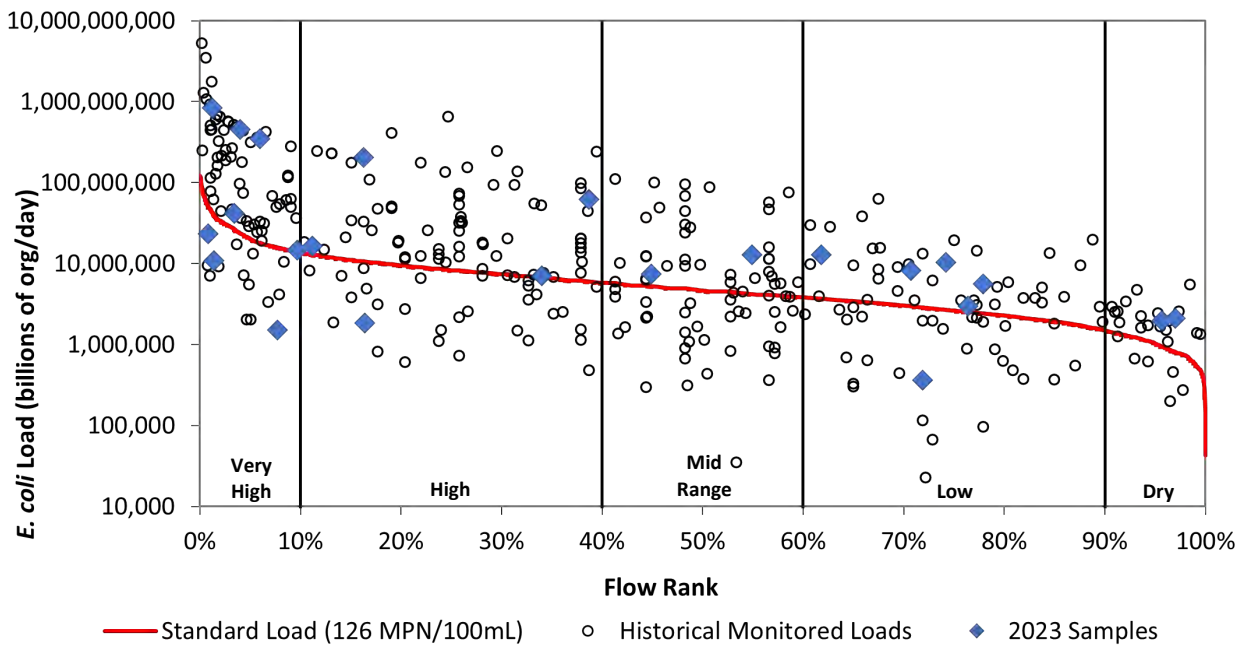
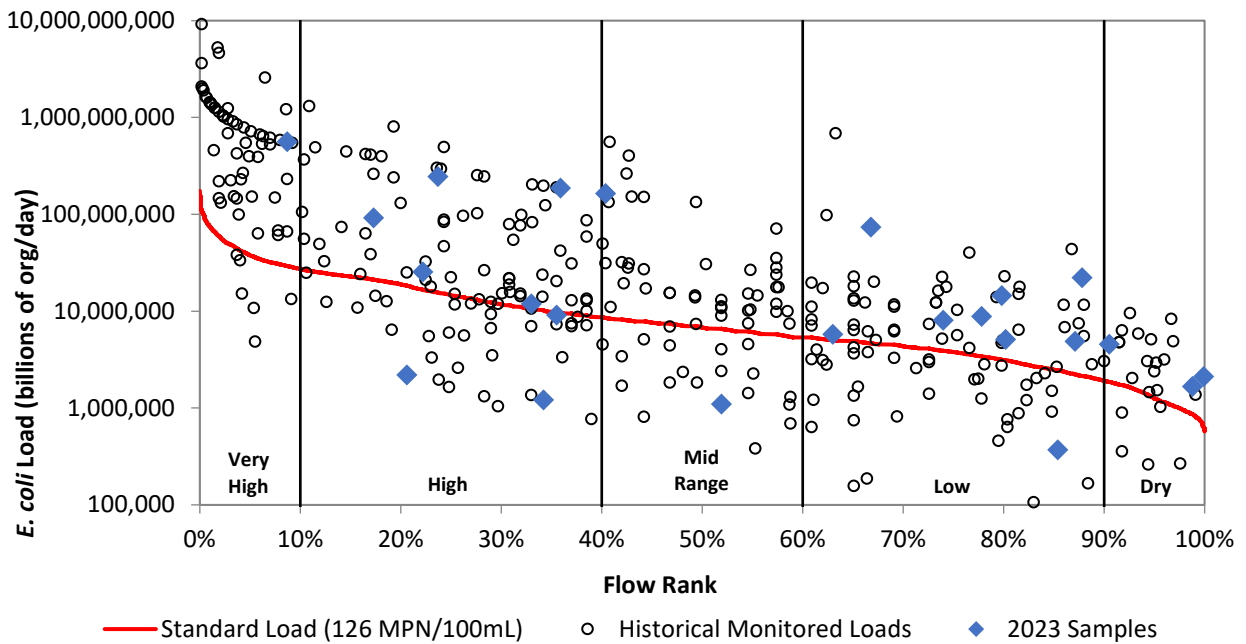
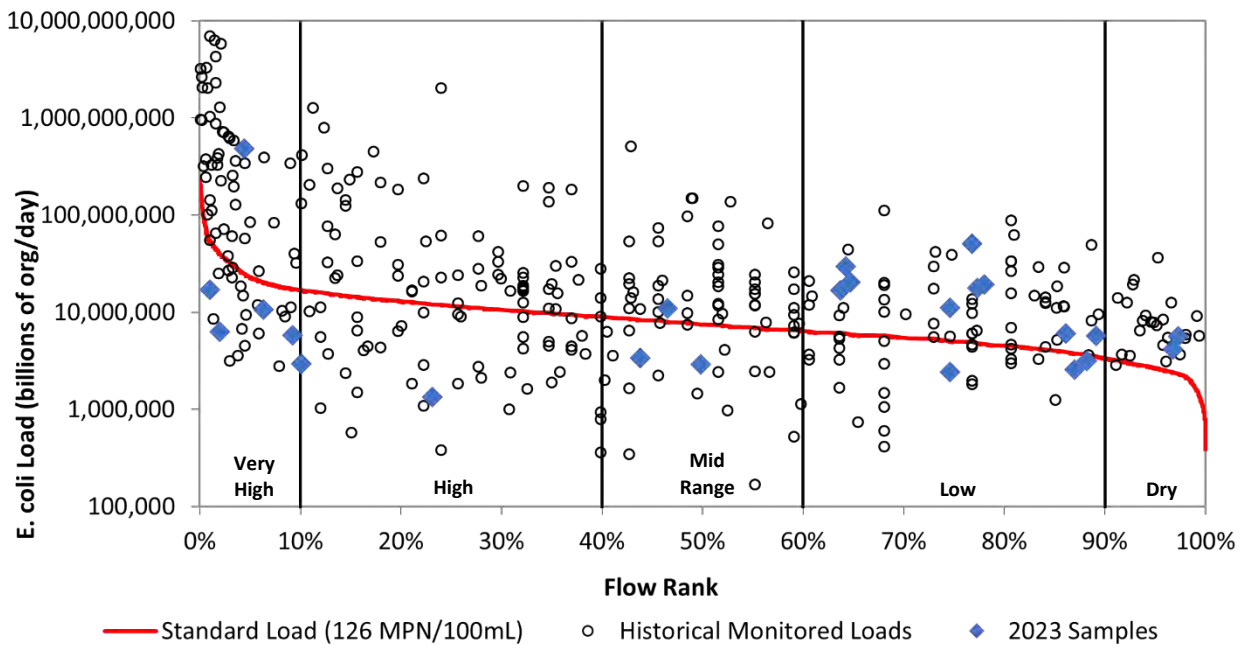
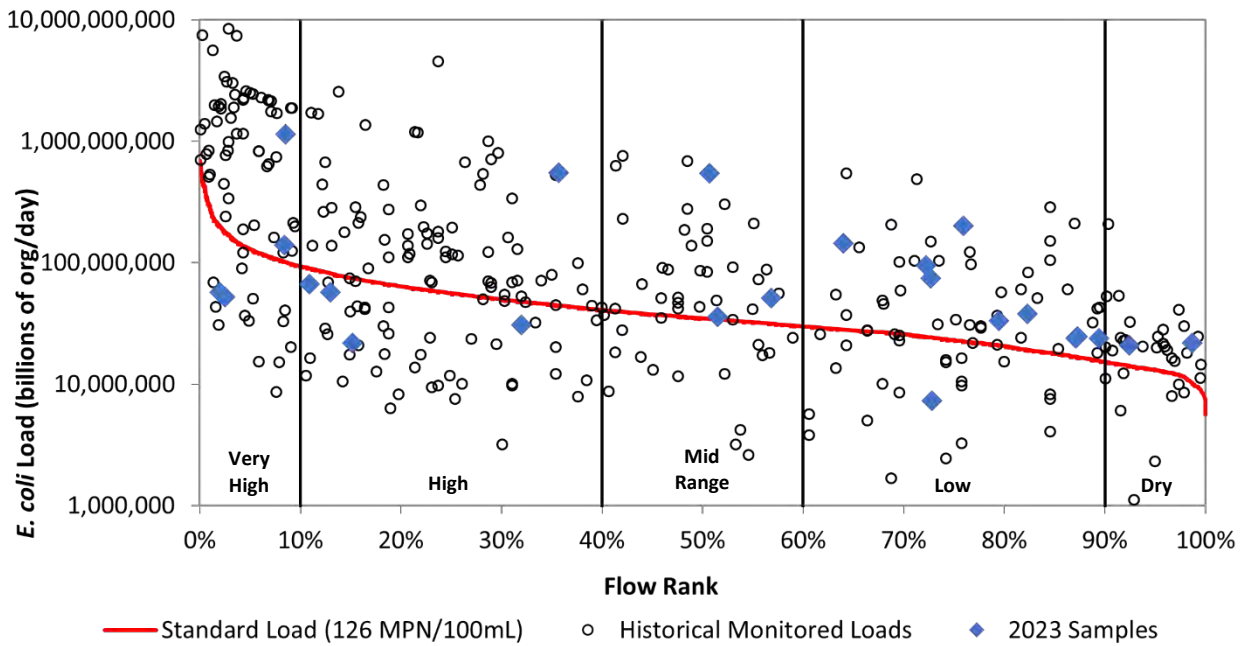
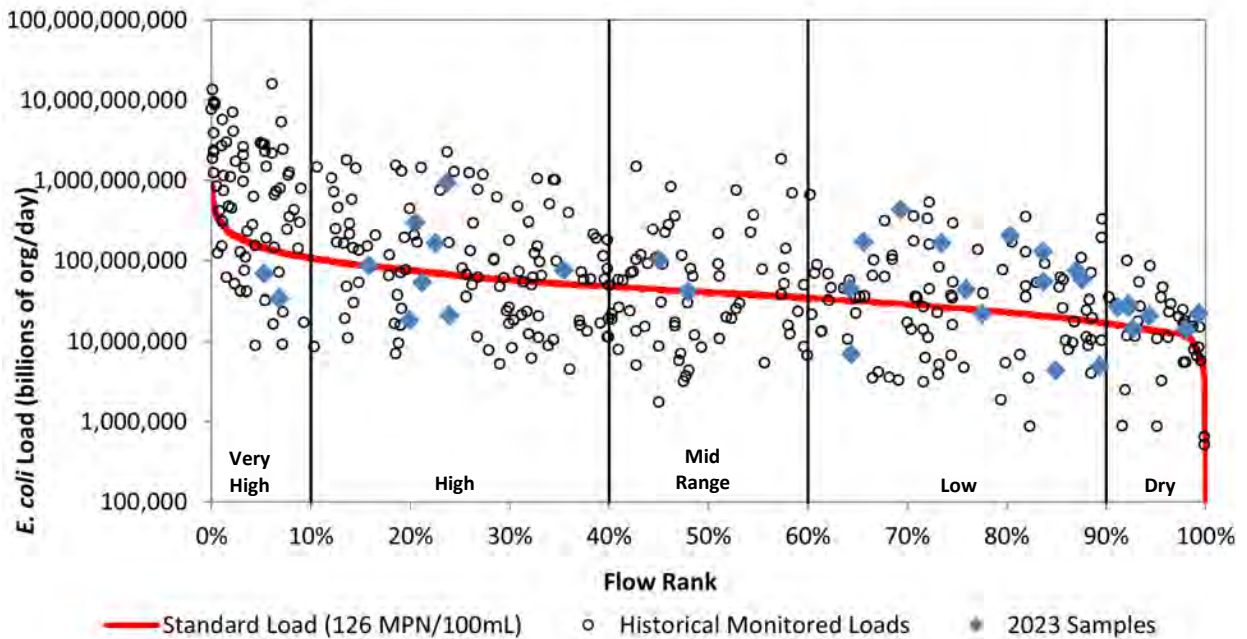
Figure 18a. Load duration curve for *E. coli* at VR24.

Figure 18b. Load duration curve for *E. coli* at SC806.

Figure 18c. Load duration curve for *E. coli* at VR804.

Figure 18d. Load duration curve for *E. coli* at VR807.

Figure 18e. Load duration curve for *E. coli* at NC808.

Figure 18f. Load duration curve for *E. coli* at NC801.

Figure 18g. Load duration curve for *E. coli* at SB802.

Figure 18h. Load duration curve for *E. coli* at VR803.

Figure 18i. Load duration curve for *E. coli* at WOMP.

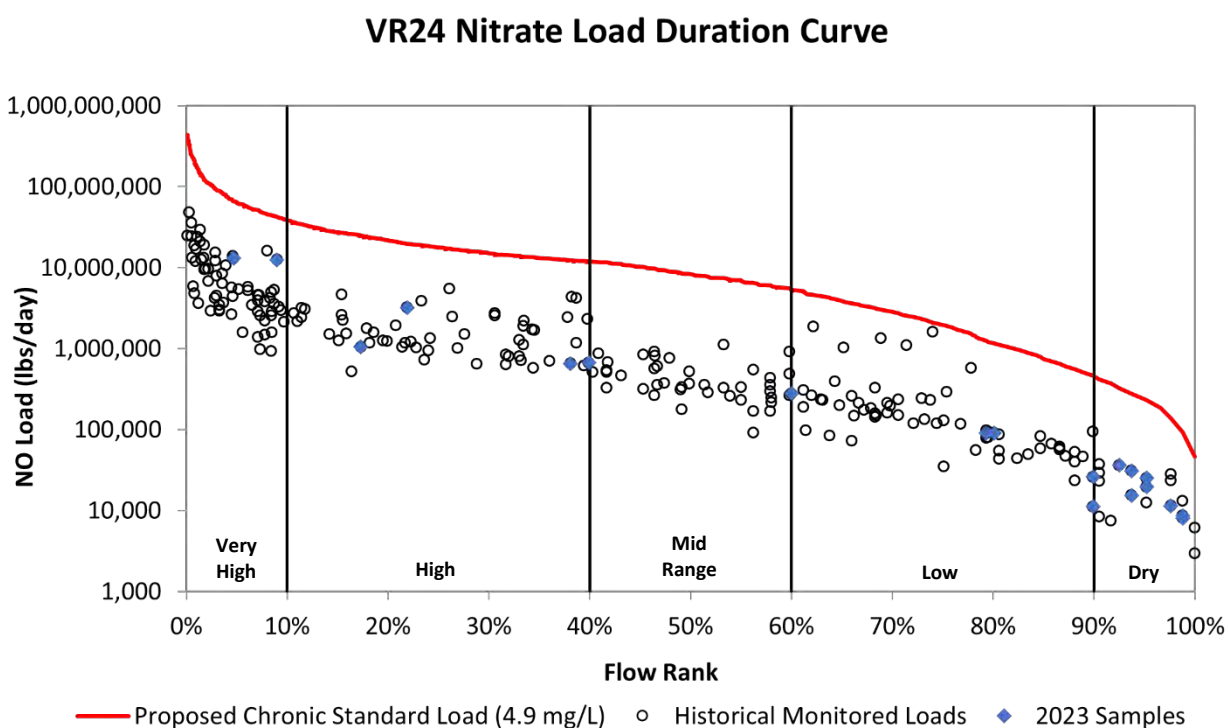
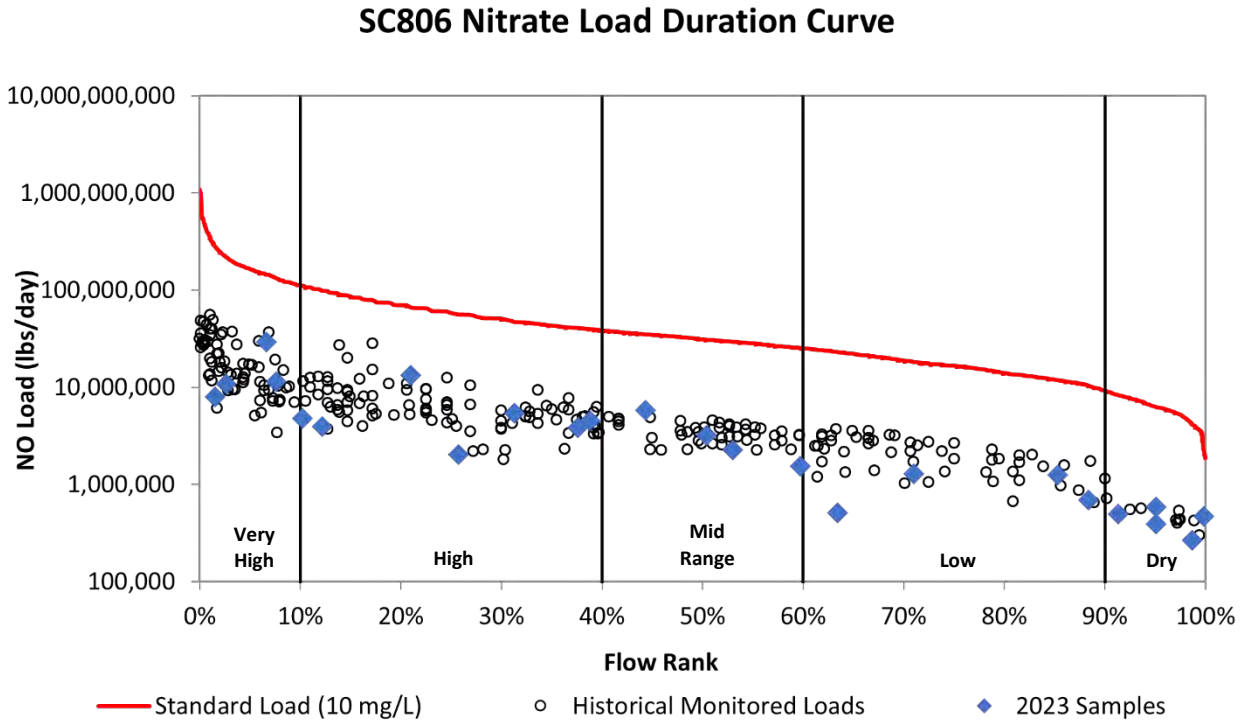
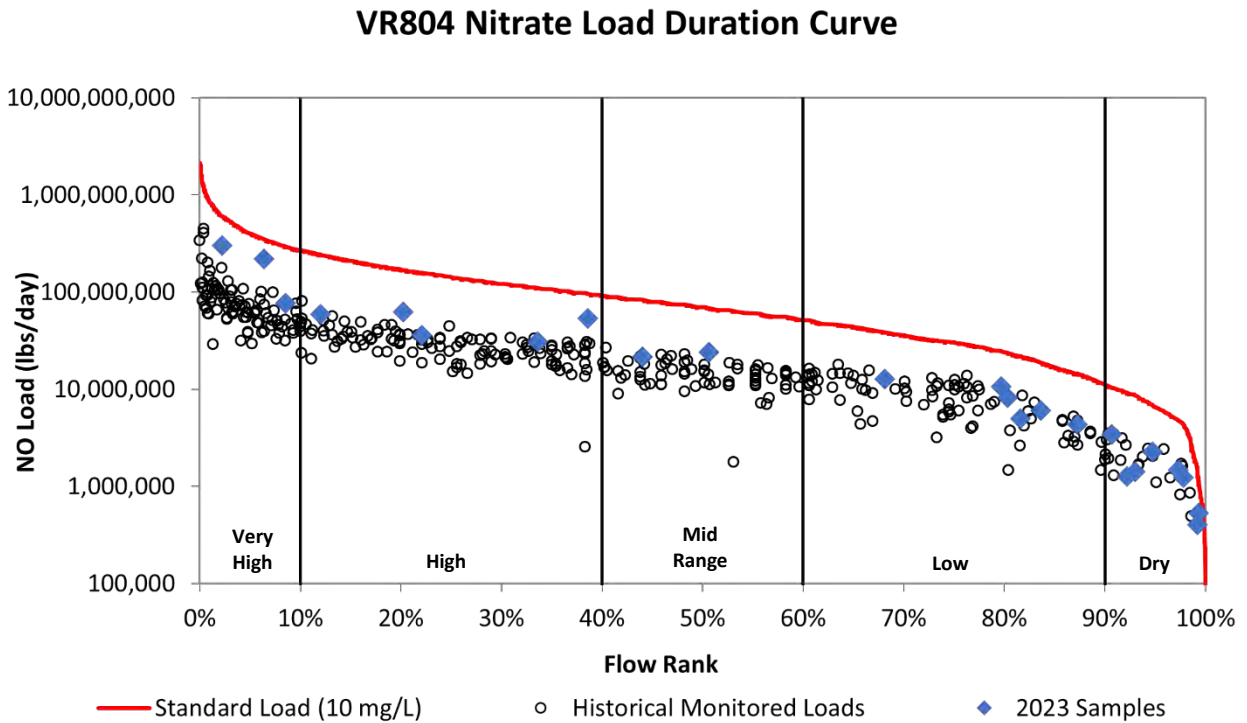
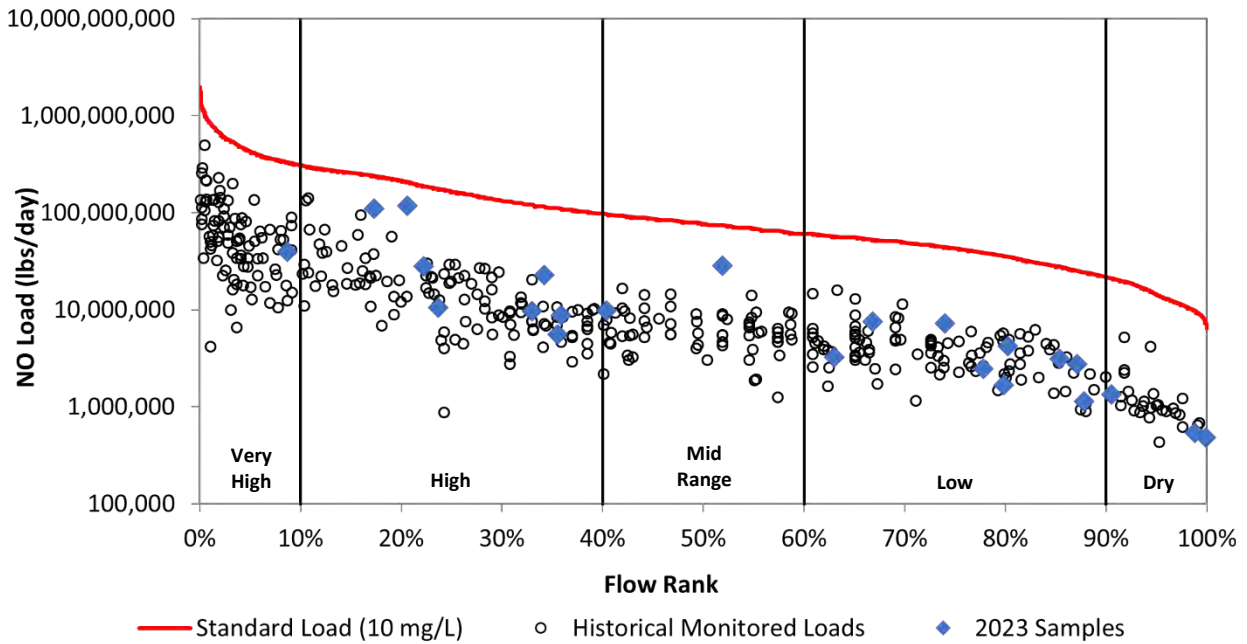
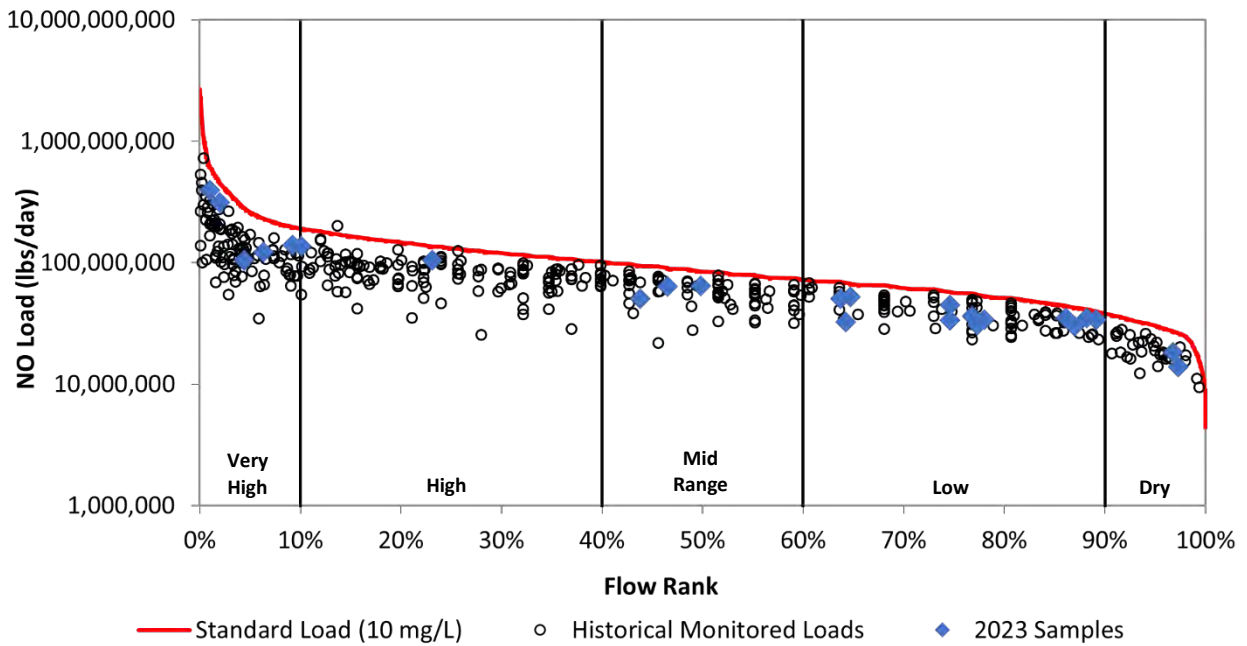
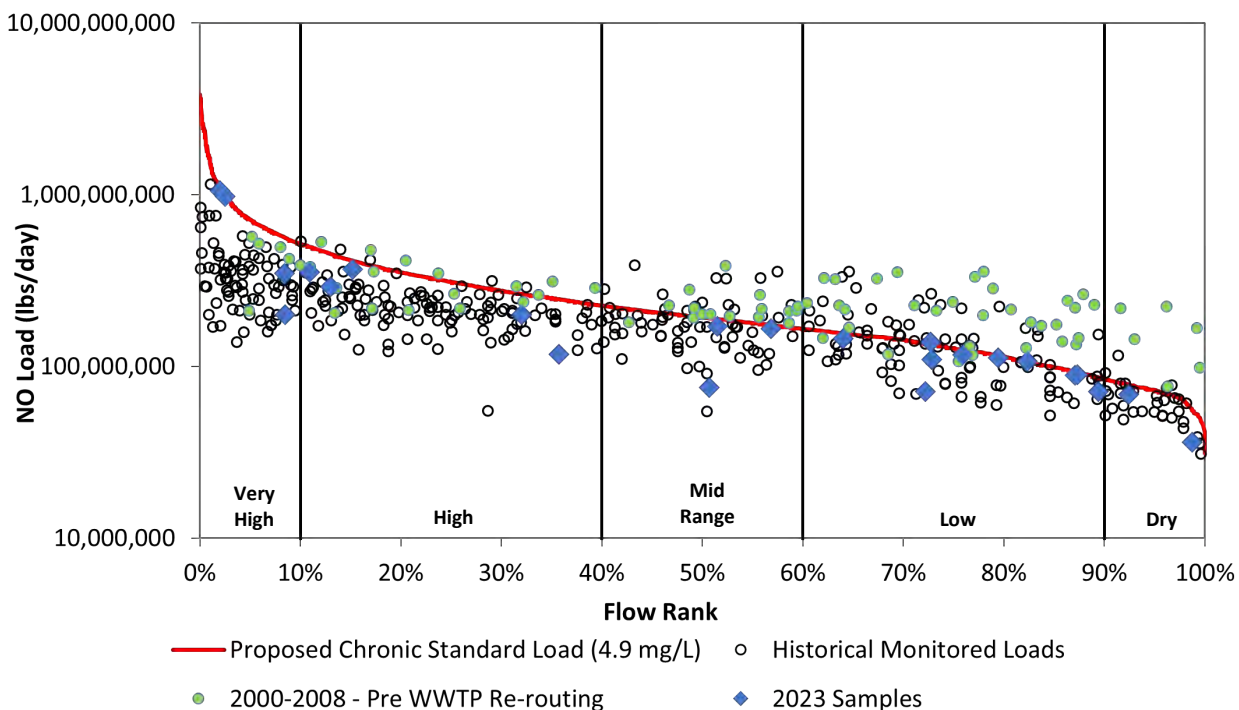
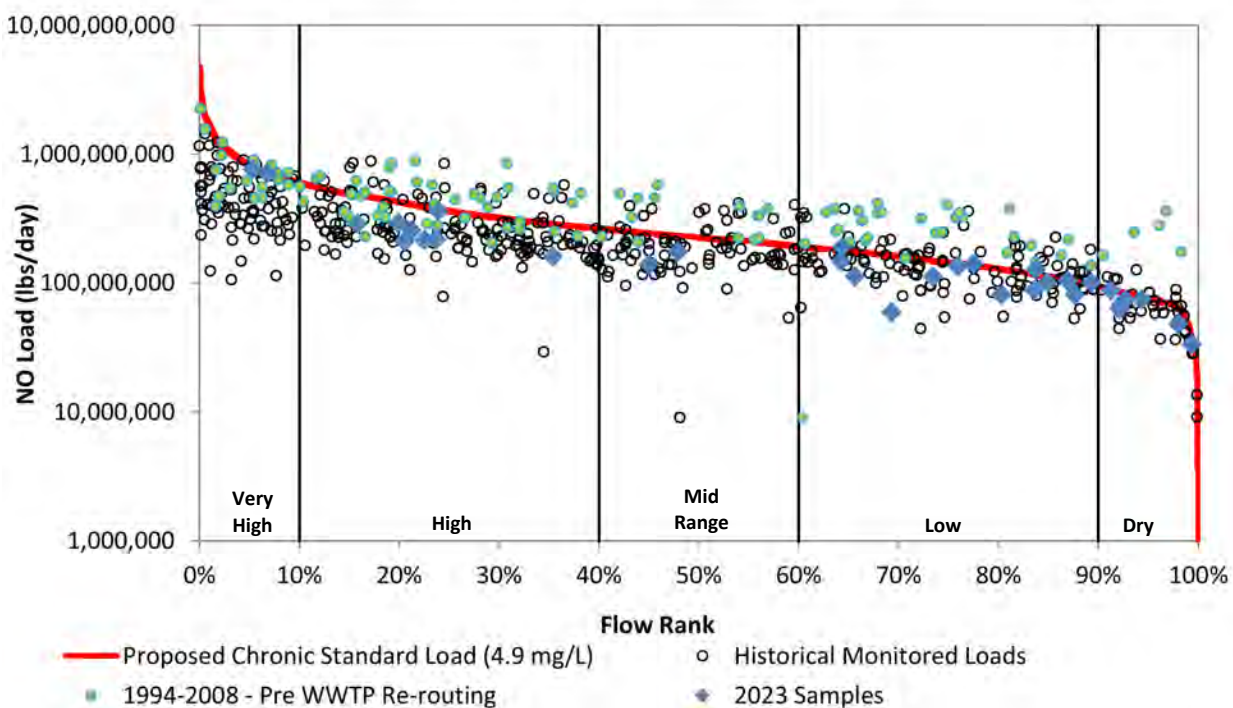
Figure 19a. Load duration curve for nitrate at VR24.

Figure 19b. Load duration curve for nitrate at SC806.

Figure 19c. Load duration curve for nitrate at VR804.

Figure 19f. Load duration curve for nitrate at NC801.

Figure 19g. Load duration curve for nitrate at SB802.

Figure 19h. Load duration curve for nitrate at VR803.

Figure 19i. Load duration curve for nitrate at WOMP.

The proposed chronic standard for acute life toxicity (four day average concentration of 4.9 mg/L) for 2B streams (warm water) was used to analyze loading capacity for VR24, VR803, and WOMP (MPCA 2010). Single day loads at VR24 were below the chronic standard (Figure 19a), but levels at VR803 and WOMP were consistently at or near the standard load during low flow and dry regimes (Figure 19h and 19i).
