Vermillion River Monitoring Network 2023 Annual Report

*Prepared for the Vermillion River Watershed Joint Powers Organization
by the Dakota County Soil and Water Conservation District*

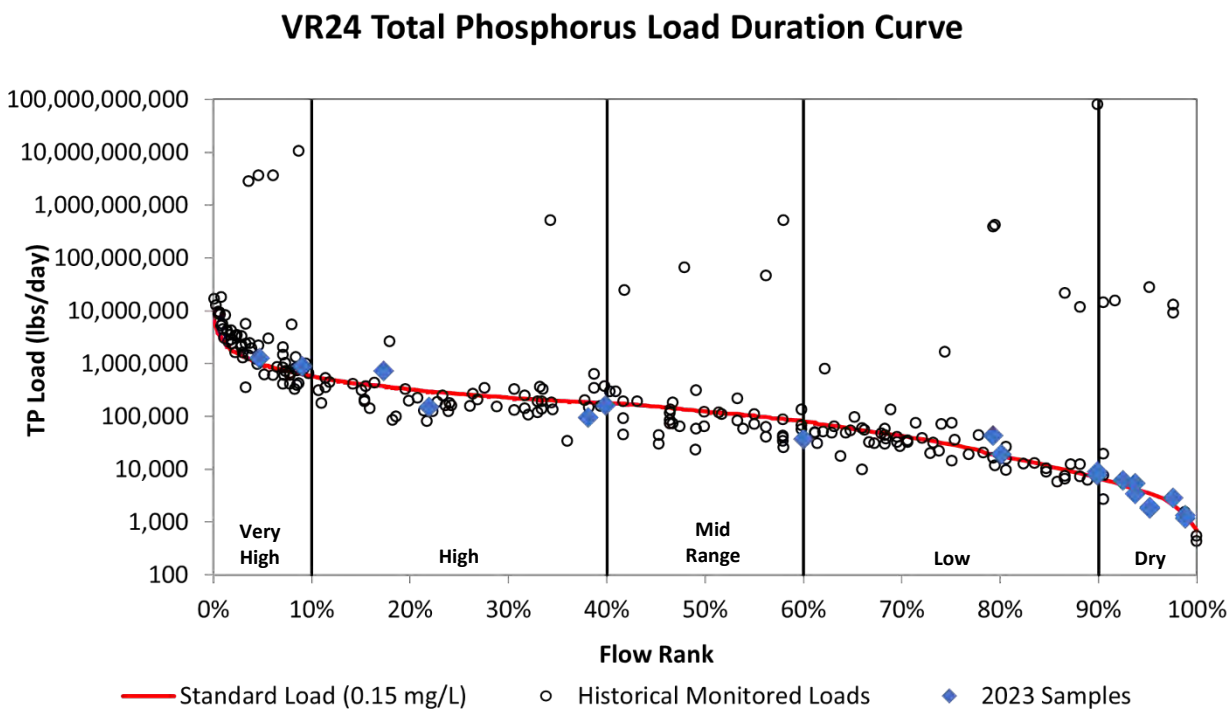
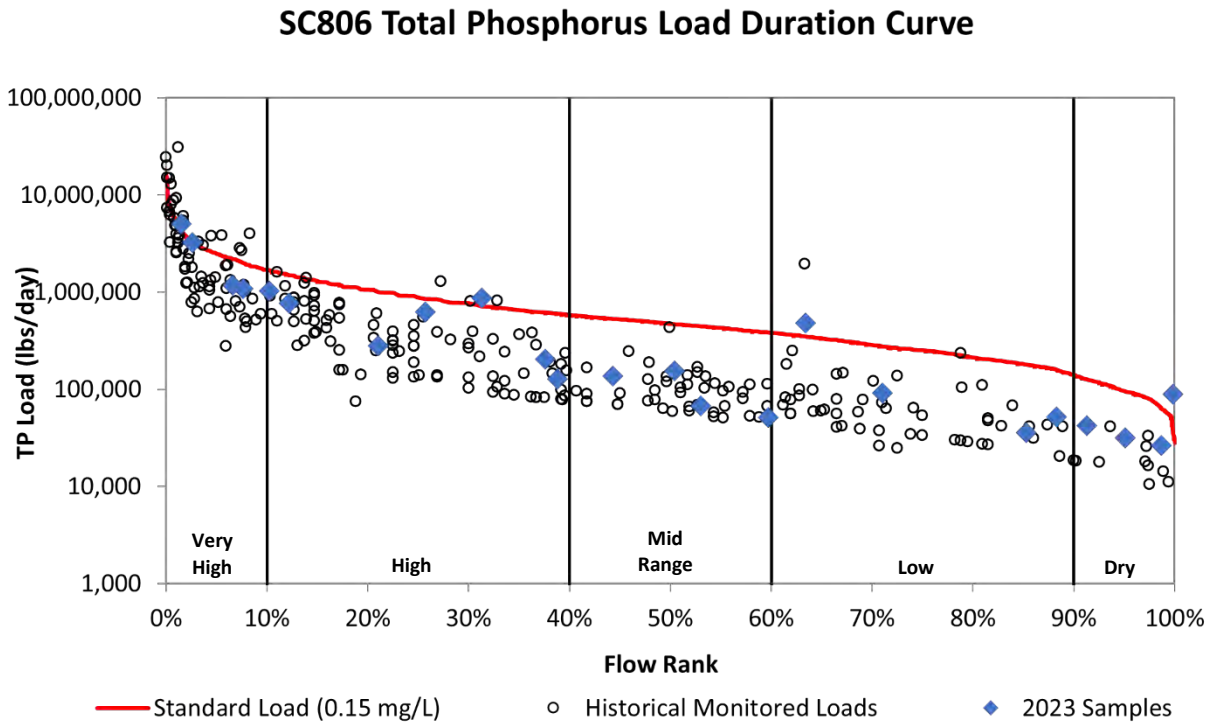
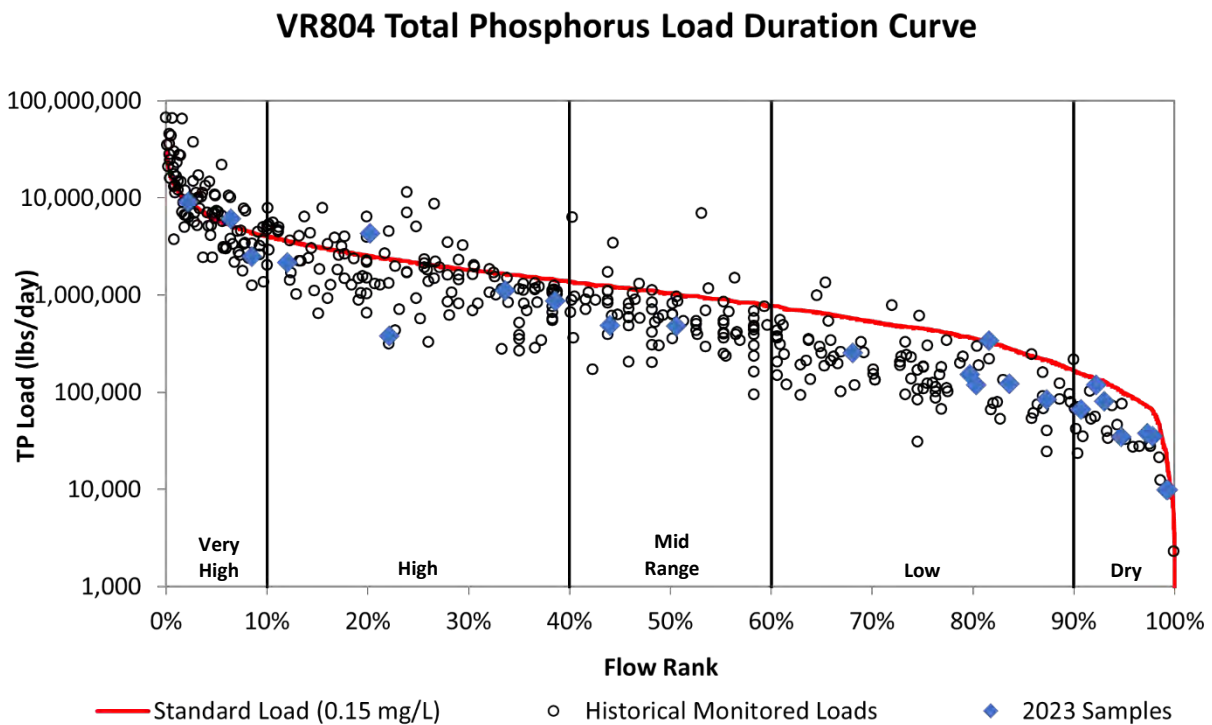
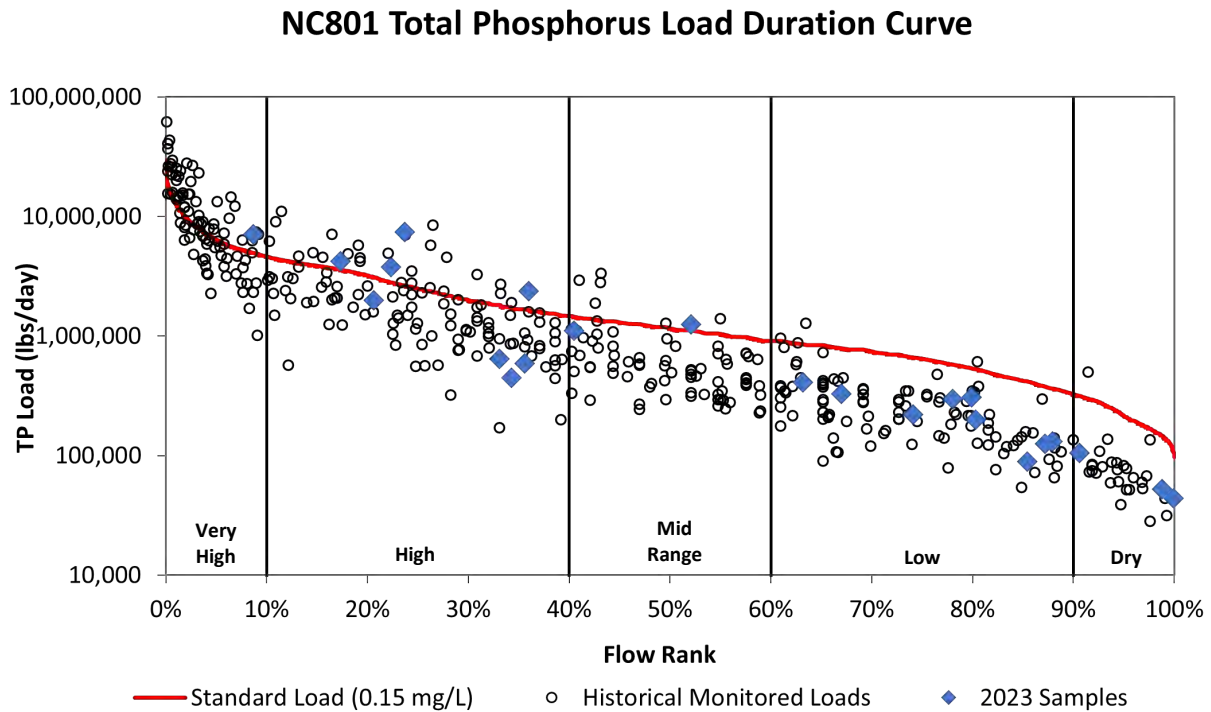
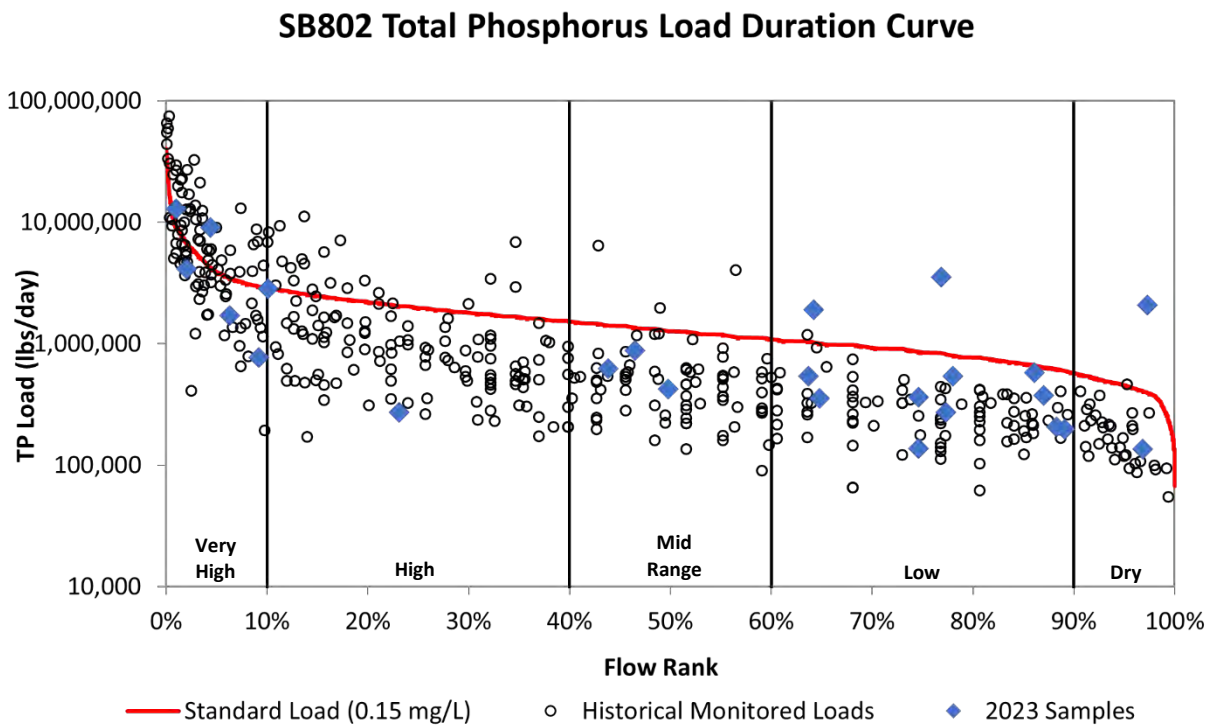
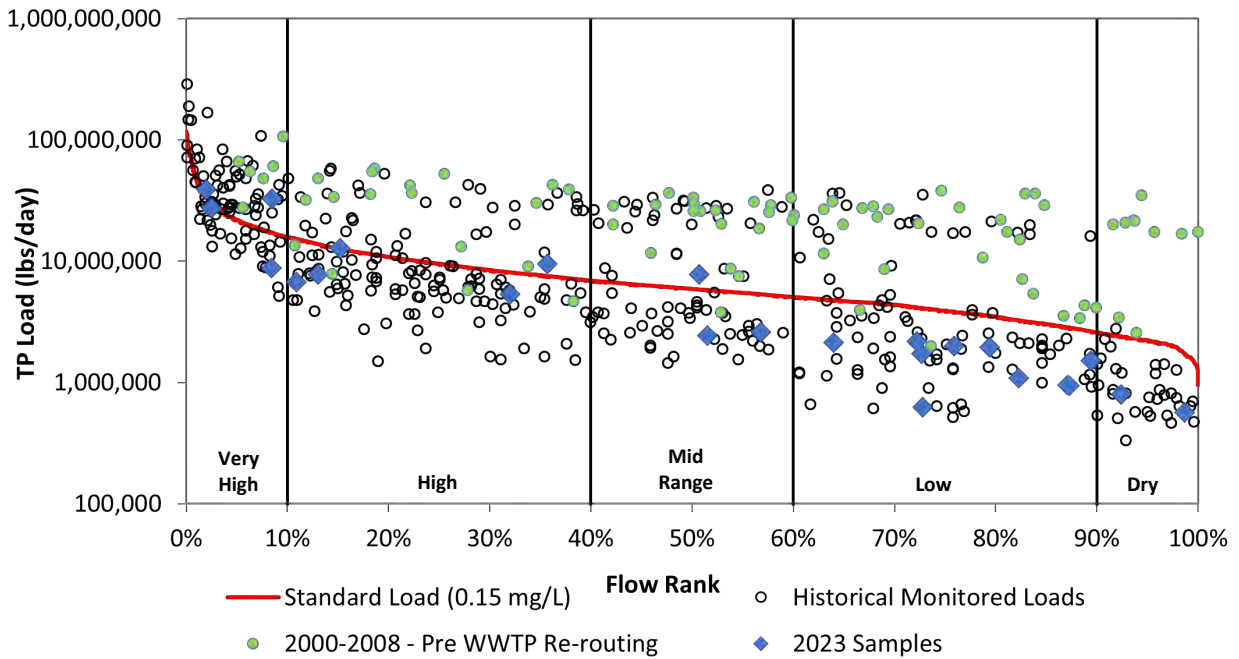
Figure 20a. Load duration curve for total phosphorus at VR24.

Figure 20b. Load duration curve for total phosphorus at SC806.

Figure 20c. Load duration curve for total phosphorus at VR804.

Figure 20f. Load duration curve for total phosphorus at NC801.

Figure 20g. Load duration curve for total phosphorus at SB802.

Figure 20h. Load duration curve for total phosphorus at VR803.

Though the Elko New Market WWTP was decommissioned and re-routed in 2012, historical total phosphorus levels are consistently at or near the standard during all flow regimes at VR24 (Figure 20a), mirroring the findings from 2023. The concentrations found at or near the standard could be a result of legacy phosphorus still present in the river and may continue to impact phosphorus levels for years to come.

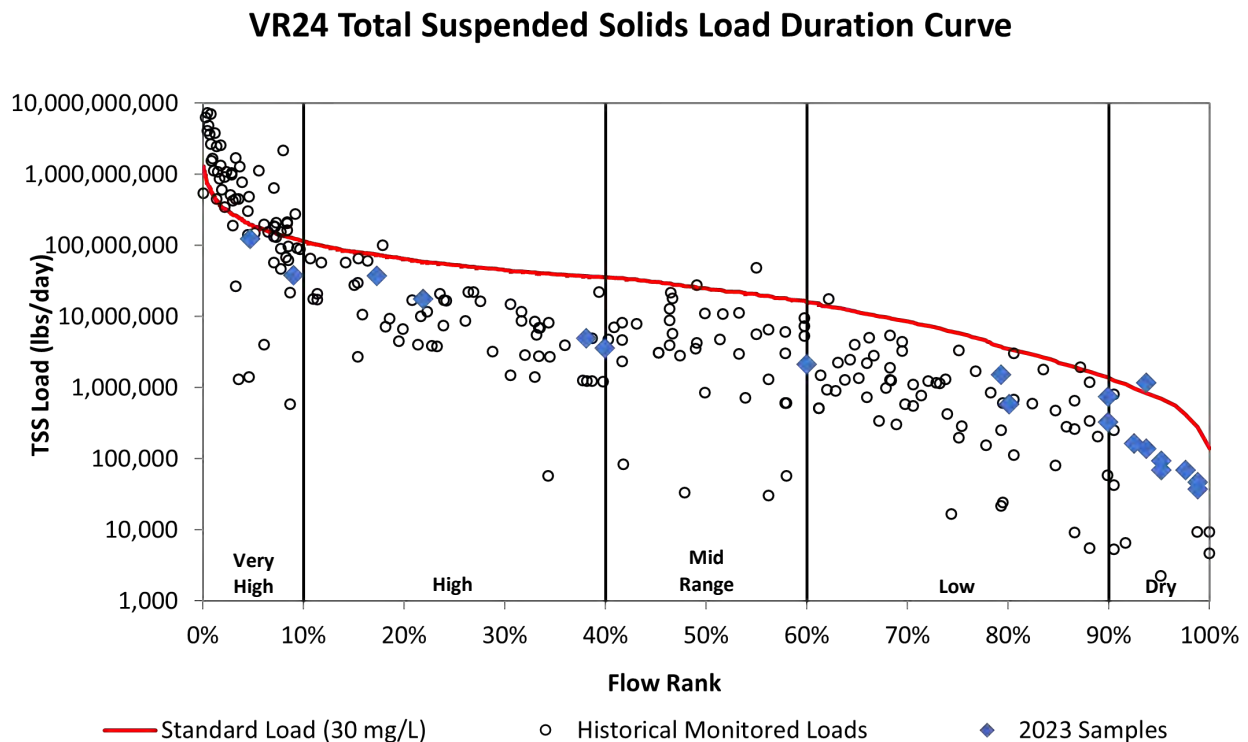
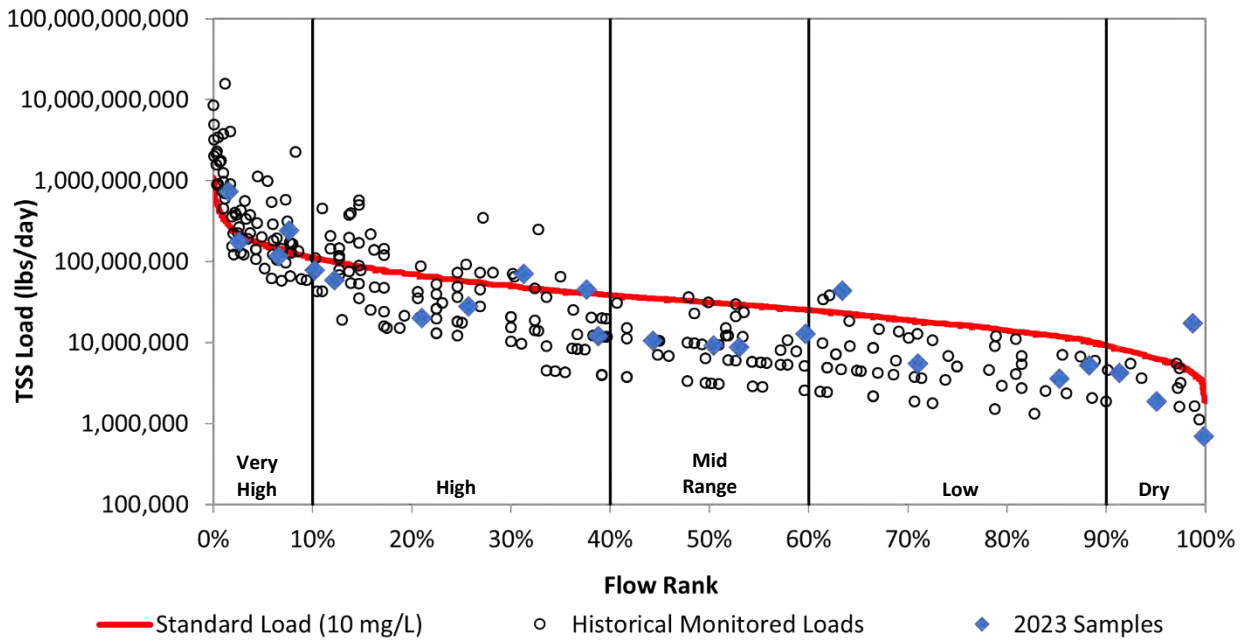
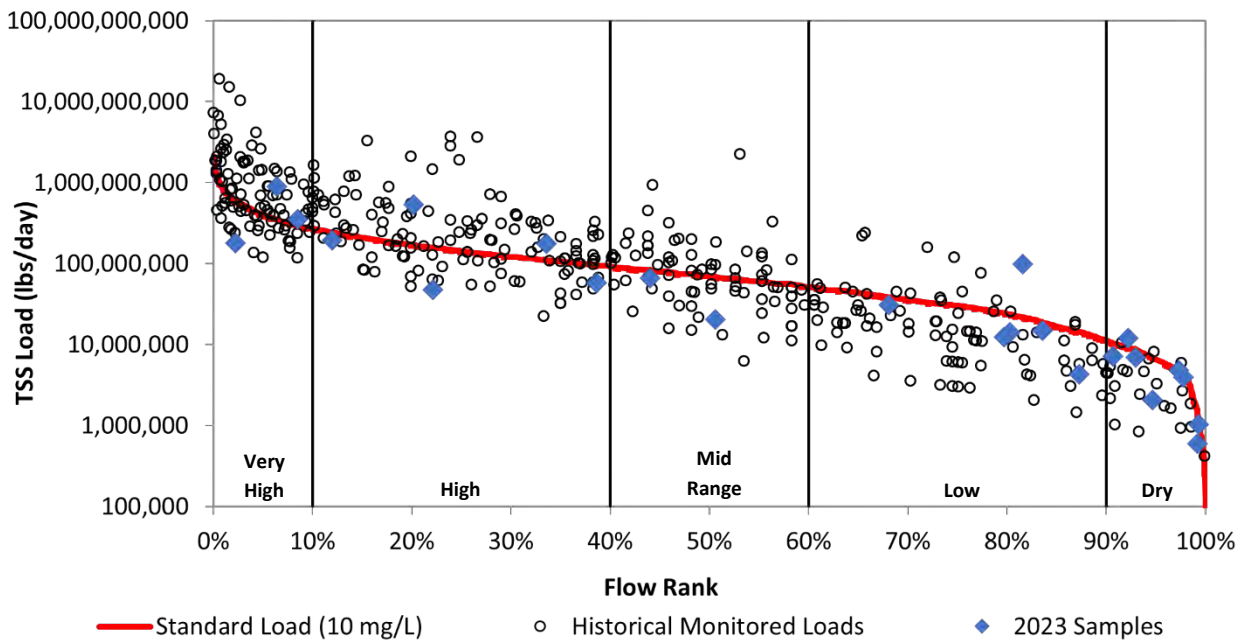
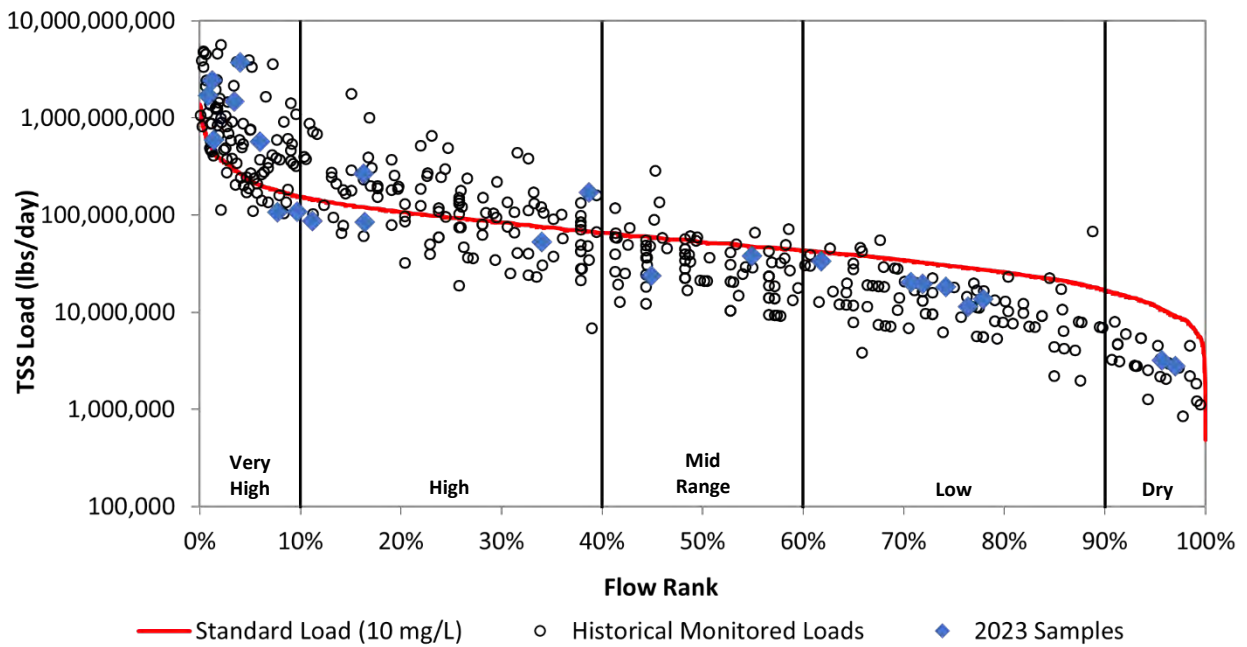
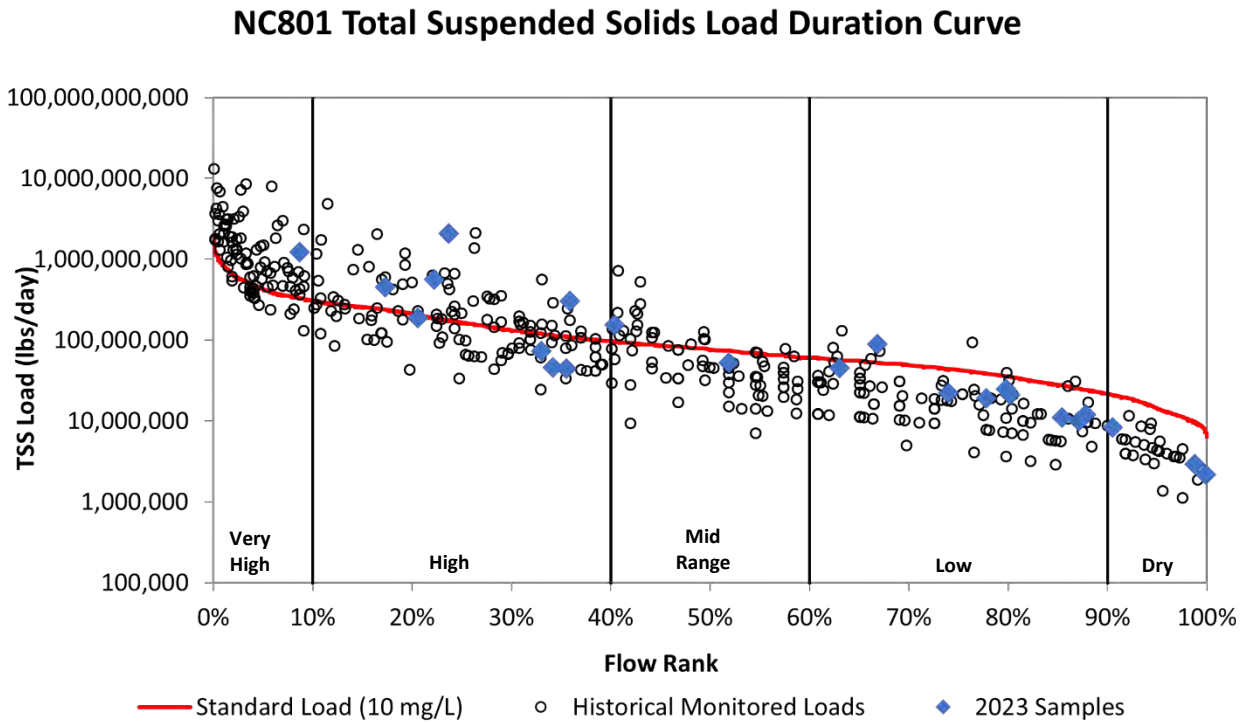
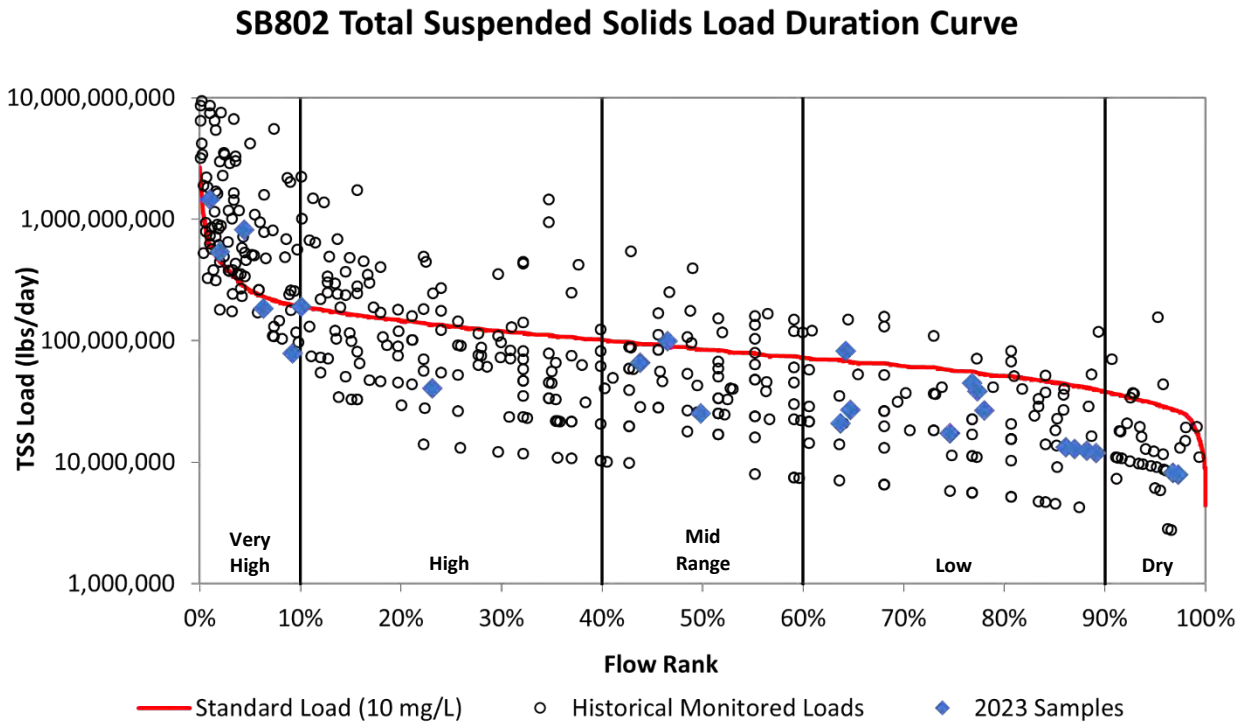
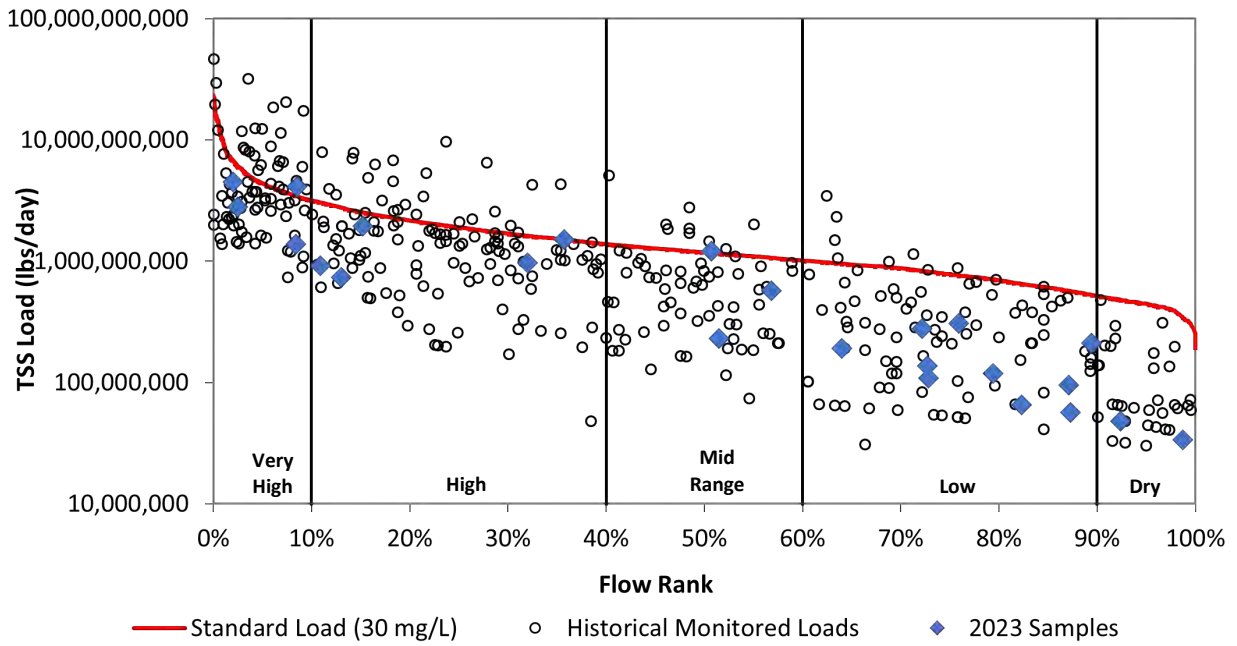
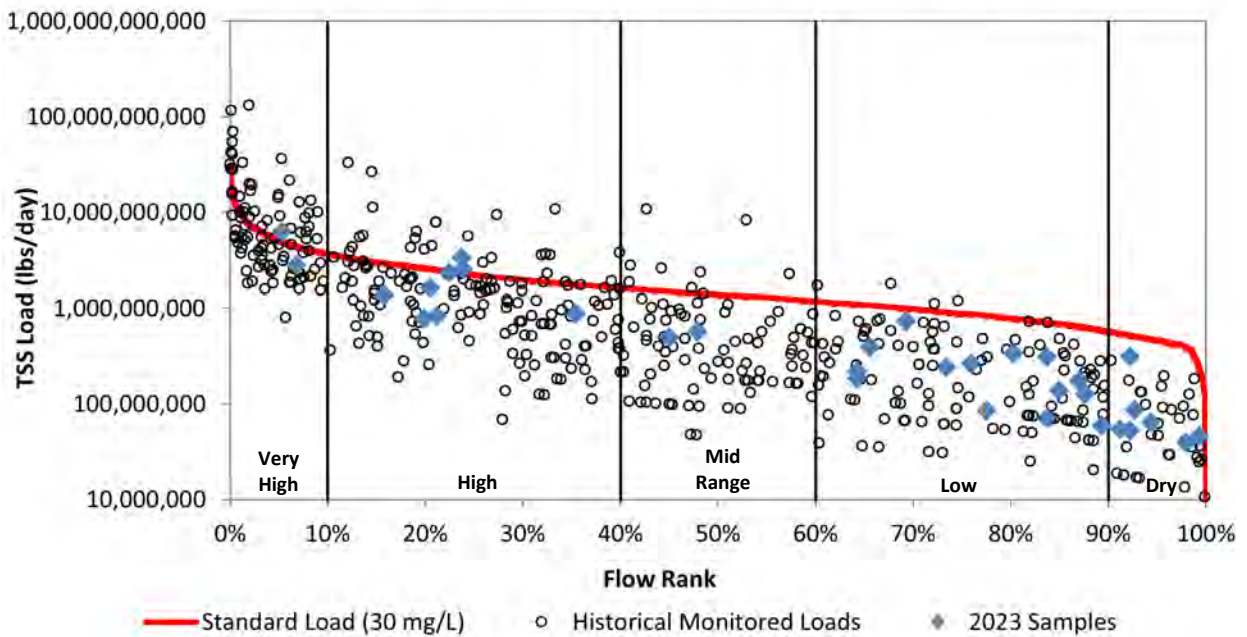
Figure 21a. Load duration curve for total suspended solids at VR24.

Figure 21b. Load duration curve for total suspended solids at SC806.

Figure 21c. Load duration curve for total suspended solids at VR804.

Figure 21e. Load duration curve for total suspended solids at NC808.

Figure 21f. Load duration curve for total suspended solids at NC801.

Figure 21g. Load duration curve for total suspended solids at SB802.

Figure 21h. Load duration curve for total suspended solids at VR803.

Figure 21i. Load duration curve for total suspended solids at WOMP.

Exceedances of the standard load for TSS in 2023 occurred during all flow regimes. Much of the field season was during another drought so a lot of the samples were collected during low flow or dry conditions. Exceedances during those regimes are historically atypical, but were common in 2023, much like in past years.

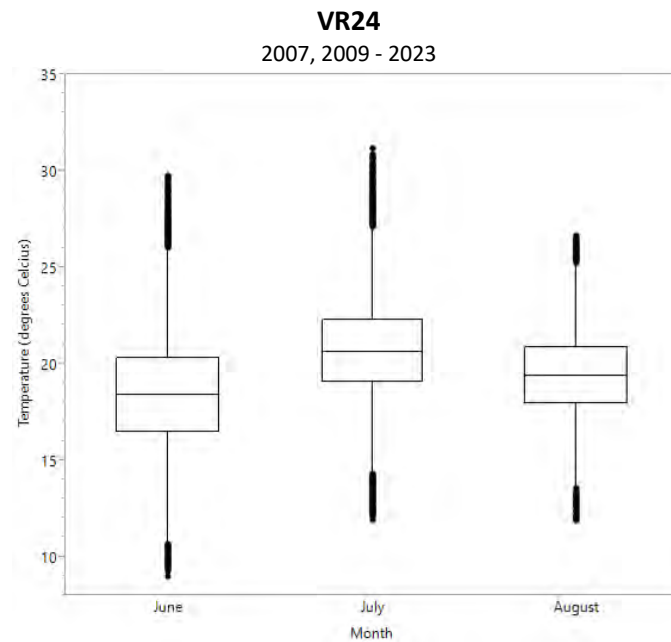
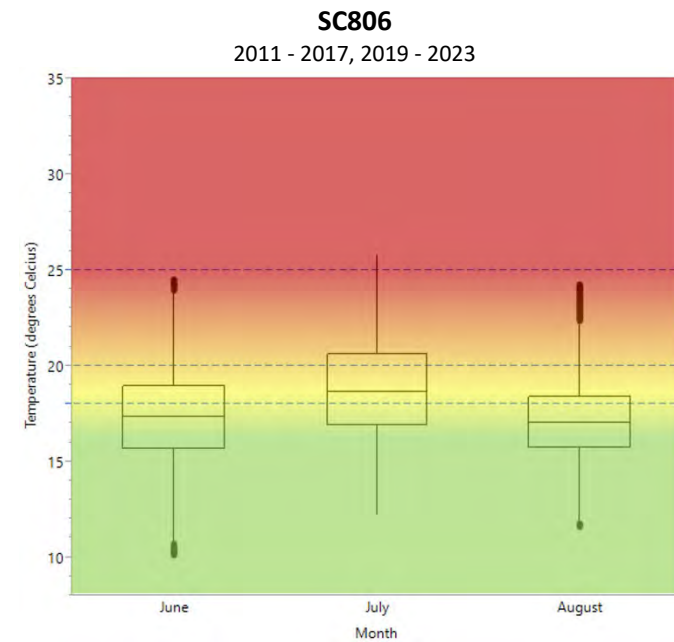
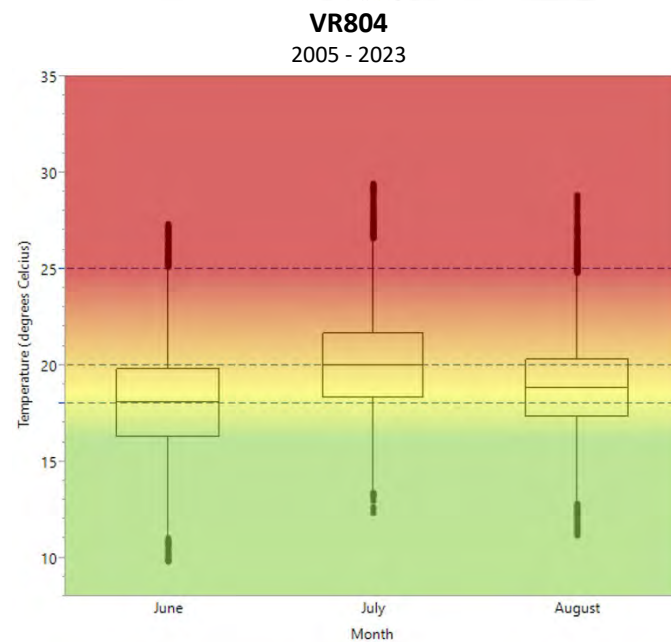
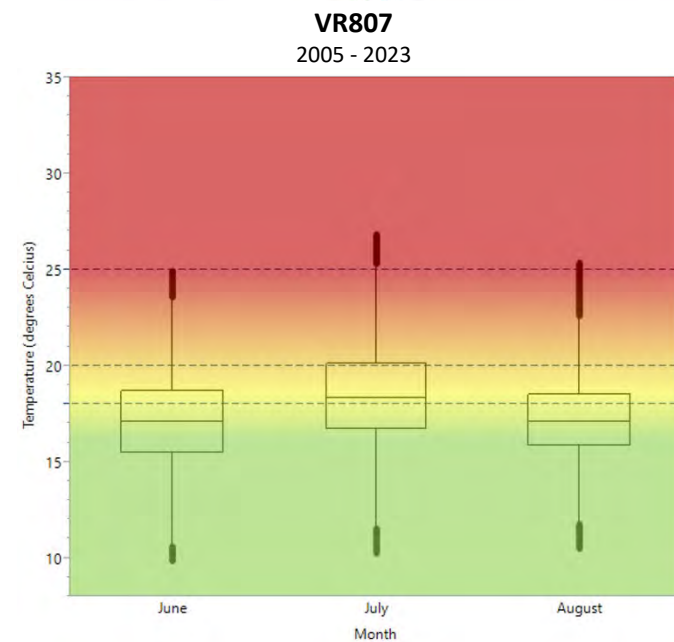
Figure 22. Continuous temperature data for each permanent monitoring station during the summer months from 2005-2023 (when available).
Temperature ranges apply to adult brown trout - Optimal <18°C, tolerance 18-20°C, resistance 20-22°C, and complete mortality at 25°C.

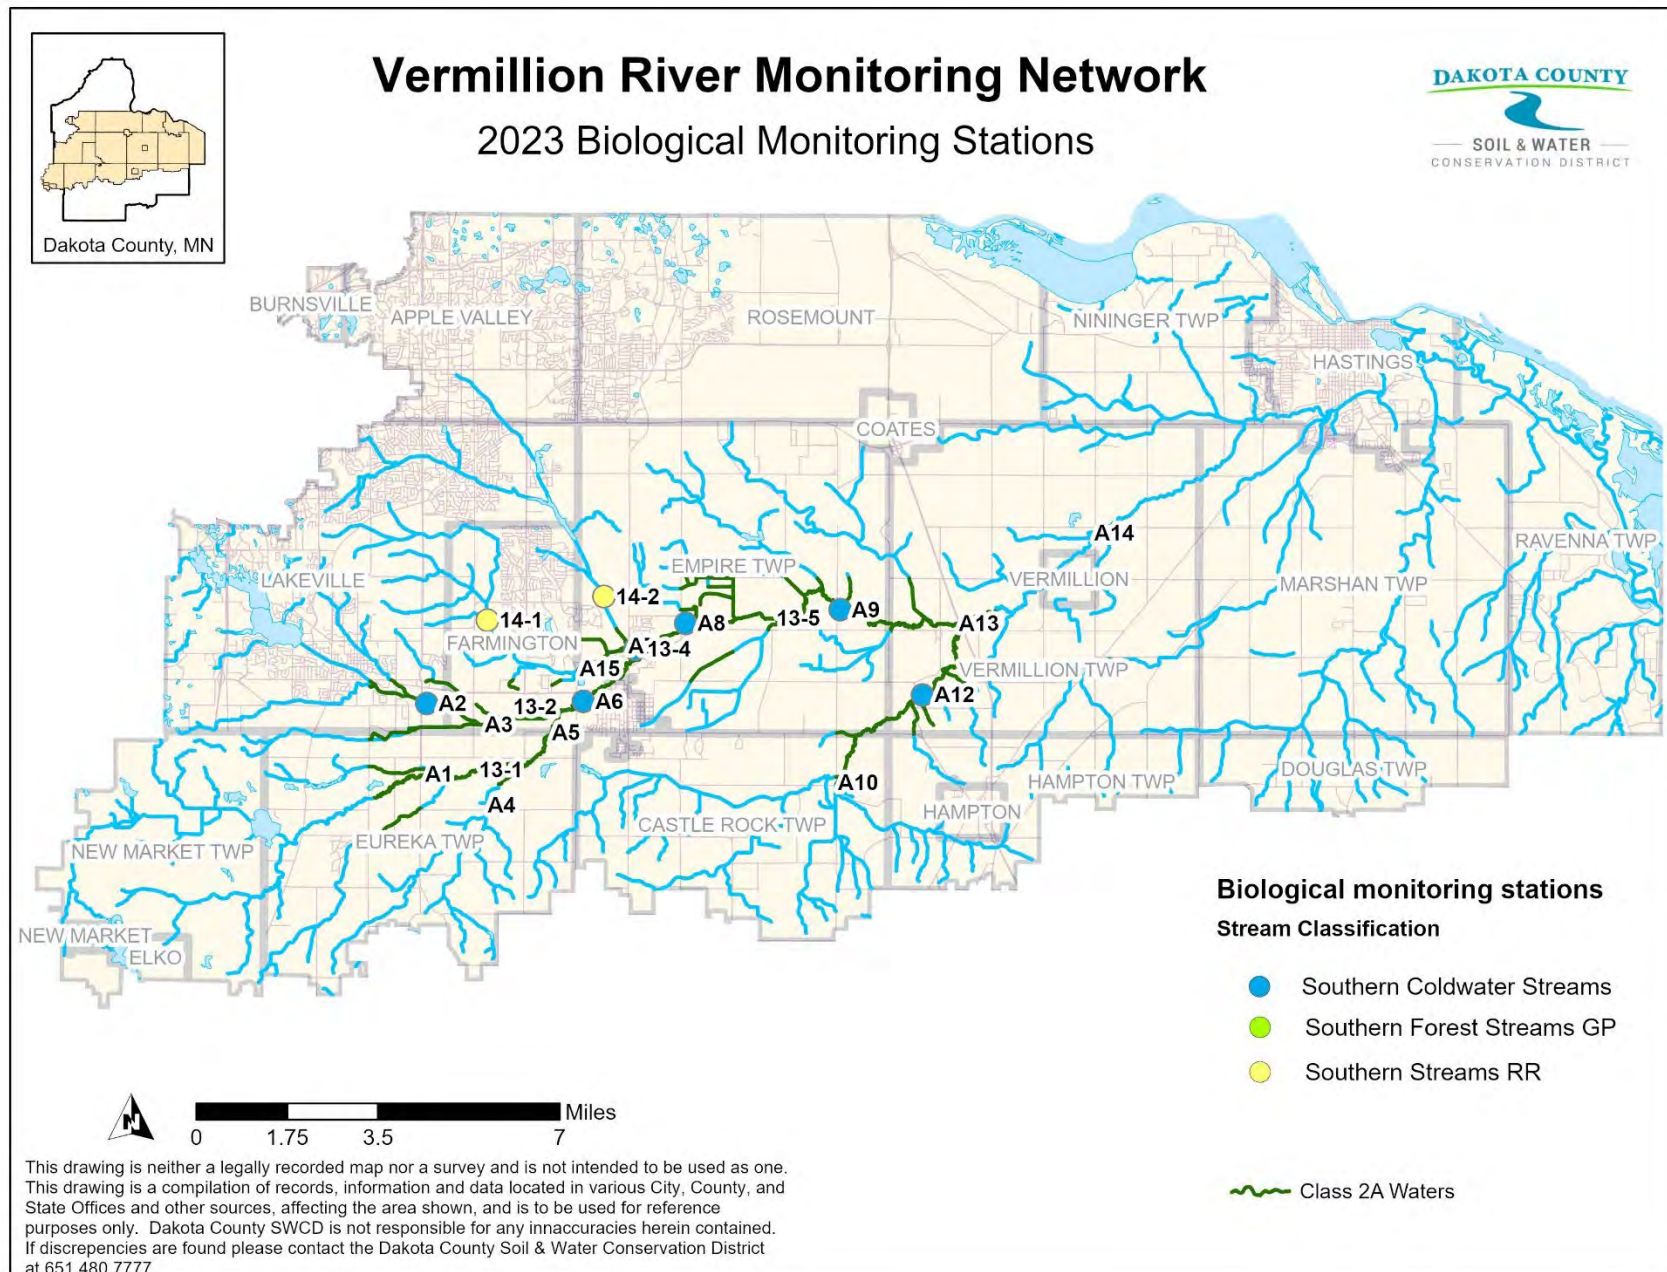
Figure 23. Vermillion River Monitoring Network biological monitoring stations for habitat and macroinvertebrates in 2023.

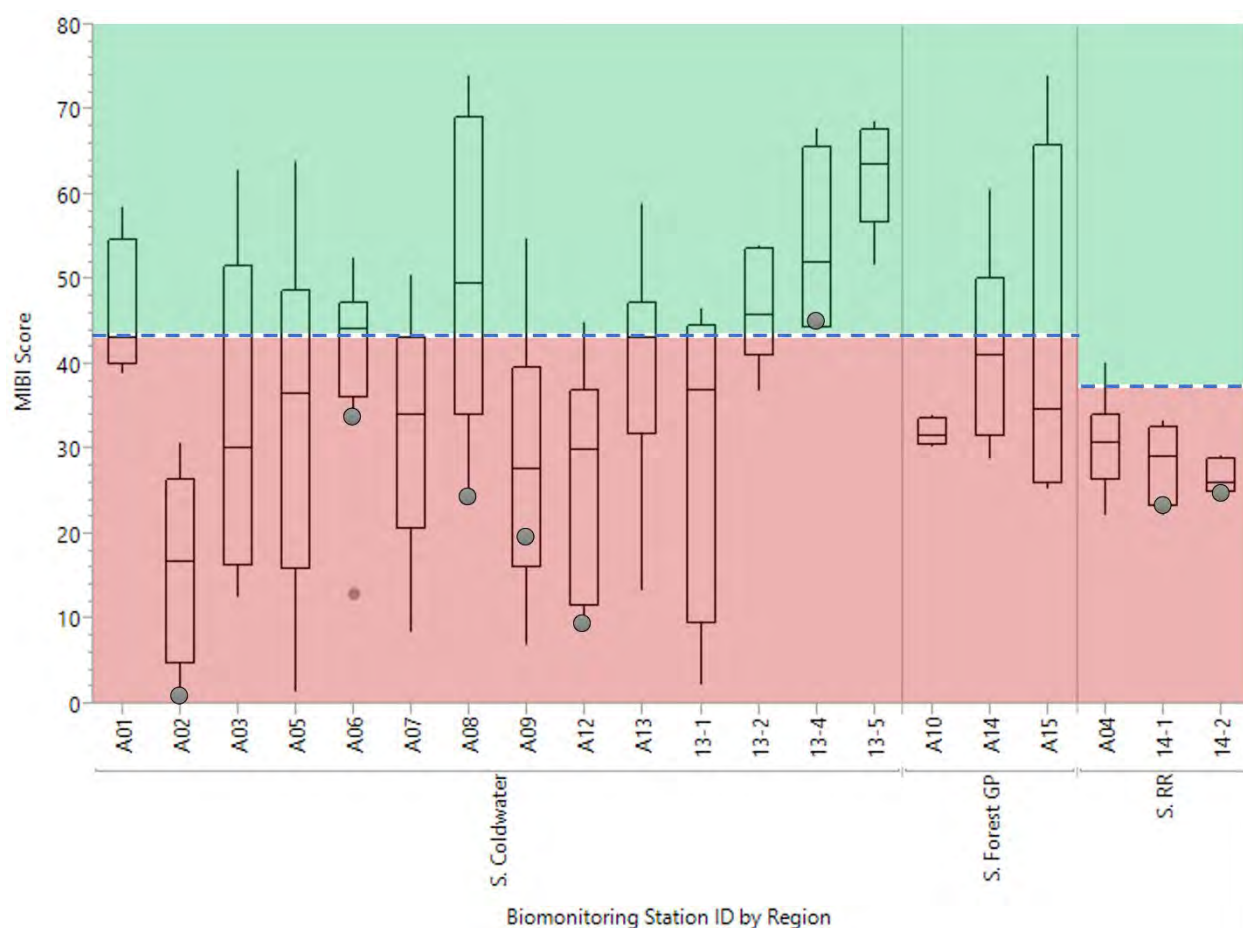
Figure 24. Macroinvertebrate Index of Biological Integrity (MIBI) score by region.

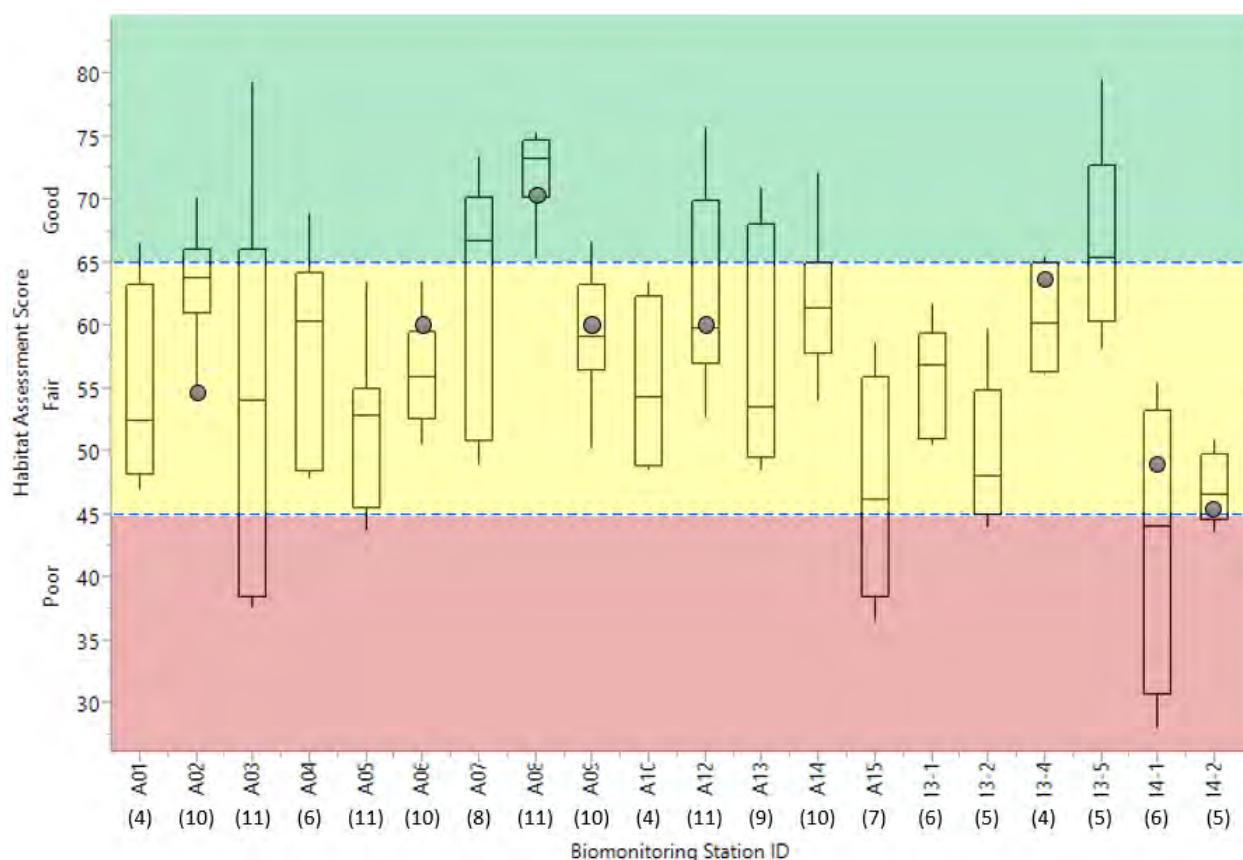
Figure 25. Habitat assessment scores for biomonitoring stations.

Seven of the eight sites monitored in 2023 received a score of 'fair' and one site received a 'good' rating.

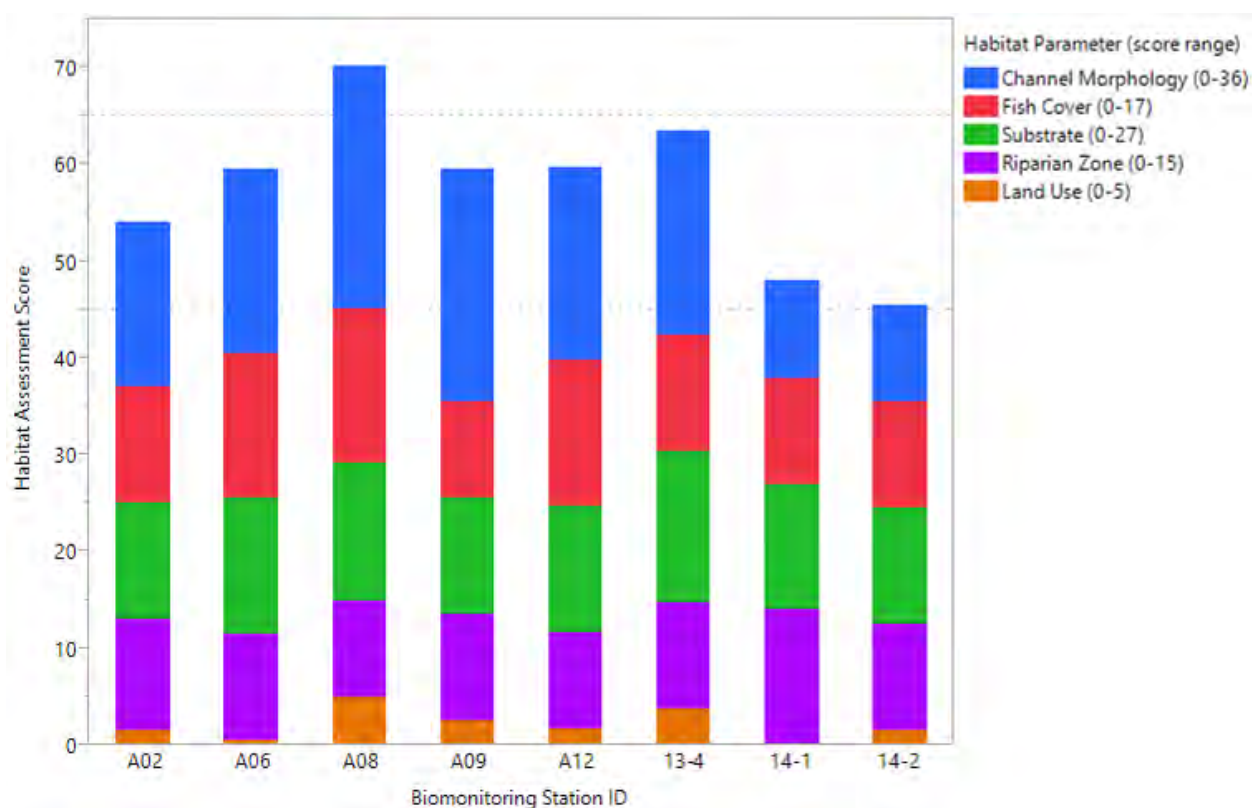
Figure 26. Habitat assessment score by habitat parameter for each biomonitoring station in 2023.
