HYLAND POINTE Homeowner Association Apple Valley, MN

Stage II Landscape Irrigation Assessment Report & Recommendations

OCTOBER 10, 2022

Water in Motion, Inc.

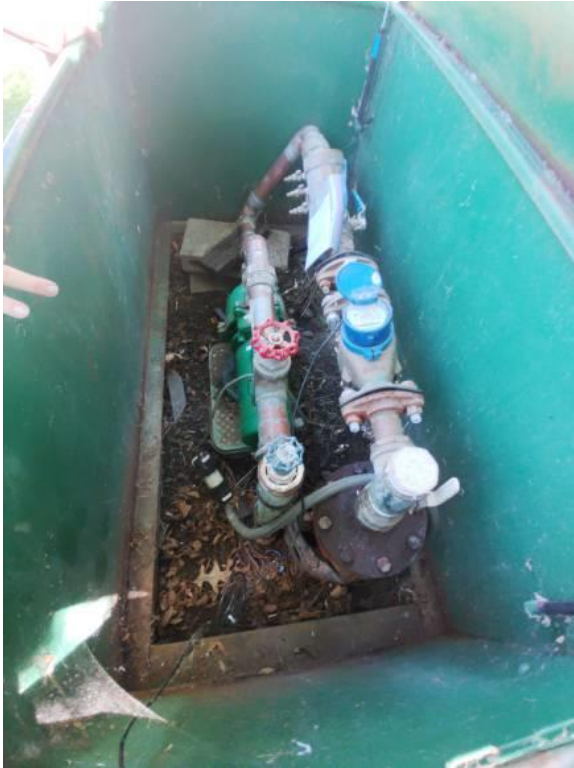
4" municipal water supply into 1.5" meter and Wilkins 975 backflow prevention assembly tested 6/9/22.

The 2hp Myers hard start booster pump is connected to the water supply with 2" metal pipe.

2" PVC pipe is attached after the pump to below grade.

Supply will benefit from all metal pipe to below grade.

Add supports to relieve stress on plumbing fittings.

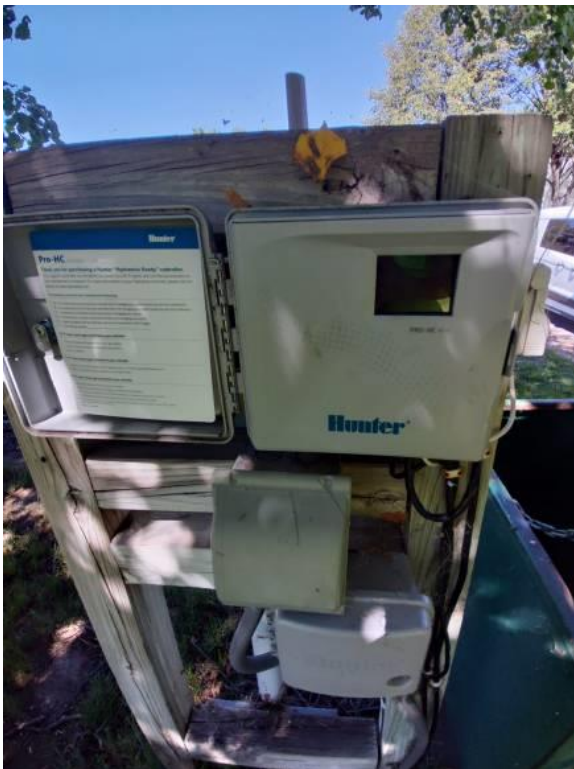
Hunter Pro -HC SMART-ready controller. Irritrol basic wireless rain sensor, not connected.

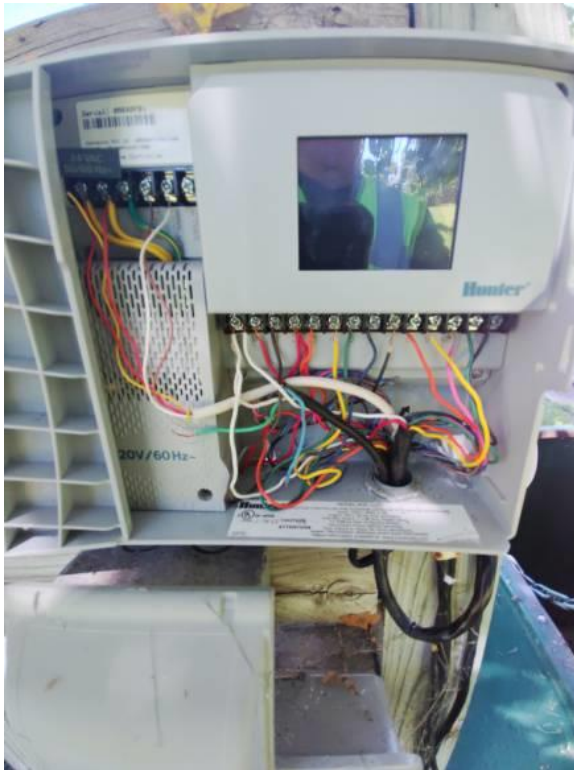
12 station controller.

Station 2 has two wires indicating two stations are wired together.

Basic scheduling: Schedule begins at 1AM on Mon and Fri only.

25 mins runtime applied to each station.

Host indicates she reduced schedule frequency to reduce water costs.

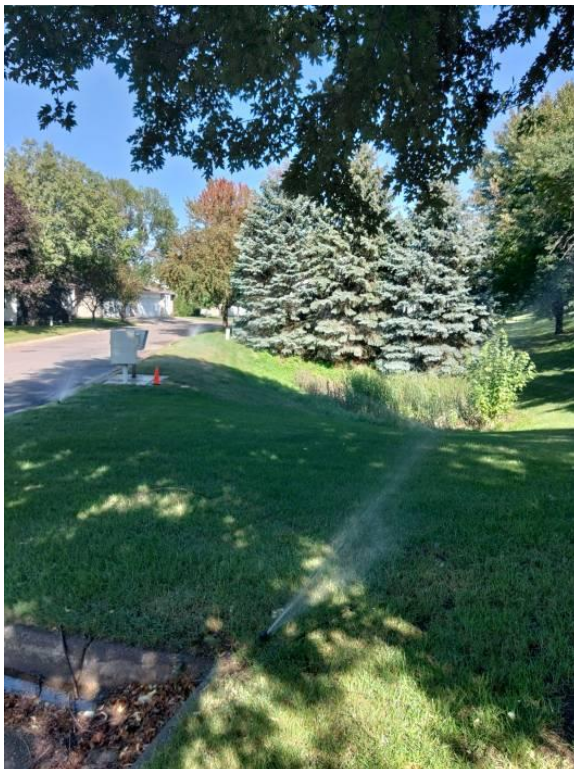
Sta 1 - rotors near water supply and in front of 15972 & 15968.

Pitched, leaking seals result in water waste and reduced effectiveness.

No matched appl rate, sprinkler to sprinkler.

Poor layout in front of 15968. See next image.

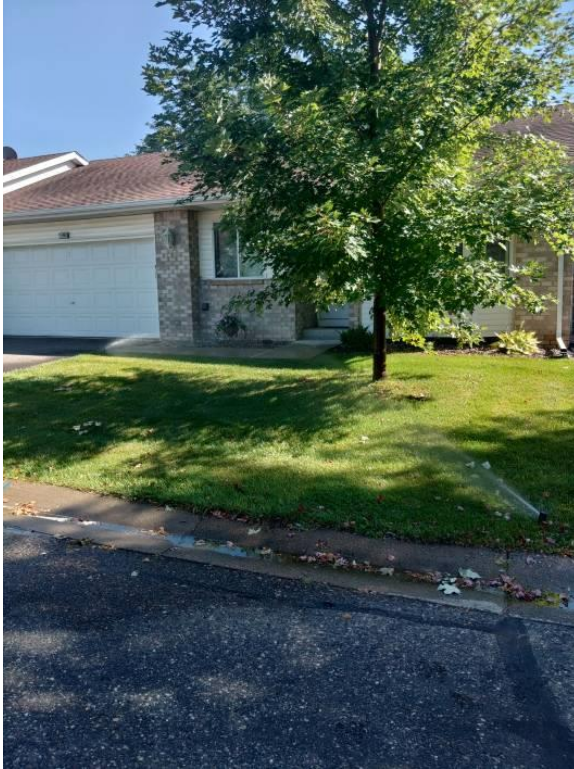
Sta 1 - front of 15968 - leaking seals
poor sprinkler selection, poor
placement.

Suggest replacing large area
sprinklers with small area sprinklers
and reconfigure layout for
improved coverage and
effectiveness.

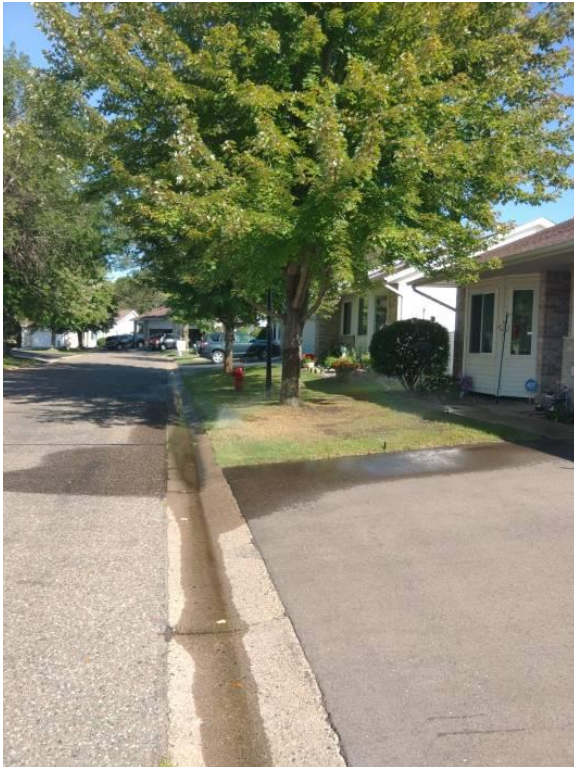
Sta 2 - mixed sprinkler types results
in overwatering areas.

Two stations are tied together at
the controller. South = Fronts &
between of 15964, 15960. See
next image.

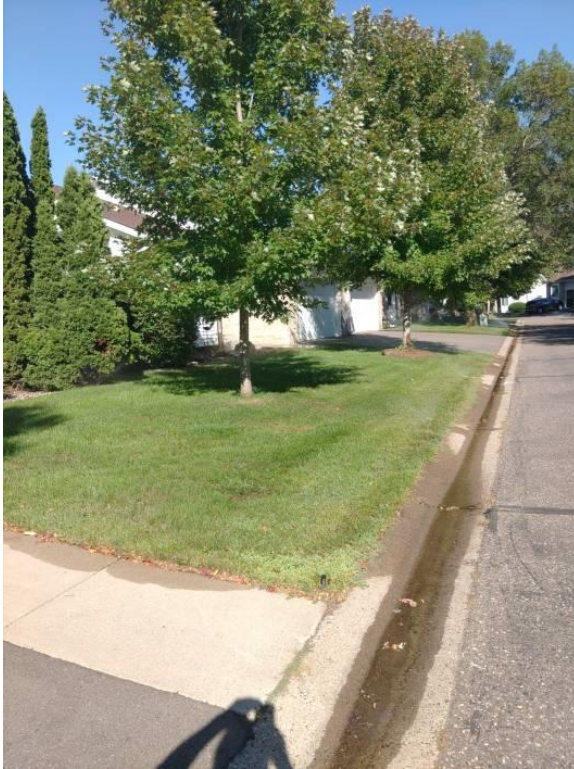
Sta 2 north side. Fronts & sides of 15967, 15963, 15959, 15955.

Mixed sprinkler types results in overwatering.

The side yards are especially overwatered. See next image.

Two separate stations of sprinklers are combined at the controller resulting in too much water demand and poor sprinkler performance. Many low quality spray-type nozzles.

Several sprinklers need maintenance including an apparent root pinch in front of 15955.

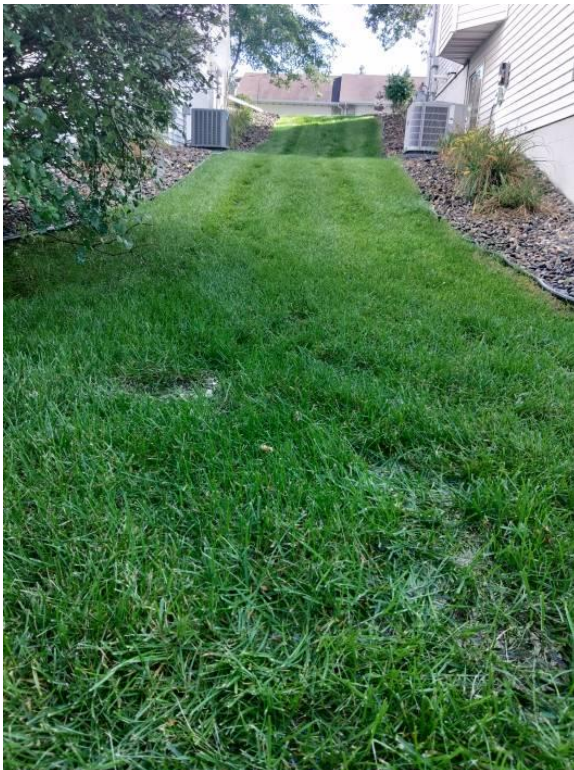
Sta 2 - Example of runoff along a side yard from over watering in less than 5 mins.

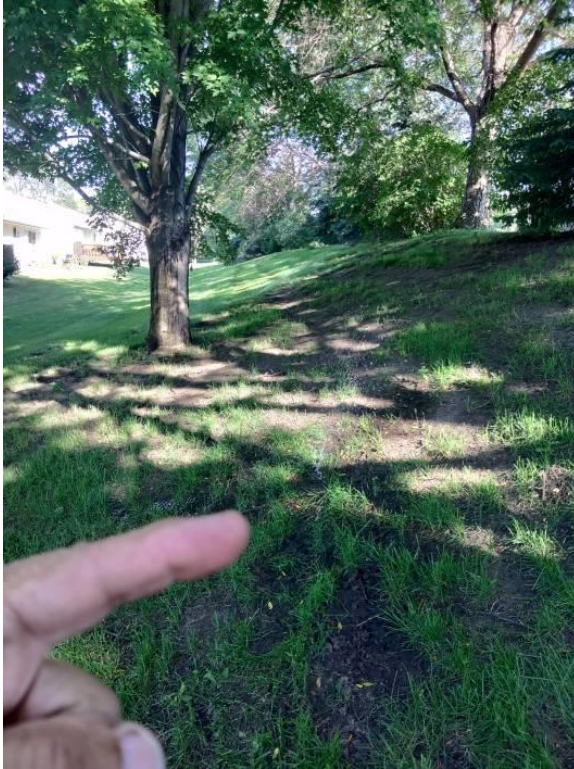
Sta 3 - 13 Hunter PgP rotor-style sprinklers on a hillside along 160th.

Possible root pinch at the maple tree cuts-off water to sprinklers resulting in poor effectiveness and water waste.

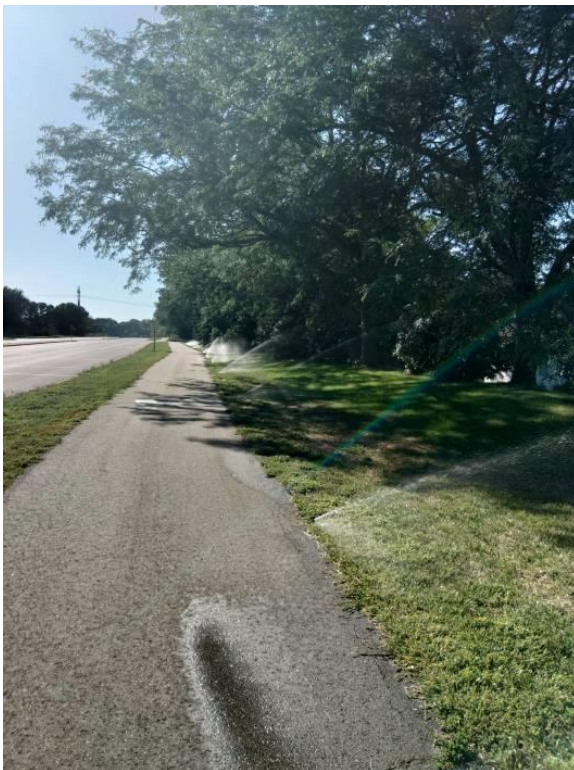
Sta 4 – Hunter PgP rotor-style sprinklers along 160th walk path from entry to entry. Some pitched sprinklers, some leaking seals.

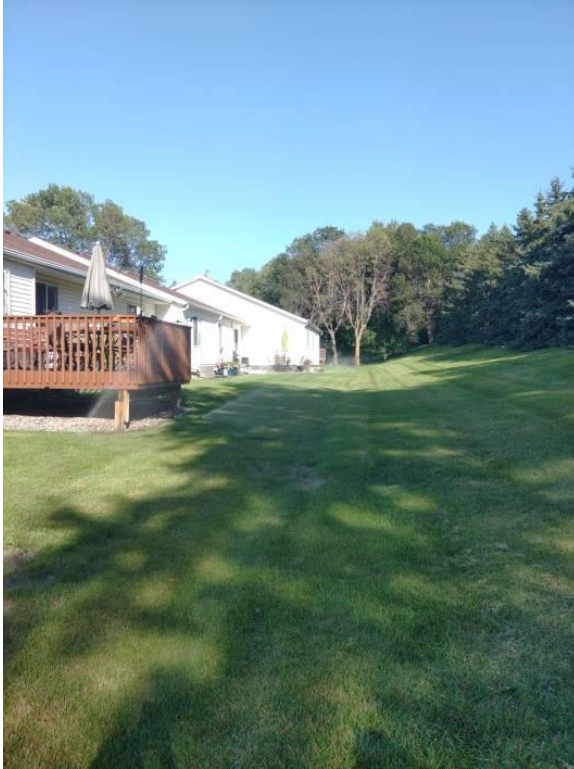
Sta 5 –11 PgP sprinklers backs of south homes -see map.

No matched appl rate nozzles resulting in overwatered areas.

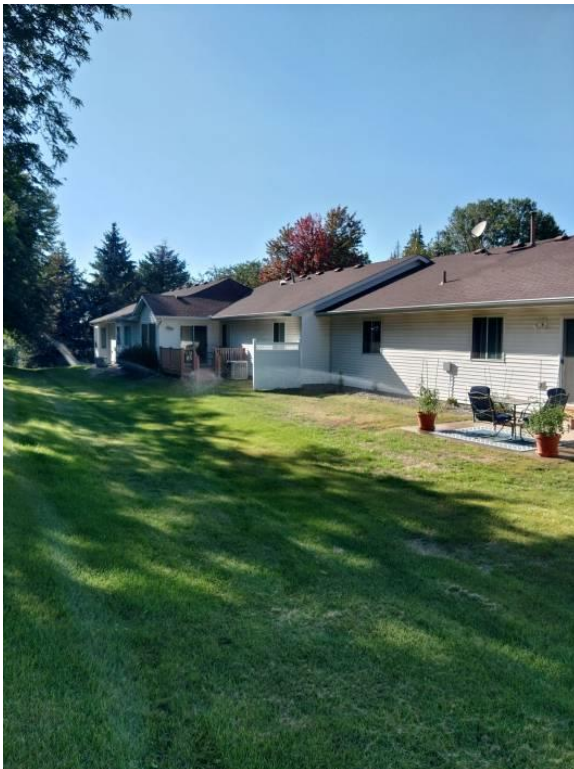
Sta 1 backs of homes. Dry area shown will benefit from larger nozzles to compensate for all-day sun.

Another example of the need to install matched application rate nozzles.

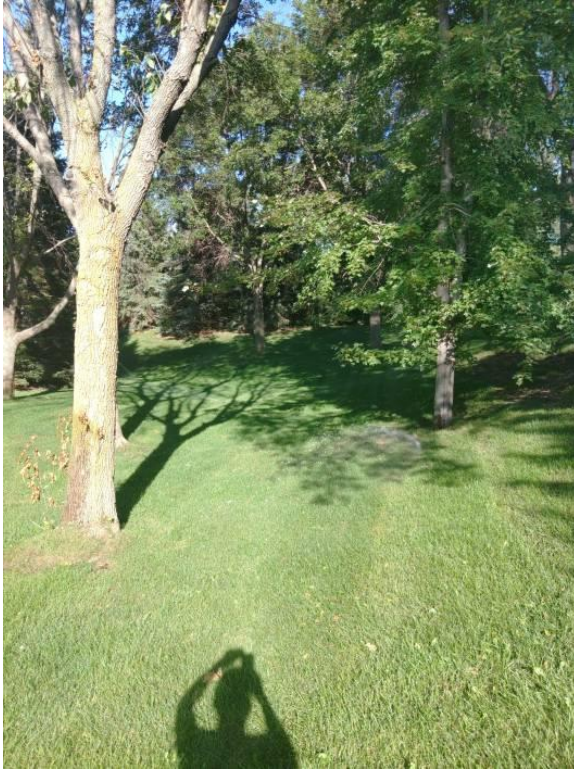
Sta 6 - 12-15 PgP sprinklers. Also operates the front of 15940 & 15944.

This station of sprinklers covers too large and diverse of an area resulting in overwatered back and side yards.

Suggest smaller nozzles in back and side yards to improve effectiveness of watering.

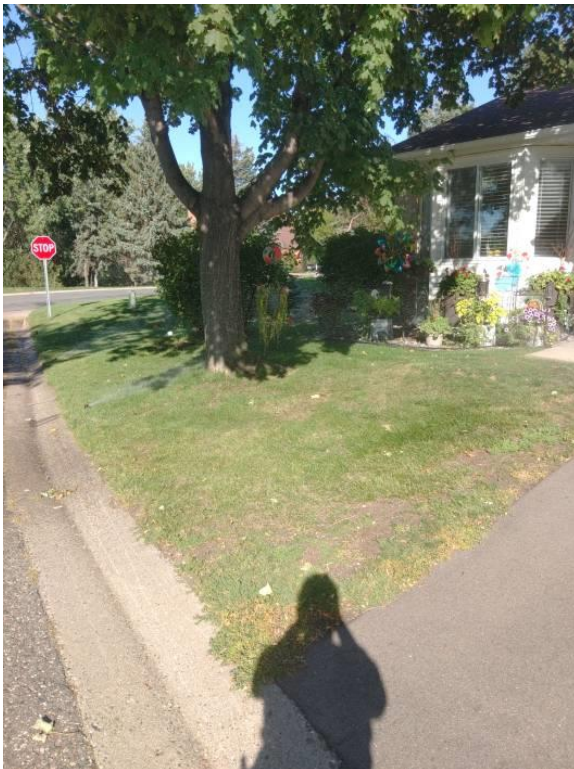
Sta 7 - rotors front & side of 15936. Wrong style of sprinklers in front.

Replace long-throw sprinklers with sprinklers appropriate to the size of area covered and add a sprinkler at drive corner.

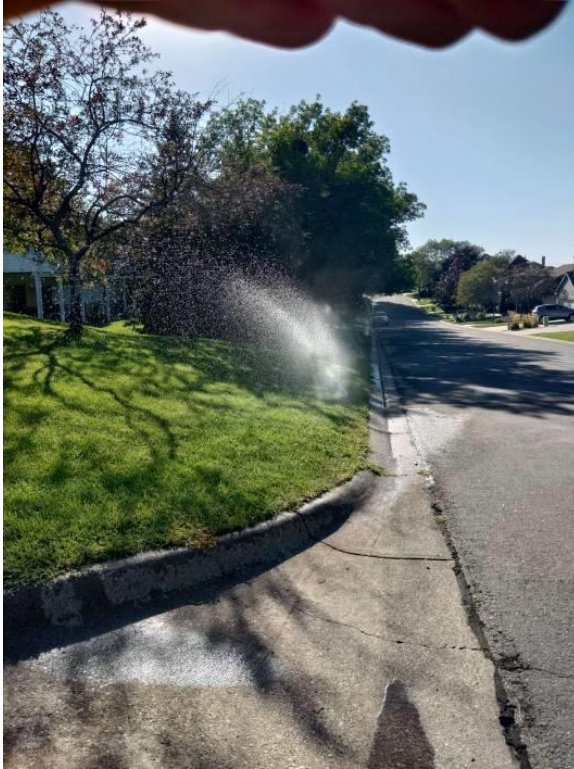
Sta 8 - 18-20 PgP & Rain Bird 5004 sprinklers mixed along Hyland Point Ct. Most PgP sprinklers have leaking seals & lots of runoff after a few minutes of operation.

Some PGPs not rotating. Mixed nozzle sizes.

Middle 5-6 sprinklers at hill bottom will benefit from check valve installation to reduce waste from low point drainage.

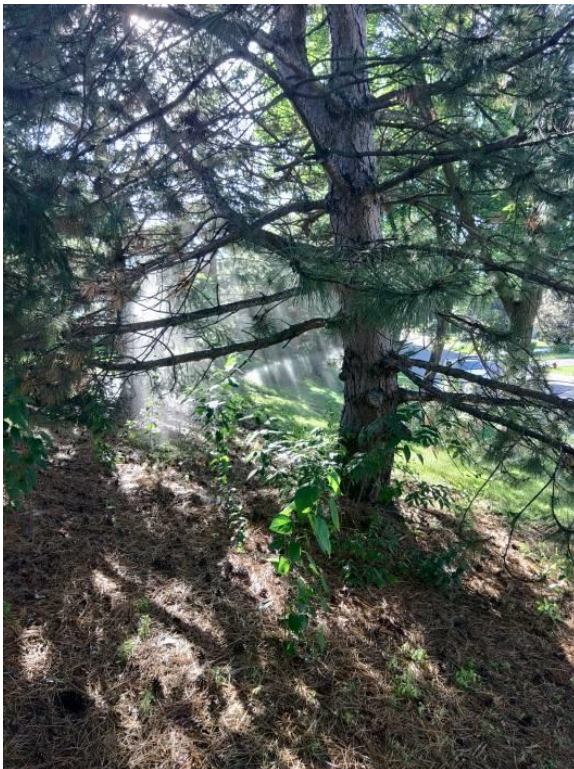
Sta 9 - 18-20 PgP sprinklers along a center hillside along Hyland Point Ct. Many are blocked due to tree growth over time.

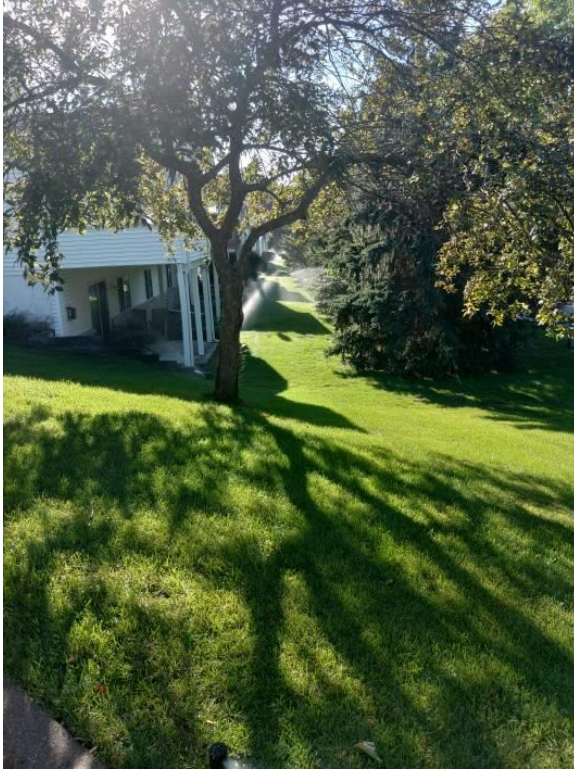
Sta 10 - 20-25 PgP sprinklers, top of hill along Hyland Point and front of 15951.

Suggest nozzle balance the entire station.

Change the large area rotor sprinklers in the front yard to smaller style sprinklers. Add a sprinkler at the drive corner.

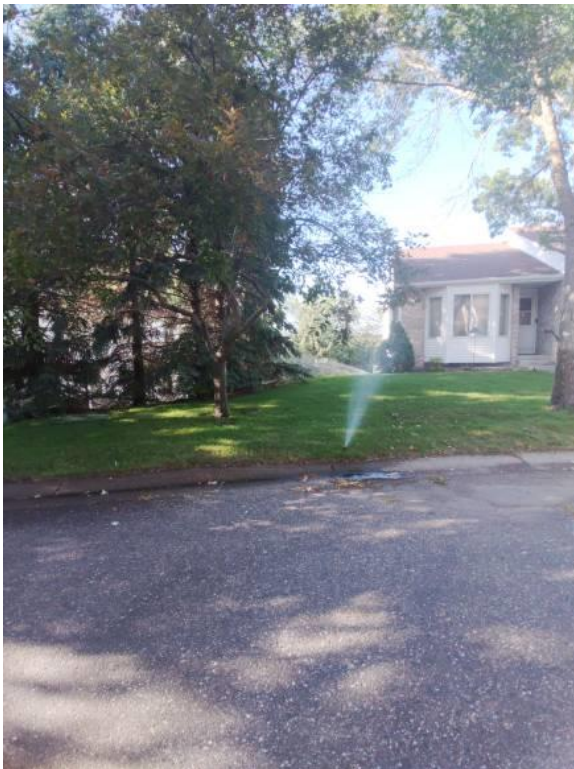
Sta 10 – sprinklers in front & side of 15969 Suggest nozzle balance the entire station. Change the large area rotor sprinklers in the front yard to smaller style sprinklers. Add a sprinkler at the drive corner.

Also add check valve sprinklers at bottom of the hillside of 15969 to reduce waste from low point drainage.

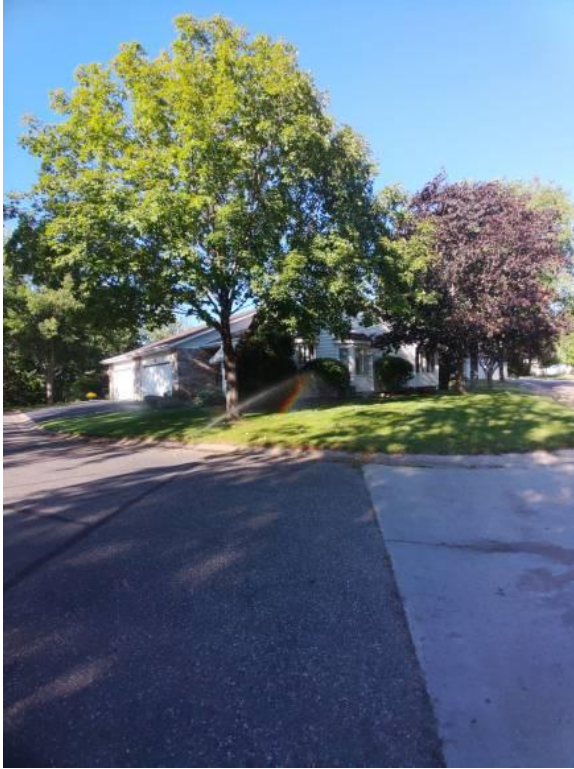
Sta 11 - 28 sprinklers covering a large area including front, sides and back of 15973 & 15977. Also, the front and north side of 15989.

Many PgP sprinklers with leaking seals. Suggest nozzle balance and smaller sprinklers in the front yards. Add sprinklers at drive corners for improved coverage.

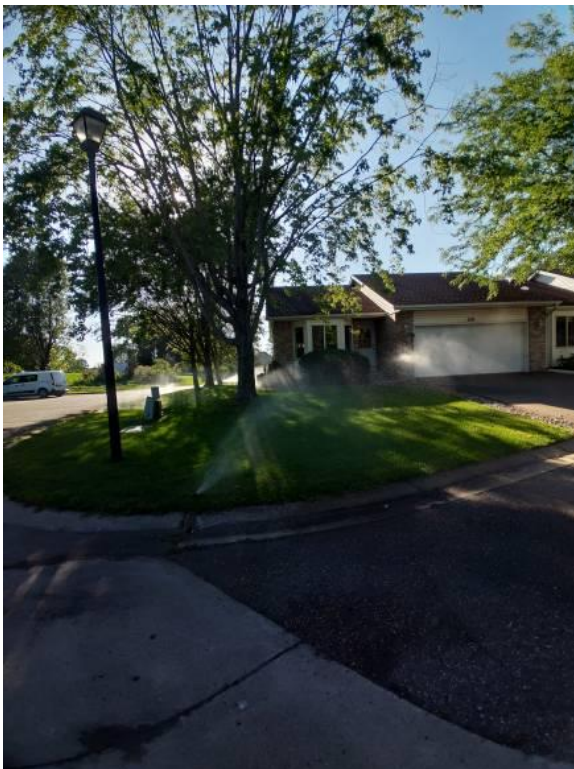
Sta 12 –18 sprinklers front, side & back of 15981 and between 15981 & 15985

Suggest extensive nozzle balance and replace the PgP sprinklers that have leaking seals.
