Williamsburg III Homeowner Association Apple Valley, MN

Landscape Irrigation Assessment Report & Recommendations

Water in Motion, Inc. Authored by: Timothy Malooly, CLIA, US EPA WaterSense Partner

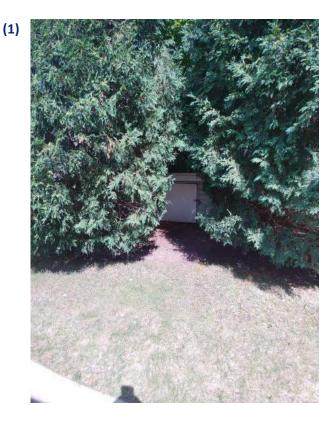
Water and controller "doghouse" cabinet

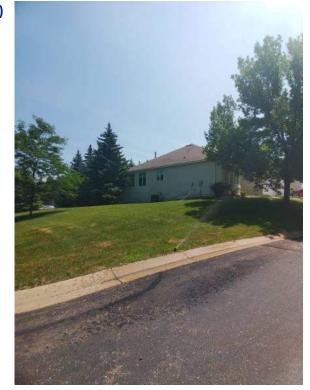
Station 1 – nine rotor sprinklers next to 13127 Gamma. Poor coverage, low sprinkler drainage, no matched application rate nozzles.

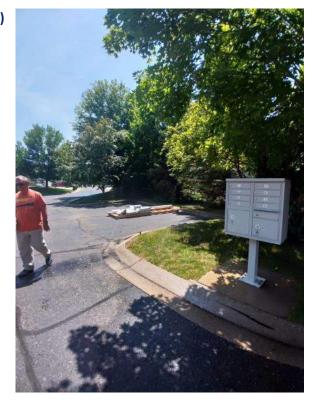
(3)

Station 3 – nine rotor sprinklers and 3 sprays into mature pines. Should be reconstructed w/sprays

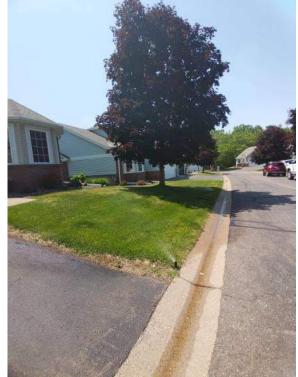
Station 4 – rotor sprinklers all around 13144, 13148, 13152. Poor sprinkler spacing, missing sprinklers for good coverage. Mixed with side yards, low sprinkler drainage.

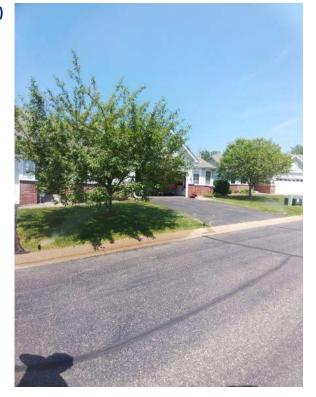
(6)

Station 5a – Around 13143, 13139, 13137. Poor coverage, low sprinkler drainage.

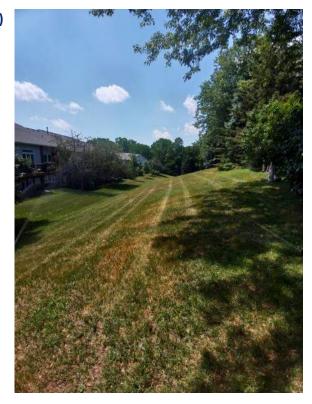
Station 5b – Around 13143, 13139, 13137. Poor coverage, low sprinkler drainage.

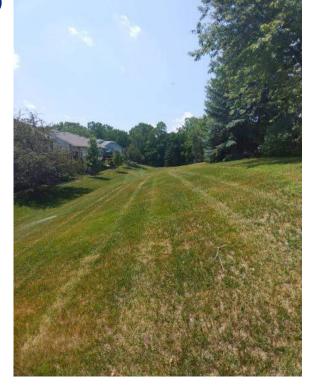
(8)

Station 6 - 19 rotor sprinklers along back slope behind several homes. Some sprinklers blocked behind the woodline. Several tilted sprinklers. Spacing is stretched, poor coverage.

Mowing too short. Wide open unused turf hillside.

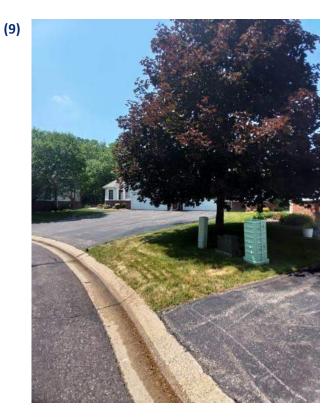
Station 7 – Approximately 20 sprinklers all around 13155, 13157, 13159 Gamma.

Poor placement, poor spacing. Blown, leaking seals, several non-rotating sprinklers, mixed rotor sprinklers and spray sprinklers.

Low sprinkler drainage.
