2024 Water Quality Monitoring Report

State of the Watershed

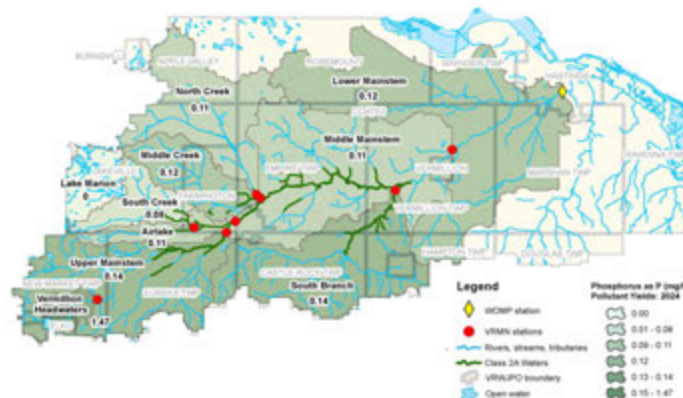
Total Phosphorus (TP) includes all forms of phosphorus; particulate and dissolved. **The state standard of 0.15 mg/L was exceeded during runoff conditions (> 1" rain in 24 hour period) in the late spring months and in early August.** Large runoff events often lead to phosphorus laden sediment being carried into the river via runoff from streets and agricultural fields. **Samples collected during baseflow conditions in the late summer and fall were below the standard at both sites.**

In 2024, the Vermillion Headwaters subwatershed (located entirely in Scott County; VR24 is the outlet site), showed TP pollutant yields 5-6x higher than all monitoring years from 2016-2023 (see map above). Climactic conditions returned to more "normal" rainfall amounts in 2024 so higher yields could be a result of legacy TP flushing through the system.
