# VERMILLION RIVER HEADWATERS

## Subwatershed Assessment

Prepared by Scott Soil and Water Conservation District with financial support from Clean Water, Land and Legacy Amendment and the Vermillion River Watershed Joint Powers Organization

May 23, 2025

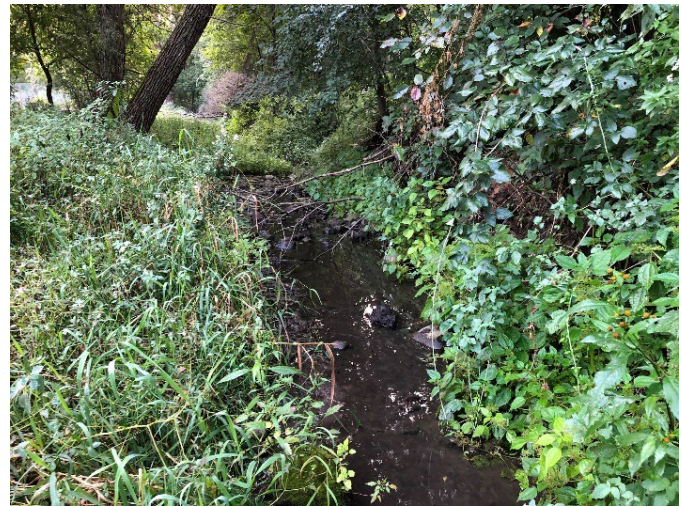
This section was inspected in the fall of 2022 and showed signs of little erosion with moderate shade. Being a county ditch, it is a priority to have the streams buffers tree free in this area and would impact the shade score even more if the trees are removed. This means that there is a significant amount of tree cover. The instream zone consisted of cobble, gravel and sand with mainly runs of flow and light substrate embeddedness. Low siltation with moderate cover of overhanging vegetation, logs and woody debris, as well as rootwads. The overall MSHA assessment score for this section was 47. Due to the condition of existing riparian cover and limited flow, stream restoration and riparian habitat practices through this section would provide minimal improvement benefits.

**Figure 1:** Looking downstream near the headwaters of CD12 Main Branch.

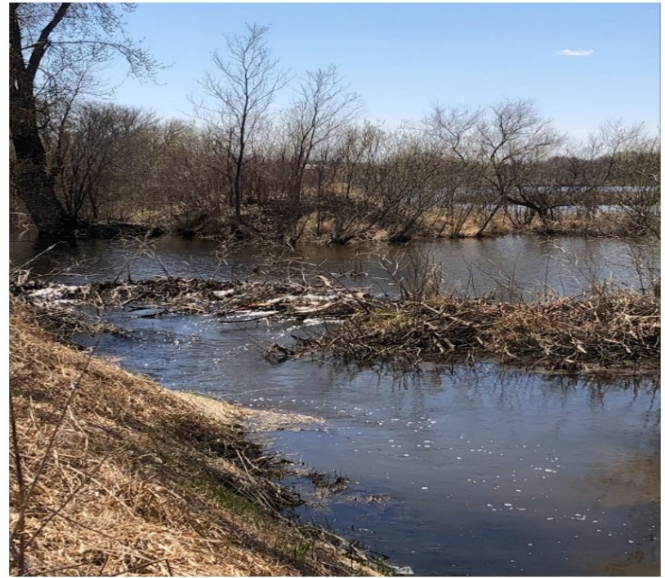
This section of the MSHA was completed with two worksheets, completed in the fall of 2022. Many of the issues in this section consist of channel sloughing, sediment deposition and wildlife (beaver) presence. Riparian widths range from moderate to extensive, with moderate bank erosion. Significant reaches west of Beard Ave are heavily shaded while little to no shade was found east of Beard Ave. Being a county ditch, it is a priority to have the streams buffers tree free in this area and would impact the shade score even more if the trees are removed. No water was observed immediately east of Beard Ave, due to the presence of a beaver dam (Figure 3). Heavy siltation with no coarse substrate. Sinuosity and channel development are lacking west of Beard Ave but begins to develop east of Beard Ave. A large portion of the immediate surrounding land use east of Beard Ave consists of turf grass farming, which may contribute to nutrient loading. Invasive vegetation of cattails and reed canary grass are heavily present in this section. This section would benefit from bank stabilizations (approx. 800 Ln Ft) and channel revetment to improve the sinuosity of the channel. MSHA scores for this section ranged from 35 and 42, with an average of 38.5. Similar to other sections that have been altered for drainage purposes, this section would benefit from stabilization practices (approx. 800 Ln ft), riparian buffer improvement, and potentially remeandering to improve sinuosity and aquatic habitat quality.

Figure 3: Beaver Dam observed approx. 3000' downstream of Natchez Ave. Photo taken facing upstream (west).

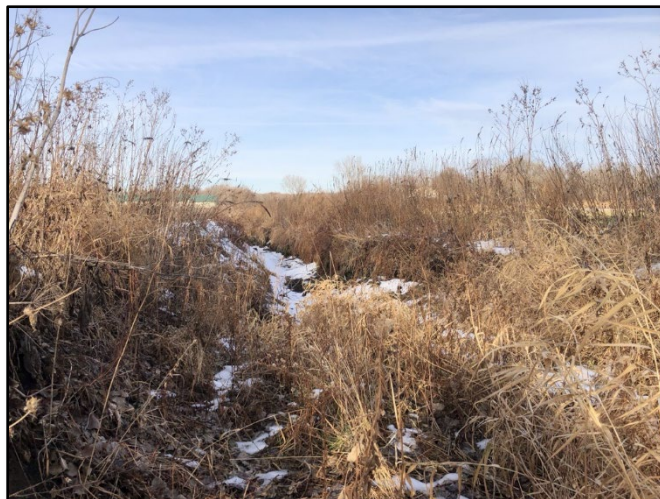
The final MSHA for the upper branch was collected through four scoring sheets on the same day during the late fall/early winter of 2022. The surrounding land use consists of forest and sod farming. Riparian buffer widths range from narrow to wide with moderate to no shade. The instream zone was primarily run channel type with cobble, sand, moderate siltation and detritus substrate with severe embeddedness. Cover type consisted of moderate undercut banks, overhanging vegetation, logs or woody debris root wads, and emergent macrophytes. Channel morphology scored the lowest in this section as the channel represents the typical drainage ditch profile with moderate stability. Sinuosity ranked fair to poor with no pooling and channel modifications of leveed and dredged. MSHA scores for this section ranged from 27.1 to 43.5, with an average of 37.3. Similar to U-2, this section would benefit from stabilization practices, riparian buffer improvement, and potentially, remeandering to improve aquatic habitat quality.

**Figure 2:** Typical channel conditions for reach U-3. Photo facing downstream (east).

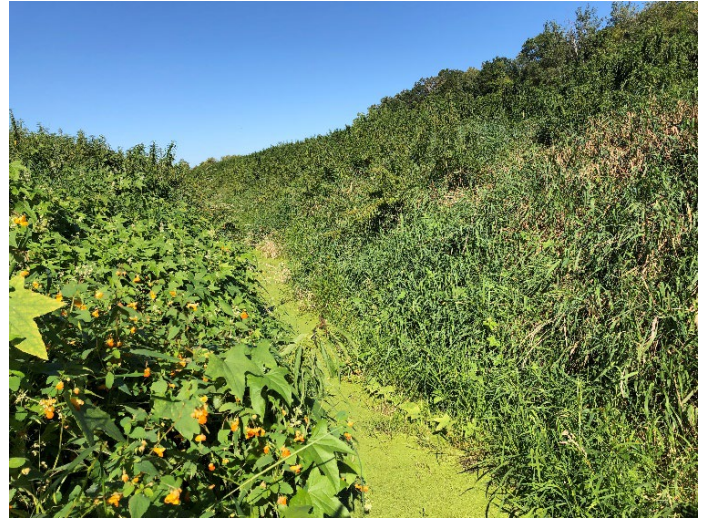
The surrounding land use is predominantly forest, wetland, prairie and shrub with portions of row crop to the south of the stream. The riparian zone width was viewed as wide with light to occasionally heavy shade. Vegetation consisted of an abundance of Reed Canarygrass, stinging nettle, and thistle. The instream zone consisted of run channel types with pool areas and little to no embeddedness. Substrate in this portion of the stream found to range from sand, silt, muck and detritus. Stream cover in this area is overhanging vegetation at a moderate (25-50%) level. This section showed moderate to high channel stability with low depth variability and slow to no velocity. The stream found to have poor sinuosity and channel development, while improving downstream in stretch L-2. With an overall MSHA score of 41, this section like U-2 and U-3 would benefit from a combination of stabilization practices, riparian buffer improvement, and potentially, remeandering to improve aquatic habitat quality.

**Figure 3:** Typical channel conditions for reach L-1. Facing downstream (east)

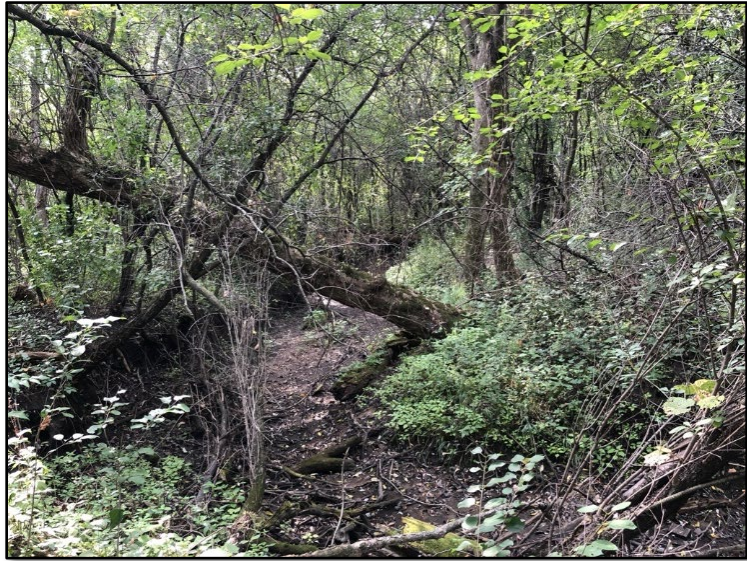
This reach held the most forest and hayfield surrounding land use with occasional row crop. Areas where row crop land use was present showed good vegetative buffer establishment. The riparian zone width scored moderate to wide but had a moderate amount of bank erosion. Water levels in this stretch were low to intermittent and nearly completely dry. A private 20- to 30-foot-long culvert was inspected in this stretch and showed substantial amount of undermining on both sides and a large washout immediately downstream (figure 6). Channel type in this area was predominantly run with sand, silt, and detritus substrate. No embeddedness was found and low to moderate siltation. Cover

Figure 4: Typical channel conditions for reach L-2. Facing upstream.

amount is moderate to extensive with cover types in this area of large undercuts, overhanging vegetation, logs or woody debris with root wads and emergent macrophytes. Channel morphology was viewed as having moderate stability with good sinuosity, resulting in fair channel development. Most sections were dry with pockets of stream pooling. It is assumed the interstitial is due to excessive sediment loading from bank erosion that is impeding flow. This section had a MSHA score of 45.5 and would benefit from bank stabilizations (approx. 1500 Ln ft) and near-channel grade stabilization.

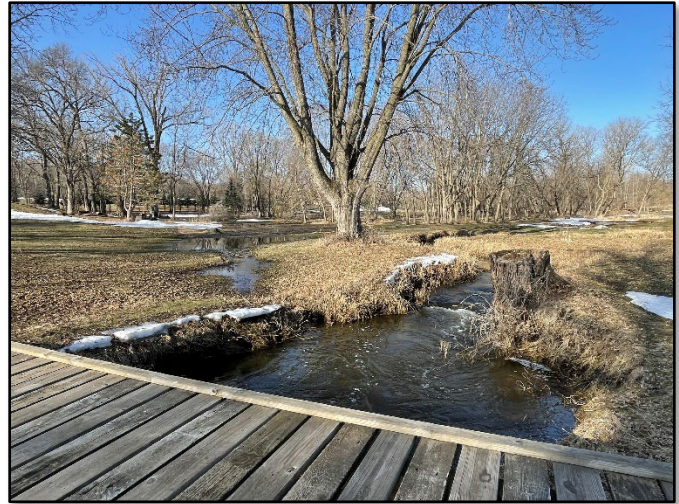
Due to land accessibility, sections for the Vermillion between the east side of 35W and Dupont Ave were not able to be inspected for this MSHA. Scott SWCD collects water quality samples at V24 (Map) biweekly, during spring melt, and rain events. Being a routinely visited site, around 850' of this reach was inspected in fall of 2024. Surrounding land use consists of forest, wetland and residential area routinely mowed. Riparian width is considered narrow to moderate with moderate bank erosion and moderate to light shade. The instream zone showed mainly run channel types with some riffle of sand and silt substrate. Cover amount is moderate comprised of undercut banks, overhanging vegetation, logs or woody debris and floating leaf macrophytes. Channel morphology showed moderate to high but areas of significant cutting on banks from overland flow during spring melts and wet seasons. Channel sinuosity and development rank as good with some bank stabilization and use of rip rap. Reed canary and duckweed present in stream. This section had an overall MSHA score of 79.5, and like L-2 it would benefit from bank stabilizations (approx. 300 Ln ft) and near-channel grade stabilization. A bank stabilization was completed previously for the single landowner in this stretch, within the right of way on the west side of Pillsbury Ave.

Figure 5: Spring melt showing overland flow to the Vermillion. Facing upstream, about 315' west of Pillsbury Ave.

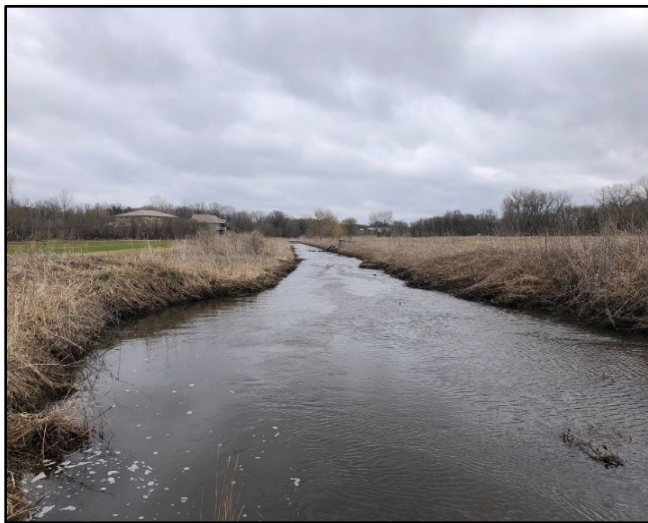
**Figure 6:** Facing east from Pillsbury Ave near Rice Lake Inlet during spring melt.

Intermittent periods of low flow within the streambed prevent aquatic species' ability to travel further upstream through its tributaries. Pooled areas with little to no cover or shade warm up and contribute to temperature fluctuations during times of higher precipitation. About 49 miles of the Vermillion Rivers main stem and tributaries are Minnesota Department of Natural Resources (DNR), designated trout streams (MNDNR). These class 2a cold-water stretches are mainly in Dakota County, while continuous temperature is recorded every 15-minutes at the V24 location in Scott County. There are no temperature standards for the reaches of Vermillion River in Scott County, but flow from these reaches can significantly impact water quality further downstream where standards do exist.

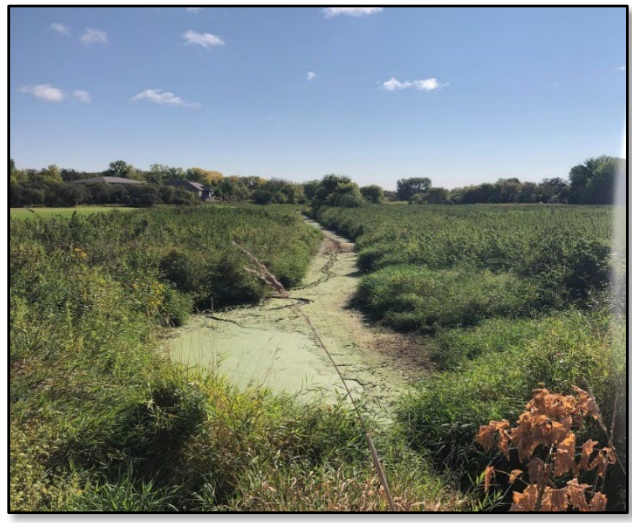
**Figure 7:** Facing east from Pillsbury Ave near Rive Lake Inlet during dry season.
