Vermillion River Watershed Joint Powers Organization  
**Empire Drainages Geomorphic Assessment, Dakota  
County, MN: Final Report**

April 30, 2013

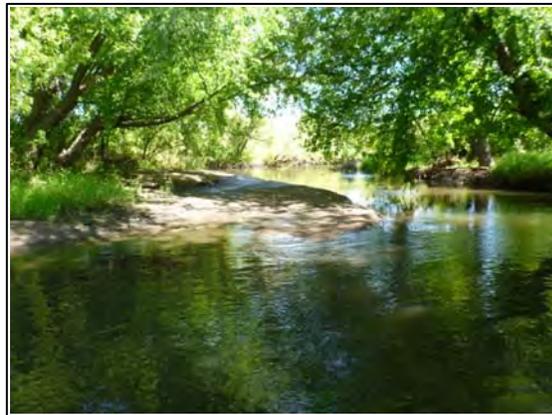
Figure C-1: Typical site within reach 1, including large silver maples and channel meanders. Photo taken at Station 2000 looking upstream at inside meander bend sand bar, large canopy of silver maples, and reed canary grass as predominant understory.

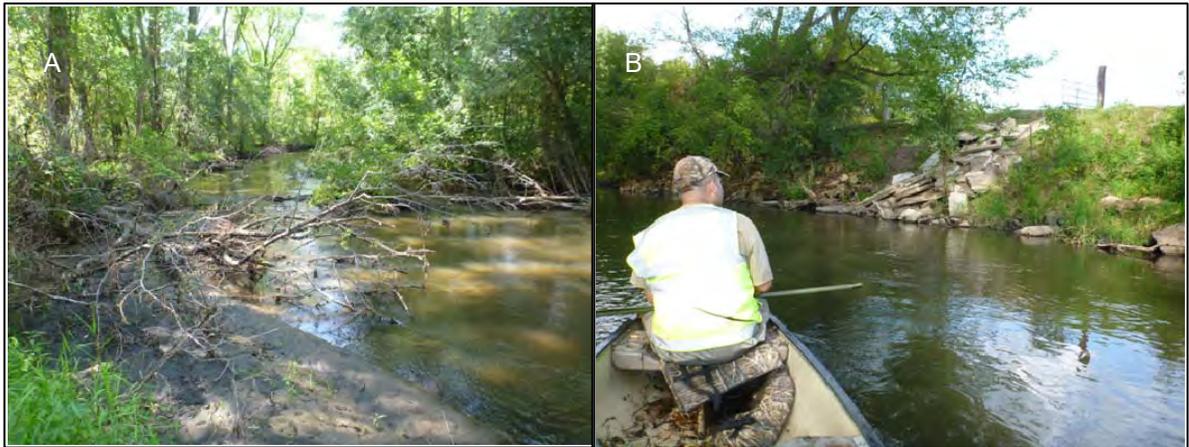
Figure C-3, Reach 3: A) Station 20,200, showing a typical site within this reach. B) photo (Station 14500) shows the sole exception to this heavily canopied reach and intact riparian corridor.

Stn 15550-15200: entire right bank is devoid of a dense riparian buffer. There is evidence that farmer no longer farms to edge of river and has implemented a setback. Also noted a linear series of tree plantings approximately 15' from edge of water (species unknown). This section would benefit by implementing a native riparian planting plan in cooperation with existing farming practices.

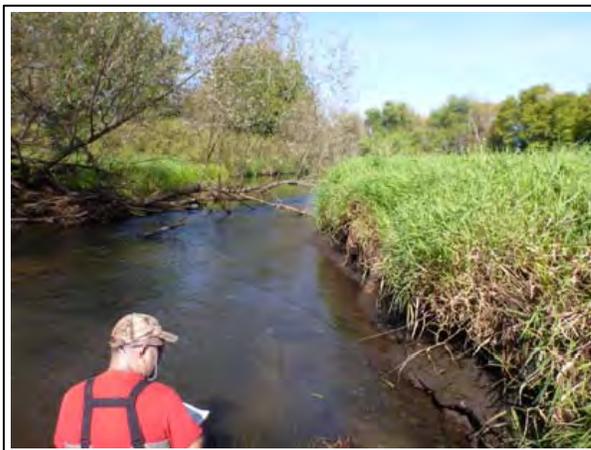
Figure C-4, Reach 4: Station 31,800 looking downstream. Note lack of mature riparian woody vegetation and reed canary grass as predominant understory.

reconnaissance, water temperatures coming from the downstream tributary (Tributary 4) were 10° F higher than those observed in the main stem Vermillion (78° F compared to 68° F, respectively). The lack of mature riparian vegetation in this reach likely indicates previous land use practices for which riparian vegetation was completely removed. Fallen wood is available on both the banks and mid-channel, creating good wildlife habitat. Additionally, there are backwater areas, which serve as good habitat for animals seeking shelter from the swifter main current. There is one potential bridge replacement, one riparian management, and three bank stabilization projects identified in this reach.

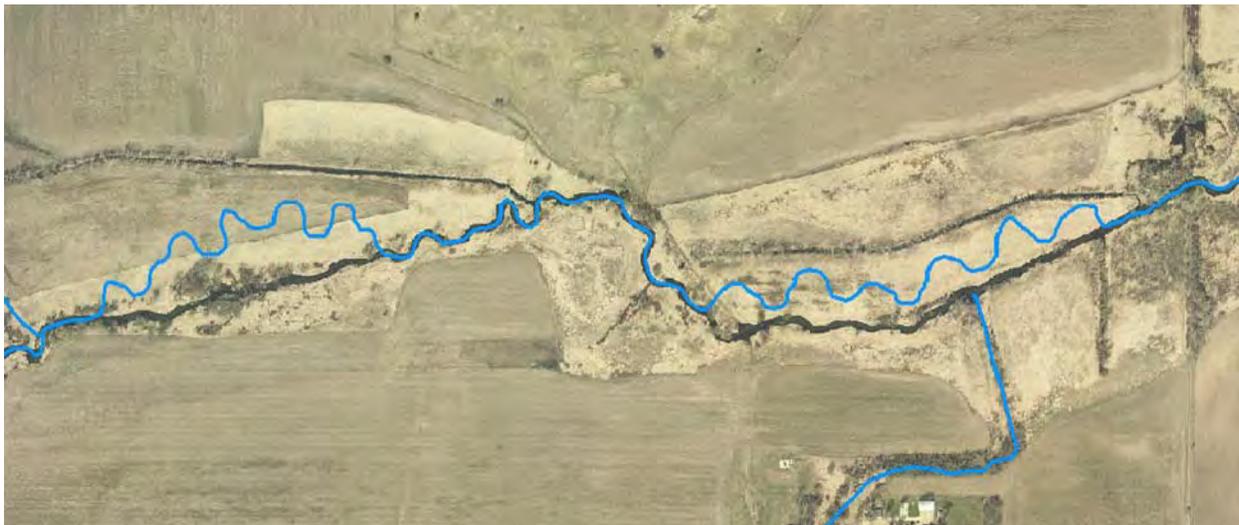
Reach 5 extends 1.40 miles from its terminus with reach 4 to its confluence with Tributary 7. Reach 5 is characterized by a major channel restoration endeavor. In the majority of this reach, channel planform, meander length, geometry, and habitat have all been restored within the last two years. The primary restoration techniques included root wad placement on the outside meander bends, woody debris toe protection, woody debris mattresses, rock cross-channel constrictions, and tree plantings throughout the riparian corridor. It is anticipated that this reach will need a few growing seasons and to experience at least one channel forming flow (bankfull flow) before a revised restoration assessment can be made.

Figure C-5, Reach 5: Satellite imagery from 2010 with current restored planform superimposed (blue line). Virtually the entire reach has been recently restored.

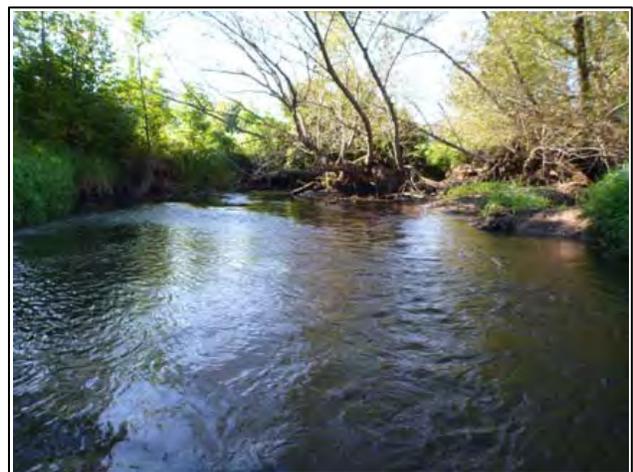
Figure C-8, Reach 8: Looking upstream at a log jam at Station 58,900.

deep pools, sand bars, and riffles. In contrast, the upstream reach is straightened and lacks biodiversity. Potential projects include removal of a bridge and fixing some excessive bank erosion.

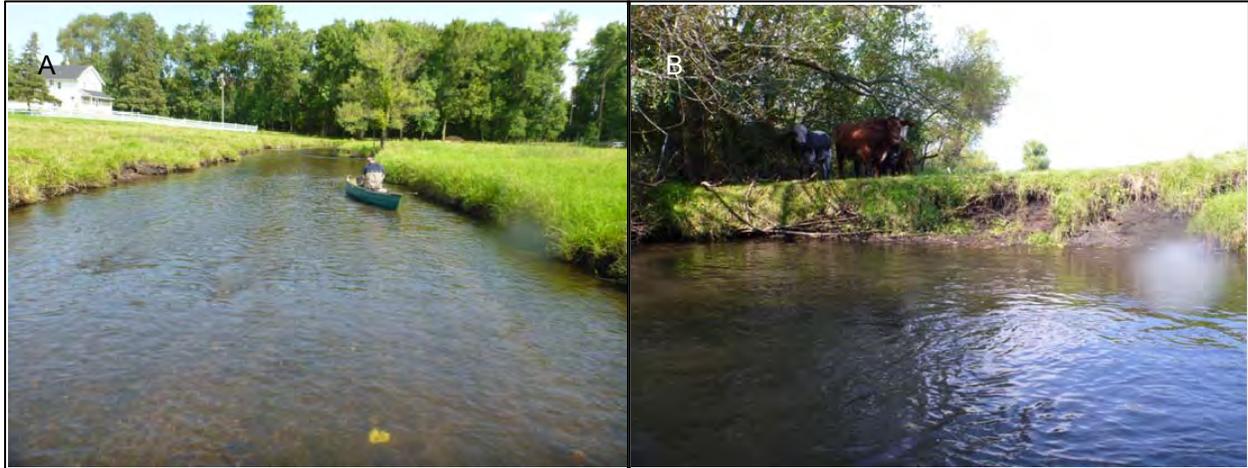
Figure C-9, Reach 8: Photos taken from the upstream section of Reach 8 at approximately Stn 61,300.

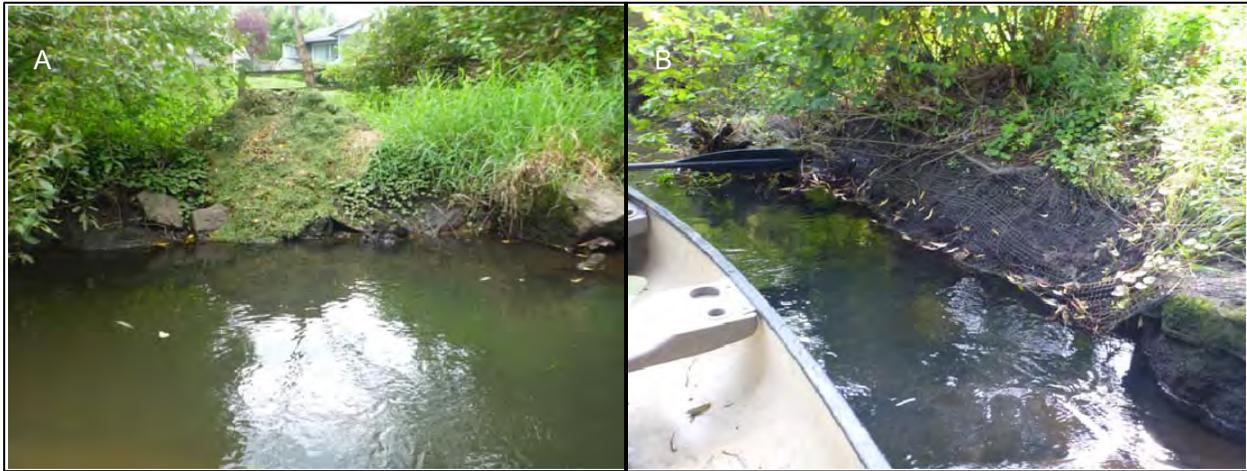
Figure C-10, Reach 9: A) Taken at Station 63,450. B) Looking at right bank at Station 63.350 to show bioengineering restoration techniques, including root wad placement, bioengineering fabric, and rock toe protection.

bank restoration projects were identified in this reach, and one bridge needs to be removed.

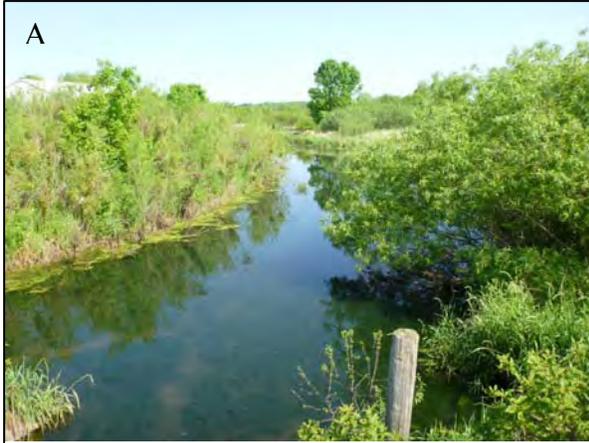
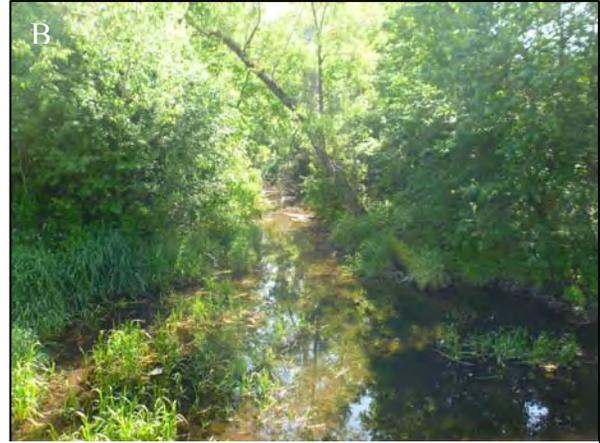
Figure C-11, Tributary 1: A) Looking upstream from 190th St E at straightened ditch with adjacent wetland vegetation. B) Looking downstream from Clayton Ave at straightened channel with more mature riparian canopy.

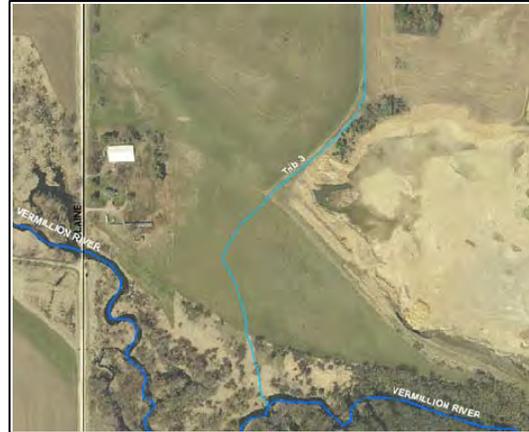
Figure C-13, Tributary 3: Air photo of the Tributary 3 alignment with no visible channel bed or banks. A shallow swale through the fields carries overland runoff to the Vermillion River, but no channel features are apparent.

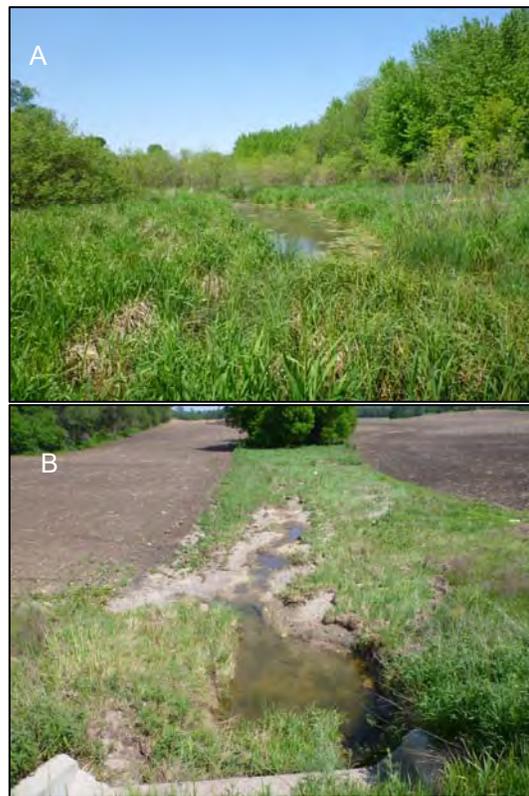
Figure C-14, Tributary 4: A) Wetland channel upstream of Annette Ave and B) barely perceptible channel downstream of Biscayne Ave.

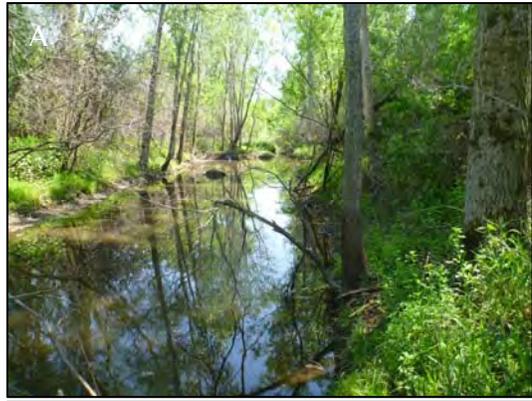
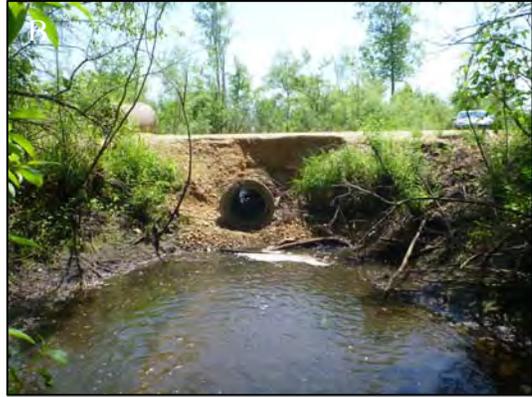
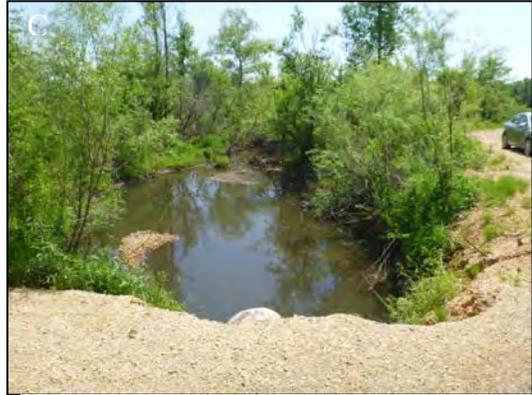
A dirt road crossing about 250 feet downstream of Annette Ave has partially washed out (Figure C-15), distributing sand and gravel in the channel downstream. Two culverts continue to allow water to flow through, but the road is not safe to travel on and the entire structure could be completely washed out in storm event. If this road is no longer necessary, it should be removed; if it is necessary, it should be rebuilt with a bridge or much larger culverts.

Figure C-15, Tributary 5: A) Looking downstream in upper half of channel. B) Looking downstream at washed out dirt road. C) Looking downstream from the washed out road.

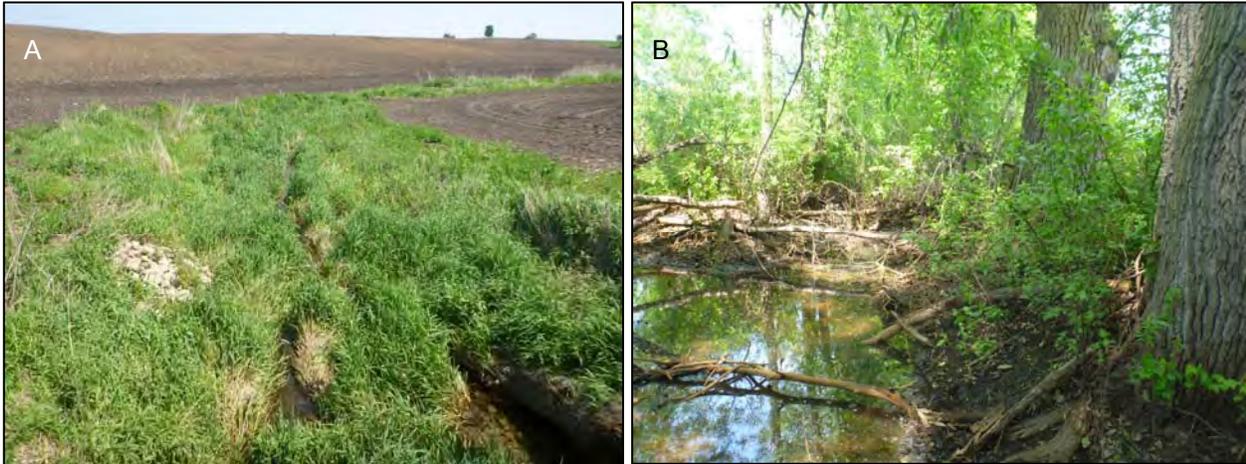
Figure C-18, Tributary 7: A) Looking downstream from Biscayne Ave. B) Looking upstream at large woody debris downstream of 190th St W.

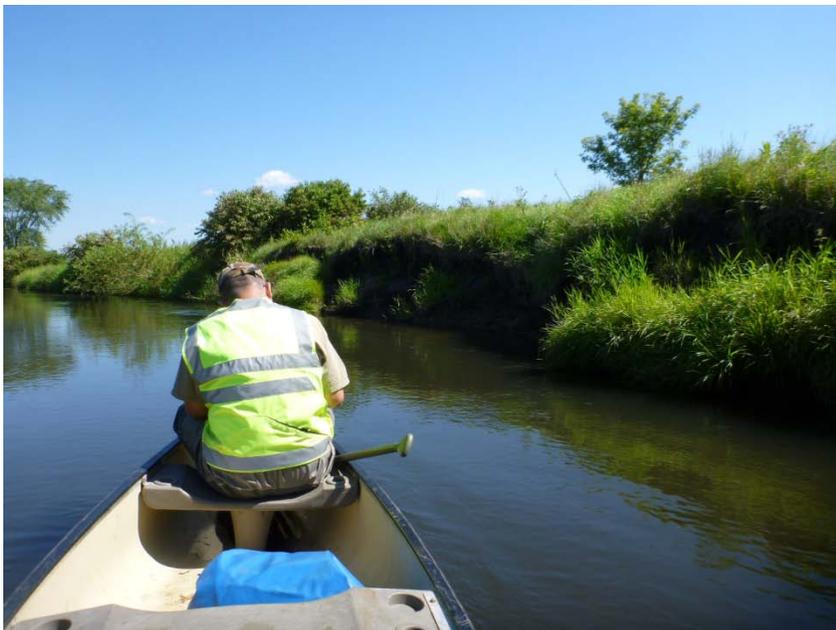
Stream: Vermillion, Reach 2	Problem description: Minor bank erosion.
Station: 7800-7875, right bank	
Solution: The site can be repaired using standard bio-engineering techniques and native plantings.

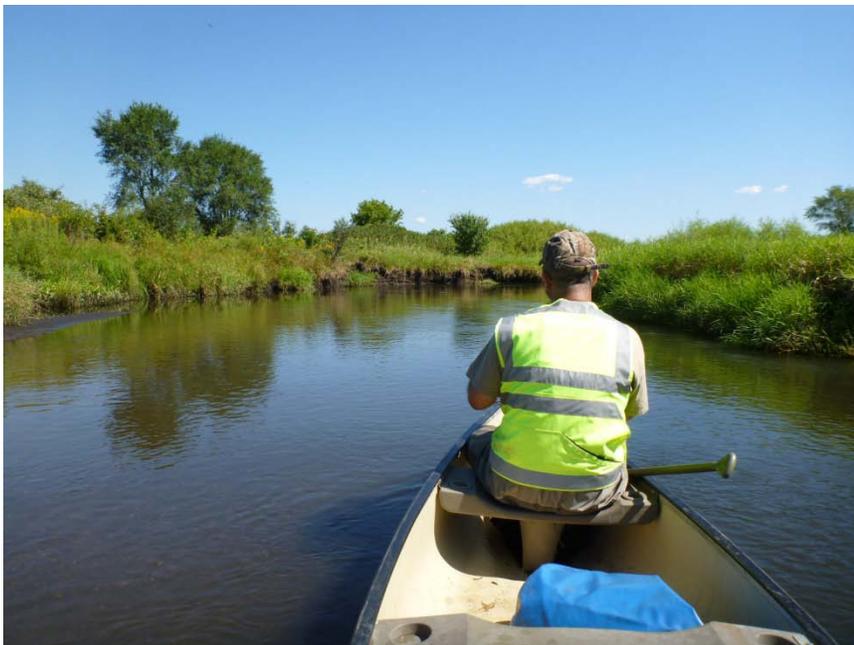
PP 05

Stream: Vermillion, Reach 2	Problem description: Minor bank erosion.
Station: 8150-8300, left bank	
Solution: The site can be repaired using standard bio-engineering techniques and native plantings.

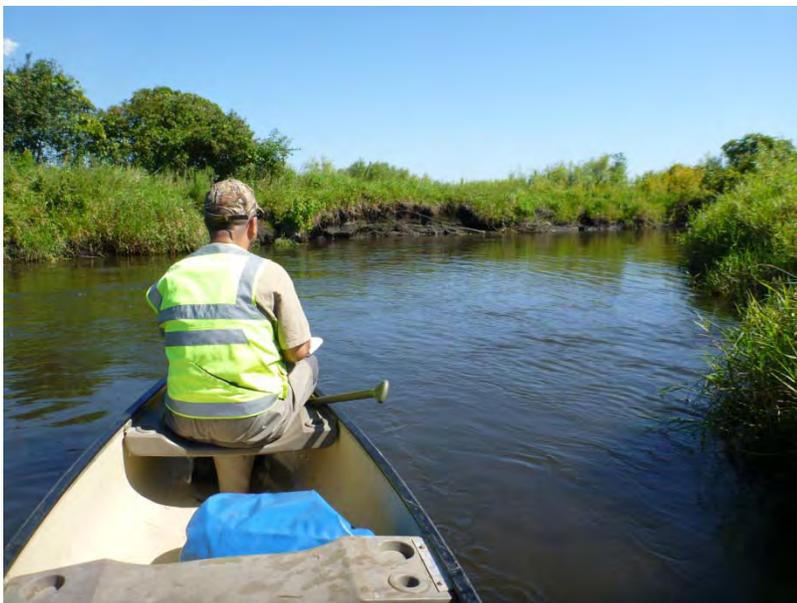
PP 06

Stream: Vermillion, Reach 2	Problem description: Minor bank erosion along 4 to 5-ft banks.
Station: 9150-9250, left bank	
Solution: The site can be repaired using standard bio-engineering techniques and native plantings. The fencing that has fallen, would also need to be removed.

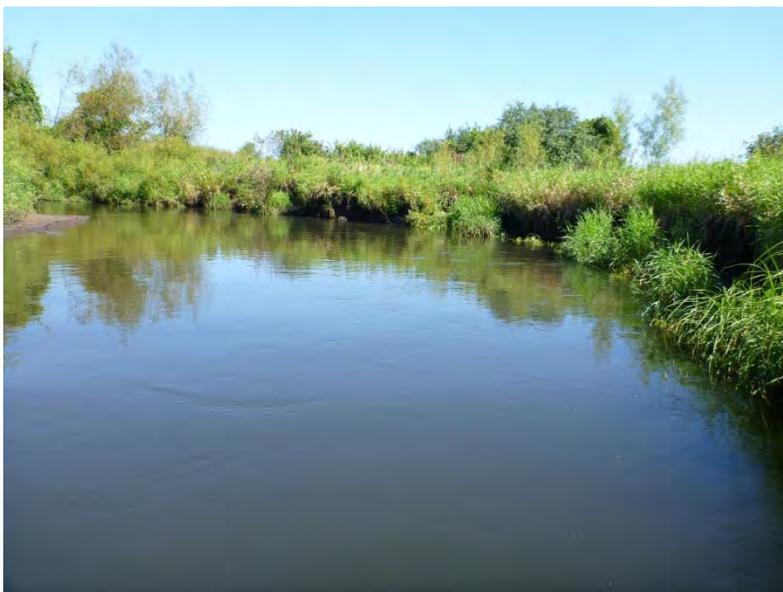
PP 07

Stream: Vermillion, Reach 2	Problem description: Minor bank erosion.
Station: 9825-9900, left bank	
Solution: The site can be repaired using standard bio-engineering techniques and native riparian planting.

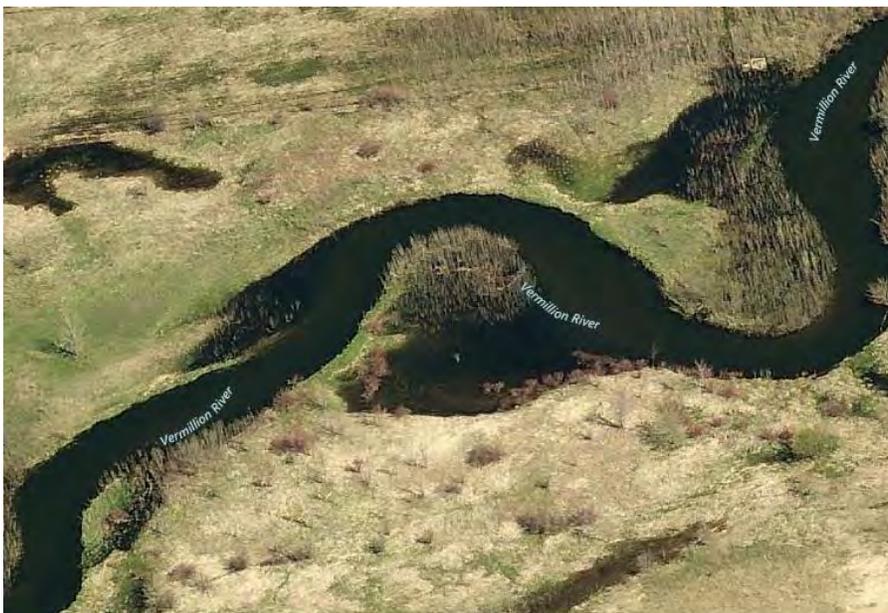
PP 08

Stream: Vermillion, Reach 2	Problem description: Minor bank erosion and lack of root stabilization from trees.
Station: 10250-10350; left bank	
Solution: The site can be repaired using standard bio-engineering techniques and native riparian planting.

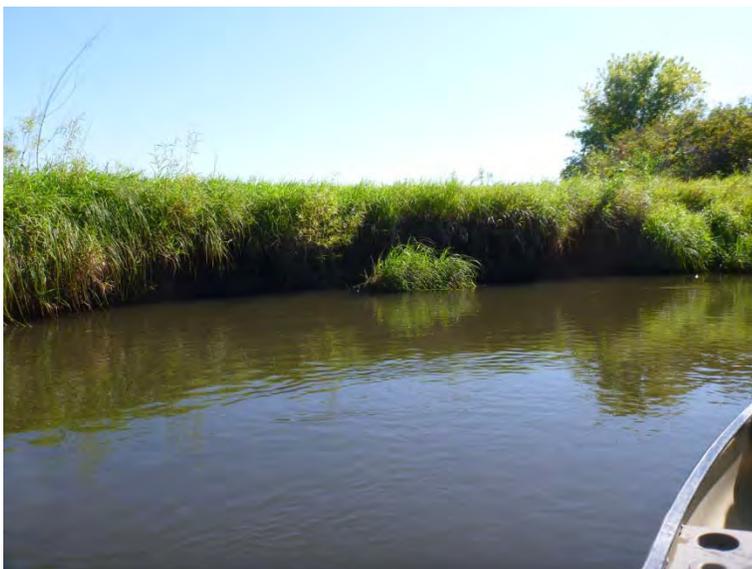
**PP 09**

Stream: Vermillion, Reach 2	Problem description: Minor bank erosion and no trees to provide root stabilization.
Station: 11200-11250, left bank	
Solution: The site can be repaired using standard bio-engineering techniques and native riparian planting.

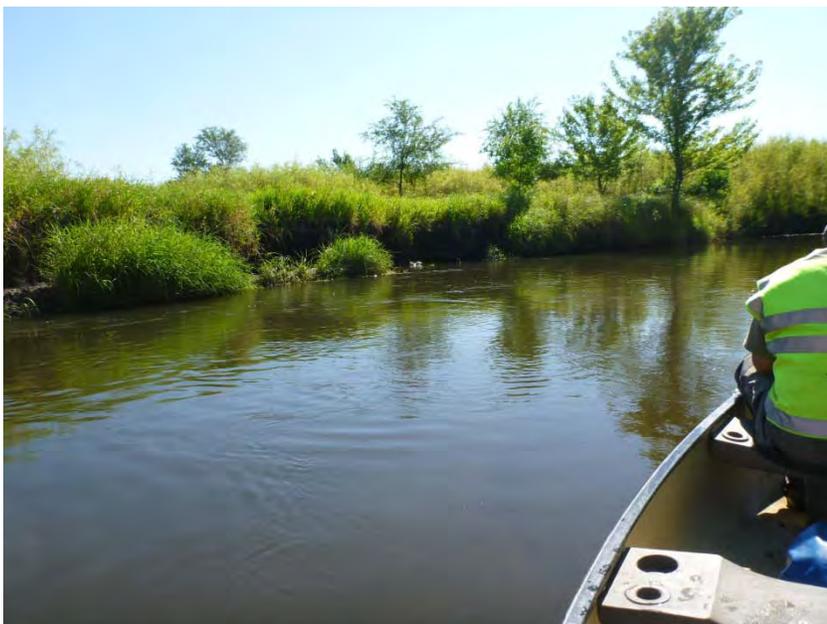
PP 10

Stream: Vermillion, Reach 2	Problem description: Minor bank erosion and little bank stabilization from tree roots.
Station: 11450-11500, left bank	
Solution: The site can be repaired using standard bio-engineering techniques and native riparian planting.

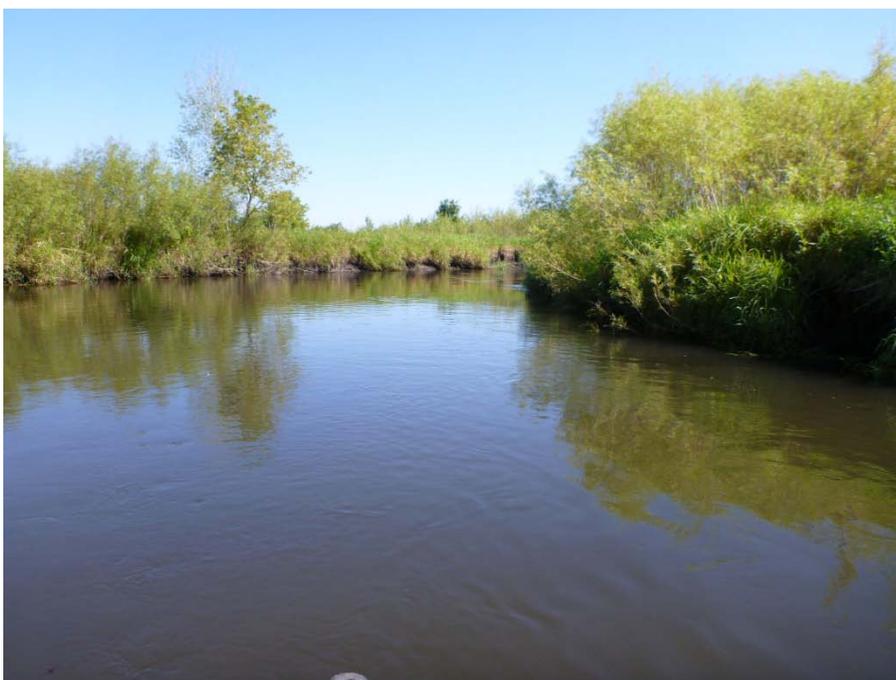
PP 11

Stream: Vermillion, Reach 2	Problem description: Minor bank erosion.
Station: 11825-11900; left bank	
Solution: The site can be repaired using standard bio-engineering techniques and native riparian planting.

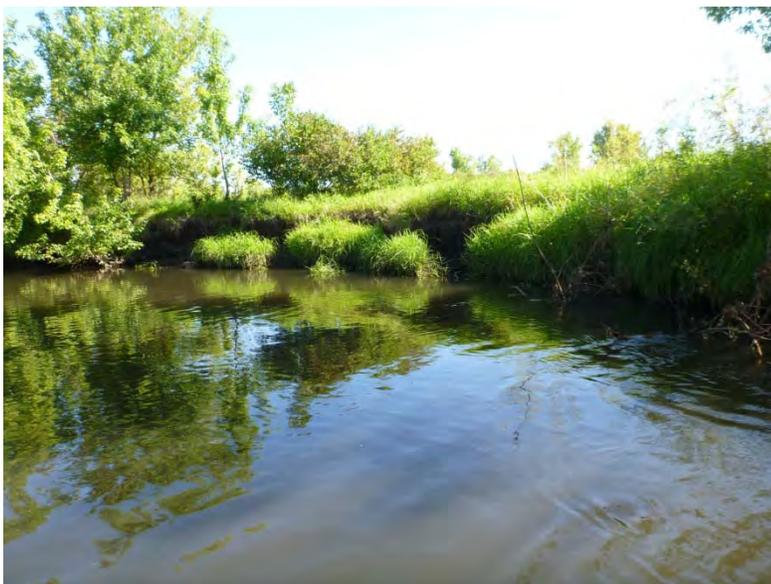
PP 12

Stream: Vermillion, Reach 2	Problem description: Minor bank erosion and little bank stabilization from tree roots.
Station: 12100-12200; left bank	
Solution: The site can be repaired using standard bio-engineering techniques and native riparian planting.

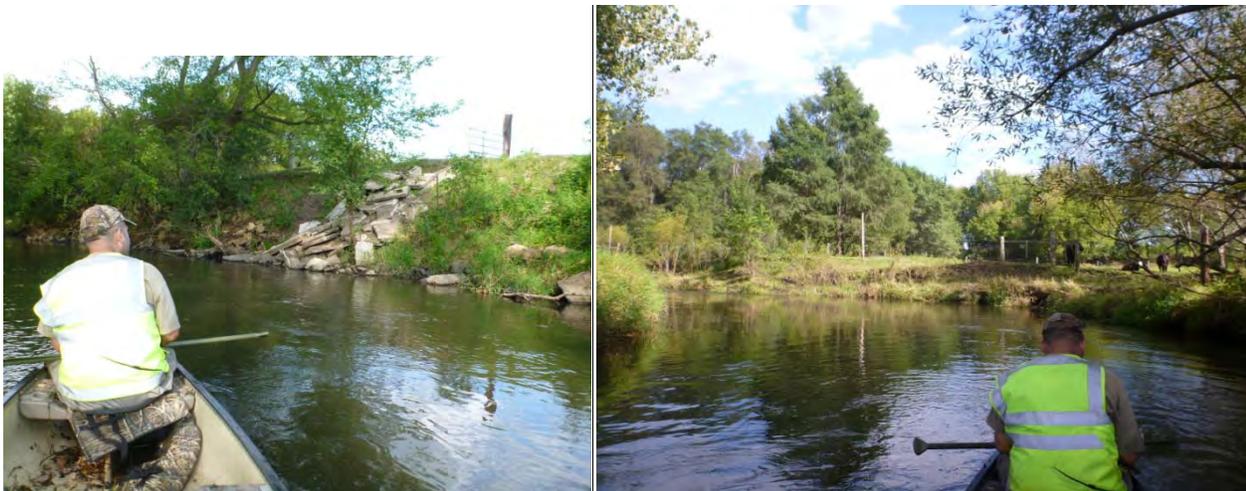
Stream: Vermillion, Reach 3	Problem description: Cattle ranch activities have encroached upon riparian corridor resulting bank erosion and likely decreasing water quality. Approximately 50' of rip-rap has been placed along the right bank to stabilize the bank, but this prevents native trees and shrubs from growing and providing bank stabilization.
Station: 13200-15000, right bank	
Solution: Implement exclusionary fencing to prevent cattle from accessing the river and trampling the channel banks. Provide watering stations away from the river for cattle. Remove rip-rap, re-grade the channel bank, and stabilize the bank using bio-engineering restoration techniques and native tree plantings.

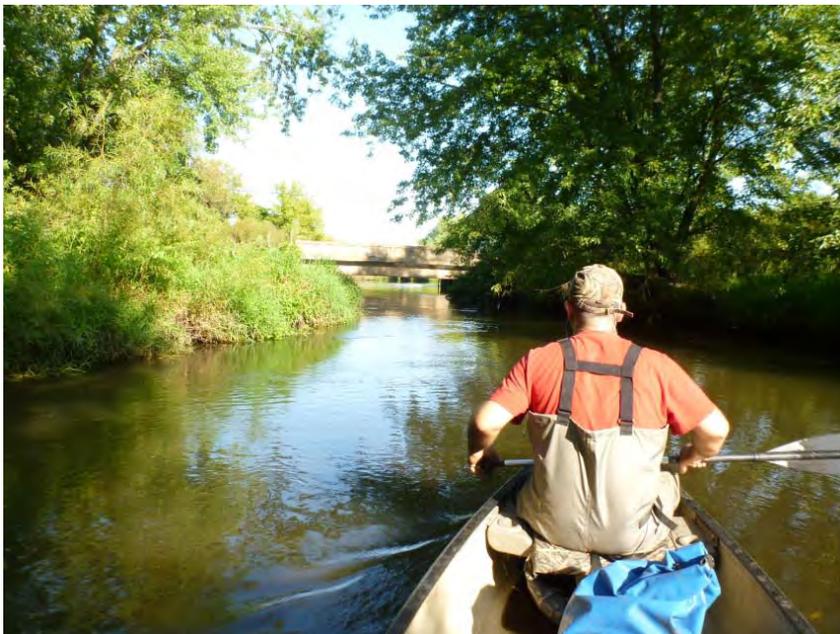
PP 16

Stream: Vermillion, Reach 4	<b>Problem description:</b> Blaine Avenue Bridge is undersized. Presently the bridge backs up water upstream of Blaine avenue and does not provide full floodplain connectivity. While major damage to the bridge was not observed, this pressure on the bridge could result in damage to the bridge over time.
Station: 22850	
<b>Solution:</b> Replace the bridge with a structure that can pass the 100 year flows.

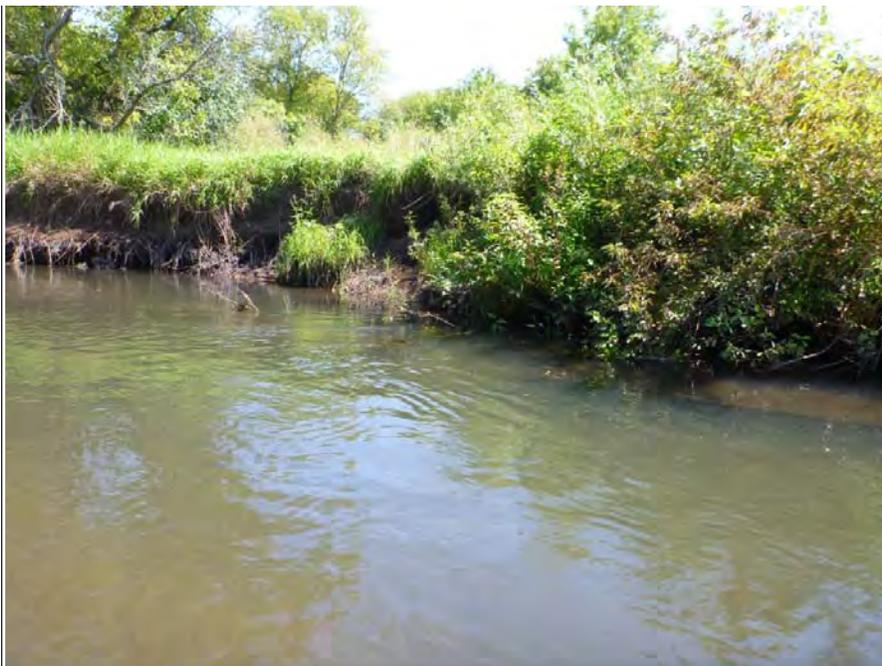
Stn 47550-47450, failed lunkers and erosion occurring behind. The river has eroded the bank behind the lunkers in this reach.

Stream: Vermillion, Reach 6	Problem description: Lunkers placed along the banks have failed and fallen into the channel or washed downstream. The river has eroded the bank behind the lunkers in this reach.
Station: 47450-47550, right bank	
Solution: Remove the failed lunkers and stabilize the banks using bio-engineering methods. Large woody habitat structures could be placed to improve habitat and stabilize the banks. Plant native vegetation.

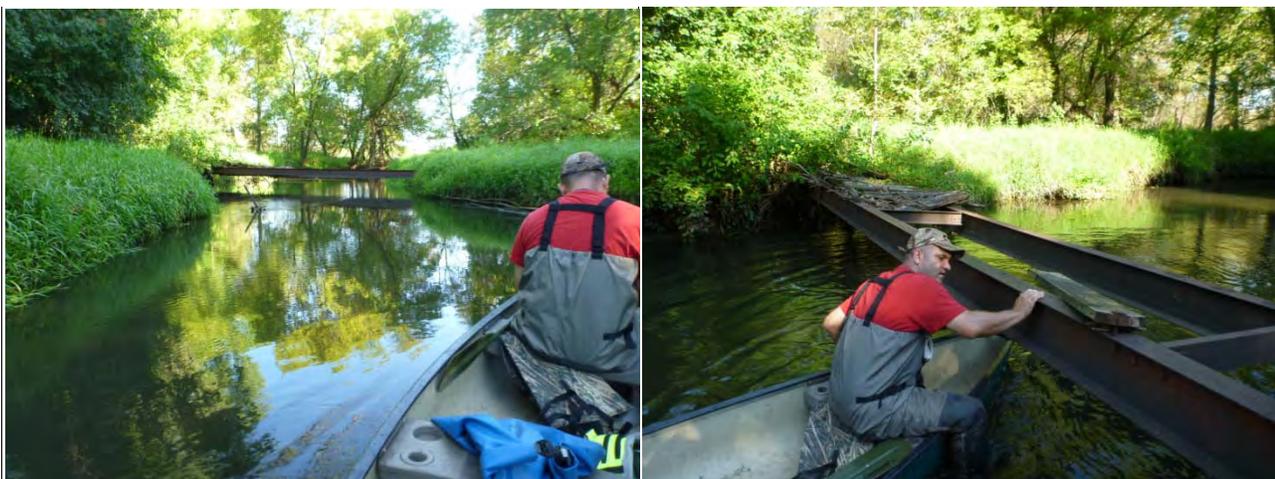
Stn 58500-double 'I-Beam' foot bridge, approximately 30' long, minor erosion around edges, no longer functional, low-cord =1.5'. This footbridge should be removed as it may cause flooding from accumulating debris during flood events.

Stream: Vermillion, Reach 8	<b>Problem description:</b> A double 'I-beam' foot bridge, approximately 30 feet long, spans the river at this site. The bridge is in disrepair and does not appear to be in use. Minor erosion was observed on the banks and the bridge likely backs water up and traps debris.
Station: 58500	
<b>Solution:</b> This footbridge should be removed as it may cause flooding from accumulating debris during flood events. It may also be a hazard to boaters.

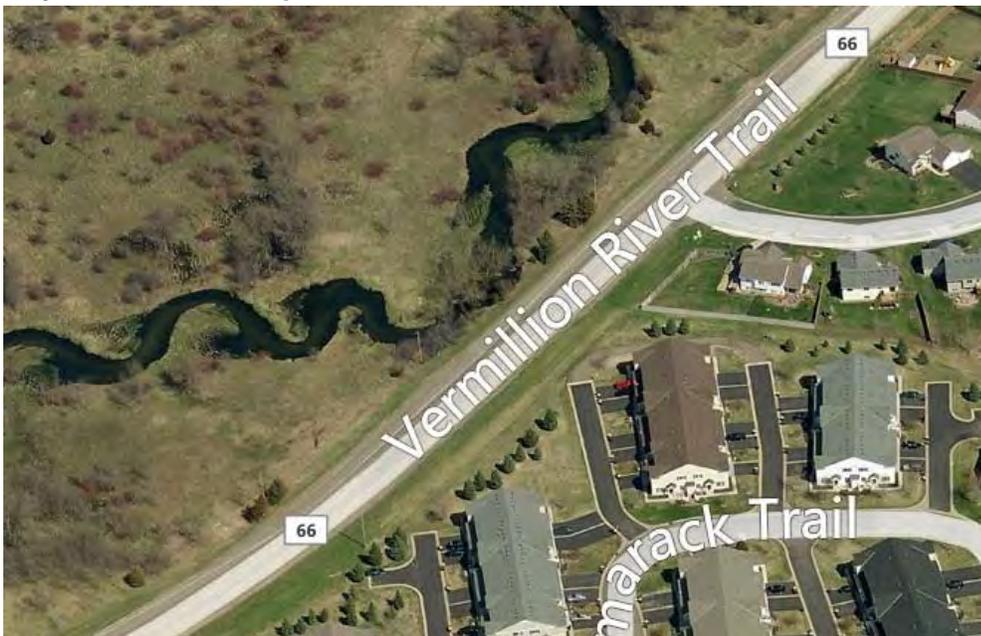
Stream: Vermillion, Reach 8	Problem description: The Vermillion River approaches to within 15 of Vermillion River Trail at this location. The 4-foot banks are eroding and while the road is not currently at risk, continued erosion could result in undermining of the road.
Station: 58950-59050, right bank	
Solution: The river should be entirely re-routed, from approximately Station 58800-59200, to the northwest. The outer banks, near the road, should be stabilized using bioengineering techniques and using native vegetation.

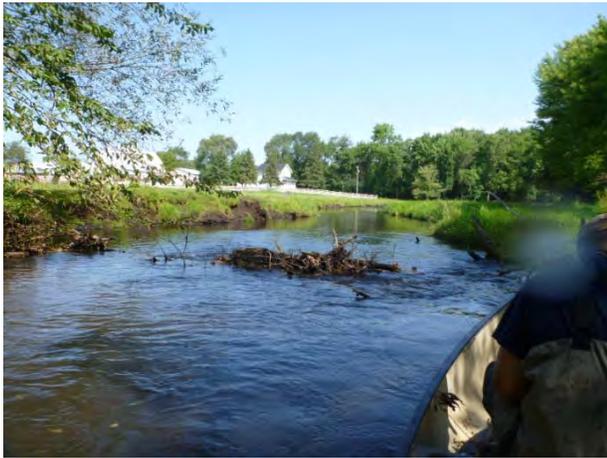
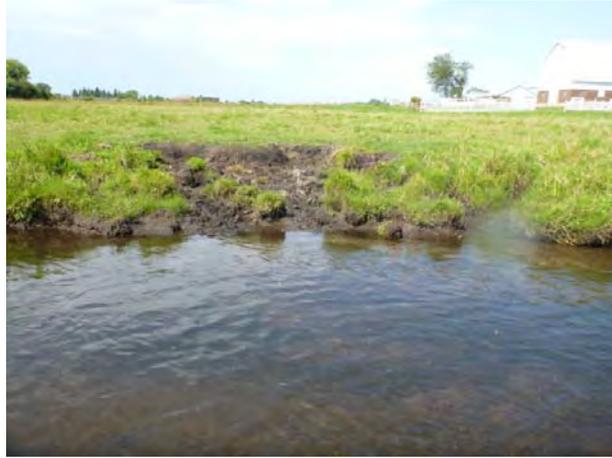
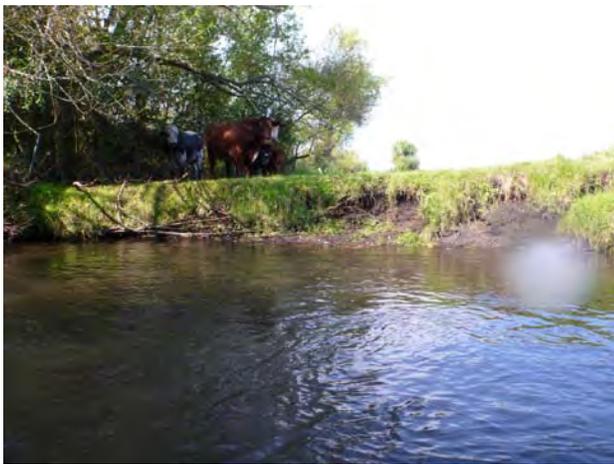
PP 25

Stream: Vermillion, Reach 8	Problem description: Bank erosion due to lack of bank vegetation and cattle trampling has caused an increase in sediment delivery to the channel and decrease in water quality. This reach of river has also been straightened, reducing the geomorphic and habitat complexity.
Station: 61000-61625, both banks	
Solution: Increase channel sinuosity to improve geomorphic and habitat complexity. A riparian buffer should be established and cattle access to the river limited. A water system for cattle away from the channel would provide water supply while limiting the bank erosion due to cattle trampling the banks.

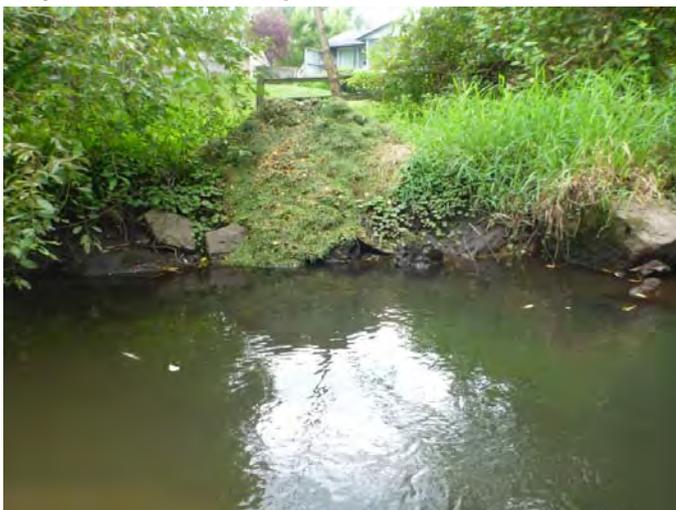
Stn 63600-63500, grass clipping observed on bank of river, outreach efforts in general would inform homeowners of negative impacts of yard waste on waterways, implementing backyard setbacks where urban gardening is discouraged would also have benefits to the river.

Stream: Vermillion, Reach 9	Problem description: Grass clipping observed on bank of river. Yard waste on channel banks prevents native vegetation from growing and providing bank stabilization.
Station: 63500-63600, right bank	
Solution: Outreach efforts would inform homeowners of negative impacts of yard waste placed next to the river. Implement a backyard setback where non-native landscapes are prohibited. The solution here is primarily based on outreach efforts.

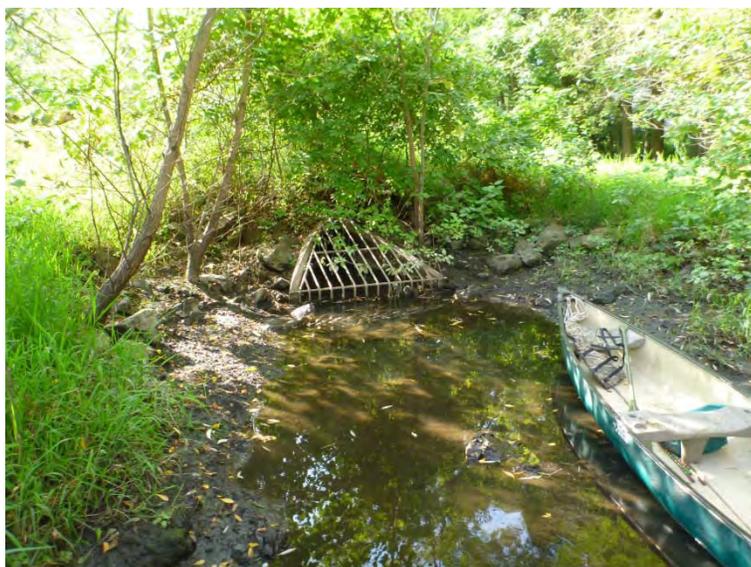
PP 28

Stream: Vermillion, Reach 9	<b>Problem description:</b> A 3-foot reinforced concrete pipe with flared wingwalls is located on the right bank on middle third of outside meander pool. Direction of pipe and outflow is perpendicular to channel flow resulting in bank erosion downstream.
Station: 64400, right bank	
<b>Solution:</b> Redirect pipe and outflow to be more parallel with channel flow. If possible, change location of outlet to a more stable riffle or run. Plant native vegetation on the channel banks to provide bank stabilization.

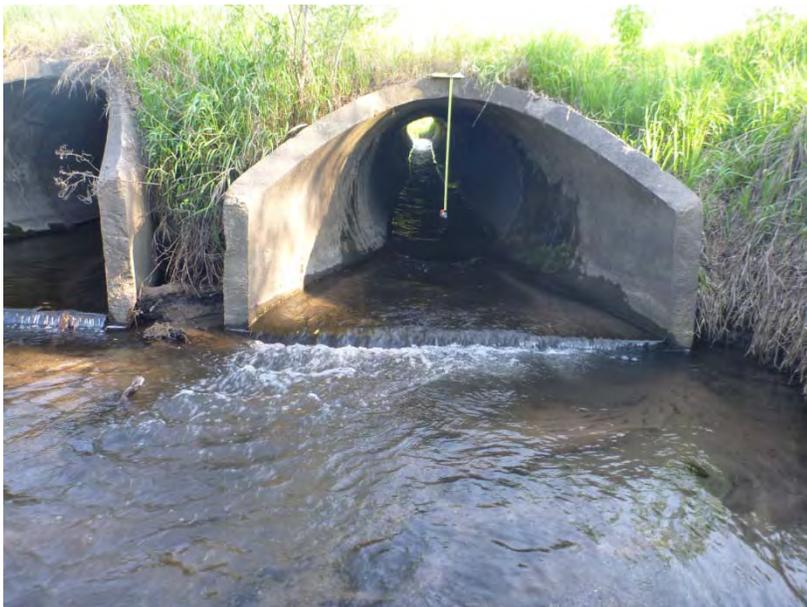
Stream: Empire Drainages, Tributary 2	Problem description: 2, 4.5-ft concrete pipes perched 0.5 ft on downstream end and very steep at upstream end. Fish passage barrier - depth, velocity, perched.
Station: 700: 200th St E	
Solution: Raise pool elevation at downstream end to backwater the culvert to provide improved fish passage. Replacing the culverts would be better, but more expensive. Could create small blockage at upstream end of one culvert so that low flows were directed into a single culvert providing additional depth for passage.

Looking upstream at perched culverts under 200th St E.

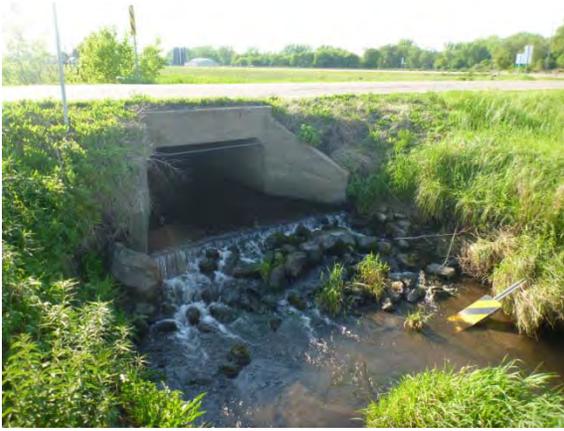
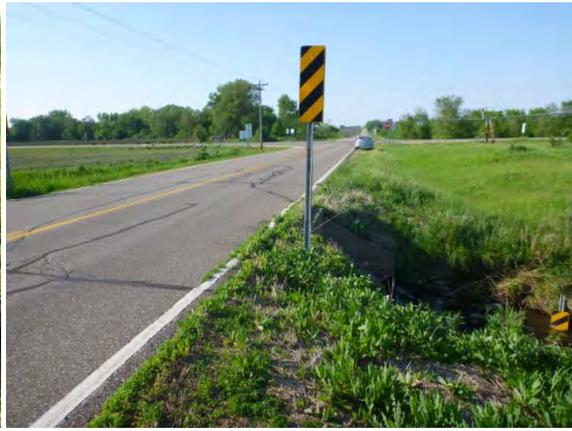
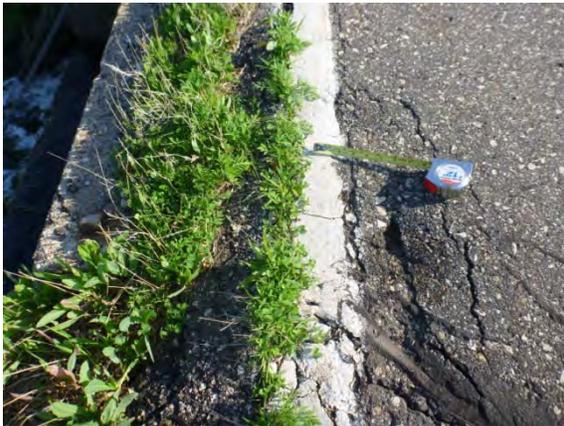
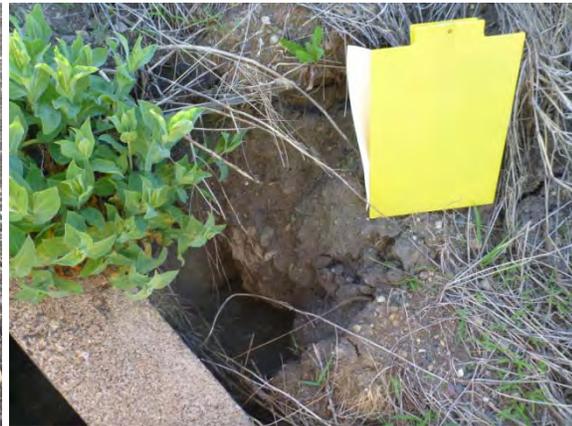
Stream: Empire Drainages, Tributary 2	Problem description: 8' x 4' concrete box culvert with flared wingwalls is cracked in many places; a 1-ft sinkhole has developed between the edge of the culvert and the road surface; the pavement in the road is cracked indicating undermining; the culvert is perched about 2 ft on the downstream end resulting in a fish passage barrier.
Station: 1100: Clayton Ave	
Solution: Replace culvert with a bridge, bottomless arch culvert, or larger box culvert. Ensure natural substrate on the bottom of the structure to enhance aquatic habitat and passage. This site should be assessed by a road/bridge engineer.

<b>Score</b>	<b>Notes</b>
<b>Infrastructure risk</b>	6	Holes and cracks developing near and in road.
<b>Erosion/channel stability</b>	3	
<b>Project complexity</b>	3	
<b>Location</b>	1	
<b>Sediment/nutrient loading</b>	1	
<b>Project cost</b>	3	
<b>Aesthetic impact</b>	1	
<b>Fish Passage</b>	5	
<b>Property Ownership</b>	3	
<b>Public Education</b>	3	
<b>In-stream Ecological Benefit</b>	3	
<b>Riparian Ecological Benefit</b>	1	
<b>Landuse Type</b>	5

Top left: looking upstream at perched culvert at Clayton Ave.

Top right: looking north along Clayton Ave.

Bottom left: cracks in road adjacent to culvert

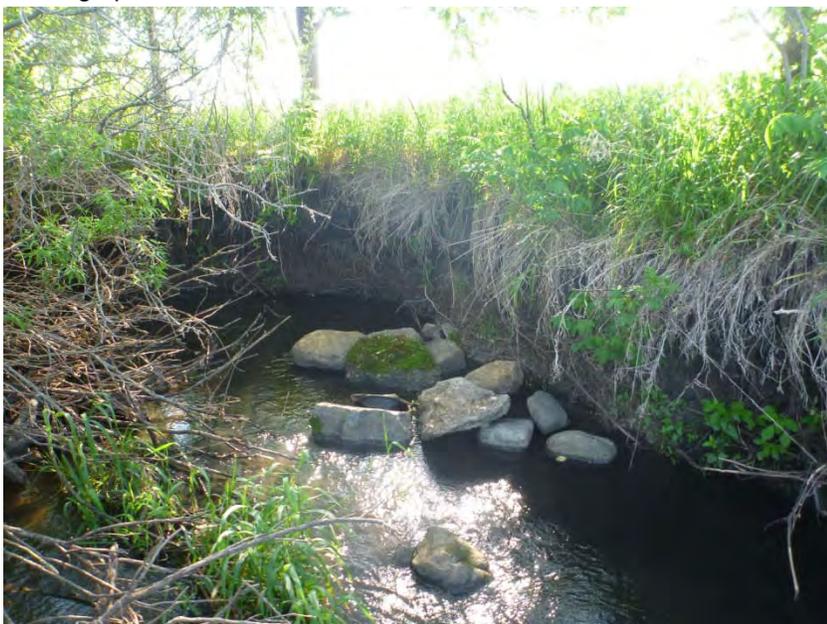
Looking upstream at bank erosion on left bank.

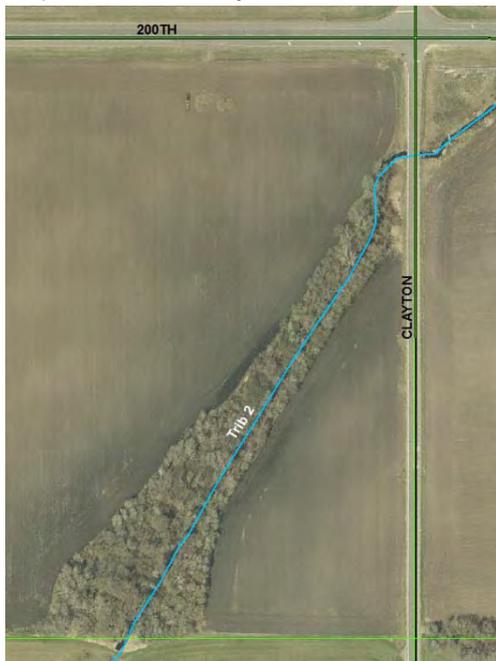
Stream: Empire Drainages, Tributary 2	Problem description: The channel is a straightened ditch with no geomorphic or habitat complexity.
Station: 0-12,000: entire tributary	
Solution: The entire tributary could be restored, but we recommend starting with the section of channel within the forested riparian corridor between Clayton Ave and 1200 ft upstream. Because the channel is incised, the channel could be raised to reactivate the floodplain and the sinuosity could be increased.

Air photo of Tributary 2 with the forested section upstream of Clayton Ave.

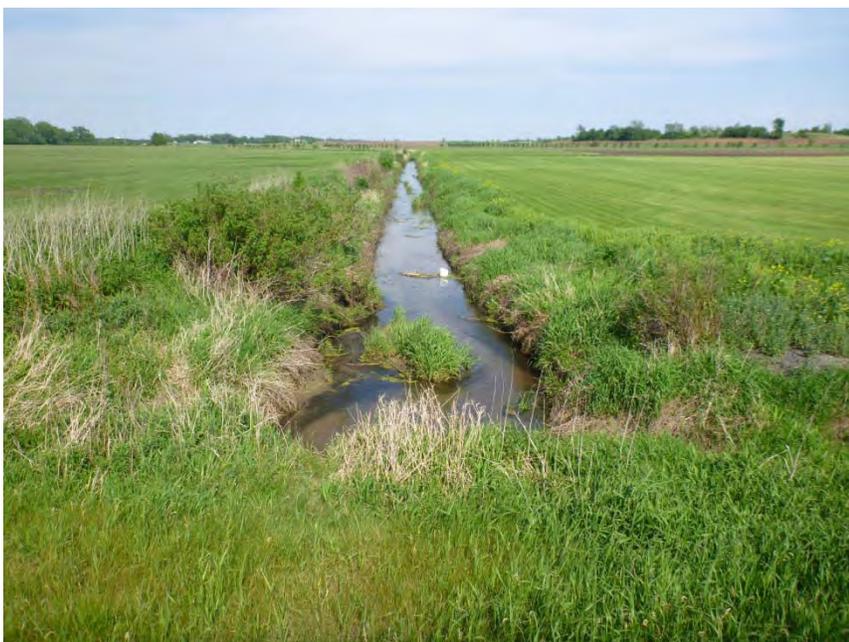
Channel with little buffer downstream of Blaine Ave.

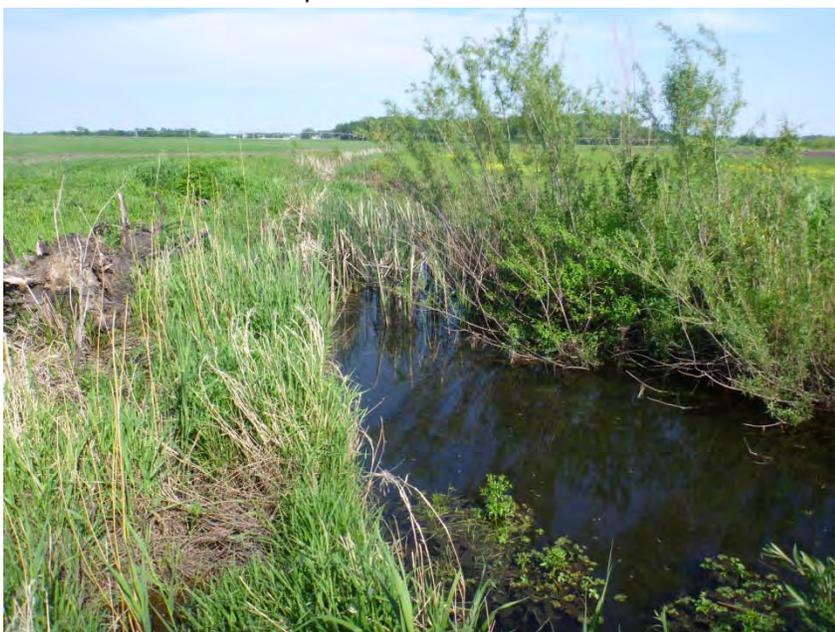
Channel with little buffer upstream of Blaine Ave.

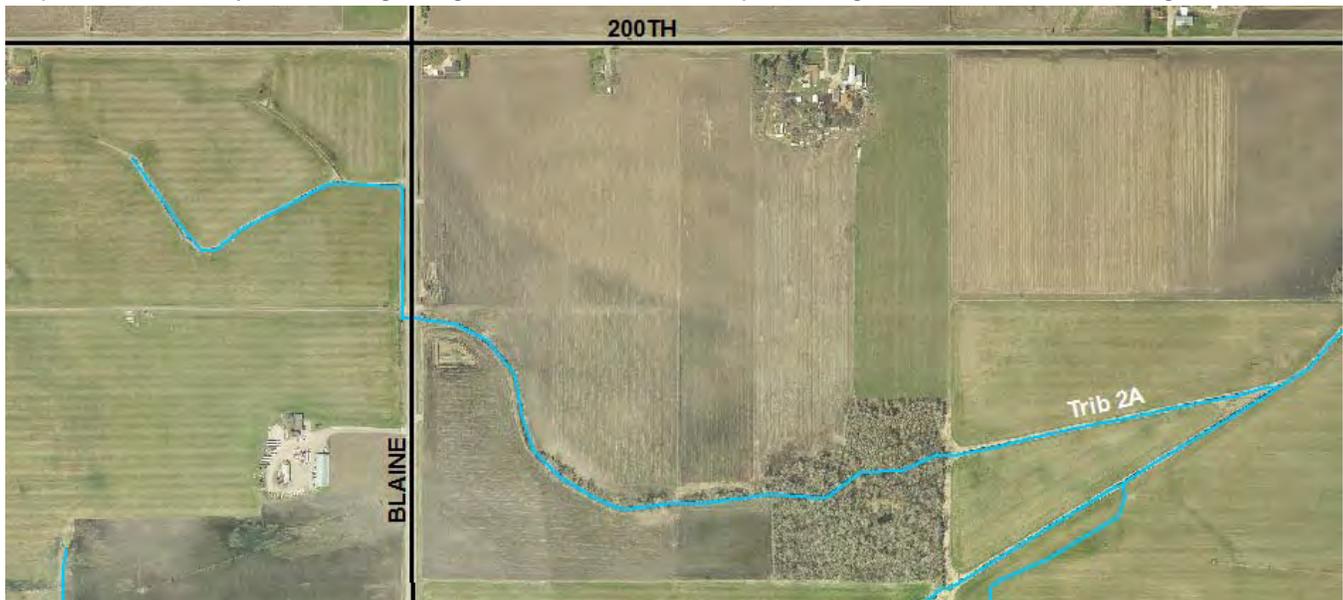
Air photo of Tributary 2A showing straightened ditch with little riparian vegetation for much of its length.
