Vermillion River Watershed Joint Powers Organization  
**Empire Drainages Geomorphic Assessment, Dakota  
County, MN: Final Report**

April 30, 2013

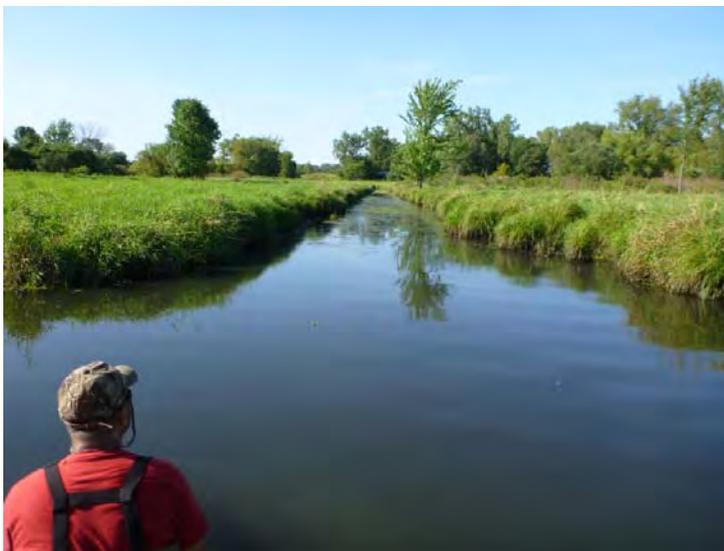
Stream: Vermillion Tributary 4	<b>Problem description:</b> Tributary 4 is contributing elevated water temperatures to the Vermillion River downstream of its confluence. Water temperatures were 10° F higher in the tributary than the mainstem. Increased water temperatures can be detrimental to aquatic habitat and water quality. The channel is straightened with no canopy cover.
Station: 0-5500	
<b>Solution:</b> Restore Tributary 4 to a more natural riparian corridor. Increase channel sinuosity, implement riparian stream plantings, increase wetted channel canopy, increase stream channel complexity, decrease nutrient loads to tributary.

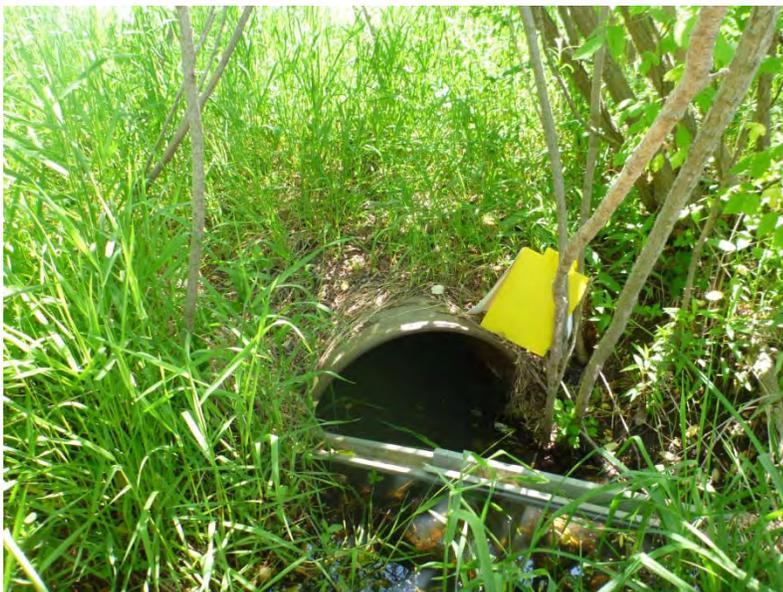
Culvert under Annette Ave.

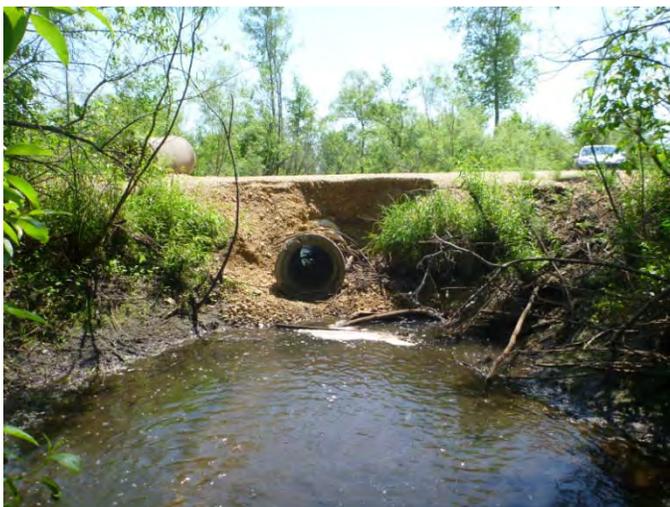
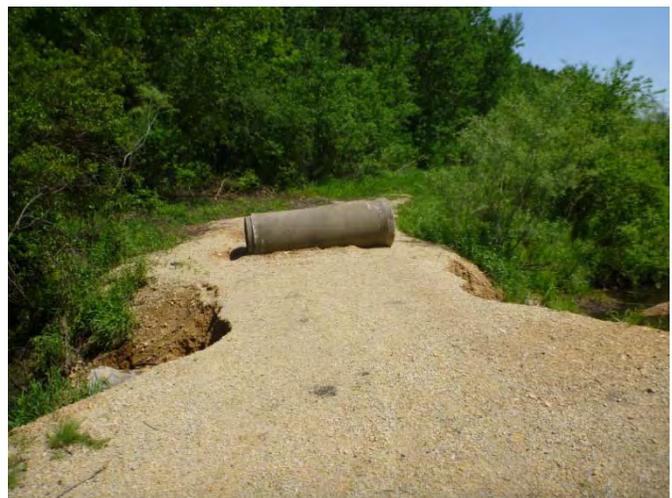
Washed out dirt road and culvert.

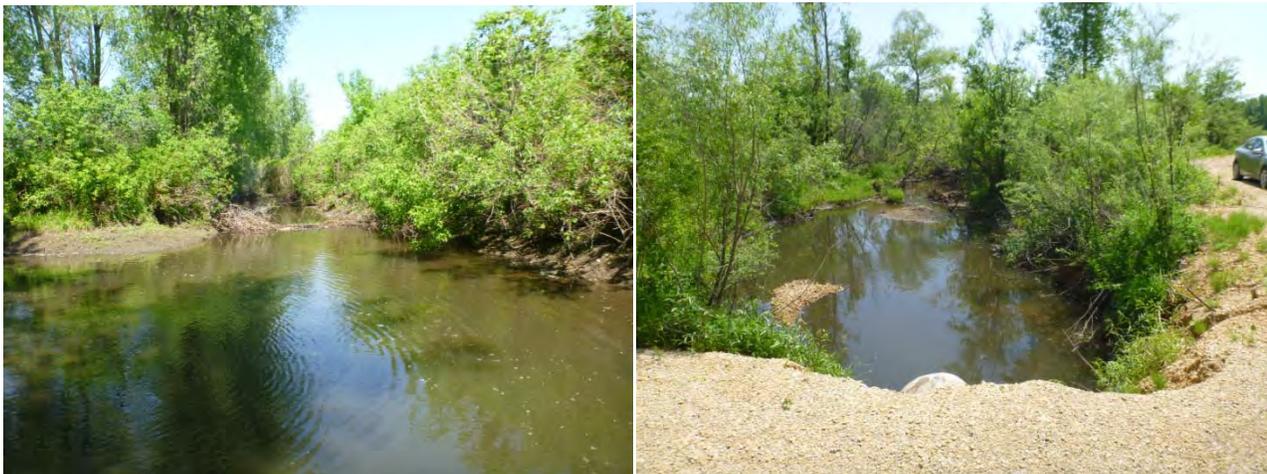
Stream: Empire Drainages, Tributary 5	Problem description: Entire channel is a straightened ditch and much of it has only a narrow riparian buffer.
Station: 0-5600: Entire tributary	
Solution: Entire tributary is within state lands, so this could be good opportunity to restore an entire tributary to natural planform and provide recreational opportunities for residents (trails, birdwatching, etc.). Complete channel restoration with increased sinuosity, reduction of channel width, creation of active floodplain, and planting of native trees and shrubs along expanded riparian buffer

(Left) Looking upstream at channel upstream of Annette Ave; (right) looking downstream at channel downstream of washed out dirt road.

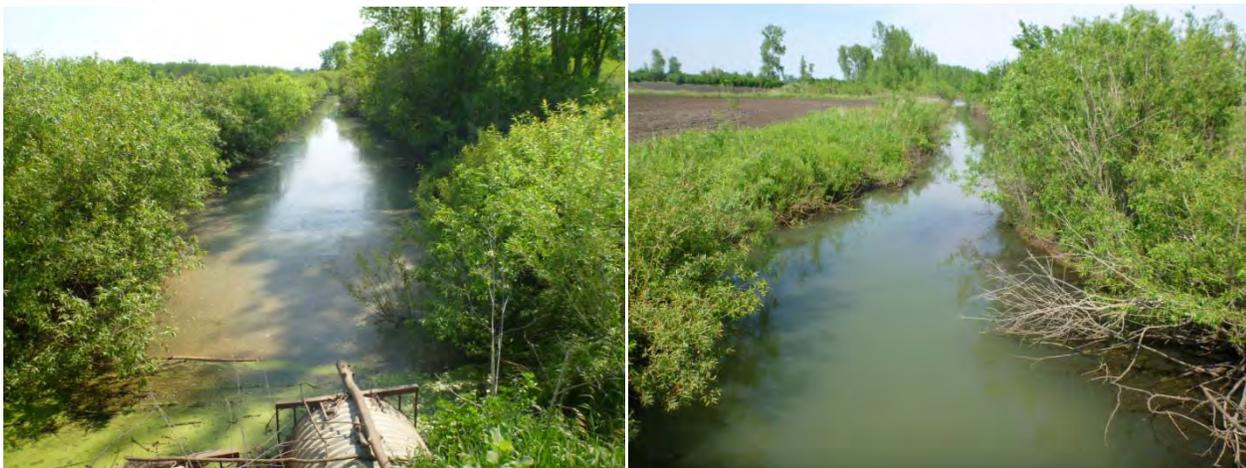
Stream: Empire Drainages, Tributary 6	Problem description: Entire channel is a straightened ditch and much of it has only a narrow riparian buffer. Water quality in upper half of channel is poor - lack of infiltration and riparian buffer may be cause.
Station: 0-17,100: Entire tributary	
Solution: Completely reconstruct natural channel and wetland within reasonable easement width between farm fields. Increase sinuosity, provide floodplain/wetland flooding, and plant native trees and shrubs to provide sufficient riparian buffer width (PP42).

(Left) Looking upstream and (right) looking downstream at channel at 210th St W.

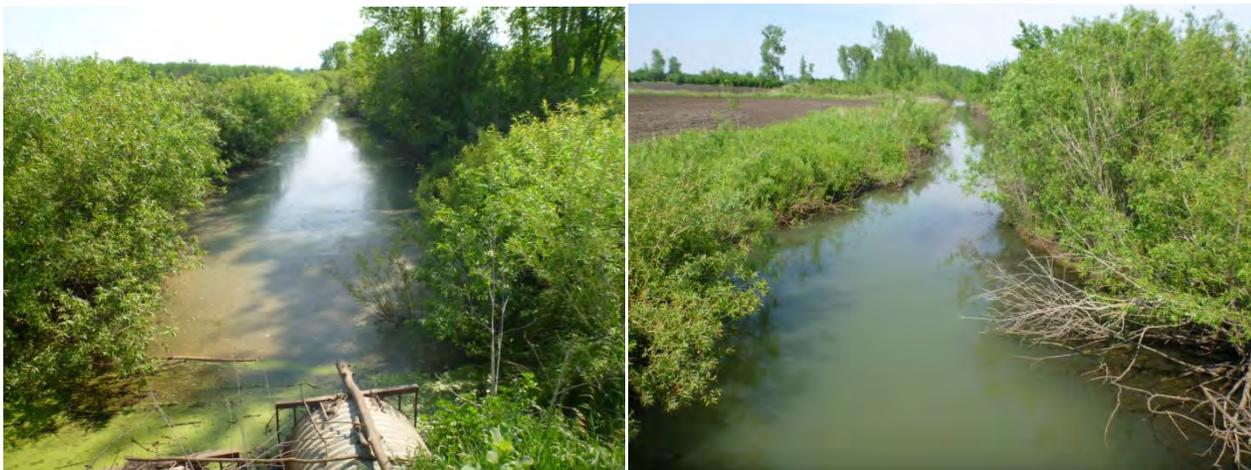
Stream: Empire Drainages, Tributary 6	Problem description: Only a narrow riparian buffer through majority of tributary length. Water quality in upper half of channel is poor - lack of infiltration and riparian buffer may be cause.
Station: 0-17,100: Entire tributary	
Solution: Enforce wider riparian buffer and plant native trees and shrubs.

(Left) Looking upstream and (right) looking downstream at channel at 210th St W.

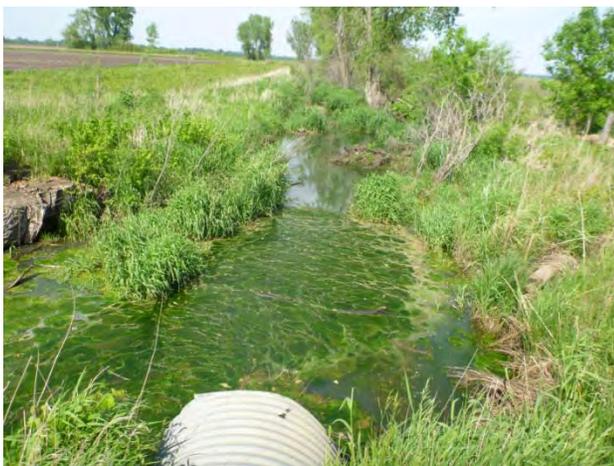
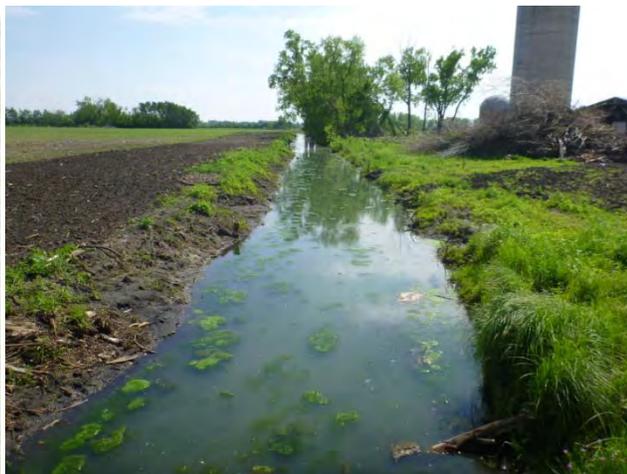
Stream: Empire Drainages, Tributary 6A	Problem description: Entire channel is a straightened ditch and much of it has only a narrow riparian buffer. Water quality in upper half of channel is poor - farm chemicals/nutrients and lack of infiltration and riparian buffer may be cause.
Station: 0-13,600: Entire tributary	
Solution: Completely reconstruct natural channel and wetland within reasonable easement width between farm fields. Increase sinuosity, provide floodplain/wetland flooding, and plant native trees and shrubs to provide sufficient riparian buffer width (PP44).

(Left) Looking downstream and (right) looking upstream at channel at 210th St W.

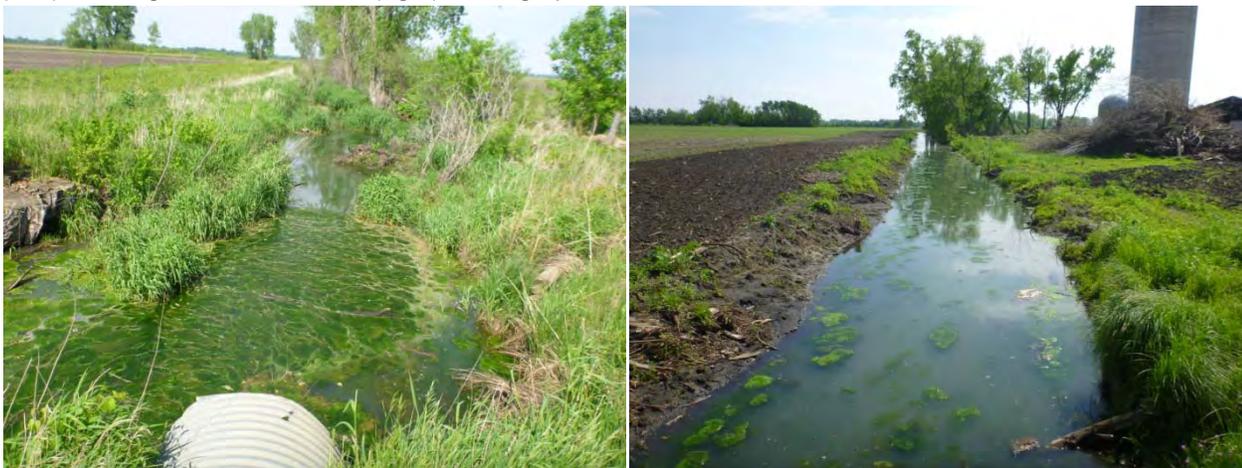
Stream: Empire Drainages, Tributary 6A	Problem description: Only a narrow riparian buffer through entirety of tributary length. Water quality in upper half of channel is poor - farm chemicals/nutrients and lack of infiltration and riparian buffer may be cause.
Station: 0-13,600: Entire tributary	
Solution: Enforce wider riparian buffer and plant native trees and shrubs. Identify source of poor water quality and fix.

(Left) Looking downstream and (right) looking upstream at channel at 210th St W.

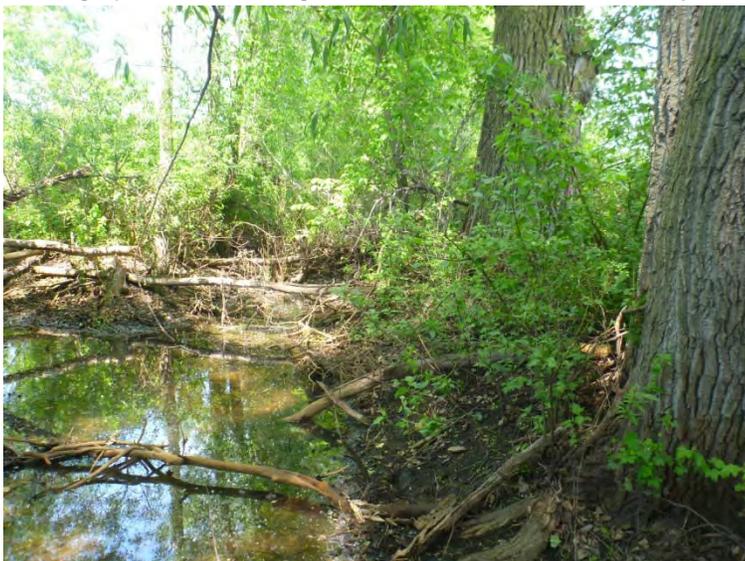
Looking upstream at straightened channel filled with woody debris and large cottonwoods growing on floodplain.

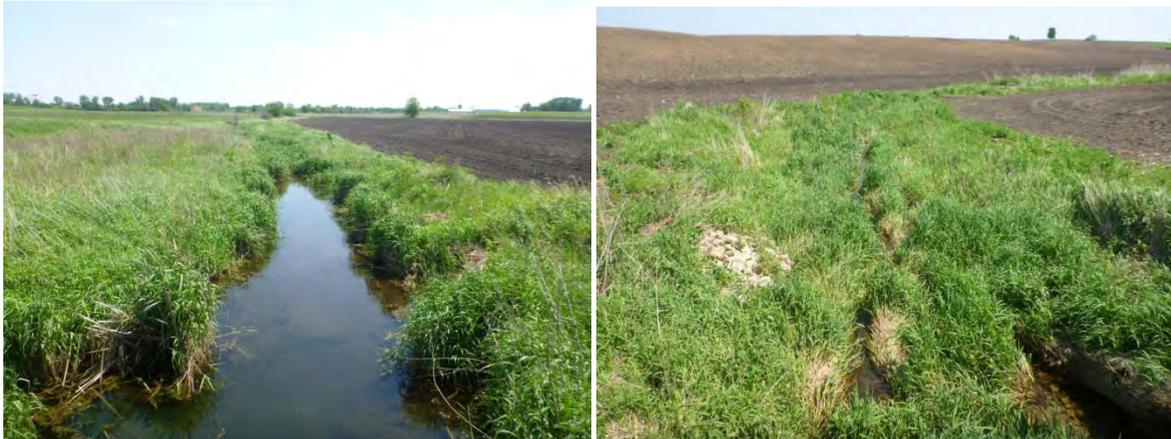
Stream: Empire Drainages, Tributary 7	Problem description: Narrow riparian buffer with few trees provides limited infiltration of overland flow. Buffer ranges from 5 to 20 ft in width and is primarily composed of grasses with some cottonwoods and willows.
Station: 4300-12,900: upper half of watershed	
Solution: Enforce wider riparian buffer with increased tree and shrub planting to provide shade and improved riparian habitat.

(Left) Looking downstream from 190th St W; (right) looking downstream from Biscayne Ave.

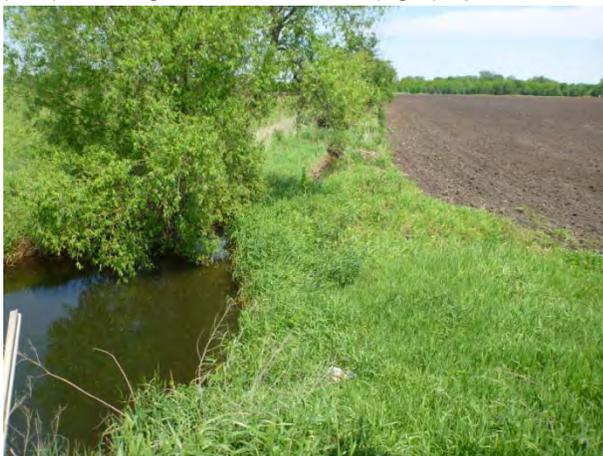
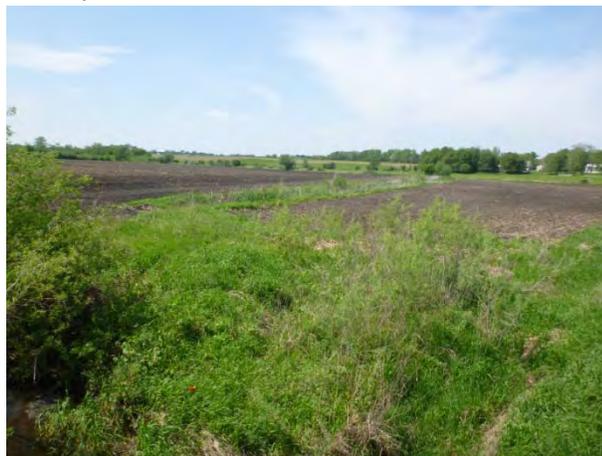
Stream: Empire Drainages, Tributary 8	Problem description: Very narrow riparian buffer does not provide sufficient channel or riparian shading, habitat, or infiltration.
Station: 0-14,200: Entire tributary	
Solution: Enforce a wider riparian buffer and plant native trees and shrubs throughout.

(Left) Looking downstream and (right) upstream from Biscayne Ave.s
