Vermillion River Watershed Joint Powers Organization
**Fluvial Geomorphic Assessment of Etter Creek and the
Ravenna Coulees, Dakota County, MN: Final Report**

February 25, 2011

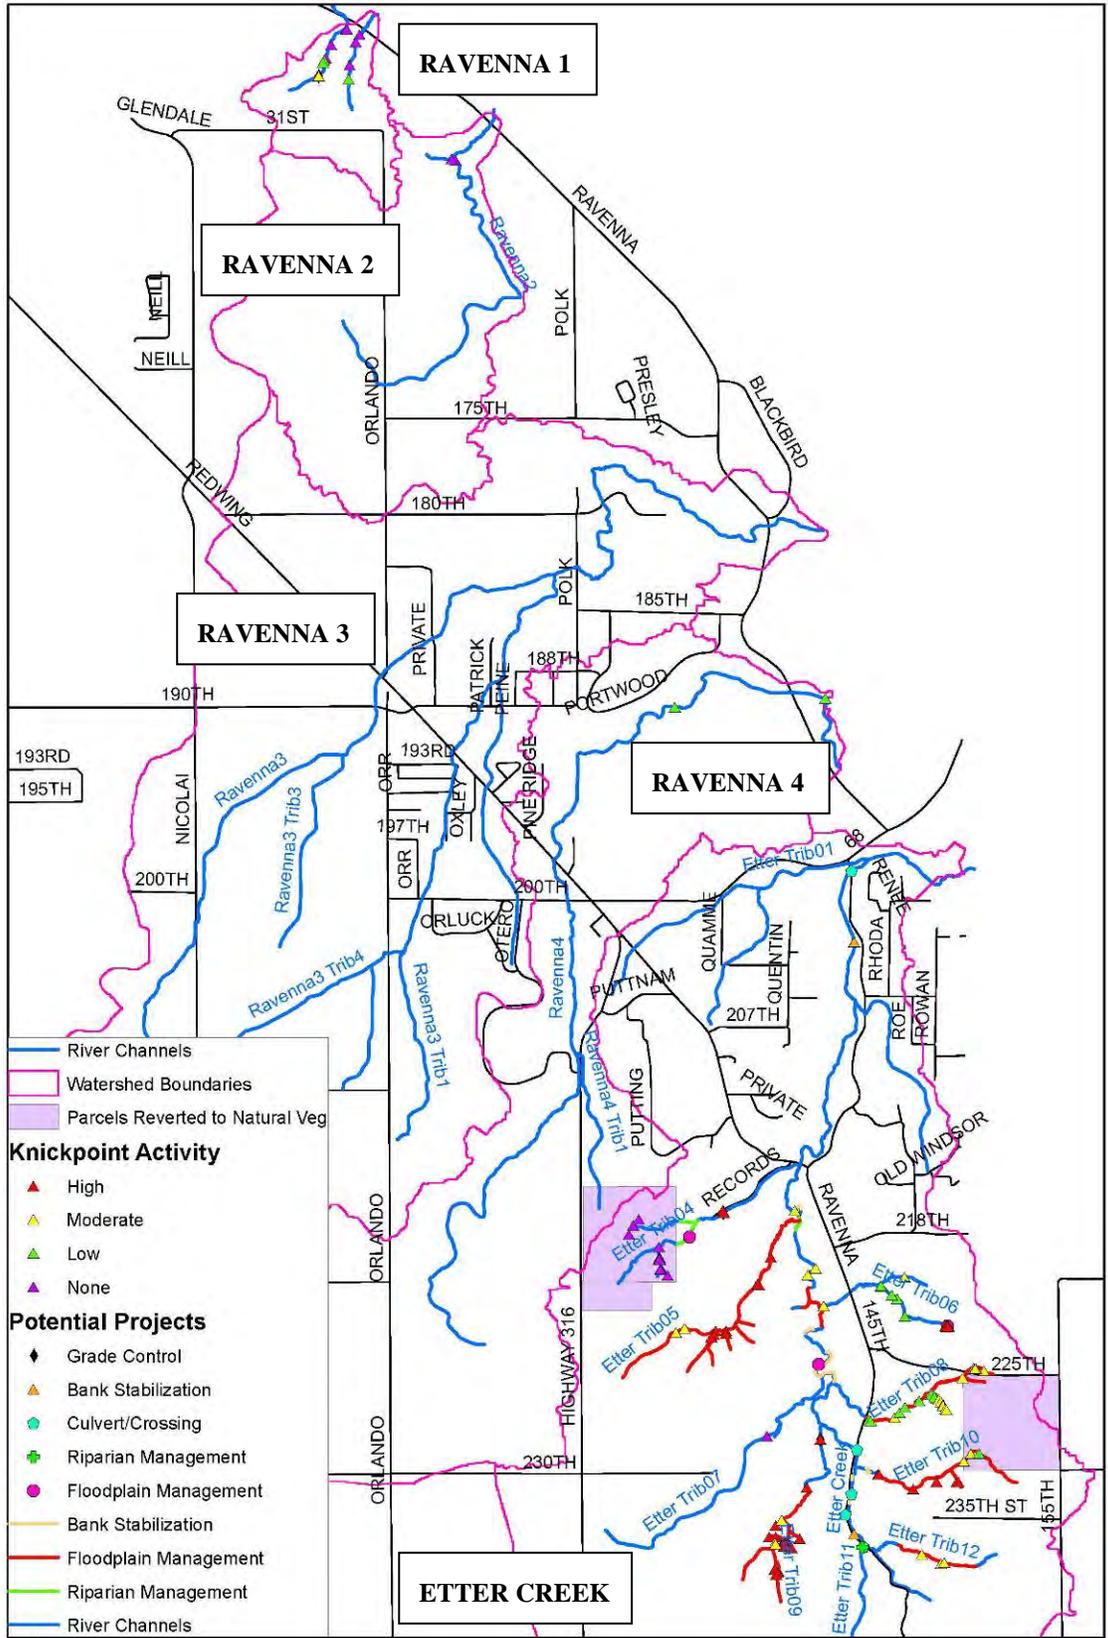
Figure 4: Overview of potential projects and knickpoints in the study area.

We identified 29 problem areas in the Etter Creek and Ravenna Coulee subwatersheds; 28 of these potential projects are located in the Etter Creek subwatershed and one is located in Ravenna Coulee 1 (Table 2, Figure 4; see Appendix F for full scoring spreadsheets; see Appendix G for detailed maps). We will focus our discussion in this section on the Etter Creek subwatershed, and in particular the upper portion of the subwatershed, because this is where most of the projects are located.

The majority of projects along the Etter Creek mainstem were bank stabilization and road crossing projects; along the tributaries, floodplain and riparian management projects made up nine of the 13 projects (see Appendix B for discussion of project types). The highest scoring projects, and thus highest priority, are floodplain and riparian management projects that involve long portions of channel or entire subwatersheds.

We recommend addressing the higher scoring projects in two phases. Although the Phase 1 projects can be completed more quickly, we recommend starting both Phases concurrently as Phase 2 addresses the root cause of most of the problems and will take years to complete. Phase 1 addresses short-term issues that have the potential to impact infrastructure such as roads, culverts, and driveways within a few years. This phase includes the following priority projects (PP):

- PP10 - 40 points - bank erosion on Etter Creek between Stn 26,950 and 27,050 that is within 10 ft of 145th Ave
- PP15 - 40 points - bank erosion on Etter Creek at Stn 28,650 that is within 8 ft of 145th Ave
- PP14 - 40 points - culvert under 145th Ave for a drainage that flows into Etter Creek at Stn 28,050; erosion around the culvert threatens the road
- PP11 - 33 points - culvert under a private driveway at Stn 27,450; the pipe is corroded and the concrete is severely cracked

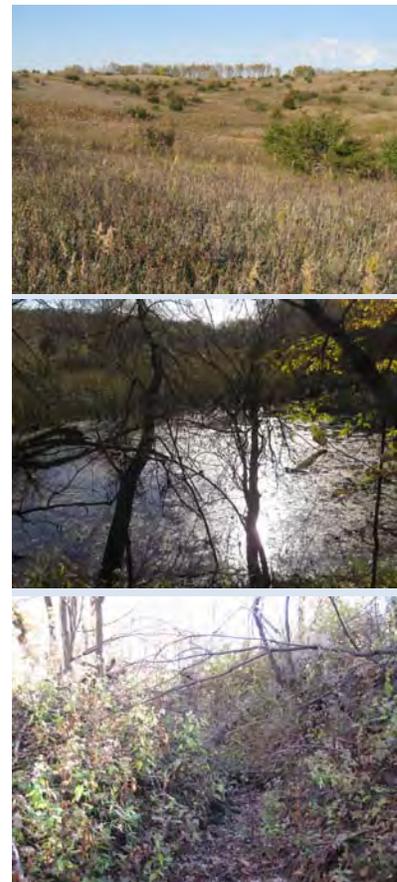
Retention basins are created by building a small dam with a high-flow discharge pipe; these are designed to store runoff from rain or snow-melt events and allow the water to infiltrate rather than flow downstream. These have been effective in a few locations in the Etter Creek subwatershed (Figure 8). We identified locations where retention basins could be built to

Converting erodible cropland to other vegetative cover such as native grasses, prairie grasses, and native shrubs and trees can be very effective in slowing the flow of water to stream channels. Sufficient ground cover slows the flow of water and encourages infiltration and the roots from the plants stabilize the soil. The Conservation Reserve Program, administered by the NRCS, is active in Dakota and neighboring Counties and is an effective way of encouraging farmers to make this conversion. A few parcels have been converted to native grasses and shrubs in the Etter Creek subwatershed (Figure 6). Our on-the-ground assessment and discussions with downstream landowners confirmed that this type of management, combined with retention basins, can be very effective at limiting stormwater flow and minimizing downstream degradation (Figure 8).

Figure 8: In the headwaters of Etter Creek Tributary 4, row crops were converted to native vegetation (top), a retention basin was built (middle), and previously active knickpoints are now inactive and obscured by vegetation.

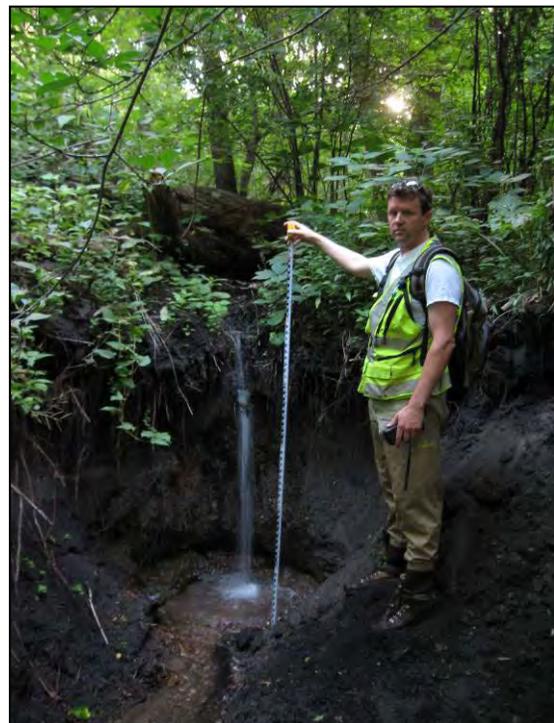
Figure A-2: A headcut and incised channel on a small stream in Scott County.

Vertical instability often follows a certain pattern whereby changes in the bed elevation of a stream are translated upstream through a series of small vertical drops called *knickpoints* or *headcuts*. This situation can arise from the straightening of streams and an associated decrease in channel length or by direct changes in the bed elevation of a stream (eg. improper road crossing installation or decreased bed elevation in a main channel). This process of downcutting is called *incision*. A waterfall would be an extreme example of a knickpoint in bedrock. As a headcut moves upstream, the stream becomes more incised and the flood energy increases as more and more volume is confined to an incised or *entrenched* channel (Figure A-2). Whereas prior to incision, the stream was able to dissipate its energy over a wide floodplain, after incision this energy is concentrated. Following incision, the stream typically begins to erode laterally with the end result being new floodplain formation at a lower grade. The Schumm channel evolution model demonstrates how a headcut creates an incised channel that becomes laterally unstable and eventually forms a new stable channel at a lower elevation (Figure A-3).

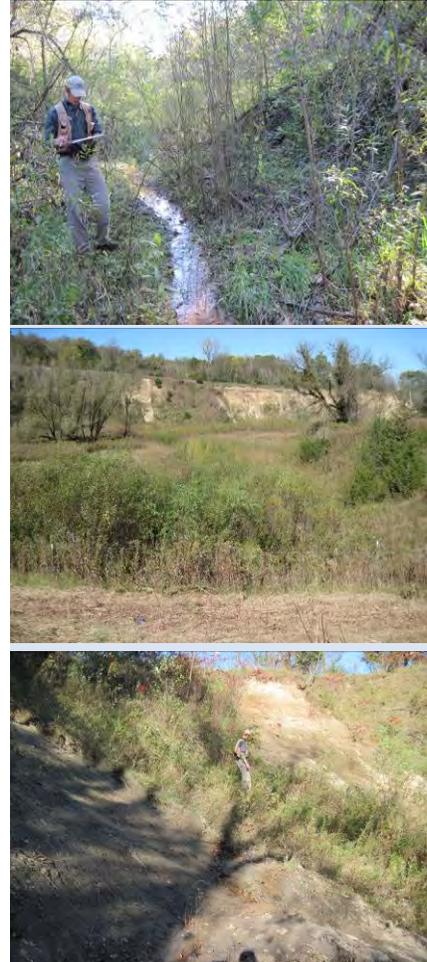
There is evidence of past incision of the channel. The current stream channel is 4-8ft below the floodplain surface and valley floor, but in the past, the channel was likely a shallow swale. We identified multiple small (0.5-1ft) knickpoints throughout the reach, which suggests that minor incision continues to occur. Etter Creek has incised to limestone in a few locations, and this will likely slow or halt the incision.

Figure C-3: Etter Creek, Reach 3 (Top) Stn 14,500 looking upstream; (middle) Stn 13,800 looking downstream at restored channel; (bottom) Stn 15,700 looking upstream at eroding bluff.

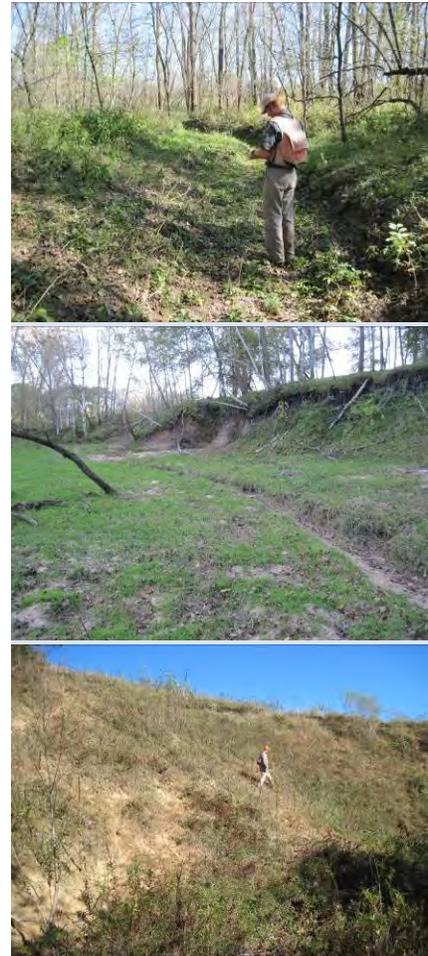
At stations 20,350-20,600, the 25-50ft bluff on the left side of the channel is eroding (Figure C-4). There is some vegetation stabilizing the hillside but no trees to stabilize, and crops are growing only 30ft from the edge of the slope.

The 8-10ft banks at stations 21,500-23,200 are eroding, and there is very little buffer between crops and the channel. At station 21,950, a small drainage enters on the left side of channel and has incised about 150ft up its drainage. A 4-ft knickpoint is actively moving upstream. Finally, at

Figure C-4: Etter Creek, Reach 4 (Top) Stn 23,750 looking downstream; (middle) Stn 18,750 looking upstream at grazing and eroding hillslopes; (bottom) Stn 20,550 looking downstream at eroding bluff.

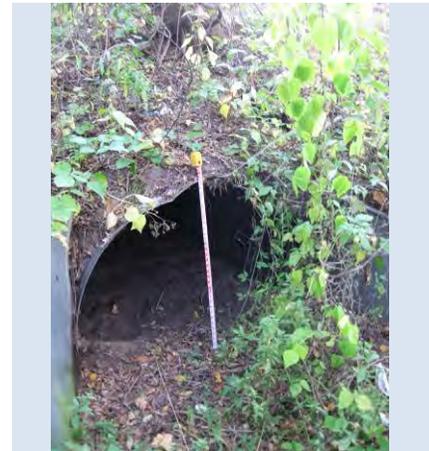
Figure C-6: Etter Creek, Tributary 1 (Top) Stn 4,450 looking upstream at partially filled culvert.

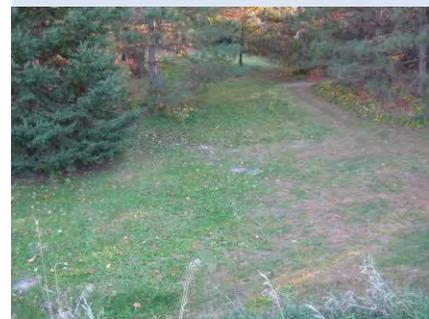
Tributary 2 of Etter Creek is 4600ft long and flows into Tributary 1. It has very similar attributes as Tributary 1: Tributary 2 is a shallow swale or is undetectable in yards as part of the mowed lawn (Figure C-7). When the swale goes through wooded areas, the predominant species are ash and oak, with some buckthorn and other saplings. One culvert at station 2800 indicates occasional water flow, and this 4ft corrugated

Figure C-7: Etter Creek, Tributary 2 Stn 2,800 looking upstream at mowed 'channel'.

metal pipe is partially filled with 2ft of sand. This tributary is stable and no restoration projects were identified.

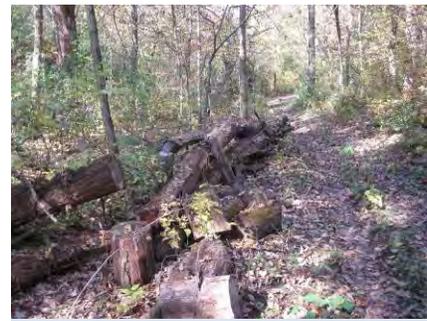
Figure C-8: Etter Creek, Tributary 3 Stn 5,300 looking downstream at trail/channel.

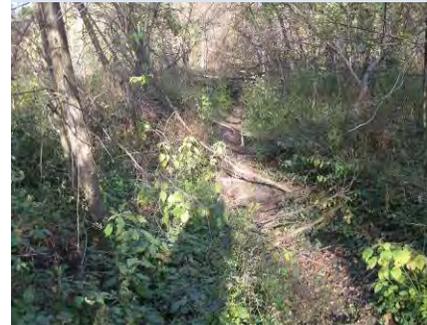
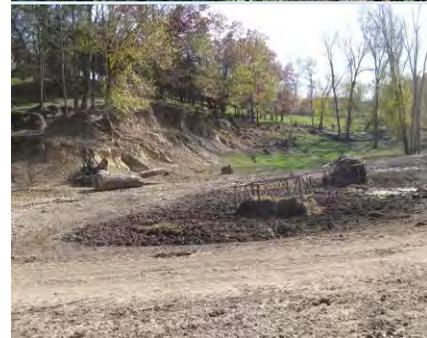
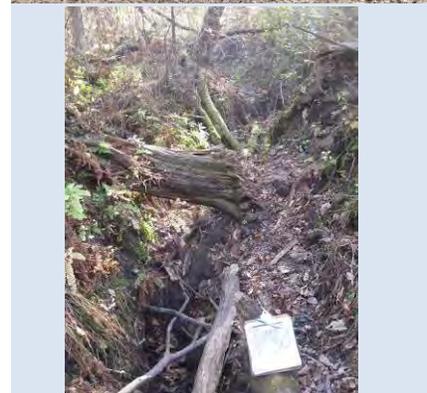
Figure C-9: Etter Creek, Tributary 4 (Top) Stn 1,900 looking downstream; (middle) Stn 3,550 looking upstream at eroding slopes; (bottom) Stn 0 of Drainage 2 looking upstream at inactive knickpoint.

Incision is working through Tributary 4 and its associated drainages, though land use changes and active management in the headwaters have decreased problems in the upper portion of the subwatershed. We observed knickpoints sporadically along Tributary 4, Drainages 1 and 2, and the upper portions of the North Drainage. The knickpoint at station 2600 is actively migrating upstream, and a portion of this knickpoint is within a few feet of Records Trail. Active cattle grazing has reduced the vegetation throughout the valley bottom and hillslopes in the middle portion of Tributary 4, and the hillslopes are badly eroding. Old detention basins at station 3850 of Tributary 4 and 400 of the North Drainage may have previously helped stem some of the erosion and incision. As the land surrounding the headwaters stopped being farmed and a new retention basin and 20-ft earthen dam was created at station 6550, incision and erosion between the headwaters and station 4300 has been stemmed. The knickpoints in the headwaters, though noticeable, are vegetated and do not appear active (Figure C-9). The channels are obscured by vegetation in this area, and we saw no evidence of recent erosion.

We recommend that this entire subwatershed be managed to control the actively migrating knickpoints and excessive erosion. The knickpoints may impact agriculture, and the incision and bank failure is the source of much of the sediment found in Etter Creek. Fixing individual knickpoints may temporarily halt incision, but long-term solutions should likely involve a combination of management practices: changes in farming practices, conversion of fields to native vegetation, construction of retention basins, stabilizing the channel and banks in select places.

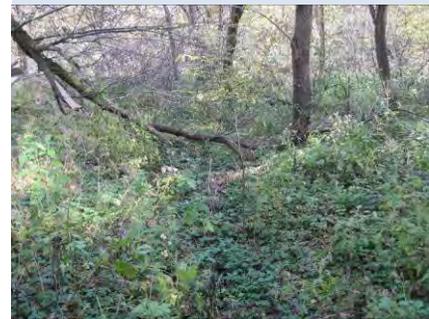
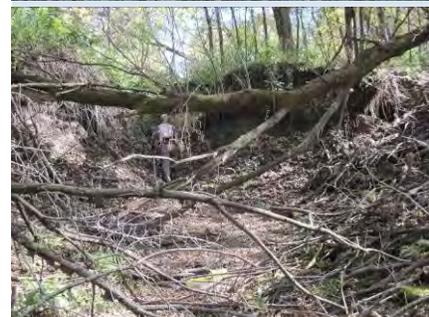
Figure C-12: Etter Creek, Tributary 6, Reach 2; (Top) Stn 1,750 looking upstream; (bottom) Stn 4,500 looking upstream at

these actions appear to have created knickpoints on the sides of the channel as well. This incision is resulting in excessive bank erosion and sedimentation (Figure C-12).

We recommend management of the 8-11ft knickpoints at station 4400-4500. These knickpoints are active, nearing open fields, and resulting in bank erosion and sedimentation. An increased riparian buffer upstream of these knickpoints, or a retention basin to capture runoff would help stem the incision and bank erosion.

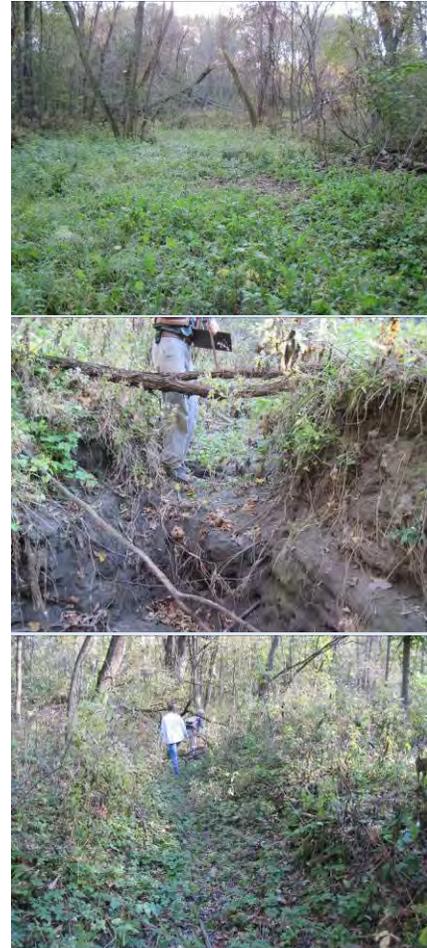
Tributary 8 of Etter Creek is 5800ft long and enters Etter Creek at station 23,250. The tributary contains two drainages in the upper portions of the subwatershed. Drainage 1 drains agriculture fields, contains multiple knickpoints, and flows into Tributary 8 at station 3650. Drainage 2 also drains fields, but it is not as steep as Drainage 1, so knickpoints are not as problematic. Drainage 2 reaches the mainstem at station 4800. The section of Tributary 8 that is upstream of 145th Ave. flows through steep hillslopes and contains small knickpoints that range in height from 1-6ft (Figure C-15). Knickpoints often stop at tree roots, but continue to be found further upstream. In this section, the bankfull width is 8ft and the depth is 4-6ft. The steep banks are made up of silty loam, and the channel bed is sand and silt. Downstream of 145th Ave., the channel is difficult to detect, and the alluvial valley appears to have been an area where eroded sediment from the headwaters is deposited (Figure C-15).

Figure C-15: Etter Creek, Tributary 8 (Top) Stn 1,100 looking upstream; (middle) Stn 3,700 looking upstream; (bottom) Stn 3,900 looking upstream .

Our recommended projects focus on the knickpoints between stations 1500-5800. These knickpoints are nearing farm fields and will continue to migrate unless retention is improved and stormwater can infiltrate before it reaches the stream.

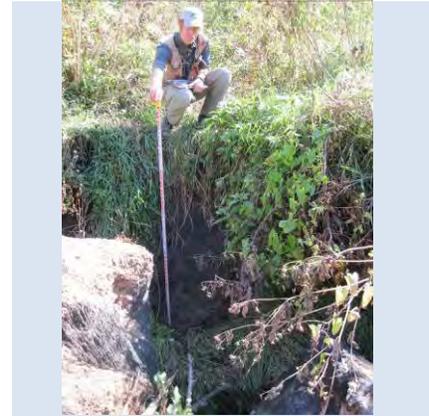
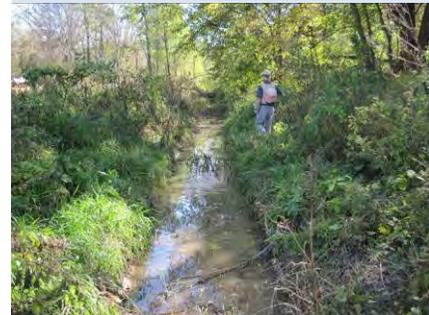
Reach 1 of Tributary 9 is 1600ft long and enters Etter Creek at station 24,850. It is a straightened reach that primarily flows through agriculture fields (Figure C-16). It is mostly a flat reach that is located at the base of surrounding steep hills. The upper portion of the reach does flow through a wooded area that characterizes reach 2. An active knickpoint, resulting from the lowering of Etter Creek, has begun migrating into the agriculture fields and landowners have subsequently dumped woody debris, sawdust, and other materials into the hole created (Figure C-16). Where incised, the banks are nearly vertical and made of fine silt and clay, and the bankfull width and depth are 8ft and 6ft respectively. Upstream where there is less incision, the channel is a shallow swale with a bankfull width of 9ft and depth of 3ft. This incision will likely continue upstream, however, unless management actions are taken.

Figure C-16: Etter Creek, Tributary 9, Reach 1 (Top) Stn 450 looking upstream at knickpoint; (bottom) Stn 850 looking upstream .

We recommend stabilizing the knickpoint at station 450. Floodplain and riparian management upstream in reach 2 to reduce the volume of water flowing downstream will help stem upstream migration of this knickpoint, but immediate stabilization may help reduce loss of fields.

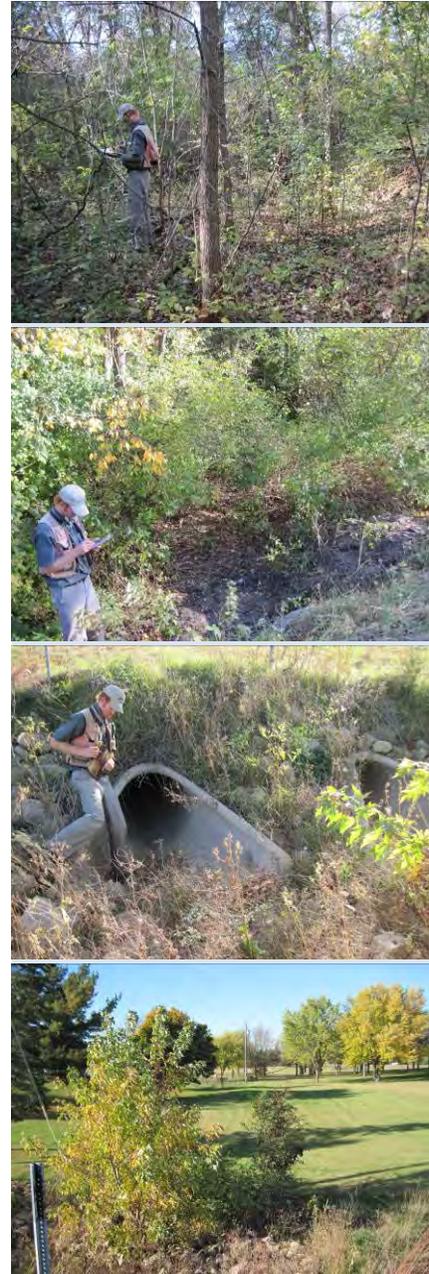
Figure C-23: Ravenna Coulee 3 (top to bottom): Reach 1, Stn 3,700 looking upstream; Reach 1, Stn 8,950 looking upstream; Reach 2, Stn 20,450 looking at culverts under 190th St; Reach 2, Stn 20,450 looking downstream.

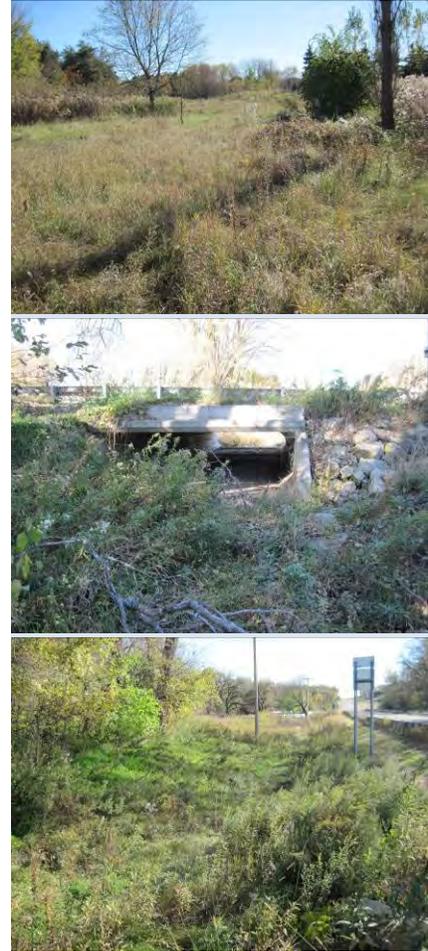
There is a large concrete box culvert at station 20,700, which looks new and in good condition (Figure C-26). The size of this culvert indicates that large quantities of water can move through the channel. We do not recommend any restoration projects for this reach.

Figure C-26: Ravenna Coulee 4, (Top) Reach 2, Stn 14,450 looking upstream; (middle) Reach 3, Stn 20,750 looking downstream; (bottom) Tributary 1, Stn 200 looking upstream at roadside ditch.

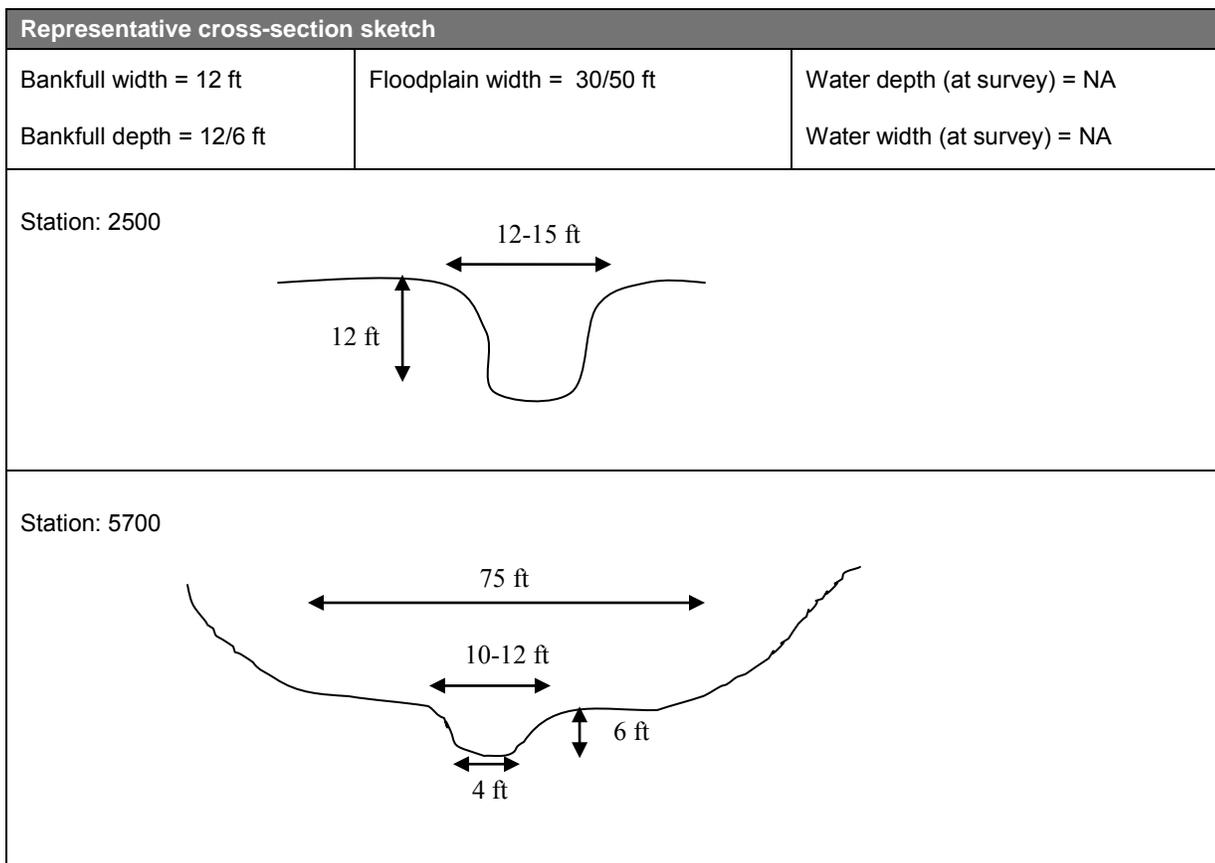
Channel Stability Form - INCISED SECTION DOWNSTREAM OF STN 2600; UPSTREAM CHANNEL IS STABLE

Reach stability		1-2 Degrading		3 Stable		4-5 Aggrading
Estimated sediment mobility (D50 moves at:)	<2yr Q	1	2-10 yr		>10 yr	
Substrate consolidation	Strong, gravels/cobble		Strong, gravels		Weak, sand/silt	4
Bank failure mechanism	High banks, grav. collapse, variable channel width	1	Localized surficial erosion, constant width		Low banks, overflows, surficial erosion	
Bar development	Poorly formed	1	Narrow, vegetated		Wide (>1/2 channel length), unveg.	
Bank erosion extent	Extensive	2	Local erosion/pools		Extensive bar pressure	
Relative Width:Depth ratio	Low	1	Average		High	
Channel pattern	Single thread	1	Single thread		Multiple thread/braided	
Average bank slope	<3:1	1	>3:1			
Vegetative bank protection	Poor	1	Extensive		Poor	
Field stability rating (add all cells)/9		= 13/9 = 1.44

This subwatershed is made up of the mainstem of Tributary 4, the North Drainage that flows into the mainstem at Stn 3500, and two drainages that flow into the mainstem at Stn 4900. Incision is working through Tributary 4 and associated drainages, though land use changes and active management in the headwaters has decreased problems in the upper portion of the subwatershed. A 12-ft knickpoint at Stn 2600 is actively migrating upstream and a portion of this knickpoint is within a few feet of Records Trail. Upstream of this point, active cattle grazing has reduced the vegetation throughout the valley bottom and hillslopes to short grass and a few tall trees. The hillslopes are eroding badly through this middle portion of Trib 4 and the beginning of the North Drainage. Old detention basins on Trib 4 and on the North Drainage may have helped stem some of the erosion and incision in the past. Upstream of these basins, and upstream of the cattle grazing, the valley bottom and hillslopes are heavily forested. Knickpoints were observed sporadically along Trib 4, Drainages 1 and 2, and where the North Drainage began to erode into agriculture fields. However, the land surrounding the headwaters is no longer farmed and is made up of native grasses and shrubs. This land use change, along with a newer retention basin at the upper extent of Trib 4 has stemmed the incision and erosion between the headwaters and the farm with active cattle grazing. The knickpoints in the headwaters, though noticeable, were vegetated and did not appear active. No evidence of recent erosion was observed and the channels were obscured by vegetation.

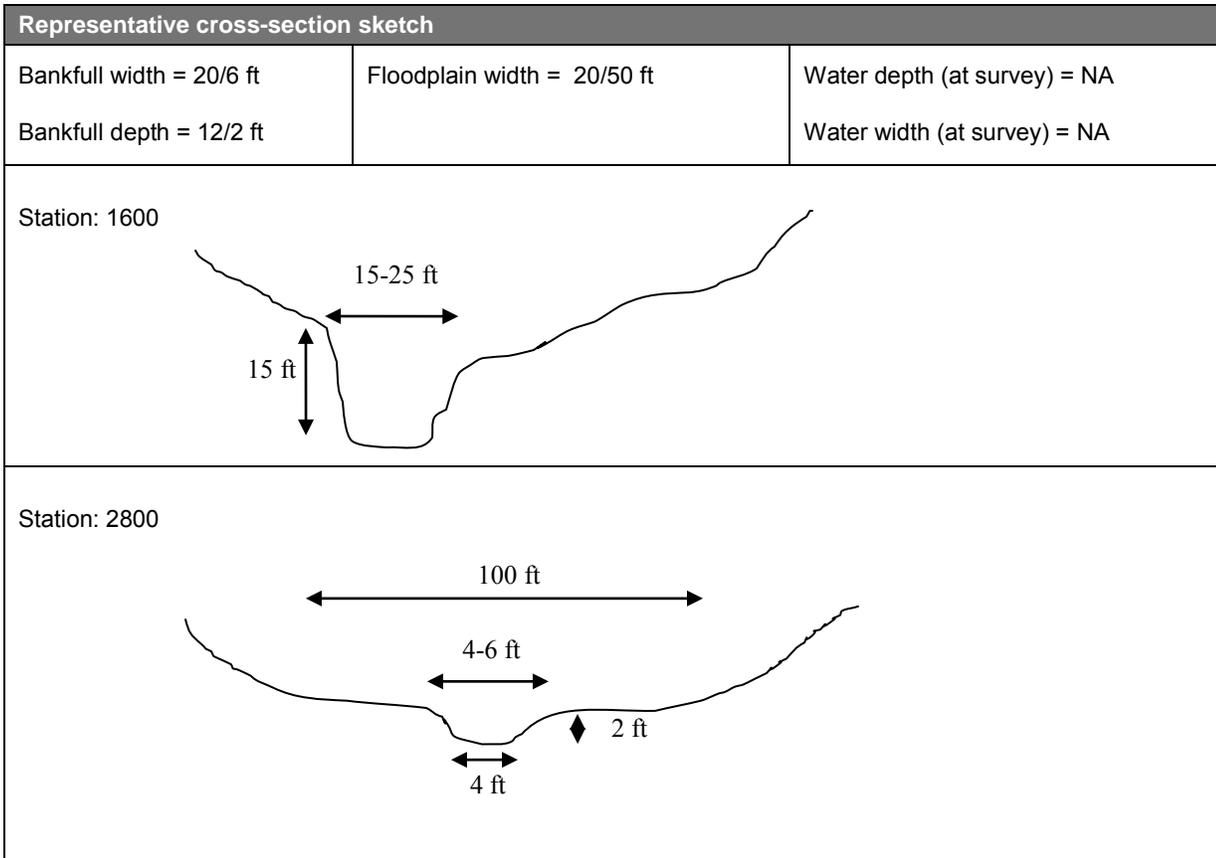
Reach stability		1-2 Degrading		3 Stable		4-5 Aggrading
Estimated sediment mobility (D50 moves at:)	<2yr Q	1	2-10 yr		>10 yr	
Substrate consolidation	Strong, gravels/cobble		Strong, gravels		Weak, sand/silt	4
Bank failure mechanism	High banks, grav. collapse, variable channel width	1	Localized surficial erosion, constant width		Low banks, overflows, surficial erosion	
Bar development	Poorly formed	1	Narrow, vegetated		Wide (>1/2 channel length), unveg.	
Bank erosion extent	Extensive	2	Local erosion/pools		Extensive bar pressure	
Relative Width:Depth ratio	Low	1	Average		High	
Channel pattern	Single thread	1	Single thread		Multiple thread/braided	
Average bank slope	<3:1	1	>3:1			
Vegetative bank protection	Poor	1	Extensive		Poor	
Field stability rating (add all cells)/9		= 13/9 = 1.44

Tributary 5 flows between steep valley walls and many drainages flow into the tributary. Tributary 5 and its tributaries is characterized by successive knickpoints migrating upstream. These knickpoints generally stop at the root clusters of large cottonwood trees or other species. As the erosive forces increase in following storms, the knickpoints break through the roots and stop at the next tree. The incision throughout the subwatershed, ranging from 10 ft near the mouth to 2-6 ft upstream, results in bank and slope failure and excessive sedimentation of Etter Creek. Downstream of the 10-ft knickpoint at Stn 1650, saplings have begun to grow along the channel bed as a new equilibrium channel geometry is forming. The subwatershed is heavily forested in the steeper areas, but agriculture is active where vehicles can navigate the terrain. The knickpoints are continuing upstream and into the drainages. The knickpoints are nearing crops along these drainages.

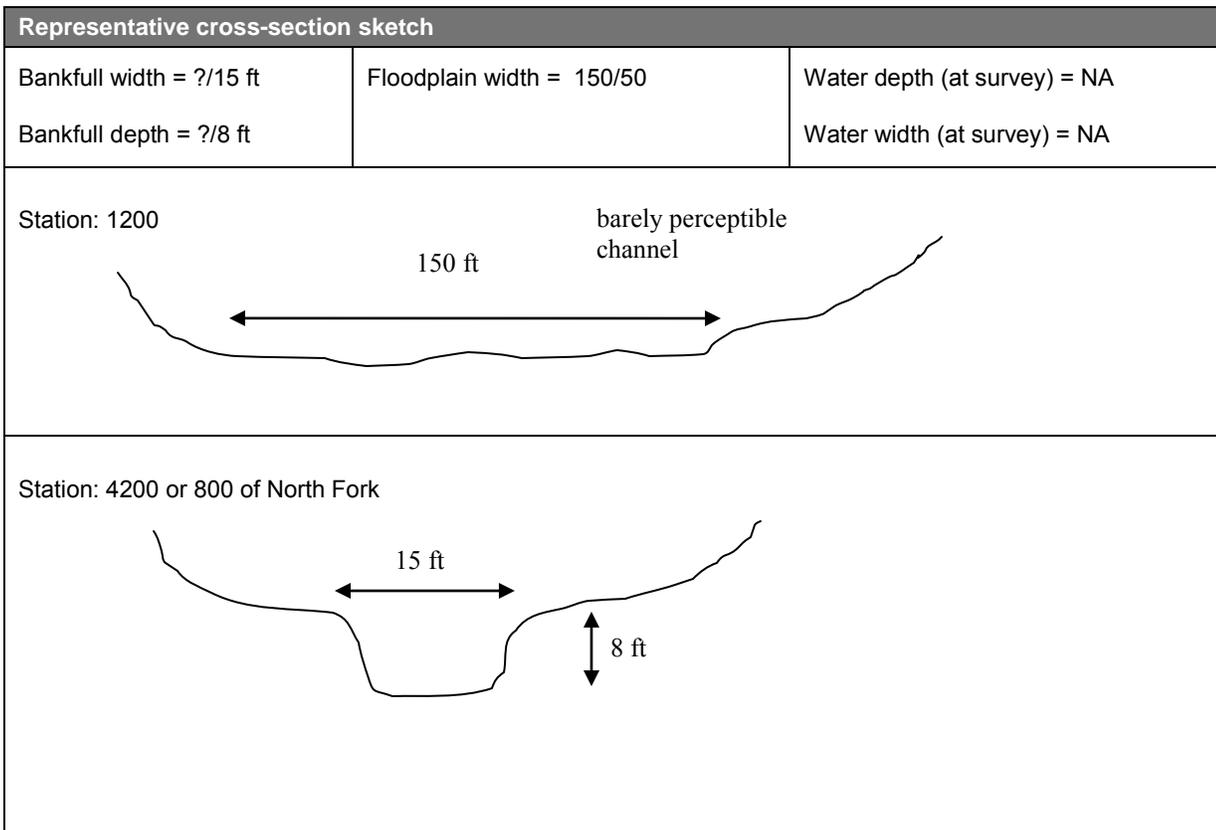
Channel Stability Form - IN INCISED AREAS

Reach stability		1-2 Degrading		3 Stable		4-5 Aggrading
Estimated sediment mobility (D50 moves at:)	<2yr Q	1	2-10 yr		>10 yr	
Substrate consolidation	Strong, gravels/cobble		Strong, gravels		Weak, sand/silt	4
Bank failure mechanism	High banks, grav. collapse, variable channel width	2	Localized surficial erosion, constant width		Low banks, overflows, surficial erosion	
Bar development	Poorly formed		Narrow, vegetated		Wide (>1/2 channel length), unveg.	
Bank erosion extent	Extensive	2	Local erosion/pools		Extensive bar pressure	
Relative Width:Depth ratio	Low	2	Average		High	
Channel pattern	Single thread	2	Single thread		Multiple thread/braided	
Average bank slope	<3:1	1	>3:1			
Vegetative bank protection	Poor	1	Extensive		Poor	
Field stability rating (add all cells)/9		= 15/8 = 1.88

Reach 2 of Tributary 6 also contains the North Fork, which is 1400 ft long and joins Tributary 6 at Stn 2100. Both Tributary 6 and the North Fork are heavily forested with thick canopy cover and mixed underbrush with no encroachment by development. Downstream from Stn 2500 is an aggradational section where the silt from upstream is deposited and no defined channel could be identified. Upstream of Stn 2500 and on the North Fork, the channel is defined as it flows through the steeper hillsides; here, low to moderately active knickpoints were observed. At Stn 4500, 8-11 ft knickpoints are nearing open fields. Landowners have dumped woody debris into the channel here and have attempted to slow the incision by diverting the water; but this appears to have created knickpoints on the sides of the channel as well. This incision results in excessive bank erosion and sedimentation of the lower section of this reach.

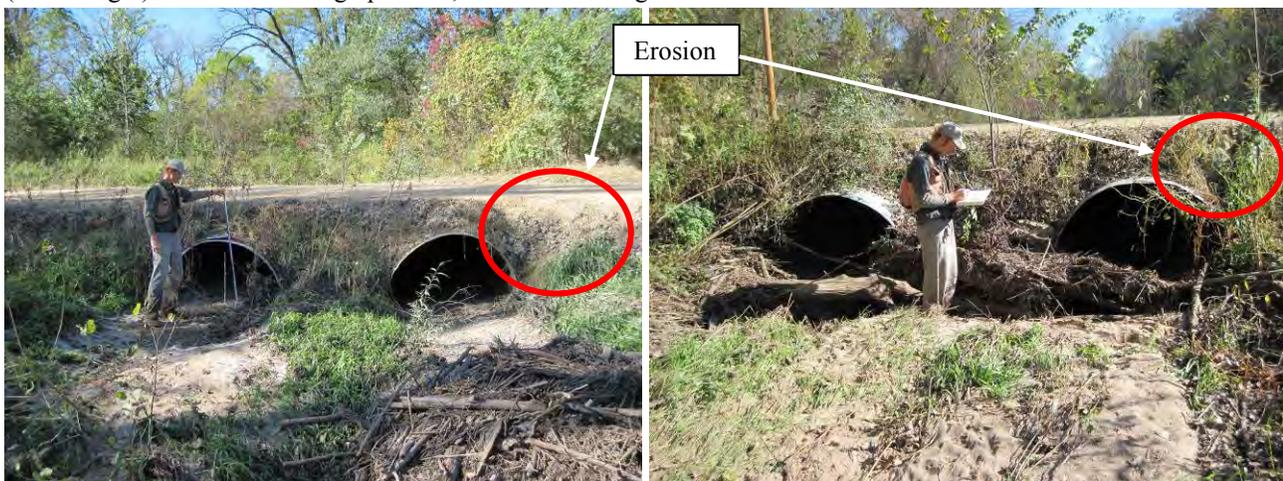
(Left to right): Stn 4000 looking upstream; Stn 4075 looking downstream.

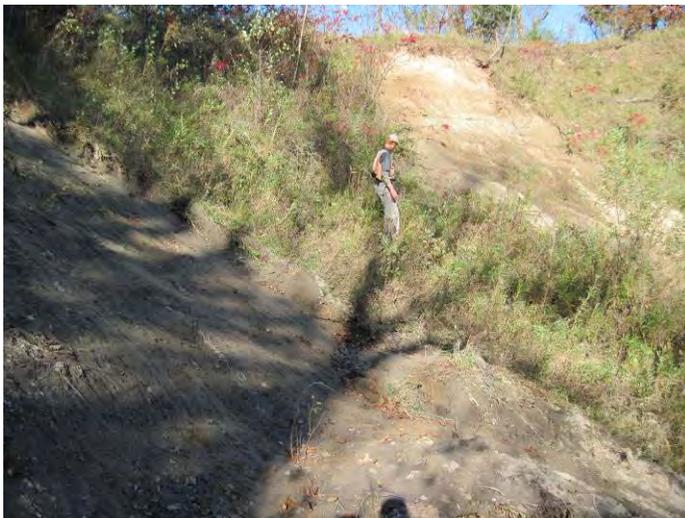
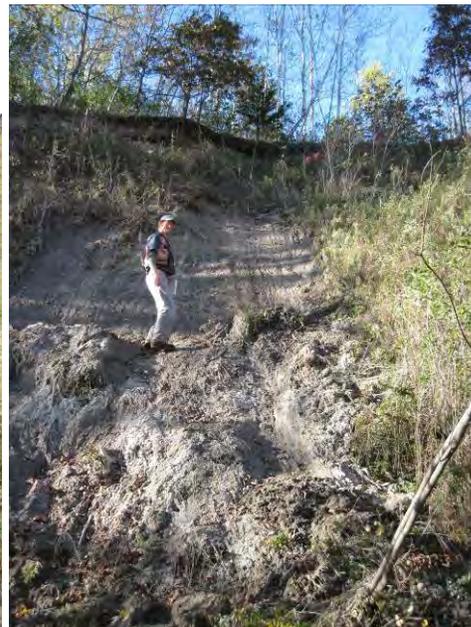
Stream: Etter Creek, Reach 3	Problem description: A bluff ~50 ft tall is actively eroding and slumping. This is natural and was seen elsewhere, but at this location paths are maintained to the edge of the bluff and a bench that has been cemented into the ground is about 6 ft from the edge of the bluff. Through channel migration, the channel has destabilized the toe of the bluff and seeps 30 ft above the channel destabilize the slope. Recent slumps were observed and the sediment lobes had pushed over small willow saplings on the banks of the channel.
Station: 15,600-15,750; right bank	
Solution: The cost effective approach would be to allow the bluff and channel come to an equilibrium: the slumping material will push the channel far enough away from the bluff that further erosion will be minimized. The lower slope will stabilize, revegetate, and the seeps will likely not cause further erosion of the upper slopes. This option would require that the bench be moved away from the eroding slope and that the top of the bluff be planted with shrubs and trees so the roots can help stabilize the slope. A second option is to actively stabilize the toe of the slope with rock or logs and plant vegetation along the slope. The scoring below is for the first option; costs and complexity would greatly increase for the second option.

Stn 15,650 looking at the eroding bluff on the right bank.

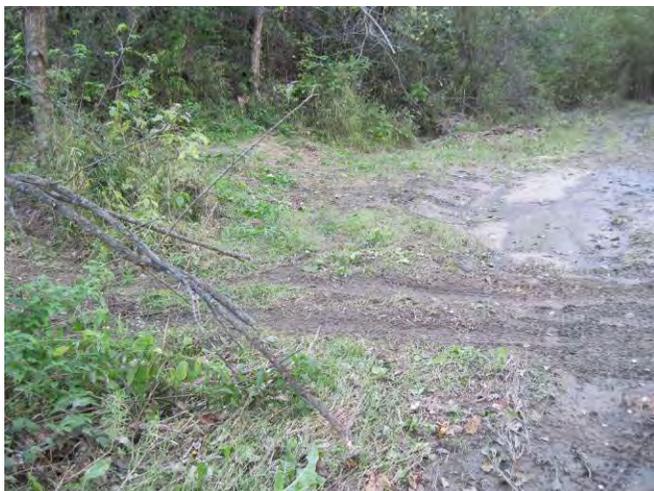
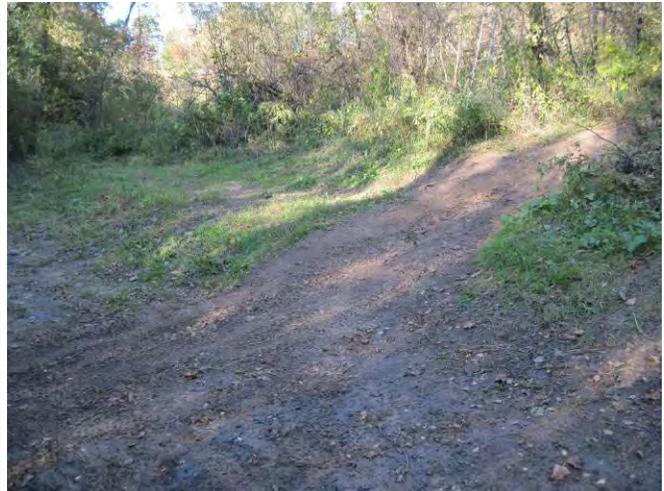
Stn 16,075 looking downstream at an ATV crossing.

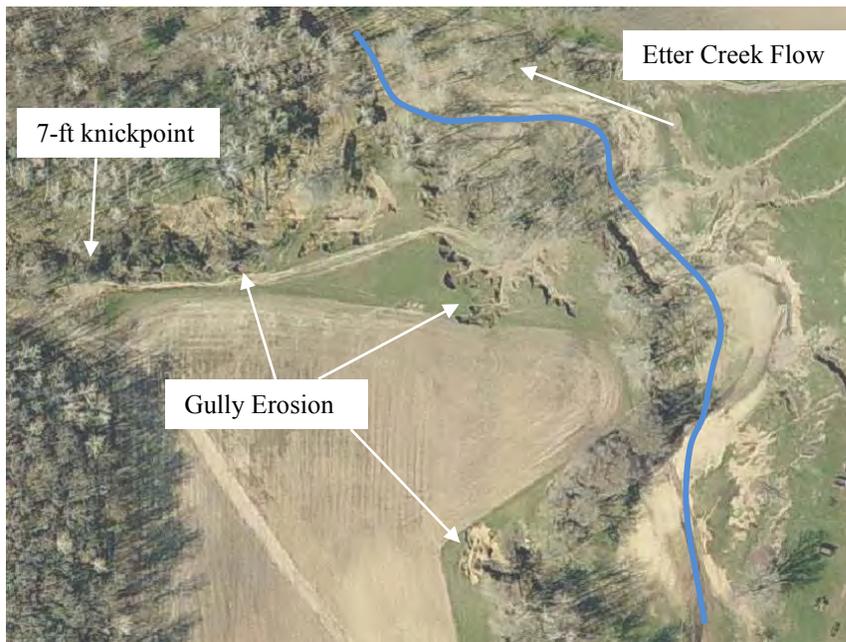
Stream: Etter Creek, Reach 4	Problem description: Excessive bank and hillslope erosion and incision of drainages is resulting in increased sedimentation in Etter Creek and loss of hillslope crop land and forest habitat. The channel, channel banks, and hillslopes are actively grazed and much of the understory has been reduced to short grass. Farm vehicle traffic throughout the channel has also altered the channel form and reduced the vegetative growth. One drainage has a 7-ft knickpoint and gorge resulting from the incision here and elsewhere is visible on aerial photography.
Station: 18,600-20,000	
Solution: Limit vehicle and animal access to the channel to one or two crossings. Create a vegetation buffer adjacent to the stream and the eroding drainages. Vegetation should include native forbs, shrubs, and trees to provide root stabilization as well as vegetative roughness to slow and reduce the overland flow of rainwater. Revegetate hillslopes and limit grazing on left side to minimize overland flow that's resulting in large gullies and incision.

Air photo with the knickpoint and gullies identified.

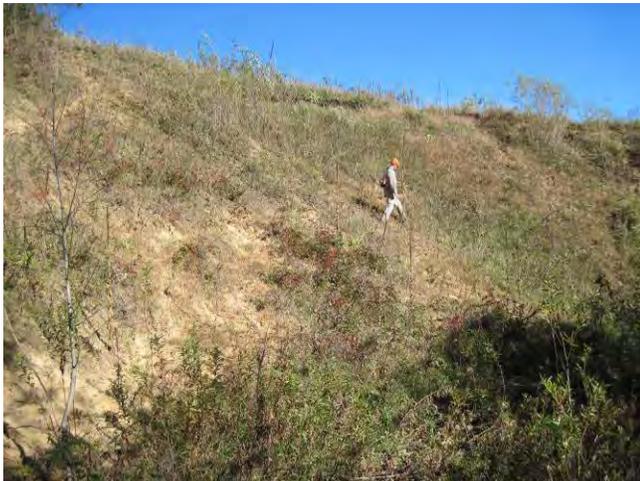
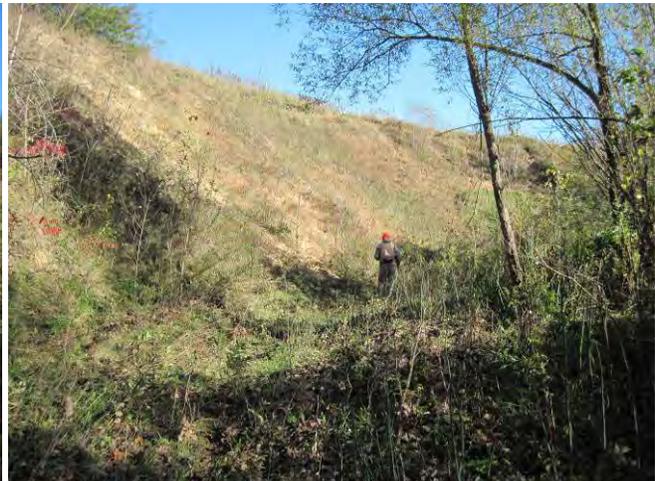
Stream: Etter Creek, Reach 4	Problem description: The channel is eroding the toe of a 25 to 50-ft bluff. No seeps were observed and grasses and forbs are growing on the slope, but no trees are on the slope to stabilize. The top of the bluff has no root stabilization and crops are growing about 30 ft from the bluff edge. No infrastructure is at risk, and the bluff and channel will eventually come to an equilibrium, but stabilization may be necessary if the landowner is concerned about losing land.
Station: 20,350-20,600; left bank	
Solution: Monitor to determine the likelihood of loss of cropland. Revegetate the bluff slope and the top of the bluff to minimize soil loss. If necessary, stabilize the toe of the slope. The scores and costs below do not include toe stabilization.

Stn 20,600 looking downstream at bluff along left bank.

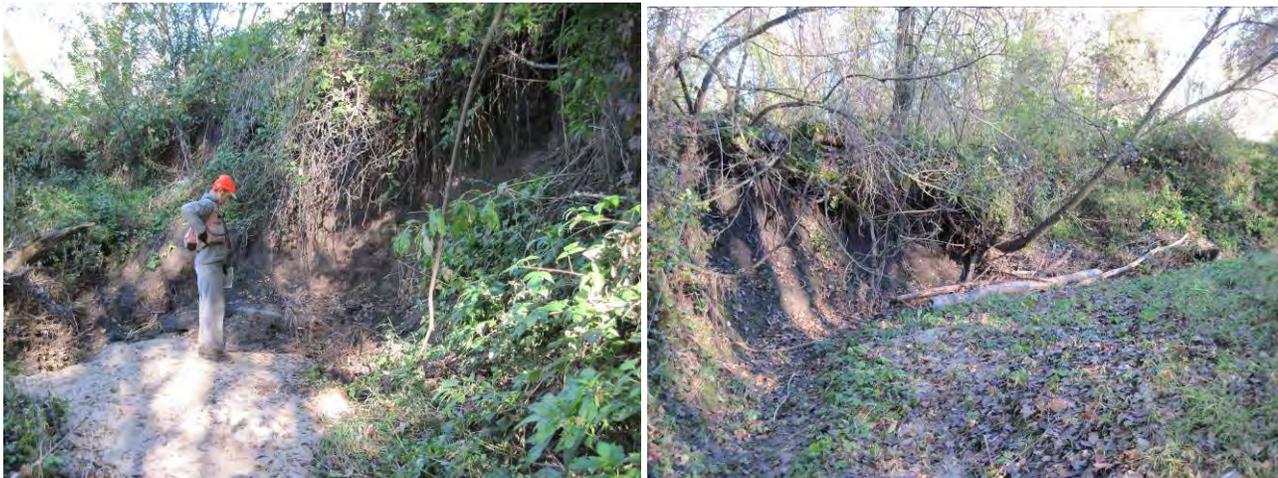
Stream: Etter Creek, Reach 4	<p>Problem description: The channel is eroding the terrace surface along the outside bends in this section. The steep banks are 8-10 ft tall with little vegetation and the erosion is approaching crops in some locations. Very little vegetative buffer is between the channel banks and crops. The channel migration is natural, but because of the historic incision that has occurred throughout the reach, the erosion becomes problematic when it begins to impact the upper terrace surface on which the crops are planted. Further bank erosion could result in loss of crops. Excessive erosion results in increased sand deposits in the stream, potentially leading to further instability.</p>
Station: 21,500-23,200; outside bends of both banks	
<p>Solution: Stabilize the toe of the banks, regrade the banks, and plant native riparian shrubs and trees. Build a riparian buffer zone between the banks and the crops to improve infiltration and soil/bank stability.</p>

Left to right: Stn 21,550 looking downstream at eroding right bank; Stn 22,650 looking upstream at eroding right bank.

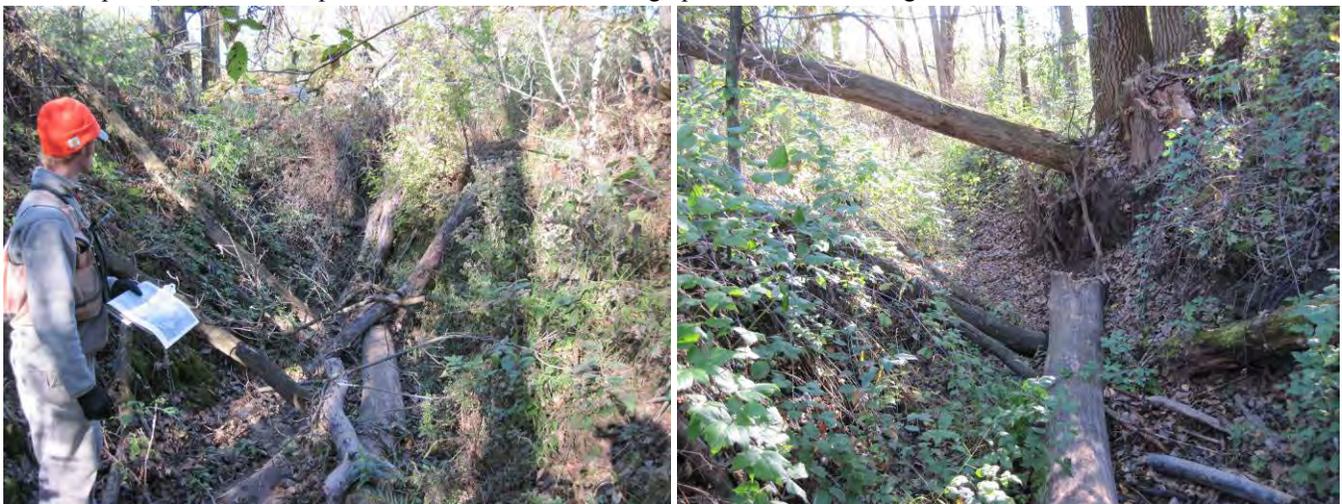
Stream: Etter Creek, Reach 4	Problem description: A small drainage entering Etter Creek on the left bank has incised about 150 ft upstream and a 4-ft knickpoint is actively moving upstream. Continuation of this knickpoint will increase sedimentation of Etter Creek and will result in further instability of the this small drainage. Increased incision could result in problems for farming with the movement of farm equipment. If the knickpoint reaches the hillside, gullying along the slope could occur and could result in loss of land and increased sedimentation.
Station: 21,950	
Solution: Increase the riparian buffer width to maximize infiltration and reduce overland flow to the stream. Monitor: if incision continues and threatens crops or hillslope, build grade control or convert the drainage into a stormwater detention basin. Scores below do not include active channel work, only the development of a riparian buffer.

Left to right, drainage that enters the mainstem at Stn 21,950: About 100 ft upstream from the mouth and looking upstream at the knickpoint; about 150 ft upstream from the mouth looking upstream at the drainage.

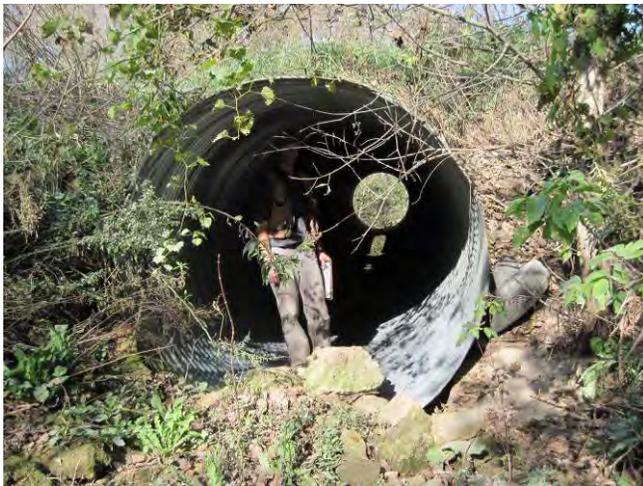
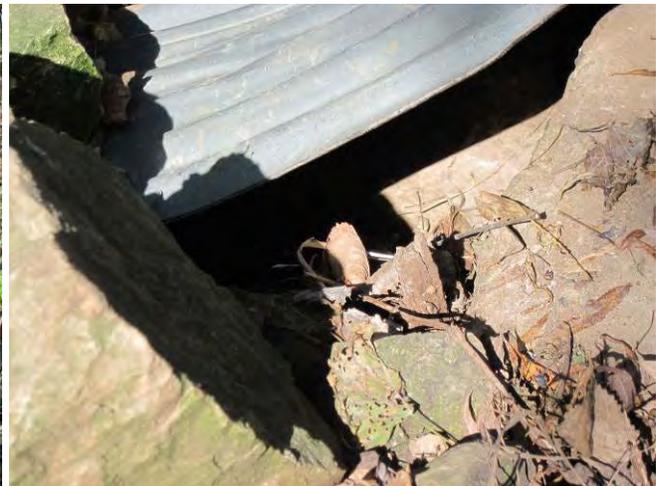
Left to right: Stn 26,175 looking downstream at the culvert with erosion visible on the right side of the culvert; Stn 26, 150 looking at the gap underneath the upstream end of the culvert.

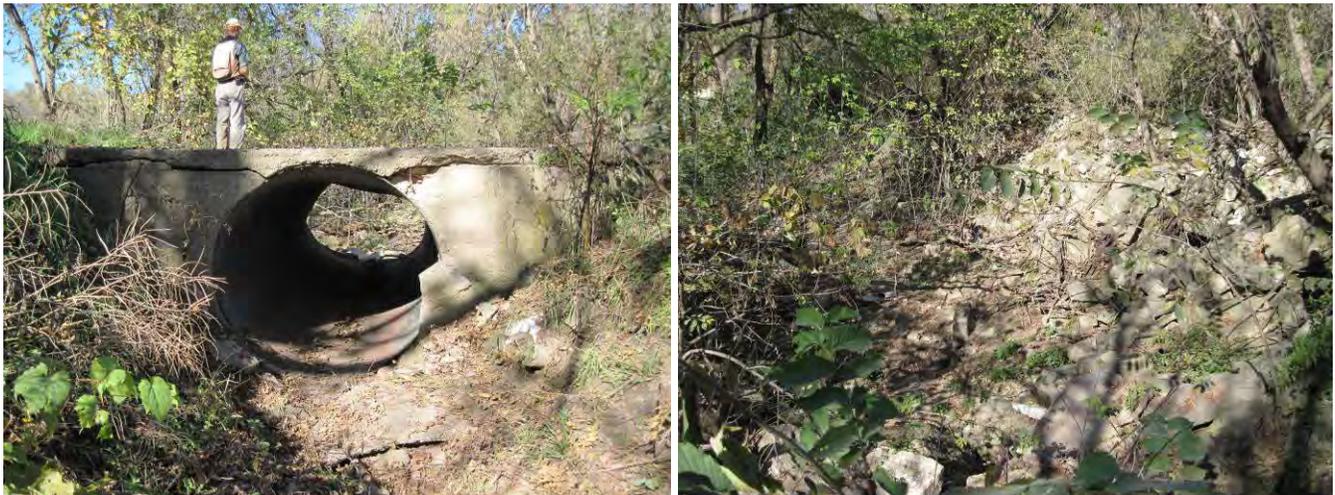
Stream: Etter Creek, Reach 5	Problem description: A 5-ft corrugated metal pipe encased in a concrete driveway is corroded through its base so that water flows through the holes in the metal and along the gravel bed under the culvert. Cracks in the concrete have already developed and continued erosion could further compromise the structural integrity of the culvert and driveway. In addition, concrete, bricks, and other debris have been placed on both banks immediately downstream of the culvert in an effort to minimize erosion. Some of this debris has fallen into the channel increasing instability and the debris on the banks prevents vegetation from stabilizing the banks.
Station: 27,450	
Solution: Replace the culvert with a larger culvert that will not result in a hydraulic jump on the downstream end. This would likely minimize the bank erosion on the downstream end; the debris could then be removed from the bed and the banks could be stabilized with native vegetation.

Left to right: Stn 27,475 looking downstream at culvert; Stn 27,450 looking downstream at rubble on channel bed and banks.
