Vermillion River Watershed Joint Powers Organization
**Fluvial Geomorphic Assessment of Etter Creek and the
Ravenna Coulees, Dakota County, MN: Final Report**

February 25, 2011

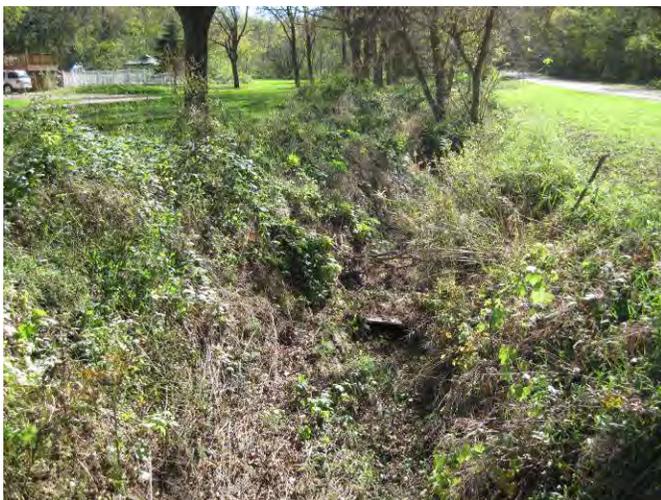
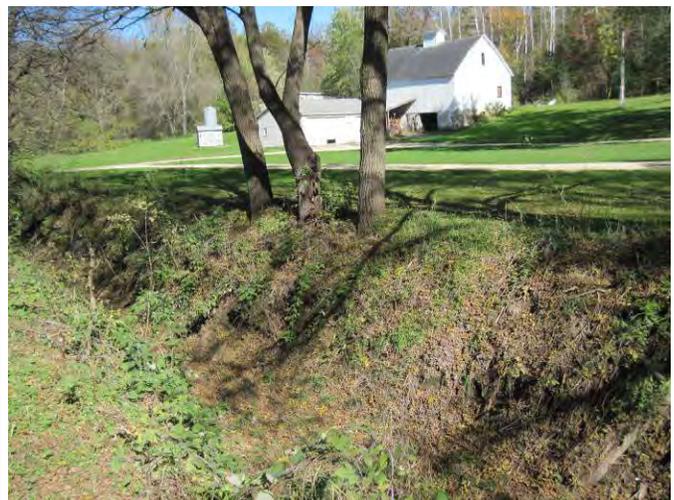
Stream: Etter Creek, Reach 5	Problem description: Most of the native vegetation has been removed and the grass is mowed to the edge of the channel banks. Other than a few trees, there is no native riparian buffer and this decreases bank stability, riparian habitat, and infiltration.
Station: 27,450-27,700	
Solution: Plant native trees, shrubs, and forbs throughout a 10 to 20-ft riparian buffer.

Left to right: Stn 27,450 looking upstream; Stn 27,550 looking towards the right bank.

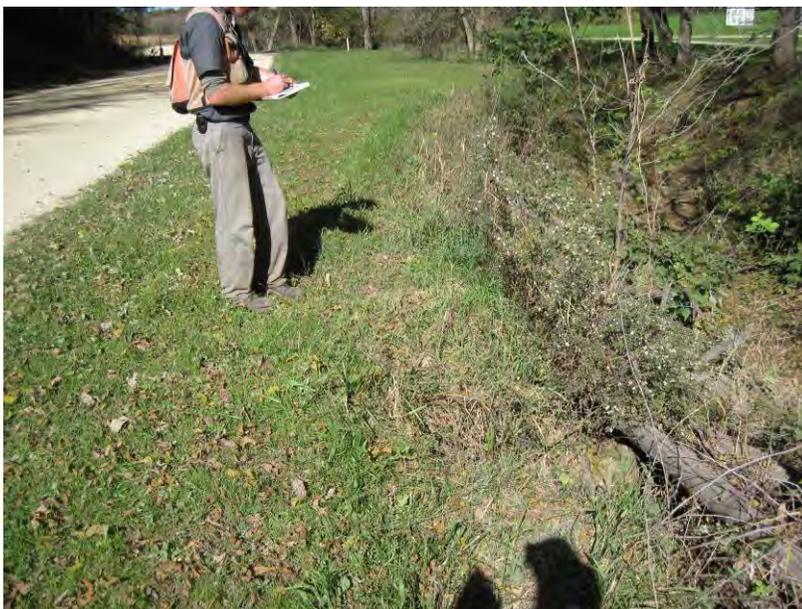
Stream: Etter Creek, Reach 5	Problem description: Piping and erosion was observed on the left bank approximately 4 ft from the edge of 145th Ave. Riprap has been placed along the left bank, but water seeping behind the riprap and erosion is continuing. The riprap prevents any native riparian vegetation from growing and stabilizing the channel banks. The area between the riprap and the road is mowed grass and managed to prevent larger vegetation from growing. Further erosion could cause damage to the road and increase risk to public safety.
Station: 27,625-27,675; left bank	
Solution: Remove riprap, stabilize the toe of the bank, build lifts that support vegetation to the top of the bank, and plant native shrubs and trees along the top of the bank to stabilize the soil.

Stn 27,650 looking downstream at piping and erosion along the left bank.

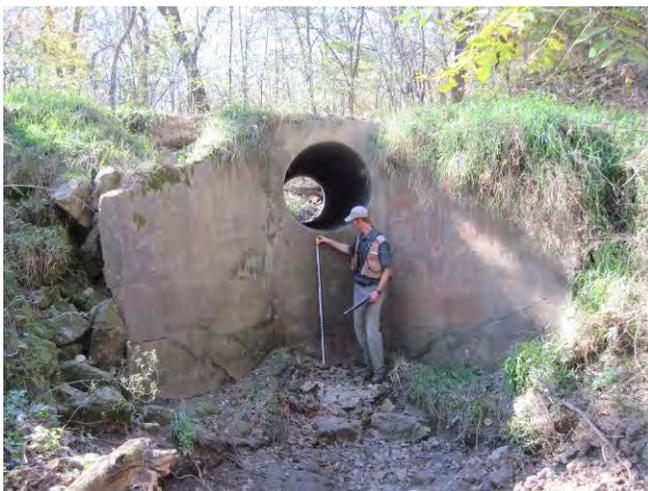
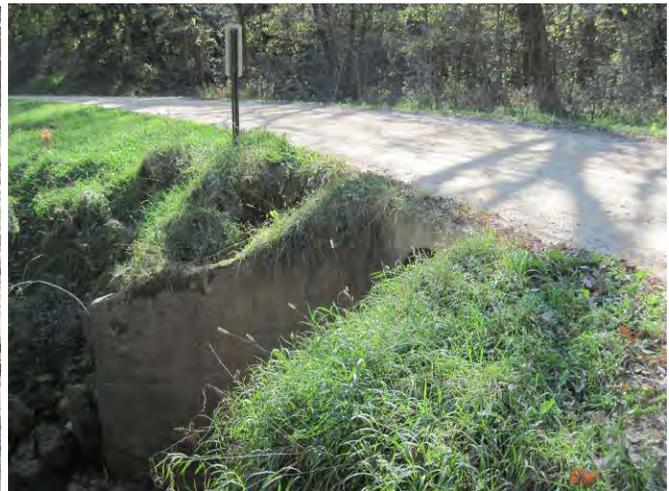
Stream: Etter Creek, Reach 5	Problem description: A small drainage flows into Etter Creek at this location. About 50 ft from the mouth of the drainage, it flows underneath 145th Ave through a 3.5-ft corrugated pipe encased in concrete. Because of mainstem incision, the downstream end of the pipe is 5 ft above the channel bed. The base of the wingwalls are cracking and erosion is occurring on the top and side of the right wingwall about 3 ft from the edge of 145th Ave. Piping was observed on the left side as well. This erosion and piping could damage the road and risk human safety.
Station: 28,050	
Solution: Replace culvert with a longer and wider culvert that will provide adequate width for vehicular traffic and a buffer between the road and the channel. The culvert will need to be placed, and grade control built, so that incision does not continue upstream of the road and erosion does not increase between the drainage outlet and the mainstem. Native riparian vegetation should then be planted between the channel banks and the road to stabilize the banks.

Left to right: Stn 28,050 looking up the drainage at the downstream end of the culvert; looking at the erosion along the right side of the culvert and wingwalls on the downstream end.

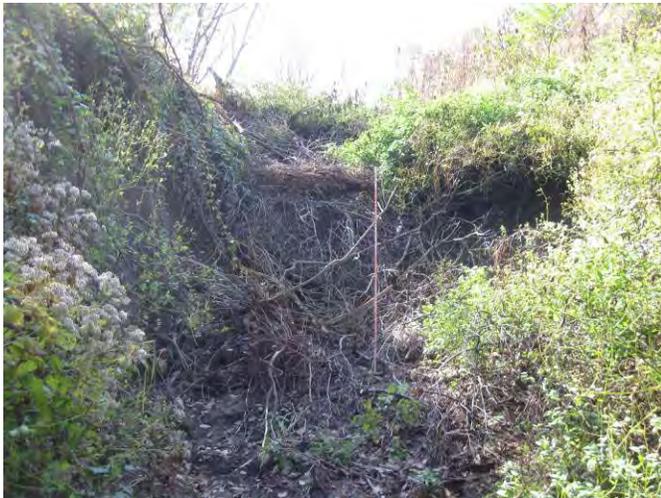
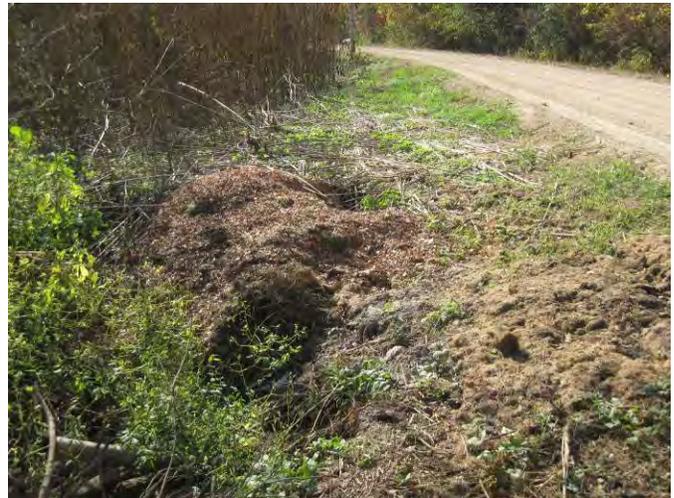
Stream: Etter Creek, Tributary 4	<p>Problem description: A 12-ft knickpoint is actively migrating upstream. A smaller, 3-ft knickpoint is about 10 ft from the edge of Records Trail. Migrating knickpoints can result in significant erosion and sedimentation of streams, damage to infrastructure, and damage to roads. Logs, concrete, and grass clippings have been dumped onto the knickpoints, but this only exacerbates the problem because this debris prevents native vegetative growth that could stabilize the banks. The knickpoints are likely the result of incision on Etter Creek migrating up the tributaries combined with increased water volumes due to land clearing.</p>
Station: 2600	
<p>Solution: A temporary solution (and the one that the scores below are based on) is to re-grade the channel into a series of grade controlling steps and energy-diffusing pools. The banks should also be re-graded to a gentler slope and planted with native riparian vegetation. The buffer between the road and the channel should be increased during this process and vegetation planted to increase infiltration and limit the amount of water draining directly off the road and into the channel. A more long-term solution is to increase the riparian buffer further upstream and incorporate stormwater retention practices to slow the flow of water downstream.</p>

Left to right: Stn 2600 looking upstream at knickpoint; Stn 2600 looking upstream at smaller knickpoint (filled with grass clippings) that is nearing the road edge.

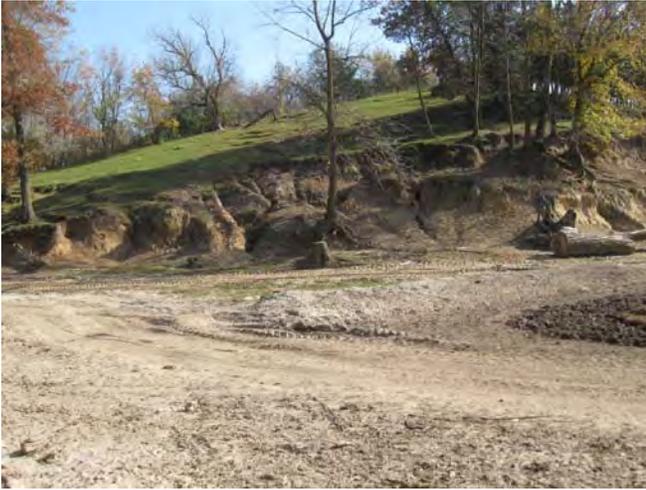
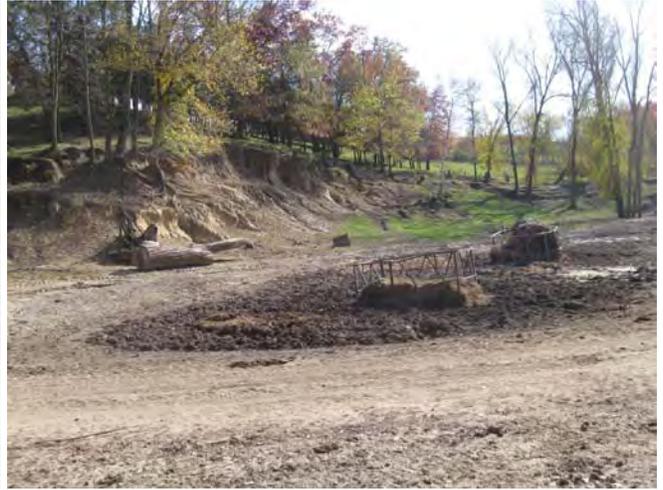
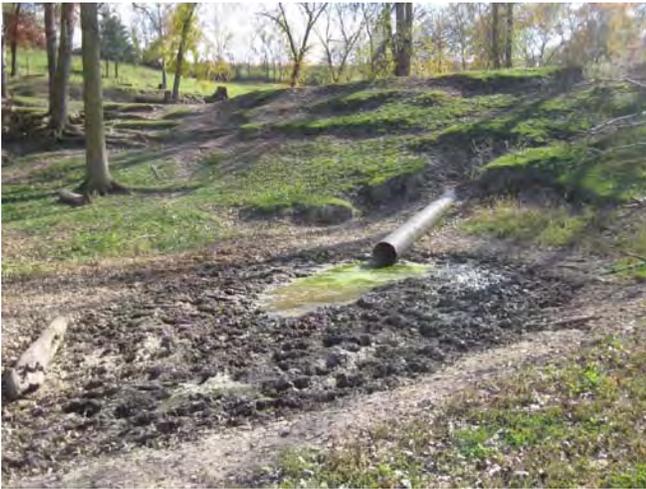
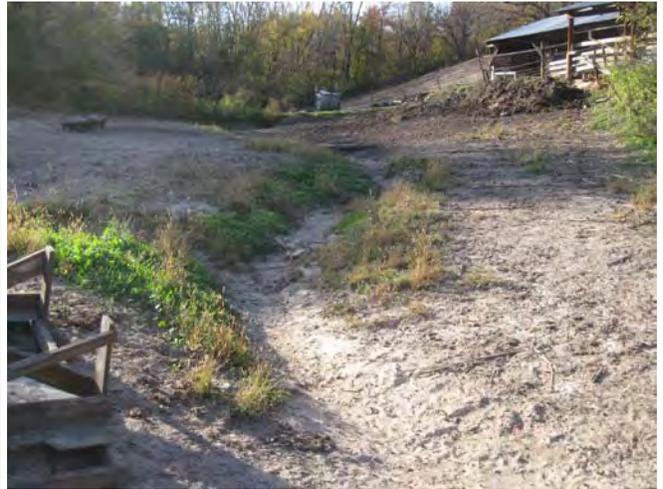
Stream: Etter Creek, Tributary 4	Problem description: This area is heavily impacted by grazing (primarily cattle, but sheep are also held in a small pen). There is no defined channel and the valley floor and slopes are devoid of vegetation except for grass grazed very low and a few trees. Overland flow off of the hillsides is resulting in gullying and excessive erosion because there is little vegetation to hold the soil in place. This overgrazing and lack of vegetation decreases infiltration and increases water flow to downstream sections, likely resulting in the upstream migration of the 12-ft knickpoint described in PP16.
Station: 3400-4300; 0-400 on North Drainage	
Solution: Eliminate, or greatly reduce, grazing on the valley floor and steep hill slopes. If grazing is continued, reduce the number of cattle and limit the grazing to portions of the property that can withstand the impacts. Limit the movement of livestock along the valley floor to one or two crossings. Revegetate valley floor and slopes with native grasses, forbs, shrubs, and trees.

Clockwise from lower left: Stn 3800 looking upstream overgrazing and erosion on dam; Stn 3500 looking towards the hillslope to the right of the channel; Stn 3500 looking upstream; Stn 100 of North Drainage looking upstream.

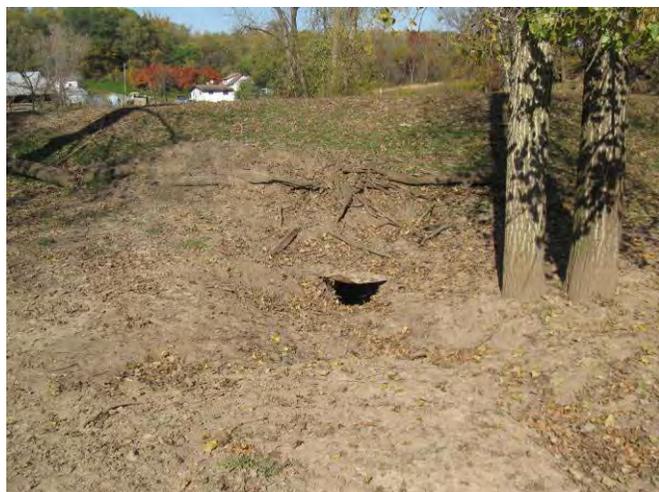
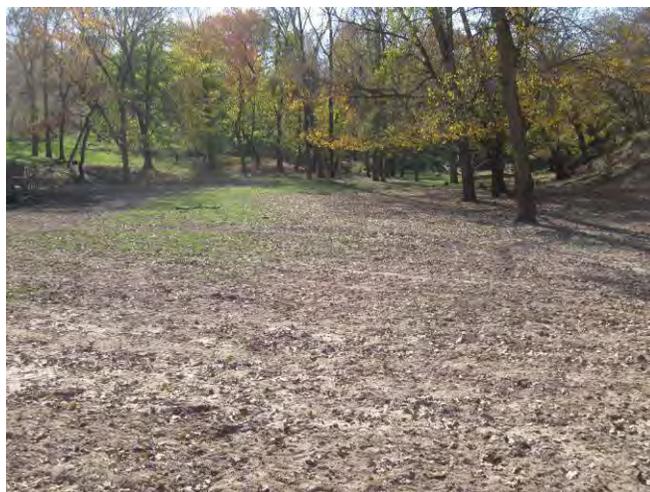
Stream: Etter Creek, Tributary 4	<p>Problem description: An earthen dam built across the valley floor at this location has likely been successful at reducing water and sediment flow downstream. The 1.5-ft pipe that allows water through the dam does not provide a great deal of storage and instead allows any water flowing through the grazed channel upstream to flow directly downstream. By eliminating grazing and retro-fitting the culvert, the area upstream of the dam could be converted into a stormwater retention basin in the form of a wetland similar to that at the headwaters of this tributary. This, combined with the reduction/elimination of grazing, would likely halt the migration of the knickpoint further downstream.</p>
Station: 3900	
<p>Solution: Retro-fit the pipe by attaching a vertical pipe with a trash grate and debris deflector to the upstream end. The top of this pipe could be 1-2 ft below the top of the dam. Once water begins to collect, plant wetland vegetation.</p>

Left to right: Stn 3900 looking downstream at pipe and dam; Stn 3900 looking upstream.

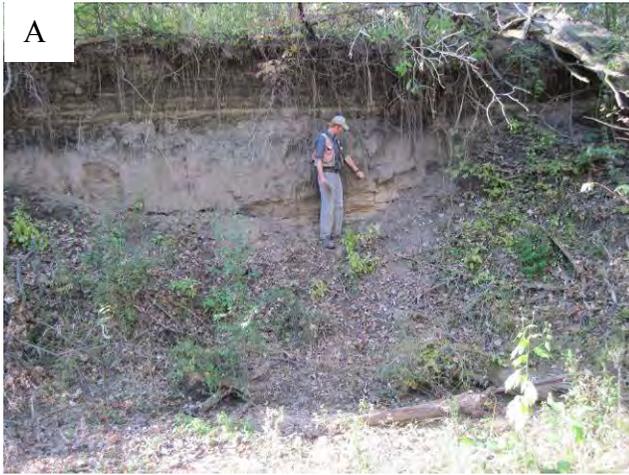
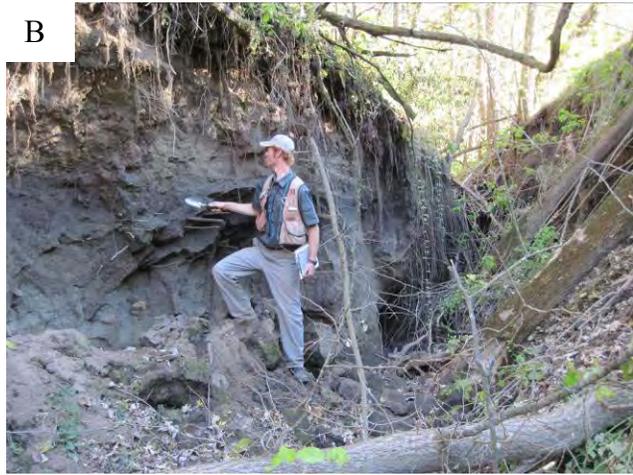
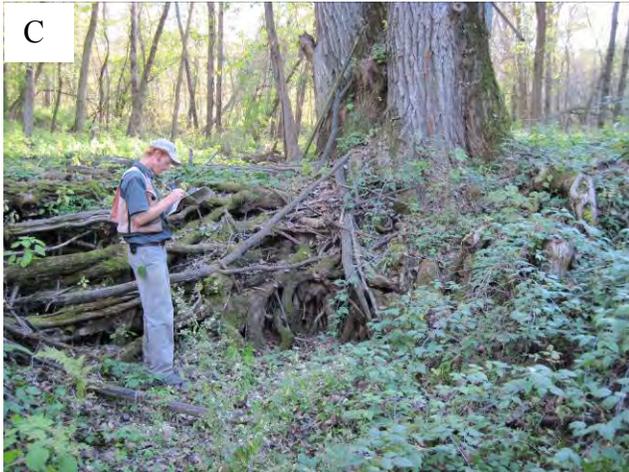
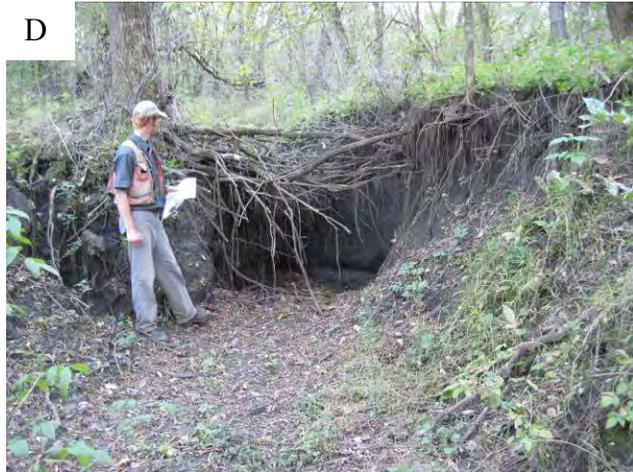
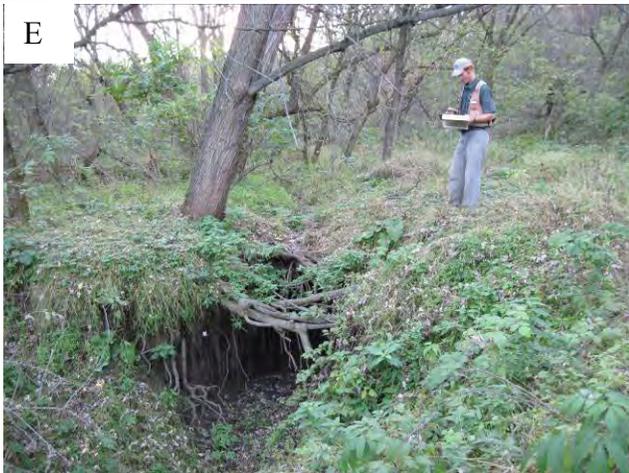
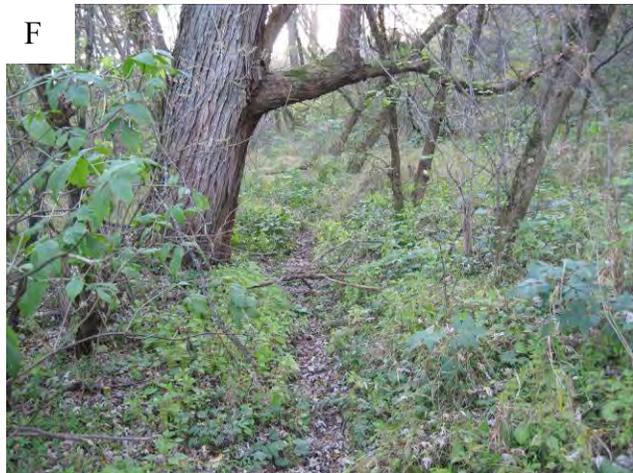
Stream: Etter Creek, Tributary 5	<p>Problem description: Mainstem Etter Creek incision has drastically impacted Tributary 5 and its numerous small drainages. At least 11 knickpoints, ranging in height from 3 to 10 ft, are actively migrating upstream. Upstream of these knickpoints, the channel generally returns to a shallow swale. This incision results in decreased lateral stability - as the channel incises, the banks become steeper and erode into the channel. From the mouth of this tributary to the 10-ft knickpoint at Stn 1675, numerous 12 to 15-ft banks are eroding on the outsides of channel bends. This vertical and horizontal instability results in increased sediment loads to Etter Creek and may begin to impact row crops if the incision continues to the top of the Tributary and the drainages.</p>
Station: 0-7700: entire reach	
<p>Solution: Instability problems along this subwatershed will likely be best solved using a subwatershed-scale approach. Halting farming over large portions of this subwatershed is not feasible. Nor, however, is building a stormwater retention basin at the mouth of each incised drainage and on the mainstem Tributary 5. A combination of the two methods, however, may be the best approach. Retention basins at Stn 1500, around Stn 1400 on the drainage that flows into Trib 5 at Stn 4500, and at Stn 5800 on Trib 5 will help capture stormwater and will create wetland habitats that could be conducive to many wetland plant and animal species. Converting row crops to native grass and tree cover, particularly along the south and southeast portions of this tributary and its drainages would improve infiltration and reduce the amount of water entering Tributary 5.</p>

A) Stn 250 looking at the eroding 12 to 15-ft left bank of Tributary 5; B) Stn 1650 looking upstream at eroding bank with 10-ft knickpoint behind N. Nelson; C) Stn 2650 looking upstream at 4-ft knickpoint halted by the roots of a large cottonwood tree; D) Stn 4800 looking upstream at 6-ft knickpoint halted by tree roots; E) Stn 5675 looking upstream at upper portion of 8-ft knickpoint halted by tree roots; Stn 5700 looking upstream at channel upstream of the knickpoint in photo E.

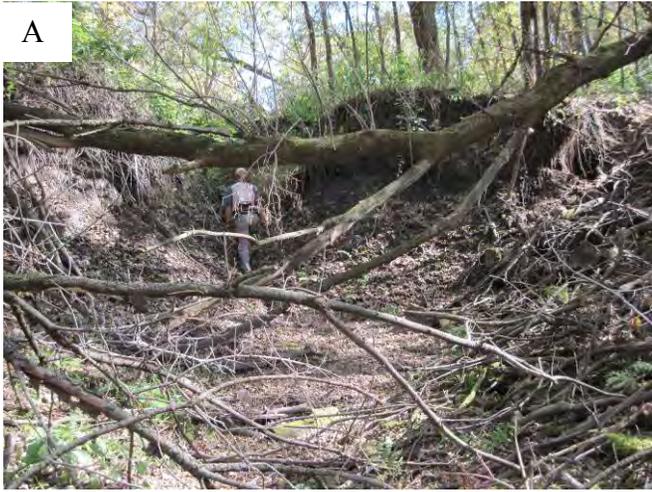
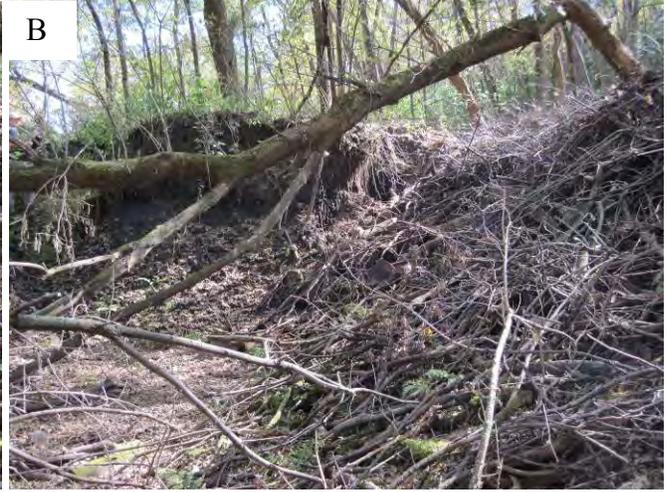
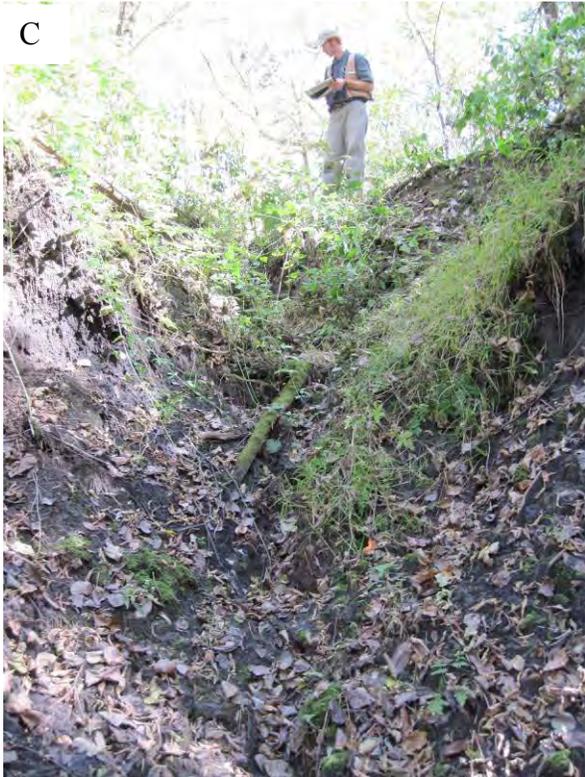
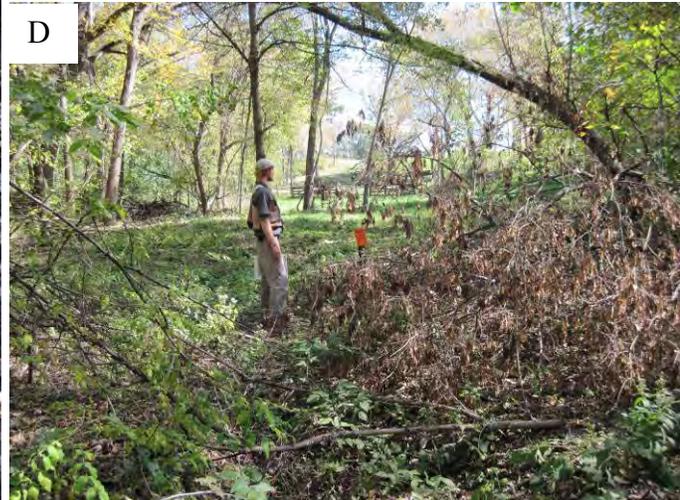
Stream: Etter Creek, Tributary 6	<p>Problem description: Tributary 6 and its North Drainage have multiple knickpoints throughout their length, but the widespread vegetative cover and the lack of nearby infrastructure has minimized the impact of this incision. However, seven 8 to 10-ft knickpoints were identified between Stn 4400 and 4450. These knickpoints are not in succession along the channel, but form 'fingers' of incision where the knickpoints meet the fields. The additional knickpoints may have been caused by diversions meant to halt the primary knickpoint. These knickpoints are active and will continue to migrate upstream with stormwater runoff causing damage farmland and increasing sedimentation downstream.</p>
Station: 4400-4450	
<p>Solution: Build a stormwater retention basin at Stn 4500 or allow native grasses, shrubs, and trees to grow in the upper part of the subwatershed. The retention basin will capture stormwater and create a small wetland and the revegetation will increase infiltration and reduce water flow downstream.</p>

A) Stn 4425 looking upstream at 11-ft primary knickpoint; B) Stn 4425 looking upstream at one of the secondary knickpoints; C) Stn 4450 looking upstream at primary knickpoint; D) Stn 4450 looking upstream of all knickpoints at survey marker in field.

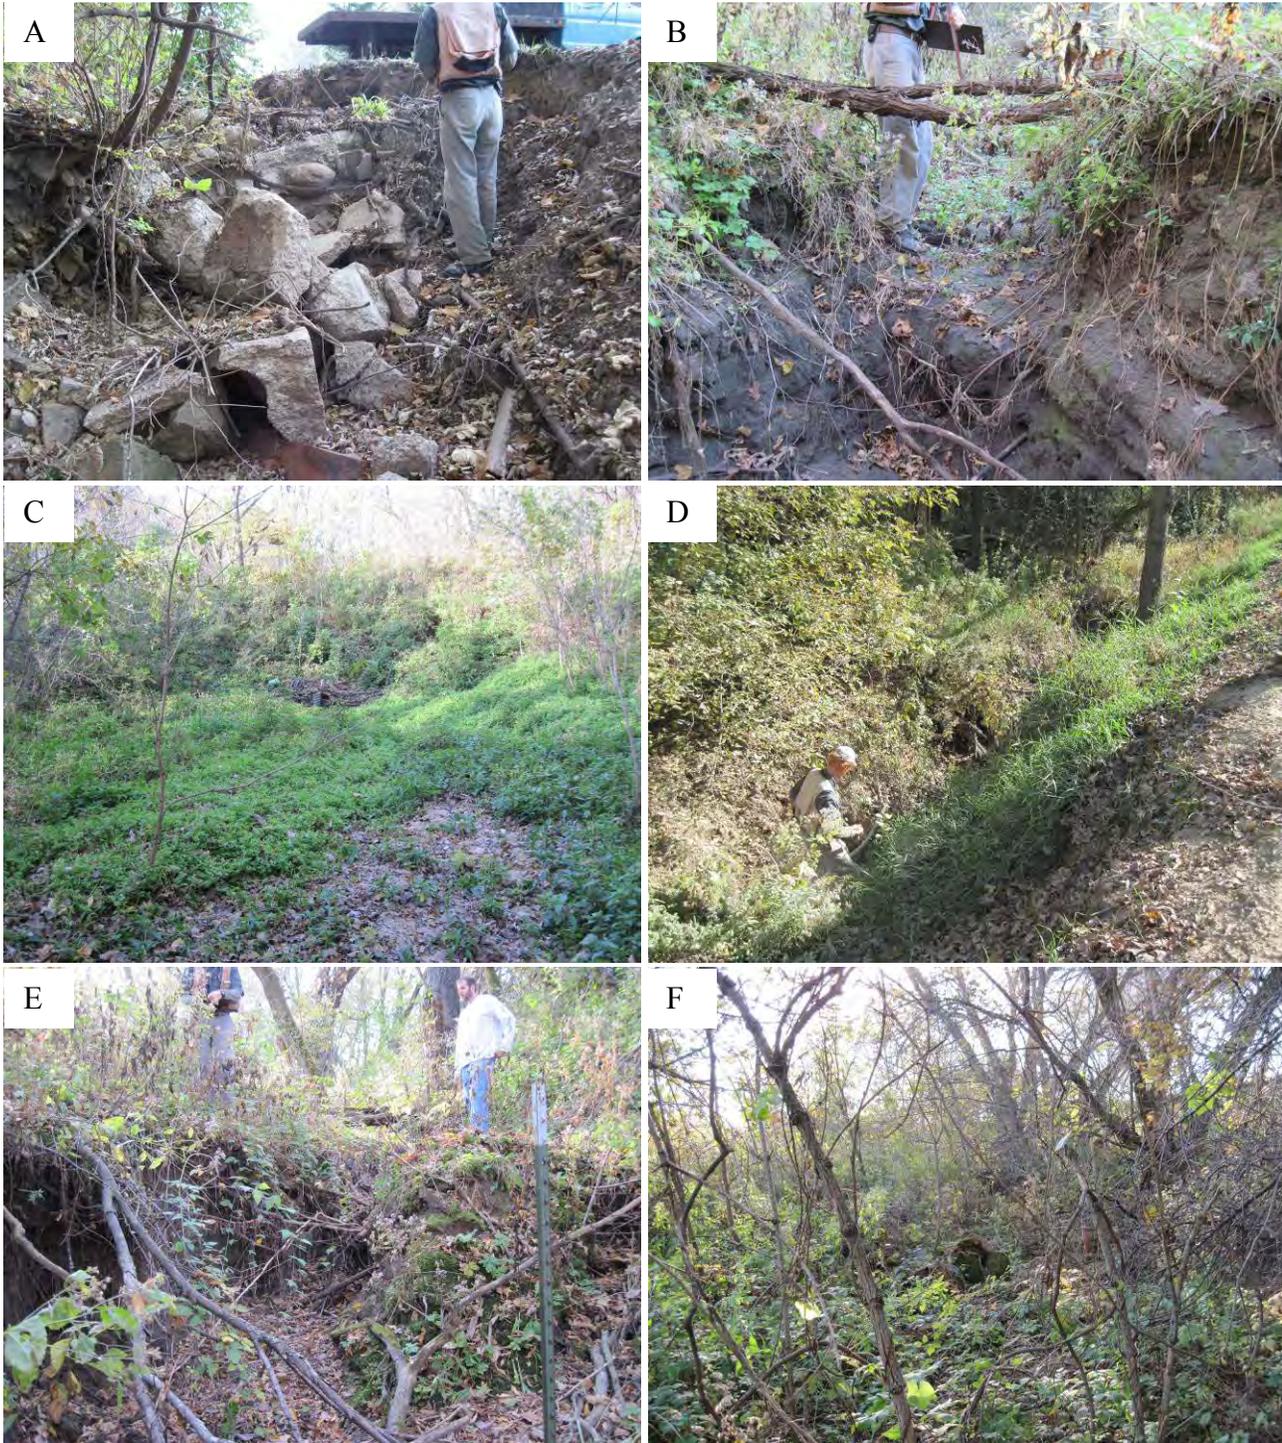
Stream: Etter Creek, Tributary 8, Reach 2	<p>Problem description: More than 20 knickpoints were identified throughout this reach and the associated drainages. Most of the knickpoints were between 1 and 3 ft in height, but an 8-ft knickpoint was identified at Stn 2375. These knickpoints are likely the result of increased hydrology due to agriculture in the upper portions of the subwatershed. The knickpoints increase sedimentation downstream (sand and silt partially fill the culvert under 145th Ave and much deposition has occurred below the culvert) and can result in damage to infrastructure or property. The 8-ft knickpoint and knickpoints at the upstream extent of this tributary and the drainages are encroaching on managed yards, fields, and crops.</p>
Station: 1500-5800; entire reach including small drainages	
<p>Solution: Similar to Tributary 5, a combination of stormwater retention basins and conversion of managed fields to native vegetation is likely the most effective way of diminishing the water volume and minimizing sediment transport. The driveway crossing at Stn 4575 and the road crossing at Stn 5000 are both 8 to 10 ft higher than the channel bottom on the upstream end. The topography in these two areas provides an opportunity to retrofit the two culverts with risers that would cause additional retention of water and create small wetlands. An additional retention basin could be built on the small drainage that enters Tributary 8 at Stn 3625. About 9 knickpoints were identified between the mouth of this drainage and about 700 ft upstream from the mouth. Upstream of Stn 700 there is no defined channel; this may provide a good location for a retention basin that would further slow the downstream flow of water. Finally, converting cropland and managed fields to native grasses, shrubs, and trees in the headwaters of the small drainage and on either side of 225th St at the headwaters of the mainstem would increase infiltration and reduce the downstream flow of water.</p>

A) Stn 2375 looking upstream at 8-ft knickpoint and concrete rubble; B) Stn 3700 looking upstream at 3-ft knickpoint; C) Stn 4675 looking downstream at driveway crossing and culvert underneath; D) Stn 5000 looking upstream from the 225th St crossing; E) Stn 700 of drainage that enters Tributary 8 at Stn 3625 looking upstream at 5-ft knickpoint; F) Stn 900 of drainage that enters Tributary 8 at Stn 3625 looking upstream.

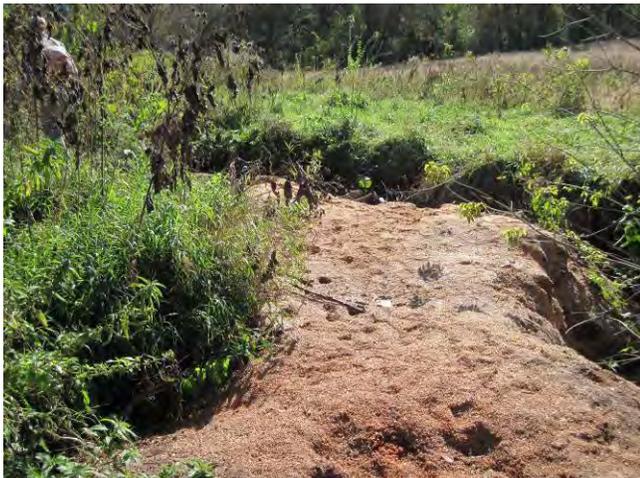
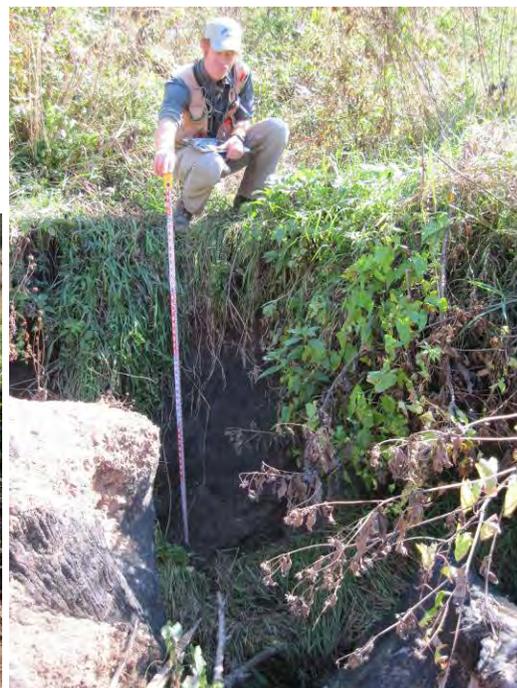
Stream: Etter Creek, Tributary 9, Reach 1	Problem description: A 5-ft knickpoint has developed at this location where the channel flows between two fields. Burned stumps, sawdust, and logs have been dumped into the incised channel at the knickpoint. Vehicular and pedestrian travel between the fields could be hazardous with this knickpoint and incised channel, but the two fields are owned by different families, so this may not be a problem. The knickpoint could continue to migrate upstream resulting in decreased channel stability and increased sedimentation into Etter Creek.
Station: 450	
Solution: Build a grade control structure to prevent continued incision and headcutting. Plant native trees along a buffer where the channel flows between the two fields to stabilize the soils.

Left to right: Stn 425 looking upstream at pile of sawdust in incised channel; Stn 450 looking upstream at knickpoint.

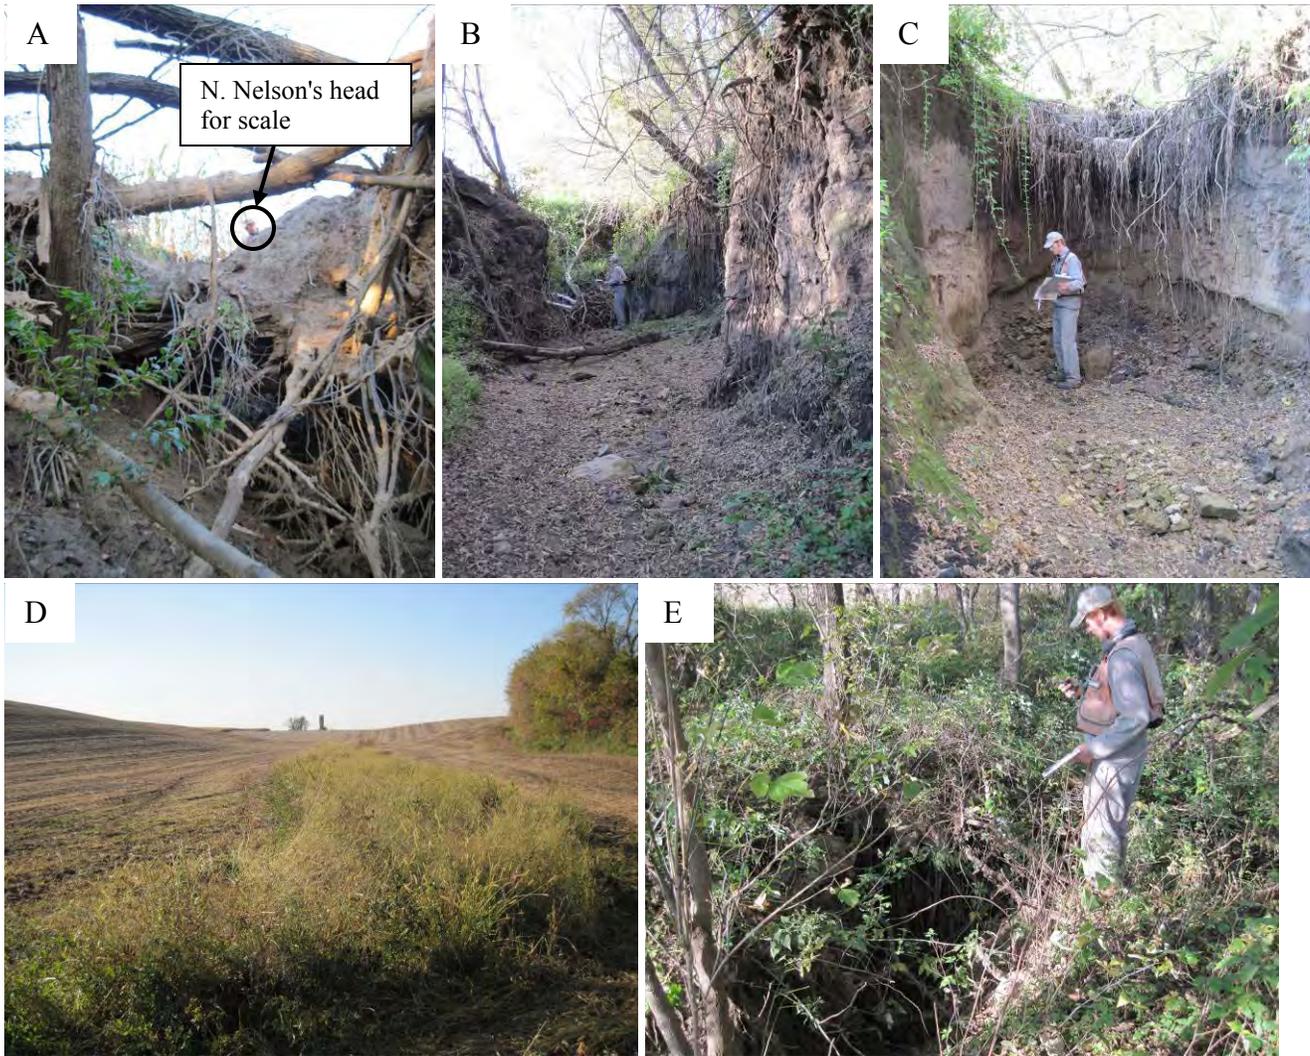
Stream: Etter Creek, Tributary 9, Reach 2	<p>Problem description: About 20 knickpoints were identified throughout this reach and the associated drainages. Some of the knickpoints were between 1 and 3 ft in height, but many were between 6 and 15 ft in height. These knickpoints are likely the result of increased hydrology due to agriculture in the upper portions of the subwatershed. These knickpoints increase sedimentation downstream and can result in damage to infrastructure or property. It is unlikely that much sediment is transported to Etter Creek given the low gradient between the channel mouth and Stn 3000. However, increased sedimentation can lead to decreased lateral stability downstream and increased bank erosion. Active knickpoints at the head of each drainage are on the edge of tilled fields and some knickpoints have entered the fields. Crops were observed falling into the channels. Besides the loss of crops, farm vehicles or laborers could fall into these incised channels resulting in severe damage to property and potential hazard to human life.</p>

A) Stn 200 on drainage flowing into Trib 9 at Stn 4650: looking upstream at 15-ft knickpoint incising into crops; B) Stn 5650 looking upstream at 13-ft incised channel walls; C) Stn 5675 looking upstream at 13-ft knickpoint; D) Stn 5700 looking upstream at headwaters with no riparian buffer; E) Stn 300 of drainage flowing into Trib 9 at Stn 4250: looking downstream at 6-ft knickpoint at head of drainage about 10 ft from crops.

Station: 2300-5800 including 7 drainages	
<p>Solution: Similar to Tributary 5, a combination of stormwater retention basins and conversion of managed fields to native vegetation is likely the most effective way of diminishing the water volume and minimizing sediment transport. A small retention basin on the drainage that flows into Etter Creek at Stn 5025 may have decreased incision in this drainage as no knickpoints were found. An additional retention basin built around Stn 5400 would further reduce the water volume flowing downstream. Building retention basins for the remaining five drainages does not appear feasible due to the surrounding topography. To minimize further incision in these drainages, we recommend converting some crop land to native grasses, shrubs, and trees. By creating a native vegetation buffer around these drainages, infiltration will increase and water volumes flowing downstream will decrease.</p>

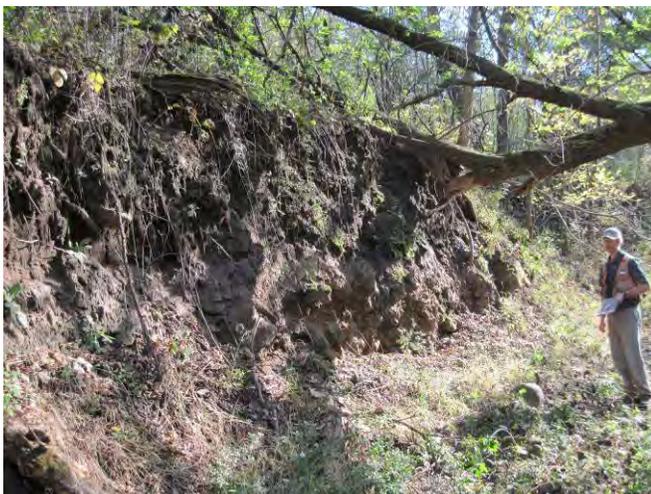
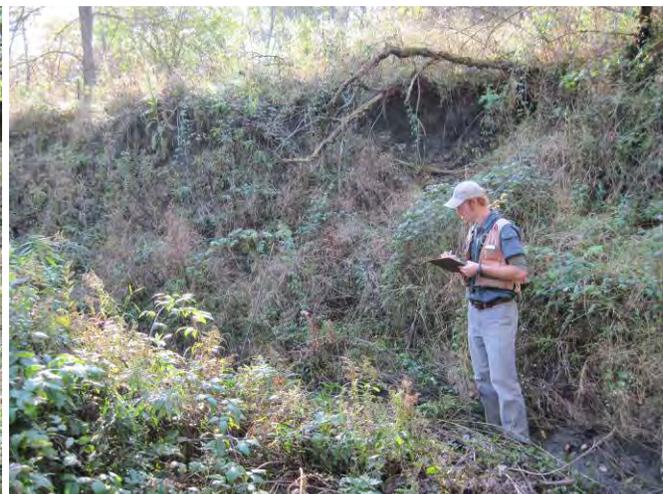
Left to right: Stn 300 looking upstream at eroding right bank; Stn 400 looking upstream at eroding left bank.

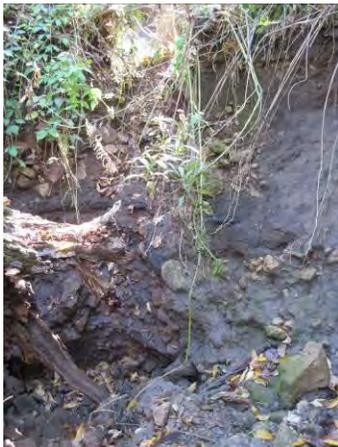
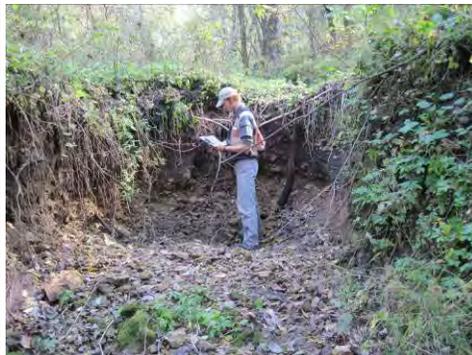
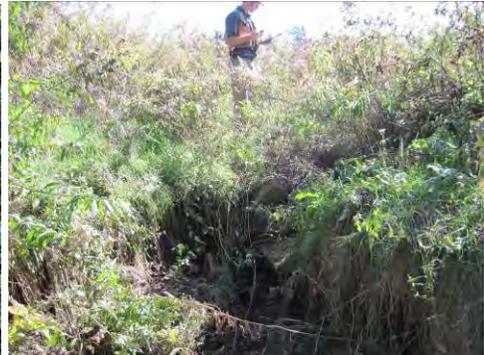
Stream: Etter Creek, Tributary 10	<p>Problem description: At least 9 knickpoints were identified throughout this reach and the associated drainages. These knickpoints are between 1 and 6 ft in height and are likely the result of increased hydrology due to agriculture in the upper portions of the subwatershed. These knickpoints are not threatening to erode crops immediately, but a few of the smaller drainages may eventually incise to cropland. Upstream of Stn 3500, the land has been converted to native grasses and shrubs. This has likely helped slow the knickpoints in this area. Elsewhere, however, there is little buffer between the crops and the edges of the steep hillsides of the drainages leading to increased water flow and headcutting.</p>
Station: 750-4100, including drainages	
<p>Solution: Similar to Tributary 5, a combination of stormwater retention basins and conversion of managed fields to native vegetation is likely the most effective way of diminishing the water volume and minimizing sediment transport. Retention basins could be built near Stn 800 and Stn 3500 of Trib 10 and Stn 500 of the drainage that flows into Trib 10 at Stn 3100. These basins will slow the flow of water and sediment to Etter Creek. To minimize further incision in this subwatershed, we recommend converting some crop land to native grasses, shrubs, and trees. While some land has already been converted, little buffer exists between crops to the south of the channel and the steep hillslopes of the drainages in that area. By creating a native vegetation buffer around these drainages, infiltration will increase and water volumes flowing downstream will decrease.</p>

Left to right: Stn 750 looking upstream at 4-ft knickpoint; Stn 1650 looking upstream at 4-ft knickpoint; Stn 4075 looking upstream at 3-ft knickpoint and fallow fields beyond.

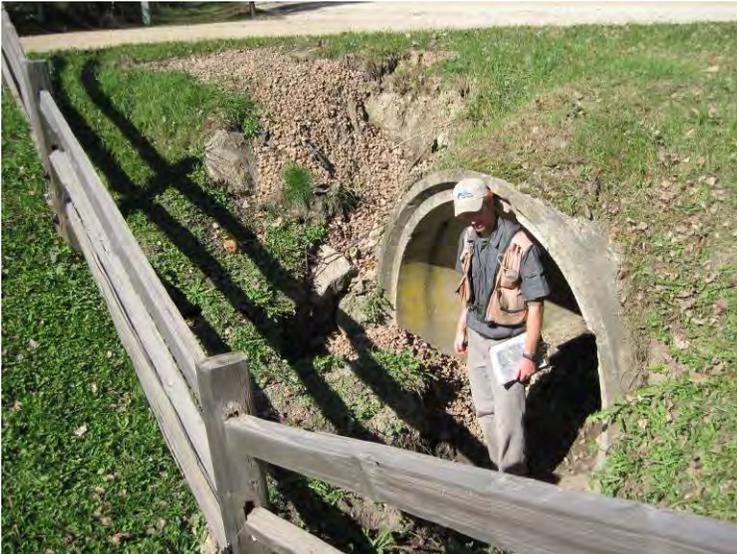
Stream: Etter Creek, Tributary 11	Problem description: Minor erosion is occurring on left side of the upstream end of the concrete culvert that is under 145th Ave. The erosion is nearing the driveway and some effort has been made to reduce the erosion by placing riprap and pouring gravel on the bank. Erosion and piping continue.
Station: 100	
Solution: Regrade the bank, stabilize the toe, and plant shrubs and trees so the longer roots can stabilize the bank. Also, remove the fence post in the middle of the 'channel' as scour is beginning to occur around the base of the post.

Stn 125 looking downstream at culvert and erosion.

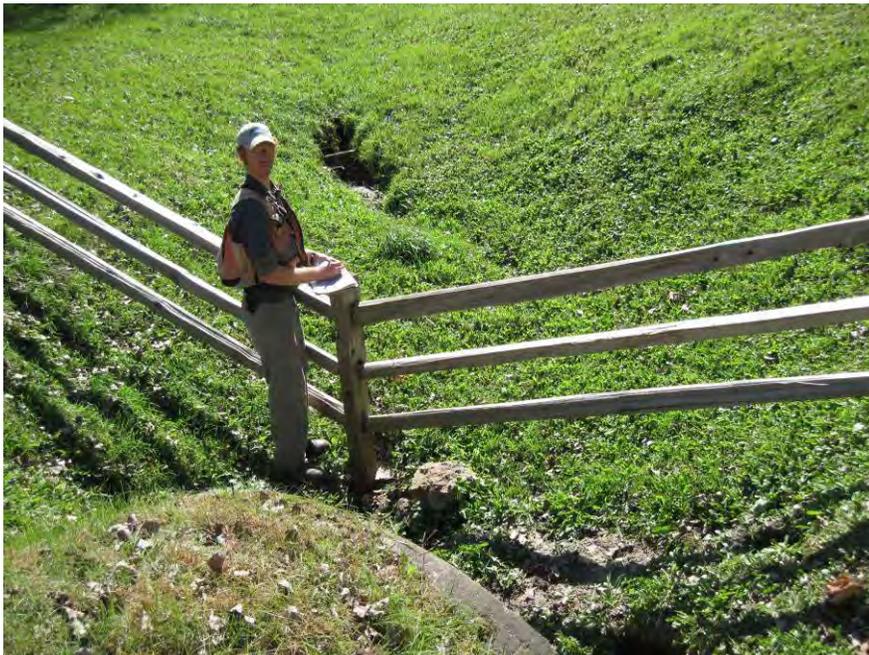
Stream: Etter Creek, Tributary 11	Problem description: A small scour hole has formed in the middle of the grassy field. This could lead to further scour or incision.
Station: 150	
Solution: Convert grassy field to native vegetation including grasses, shrubs, and trees. The increased diversity in vegetation and root length will improve stability throughout the field and will also improve riparian habitat.

Stn 100 looking upstream at small scour hole in grassy field

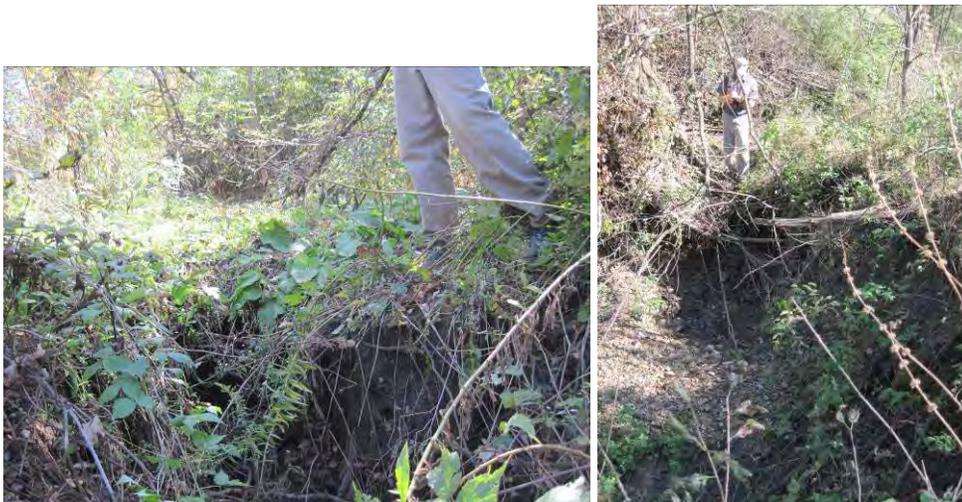
Stream: Etter Creek, Tributary 12	<p>Problem description: Three 4-ft knickpoints were identified throughout this reach and the associated drainages. These knickpoints are likely the result of increased hydrology due to agriculture in the upper portions of the subwatershed. These knickpoints are not threatening to erode crops immediately, but a few of the smaller drainages may eventually incise to cropland. The retention basin built at Stn 4000 has likely reduced incision and there are currently no active knickpoints between this basin and the junction with a small drainage at Stn 3200. The three knickpoints, however, appear to be slowly migrating upstream, which could impact side drainages and eventually cropland.</p>
Station: 1000-3300, including drainages	
<p>Solution: Similar to Tributary 5, a combination of stormwater retention basins and conversion of managed fields to native vegetation is likely the most effective way of diminishing the water volume and minimizing sediment transport. Additional retention basins could be build on the drainages that flow into Tributary 12 at Stns 1000, 1600, and 3200. To minimize further incision in this subwatershed, we recommend converting some crop land to native grasses, shrubs, and trees in the vicinity of these three drainages as well as along the southern border of Tributary 12 between Stns 2200 and 3200. By creating a native vegetation buffer around these drainages, infiltration will increase and water volumes flowing downstream will decrease.</p>

Left to right: Stn 2400 looking upstream at 4-ft knickpoint at grass road crossing; Stn 1750 looking upstream at 4-ft knickpoint.

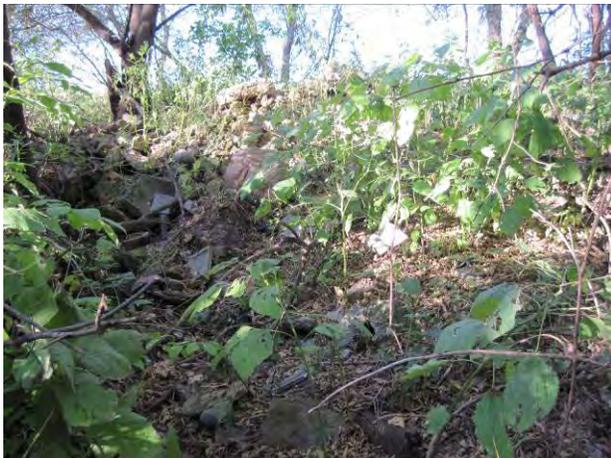
Stn 3050 looking upstream at cobbles dumped onto knickpoint.
