Vermillion River Watershed Joint Powers Organization  
**Fluvial Geomorphic Assessment of North Creek and  
Middle Creek, Dakota County, MN: Final Report**

January 6, 2012

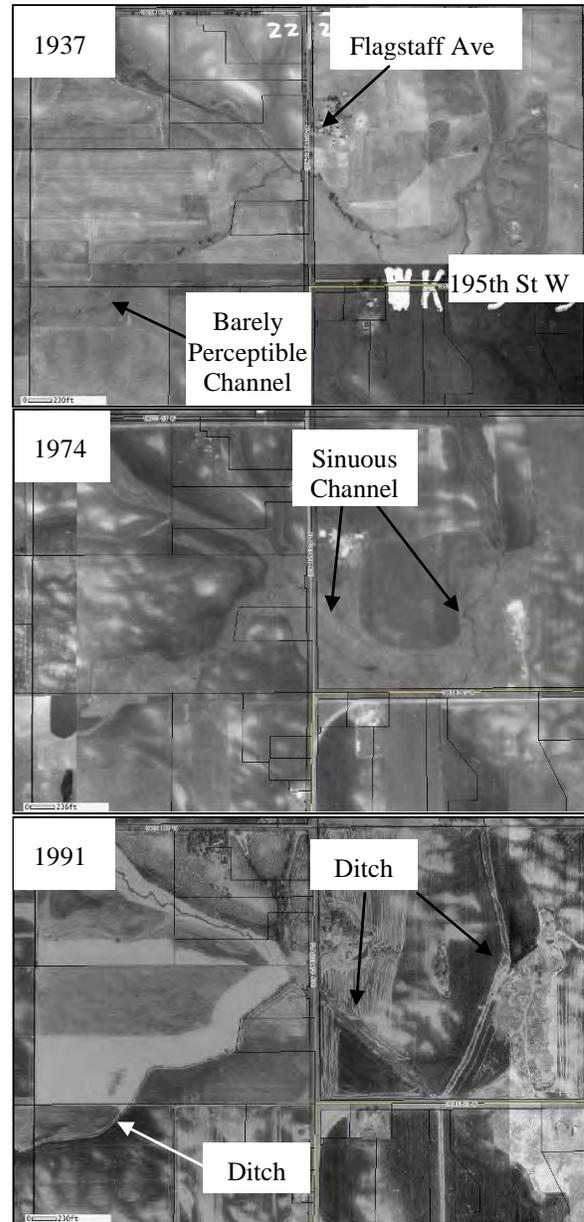
Figure 6: Air photos from (top to bottom) 1937, 1974, and 1991 showing Middle Creek channel changes from minor, intermittent, sinuous channel in 1937 to larger ditches in 1991. Upstream of 195th St W, Middle Creek is joined by Tributary 7 from the northwest.

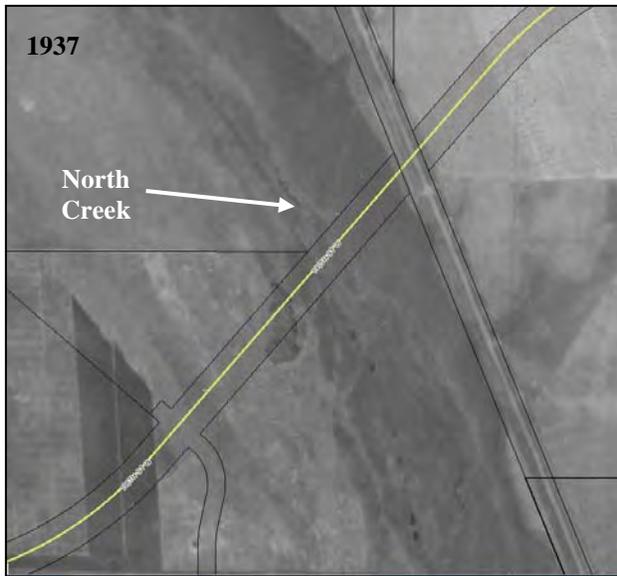
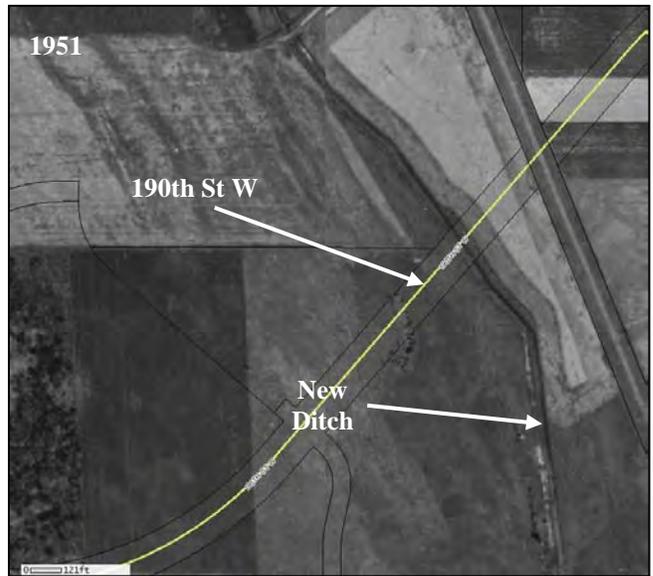
While agriculture had been active for many years, air photo analysis suggests that North Creek may have remained a meandering wetland channel until sometime between 1937 and 1951 (Figure 11). By 1951, North Creek had become a straightened channel that remained in the same alignment until the restoration project in 2009. On Middle Creek, the transformation from meandering channel to straightened ditch did not occur until between 1951 and 1964 (Figure 12). Portions of this new ditch were more than 1000 ft to the west of its original alignment. This likely partially explains the severe incision in the ditch as well as the severe incision in the tributary to the west.

Figure 11: In 1937, the portion of North Creek that was restored in 2009 was barely perceptible meandering wetland channel. By 1951, the channel had been straightened into a ditch.

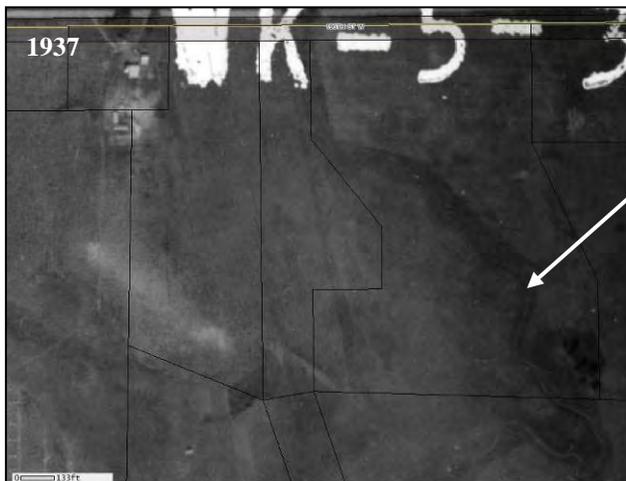
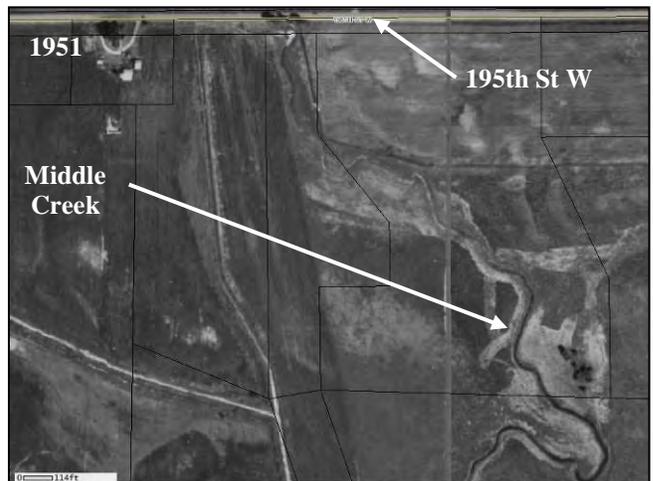
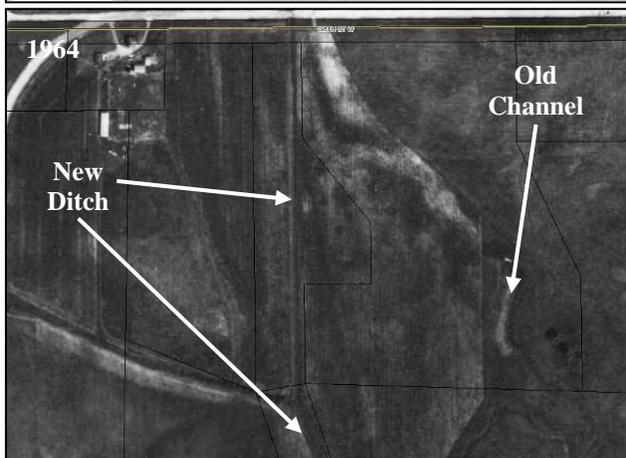
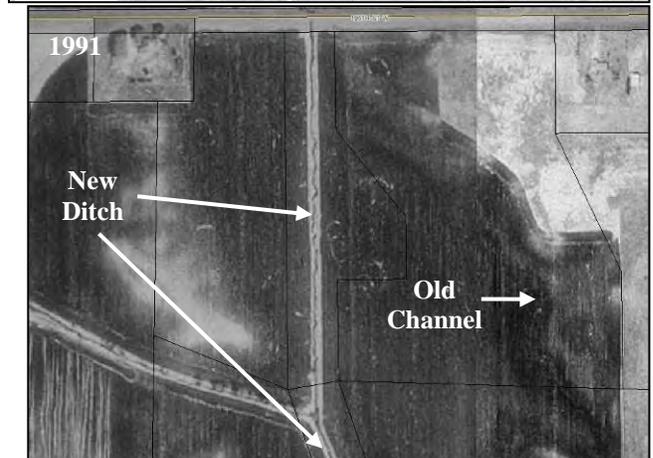
Figure 12: The Middle Creek restoration site was sinuous until sometime between 1951 (top right) and 1964 (bottom left). While the old channel scar is nearly gone by 1991 and the straightened ditch is obvious.

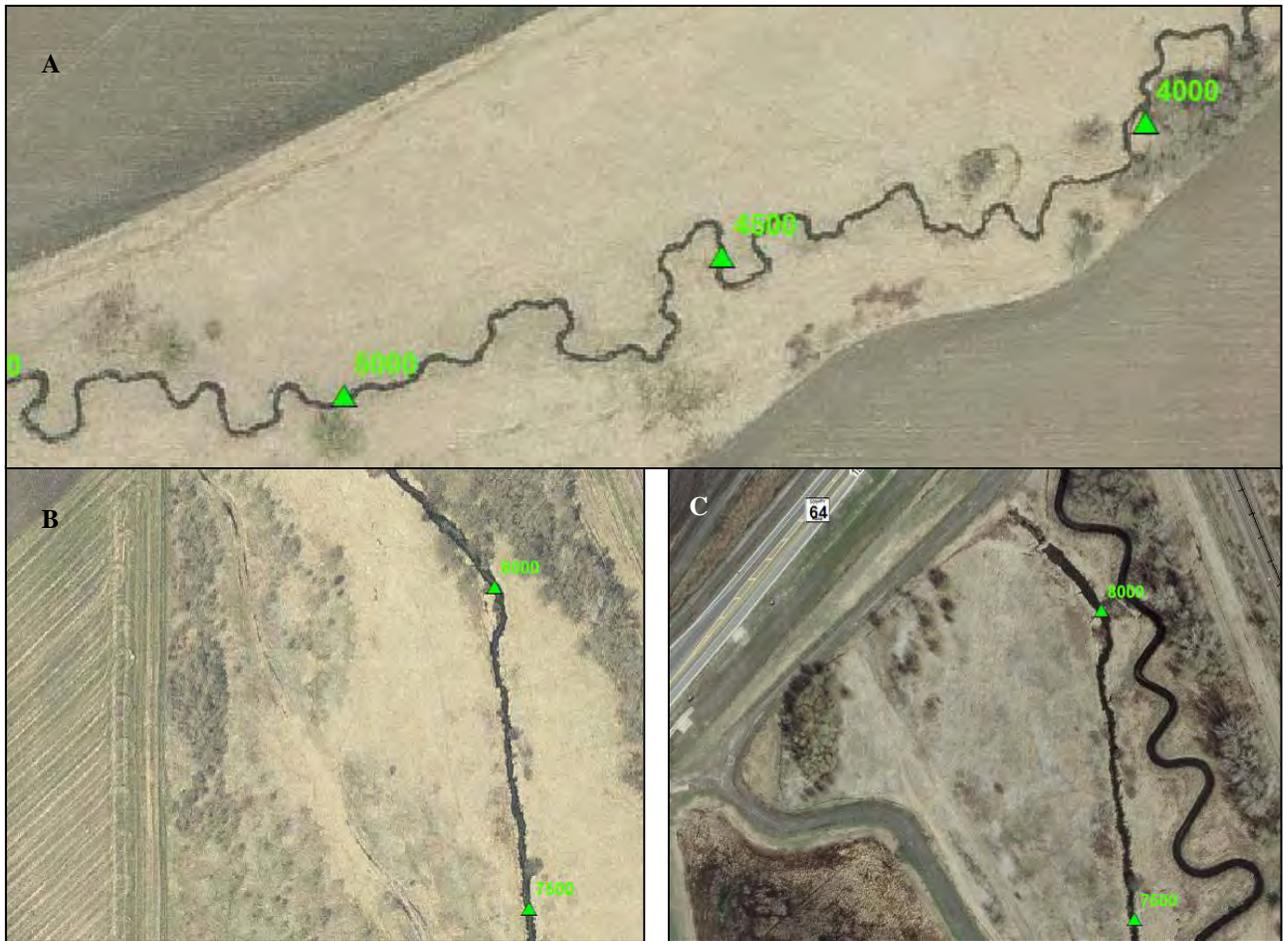
As discussed above, this portion of North Creek was identified as sinuous channel flowing through a wetland in the 1855 maps, suggesting that cold groundwater is very close to the ground surface. Between the mouth and Pilot Knob Rd, North Creek has now been straightened into a ditch, but 100-200 ft on either side of the channel is currently wetland and not being farmed or developed. This wide riparian buffer provides the opportunity to increase channel sinuosity, improve wetland and riparian vegetation, and re-activate the wetlands. The 1855 plat maps, historic air photos, and the lower portions of Middle Creek provide a template for a more natural channel planform (Figure 13).

A portion of North Creek has already been restored, between Stn 7000 and 10,000, and this restoration has provided insights to the restoration potential. In the restored section, a new sinuous channel was built and the old straightened channels were blocked off in a few locations or remained open on the downstream end. While the water temperatures in the new sinuous channel were in the mid 70s (°F), the temperatures in the abandoned channels were in the mid 50s. This suggests that the abandoned channels are receiving cold groundwater from beneath the wetland. These abandoned channels could provide excellent backwater and alcove habitat and cold-water refugia. In future restoration projects, side channels, off-channel pools, alcoves, and backwaters should be incorporated so as to benefit from this cold water.

Figure 13: (A) Lower Middle Creek showing sinuous channel left largely untouched since settlement demand in the mid-1800s. North Creek (B) before and (C) after restoration. The sinuosity and channel geometry is more uniform that on Middle Creek, but the meander width and wavelength are similar.

While more than 4 miles of North Creek has the potential for excellent cold-water habitat as described above, multiple complete fish passage barriers within this section exist. Three culverts under driveways and farm roads between the mouth and Stn 10,000 are steep and undersized, while a small dam at Stn 20,050 prevents further upstream passage. Two of the undersized culverts that present complete passage barriers are downstream of the recently restored channel. Prior to, or concurrent with, any future channel restoration, these barriers should be removed or replaced with larger culverts or bridges.

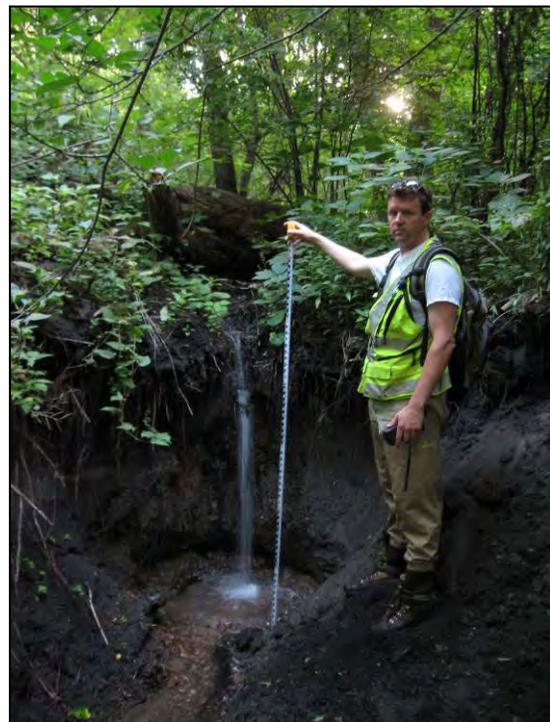
Figure A-2: A headcut and incised channel on a small stream in Scott County.

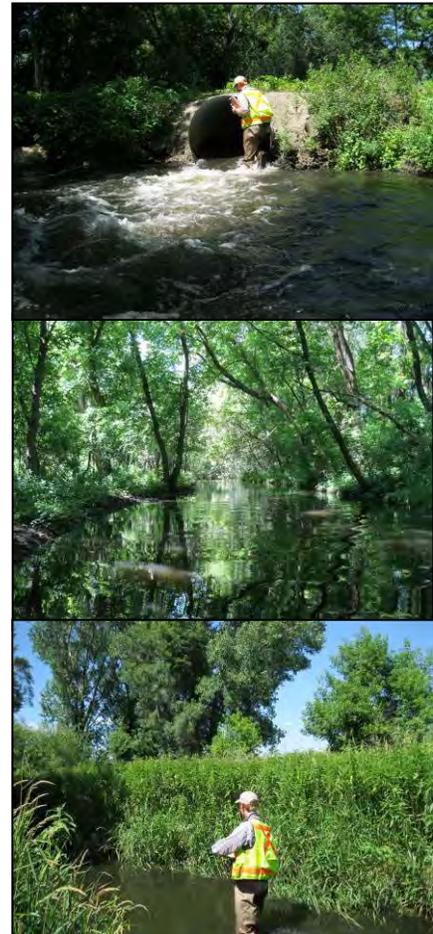
Reach 1 of North Creek is a partially forested sinuous channel with some relatively straight sections that extend 3,800 feet from its confluence with the Vermillion River. The channel geometry is relatively consistent and the channel is stable with little noticeable bank erosion or incision. The channel bed is primarily composed of sand and silt, though the lower portions of the reach near the Vermillion River contain gravel in the main channel with the finer grained material on the edges. The channel banks are primarily composed of dark silty loam. Vegetation varies between long segments dominated by reed canary grass with no canopy cover and segments with large cottonwoods, willows, and other riparian trees that provide thick canopy cover and excellent shade and riparian habitat (Figure C-2). In general, this reach is in relatively good condition, although one culvert is undersized and presents a partial fish passage barrier.

Figure C-2: North Creek, Reach 1 (Top) Stn 2,300 looking upstream at undersized culvert; (middle) Stn 2,700 looking upstream at wooded section; (bottom) Stn 3,250 looking upstream at section heavy with reed canary grass and lacking canopy cover.

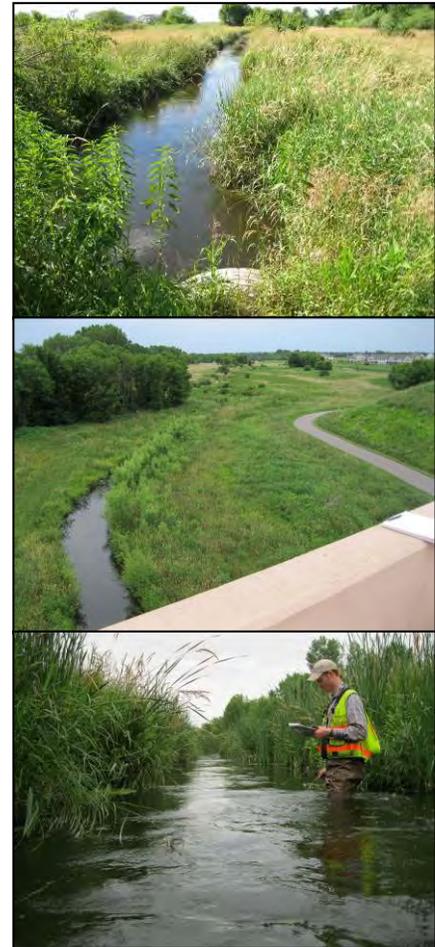
Figure C-4: North Creek, Reach 2; (top) Stn 5,375 looking upstream at the abundant reed canary grass; (middle) Stn 8,500 looking downstream from the 190<sup>th</sup> bridge; (bottom) Stn 14,700 looking upstream at the cattails.

The banks are nearly vertical and, in many locations, undercut with reed canary grass overhanging the channel. The channel banks are primarily composed of dark silty loam. The channel is in the middle of a wide (200-700 ft) wetland dominated by reed canary grass, Canada thistle, and nettle. Throughout the wetland, however, are patches of sedges, rushes and occasional willow shrubs, ash, and buckthorn. Portions of the wetland are spongy, and small channels course through in some locations.

In general, this reach has a great deal of restoration potential. The width of the wetland provides an opportunity to increase the sinuosity, build small side channels and off-channel pools, and provide recreational opportunities through the North Creek Greenway Project. Cold groundwater seeps into the wetland and channel throughout. This groundwater is apparent in the restored section where the water in the abandoned channels is 10-15°F cooler than the main, restored channel. The cooler temperatures indicate that cold groundwater is seeping into this reach but is being diluted by the warmer water from upstream. The wide wetland provides the opportunity to tap into this cold-water resource and provide habitat for all life cycles of cold-water species even when the main channel is warmer.

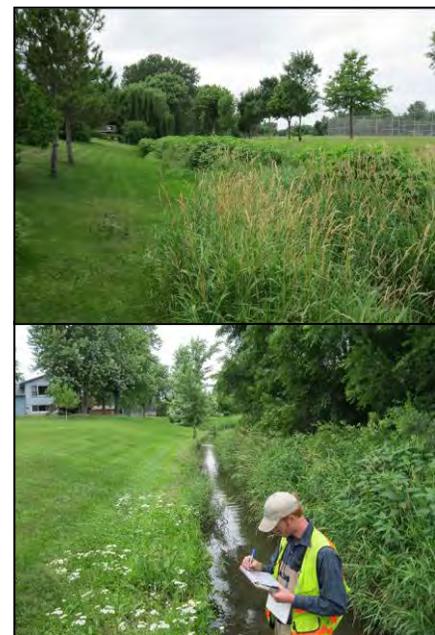
Figure C-6: North Creek, Reach 3; (top) Stn 28,250 looking upstream; (bottom) Stn 32,300 looking upstream at section with mowed lawn to the channel bank.

straightened ditch through residential neighborhoods and parks and acts as stormwater pipe to move water downstream through the reach as quickly as possible (Figure C-6). The channel is narrower than it would have been naturally, and the channel bed lies 6-10 ft below the surrounding land surfaces, on which the houses and parks are built. The channel width and depth vary throughout this reach from wide and shallow to narrow and slightly deeper, but the channel throughout is essentially a straightened ditch. While canopy cover exists in some areas, there is little effective riparian vegetation. Grass and shrub buffers have been provided in some locations, but these are too narrow to provide any stormwater attenuation. Elsewhere, residents and park maintenance personnel mow and maintain lawns to the channel edge. Bank erosion is often apparent in these locations. During the rainstorm on July 15, this ditch was completely flooded and the fields were flooded in some locations. While the large amount of park land is likely of great value, much of that area could be converted to provide wide floodplains and wetlands while still providing walking trails throughout.

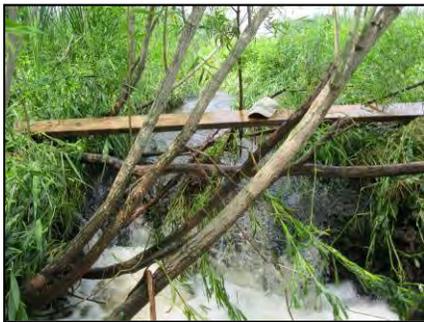
Figure C-7: North Creek, Reach 4; Stn 39,250 looking upstream at 2.5ft knickpoint.

Reach 4 of North Creek is 11,150ft from station 34,200 to station 45,350 and primarily consists of wide wetlands through which a narrow North Creek flows. North Creek was historically straightened through this reach, and the channel is actively adjusting to these changes through lateral migration and incision. Multiple 1 to 3-ft headcuts have formed through silt and clay till layers in the wetland channels resulting in steep banks and an incised channel downstream and a fairly stable channel upstream (Figure C-7). Small drainages and tributaries entering North Creek through the wetlands are incising to the new base level, and the incision can be traced upstream until the drainages blend in with the wetland surface and the channel can no longer be traced. While much of the channel contains good wetland habitat with no encroachment, incision and bank erosion is causing the downstream delivery of sediment. If the knickpoints migrate upstream to road crossings, culverts could be undermined and destabilized. With the overhanging grasses, undercut banks, and moderately deep pools and runs, this reach has decent aquatic habitat. Reach-wide restoration to eliminate the incision and utilize the functionality of the wetland could include creating a new, highly-sinuuous channel that is only

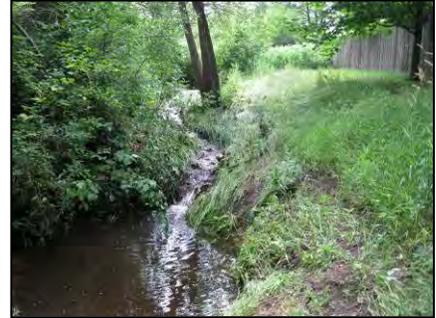
Reach 5 of North Creek runs 1,550ft from station 45,350 to station 46,900. The reach has its headwater in a stormwater basin and consists of a narrow, straightened channel. It flows through residential neighborhoods. The narrow channel flows within a narrow alluvial valley with houses constructed on a terrace about 8 ft above the channel bed. Although riparian buffer is available, especially on the right side, there is little geomorphic and habitat complexity in the channel. Three 2-ft knickpoints are migrating upstream, and downstream bank erosion is resulting, particularly where adjacent landowners have removed the riparian vegetation and mowed to the channel edge (Figure C-8).

Figure C-8: North Creek, Reach 5; Stn 46,550 looking upstream at a 2ft knickpoint.

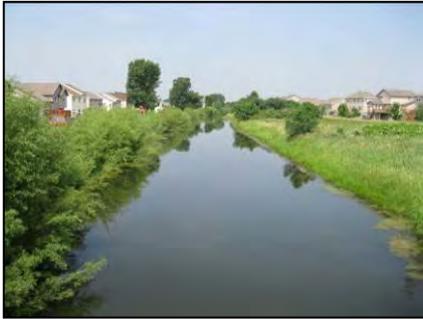
Reach 2 of North Creek Tributary 1 is 5,300ft long and consists of a series of in-stream stormwater basins built along with the residential developments that surround the current stream (Figure C-10). The river was straightened and over-widened, and multiple grade controls were built to hold back water. While stormwater retention is helpful in slowing the movement of stormwater into the river, the system of in-stream basins with little vegetation cover results in

Figure C-10: North Creek, Tributary 2; (top) Stn 2,900 looking upstream from Dunbury Ave.

high water temperatures (exceeding 75°F and 80°F) and poor water quality. It may be more appropriate to retain a very narrow and sinuous channel through a narrow corridor bounded on both sides by elongated stormwater basins that only discharge to the river during large storm events. The majority of the stormwater basins in this area are too deep to sustain wetland vegetation and too shallow to eliminate the growth of aquatic vegetation and algae.

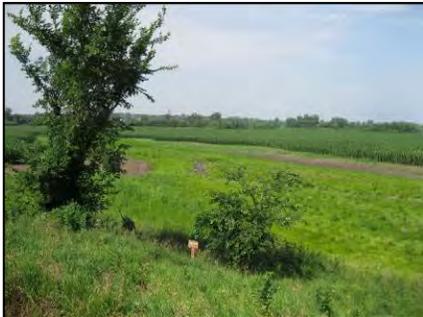
Figure C-11: North Creek, Tributary 2; Stn 2,200 looking downstream from railroad.

Where defined, North Creek Tributary 2 is a shallow swale through agriculture fields. In other areas, Tributary 2 is an undefined channel (Figure C-11). We could not find the outlet to North Creek. This swale drains ground water seeps and stormwater over fields. Water temperatures at the railroad bridge were below 60°F. No aquatic habitat or riparian habitat exists.

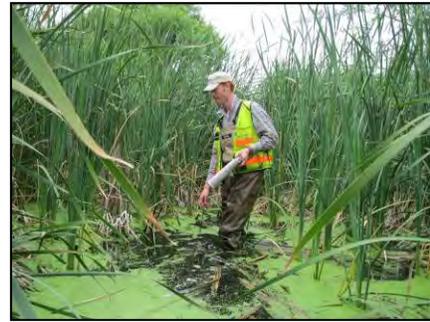
Figure C-12: North Creek, Tributary 3; (top) Stn 700 looking upstream in the wetland.

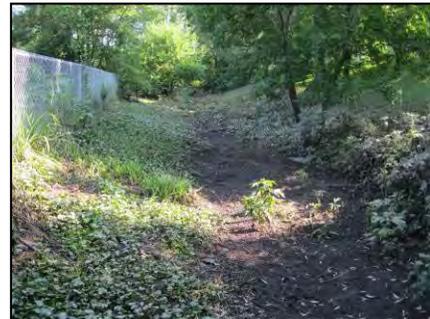
Figure C-13: North Creek, Tributary 4; (top) Stn 600 looking downstream.

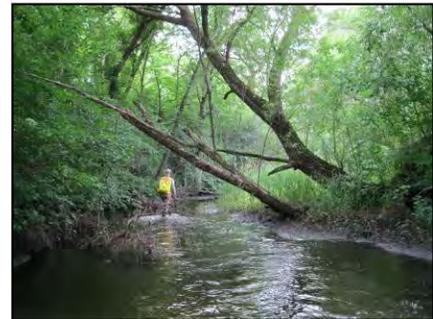
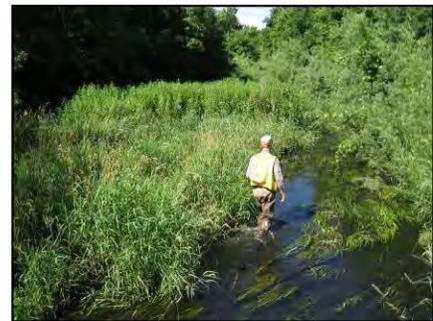
Reach 1 of Middle Creek extends 10,000 ft through wetlands to join North Creek at Stn 1700. Middle Creek in this reach is very sinuous and is actively migrating within a fairly wide wetland corridor (Figure C-15). The wetlands are dominated by reed canary grass, but in many places woody vegetation provides canopy cover. While residences are encroaching on the channel in the lower portions of this reach, there are generally wide buffers between houses or farm fields and the channel. The channel has not been straightened through much of the reach. Middle Creek, Reach 1 retains its sinuous planform and has been allowed to erode its banks and build point bars, displaying many geomorphic functions often lost in many of the over-managed streams. Because of this geomorphic complexity, habitat complexity and habitat potential is good.

Figure C-15: Middle Creek, Reach 1; (top) Stn 50 looking upstream; (bottom) Stn 7,150 looking upstream from Akin Road.

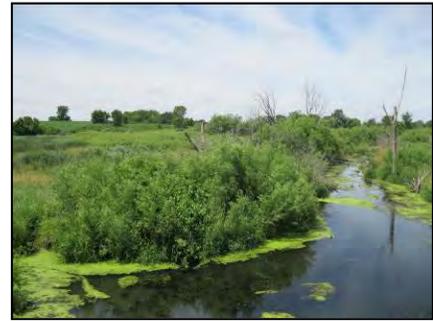
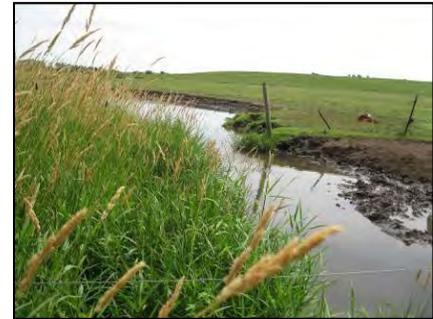
Figure C-16: Middle Creek, Reach 2; (top) Stn 13,100 looking upstream at wetland from Pilot Knob Road; (bottom) Stn 19,850 looking downstream showing active grazing.

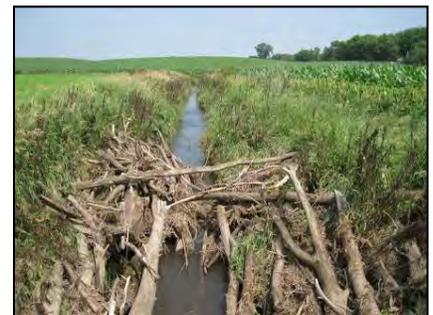
Reach 3 of Middle Creek extends 30,500 ft from the headwaters to the downstream extent of a recent stream restoration effort. The channel through the entire reach was straightened historically and has undergone varying degrees of incision (3-4 ft at the downstream extent and less upstream). The channel primarily flows through agricultural fields with no, or little, riparian buffer (Figure C-17). The lack of geomorphic complexity results in a lack of habitat, and the lack of riparian buffer decreases the canopy cover and shading. Much of the upper sections of this reach may not have been a defined channel historically but rather a swale through the rolling hills. The historic swales in this reach were straightened and deepened as the land was cleared for agriculture and tilling, and residential development. These changes increased water volume in the channel. Today, flood flows spread out over the fields and transport fine-grained sediment into the stream increasing turbidity and decreasing water quality. Knickpoints have often been halted at road crossings with deeper channels downstream than upstream. While road crossings do provide good grade control, they should be monitored to ensure there are no effects on the infrastructure.

Figure C-17: Middle Creek, Reach 3; Stn 46,550 looking upstream from farm crossing.

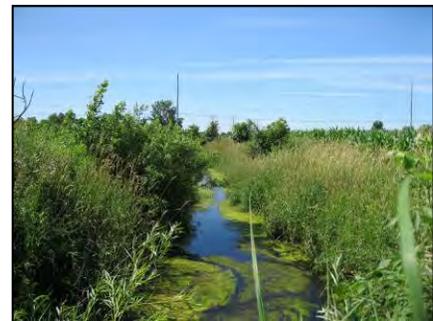
Figure C-19: Middle Creek, Tributary 2; Stn 175 looking upstream from farm crossing.

(Figure C-19). While water temperatures are warm and overhanging grasses provide some cover, there is little substrate variability, canopy cover, in-stream habitat features, or variability in channel geometry or planform. Upstream of Stn 800, there may be an opportunity to restore the channel through the open fields and wetlands between the agriculture fields and the commercial complexes. Restoration could entail increasing the sinuosity, creating multiple side channels to tap into the groundwater seeps, installing large woody habitat features, creating backwater habitat and riffles and pools, and providing canopy cover.

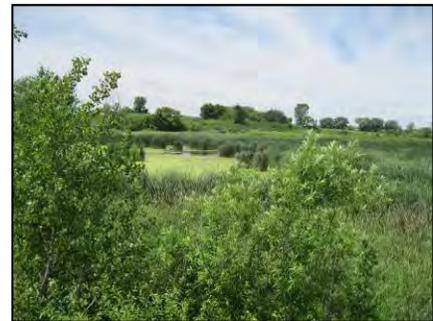
A detailed field investigation was not completed for Middle Creek Tributary 4, which extends 5900 ft from a farm field near the junction of Lakeville Blvd and Pilot Knob Rd to Middle Creek at Stn 11,500. The channel through the entire reach has been straightened and ditched. Downstream of Stn 2500, the channel joins a wide wetland with Middle Creek, and it is difficult to find a defined channel in places. The Pilot Knob Rd prism blocks complete floodplain/wetland access and all flows appear to be forced to Middle Creek and under the four box culverts (Figure C-20). This wetland, although containing straightened channels, provides good wetland habitat with many grasses, sedges, cattails, willows, and plenty of cover for in-stream species. Upstream of Stn 2500, the channel is between farm fields but a 20-50-ft buffer on either side has been maintained. Between Stn 2500 and 4000, this buffer is mixed grasses and trees, and upstream of

Figure C-20: Middle Creek, Tributary 4; Stn 1750 looking upstream from Pilot Knob Rd.

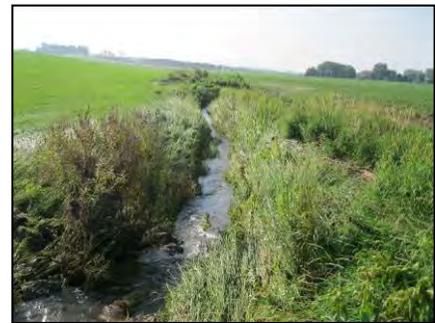
Reach 1 of Middle Creek Tributary 7 extends 1550 ft from Flagstaff Ave to Middle Creek at Stn 22,650. This portion of Tributary 7 is a channelized ditch through agricultural fields (Figure C-23). While overhanging grasses and some undercut banks provide some in-stream cover and habitat, there is little geomorphic or habitat complexity. The channel dimensions are fairly consistent throughout with little change in bed substrate or channel type. This reach is primarily made up of runs/glides with few or no deep pools or riffles. There is no canopy cover, no woody habitat and few areas for fish and other aquatic organisms to find refuge during flood flows. The flood on July 15 resulted in water spreading out onto the fields in the lower half of this reach.

Figure C-23: Middle Creek, Tributary 7, Stn 1550 looking downstream.

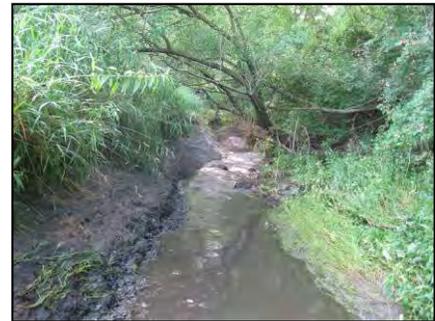
Reach 2 of Middle Creek Tributary 7 extends 6200 ft from a 190th St W to Flagstaff Ave. This portion of Tributary 7 is relatively sinuous with variable channel dimensions throughout. While the channel is incised about 3 ft at the downstream end of the reach, the channel becomes less incised moving upstream until there is essentially no incision near the 190th St W crossing (Figure C-24). In this upstream area, the channel winds through a wide wetland valley with excellent buffer width from farms. Although the adjacent ground surface is 3-8 ft above the bed of the channel, this surface remains wet from ground water seeps. The habitat is decent through this section with a large percentage of canopy cover coming from overhanging grasses and some undercut banks. There are a few canopy species but more would improve canopy cover and large woody habitat recruitment. A few trees in the downstream end have fallen and their root balls

Figure C-24: Middle Creek, Tributary 7, Stn 7550 looking downstream at incision.

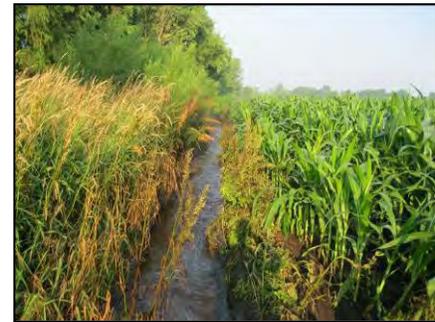
Reach 3 of Middle Creek Tributary 7 extends from close to Highview Ave to 190th St W. This portion of Tributary 7 is primarily a straightened ditch or swale in the valley bottom between fields. Much of the reach has cover from willow trees and good riparian buffer of grasses. Because the valley bottom is so flat and the farming continues into the valley bottom, however, the channel location in some places around Stn 11,000 has moved from within the vegetated wetland buffer to within the crop rows (Figure C-25). This alternative channel location is resulting in a slightly incised channel through the rows of corn. With re-grading, the channel could be encouraged to flow through the wetland again. The headwaters consist of multiple dams and small private ponds segmenting the channel.

Figure C-25: Middle Creek, Tributary 7; Stn 11,400 looking upstream at channel formed in corn field.

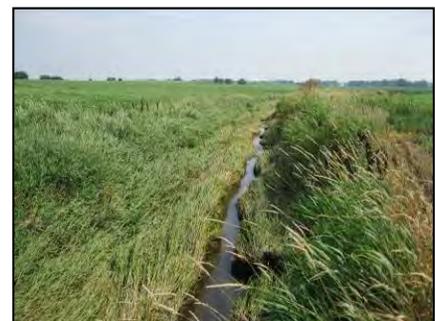
Reach 1 of Middle Creek Tributary 7A extends from Cedar Ave to Tributary 7 at Stn 1800. This portion of Tributary 7A was historically straightened and likely deepened to create the existing ditch (Figure C-26). The channel adjusted to its geometry over time to create a narrow channel between narrow floodplains within the walls of the ditch. Incision is continuing, however, resulting in excessive

Figure C-26: Middle Creek, Tributary 7A; Stn 5,300 looking downstream.

bank erosion and suspended sediment. Downstream of Stn 2100, trees provide canopy cover and some woody habitat within an approximately 50-ft riparian corridor. In this section, grasses provide an additional 50-100 ft of buffer between the riparian corridor and the farm fields. The opportunity exists in the lower portion of the reach to restore the channel with increased sinuosity, wider floodplains, and some grade control. Upstream of Stn 2100, the buffer width narrows, and the riparian vegetation is primarily grasses. The channel through this section is very narrow and entrenched within the straightened ditch with thick grass growth on the banks and slopes of the ditch. Between Stn 5750 and Cedar Ave, incision and bank erosion has resulted in 7-ft exposed clay banks and incision in small drainages entering the channel. The water is cool coming through the culvert as it is essentially ground water from tiling. This cool water (60° F) does present the opportunity to improve cool-water habitat in this reach.

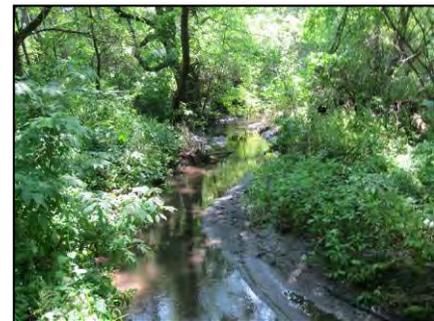
Middle Creek Tributary 7B extends from agriculture fields to Stn 6100 of Tributary 7. Downstream of Cedar Ave, the channel is fairly intact with low floodplains and copious canopy cover and woody habitat (Figure C-27). Upstream of Cedar Ave, there is no discernable channel. Cold water emanates from under the field and through the culvert under Cedar Ave. This cold water provides an opportunity for good cold-water habitat. A 3.5-ft knickpoint suggests that incision remains an active force and will continue upstream leading to increased sediment loads downstream.

Figure C-27: Middle Creek, Tributary 7B; Stn 1,100 looking downstream.

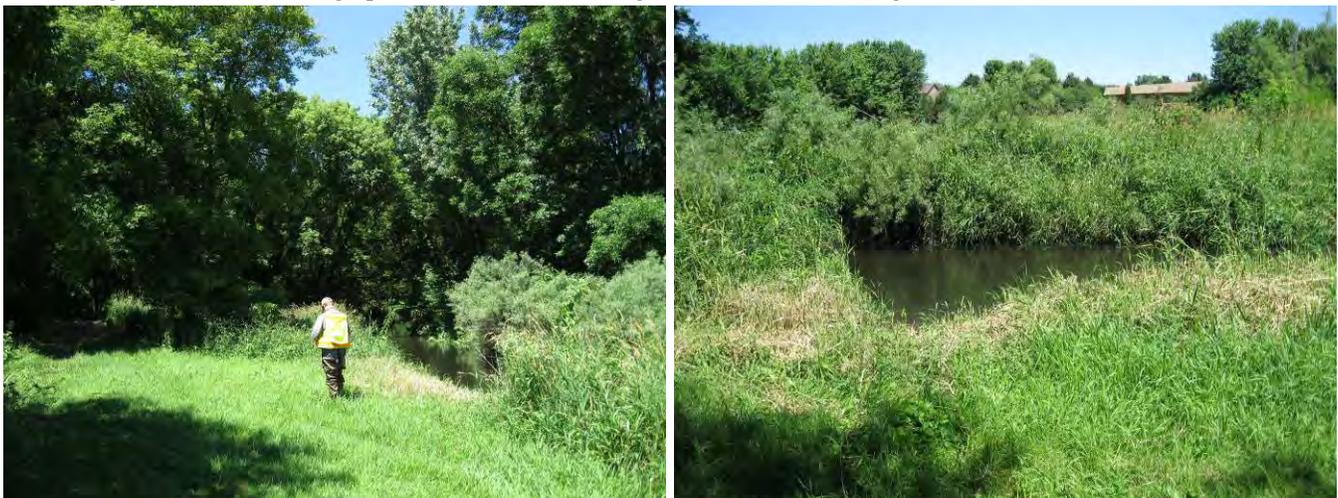
(Left to right): Stn 1100 looking upstream; Stn 1100 looking across channel from right bank

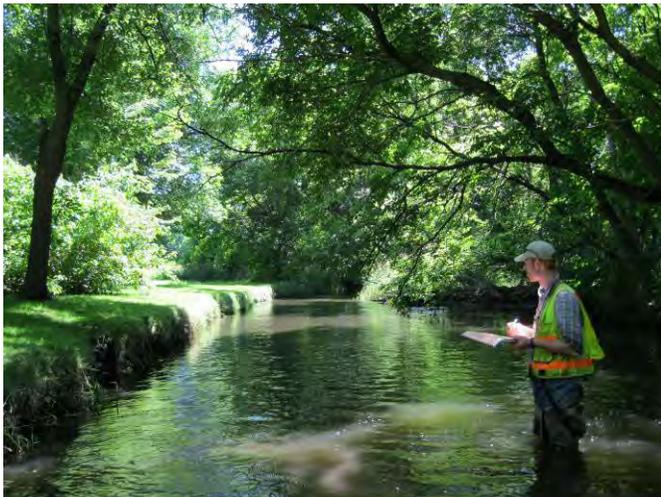
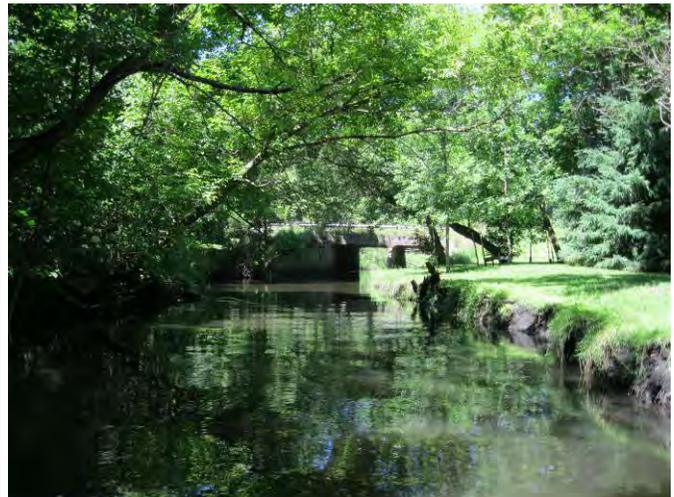
(Left to right): Stn 1400 looking downstream; Stn 1400 looking upstream

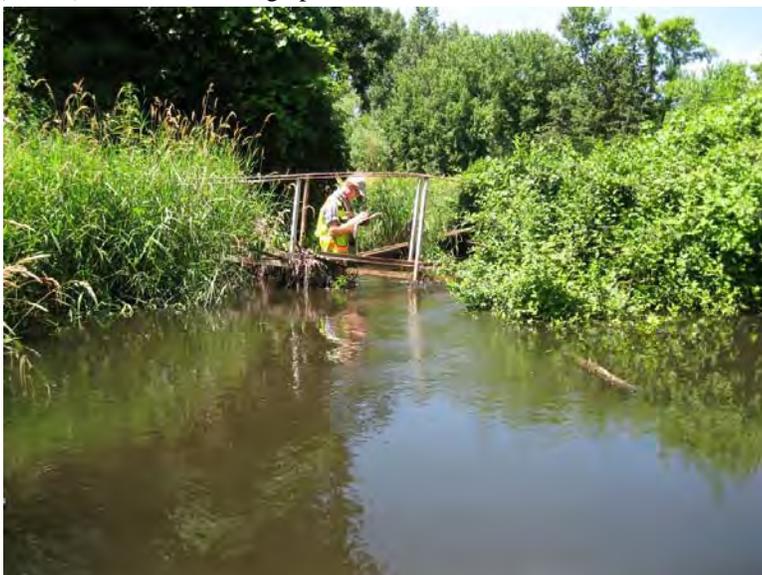
(Below): Stn 1950 looking upstream

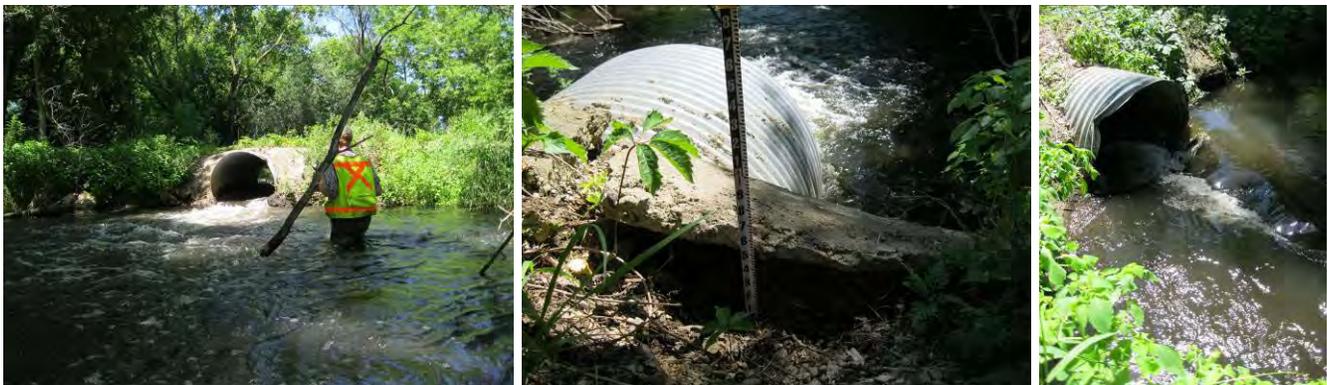
Stn 2325: 4.5-ft corrugated metal pipe is undersized and perched 1 ft; concrete around pipe is separating from the banks due to scour and water pressure during flooding; presents a partial fish passage barrier and is resulting in a deep scour pool and bank erosion on the downstream end; dirt road is likely overtopped during flooding; if road is still needed, replace with larger culvert or, if used infrequently, remove and build a gravel/cobble ford

Stream: North Creek, Reach 1	Problem description: 4.5-ft corrugated metal pipe is undersized and perched about 1 ft on the downstream end. During moderate and high flows, the velocity is too high for passage and during moderate and low flows the 1-ft drop is too high for fish to jump and water depths in the culvert would be too low. Overtopping of road crossing has caused erosion on the downstream side of road. Debris has become wedged on upstream side of culvert.
Station: 2325	
Solution: Determine the necessity of this crossing and either remove or replace crossing with a more suitable culvert or bridge. If the crossing is necessary, replace existing culvert with much larger bottomless arch culvert or multiple box culverts so that the width is greater than the bankfull width of the stream.

(Left to right): Stn 2300 looking upstream; Stn 2325 looking at erosion on downstream side of crossing; Stn 2350 looking downstream at culvert inlet

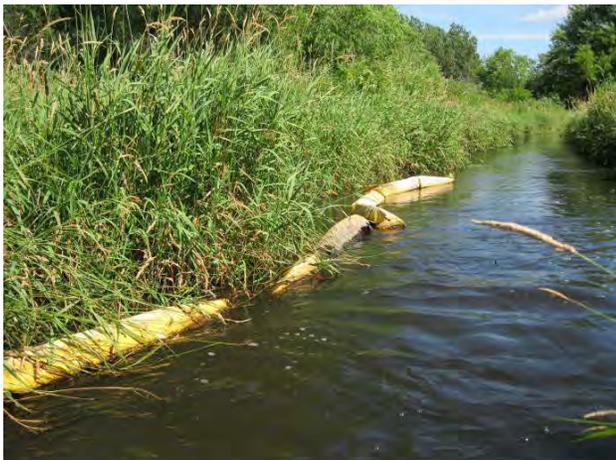
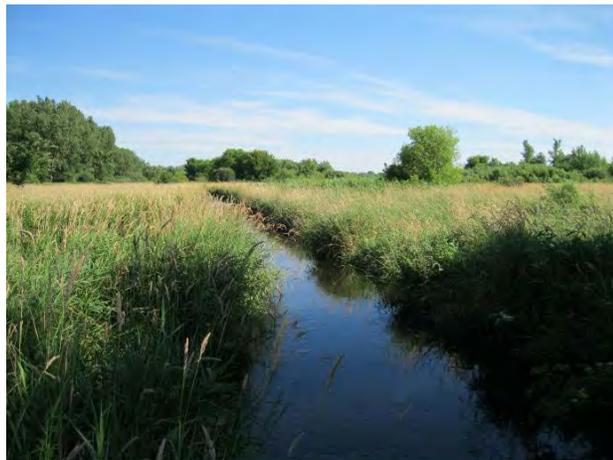
(Left to right): Stn 4400 looking downstream at silt-curtains in channel, Stn 6000 looking downstream at the straight channel

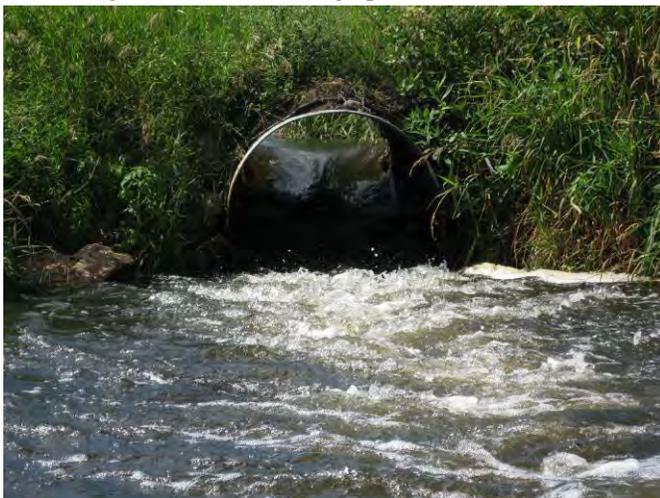
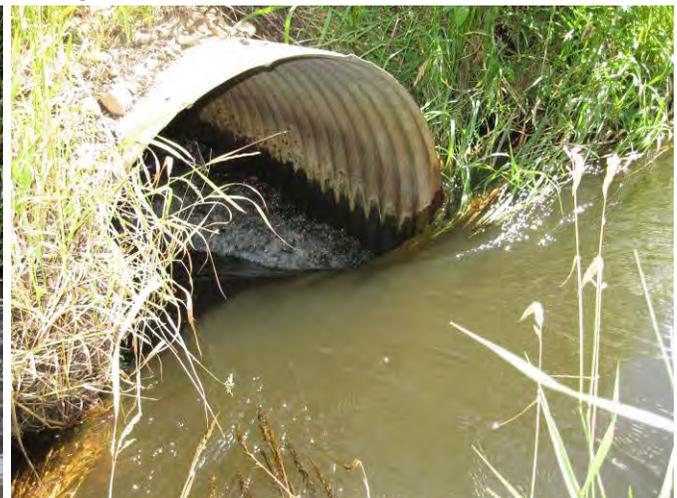
PP 08

Stream: North Creek, Reach 2	Problem description: 3.5-ft corrugated metal pipe under dirt farm road is about 2 ft higher on upstream end and is undersized. Water velocity is very high through the pipe and is likely a complete fish passage barrier during most flows. A deep (5 ft) scour hole has been created on the downstream end with associated recirculation eddies and sand bars.
Station: 5375	
Solution: Replace or if still necessary, replace with bottomless arch or partially buried box culvert. Culvert should be sized so that the width is greater than the bankfull width of the channel.

(Left to right): Stn 5300 looking upstream at culvert; Stn 5380 looking downstream at culvert inlet

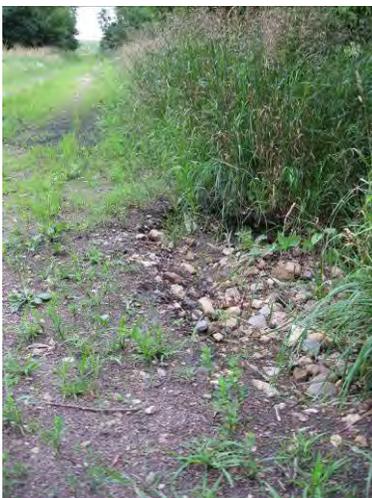
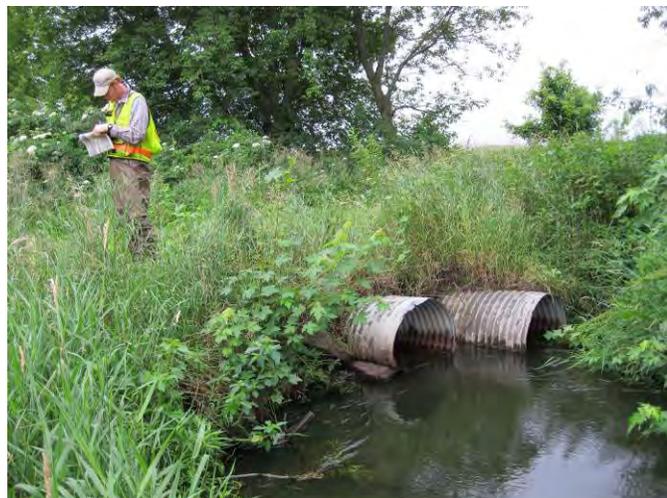
Stream: North Creek, Reach 2A	Problem description: 3, 3-ft corrugated metal pipes under dirt farm road are inadequate during high flows; some erosion of the concrete on the downstream end is visible and gullying is occurring over the road due to flooding conditions. The left pipe is lower and most of the water flows through this pipe - this provides some low-water fish passage as well. High flow passage would be difficult, however, due to high flow velocities.
Station: 9500	
Solution: If road is still needed, replace with larger culvert or if used infrequently, remove. This crossing intersects the recently restored channel, but the restored channel has not been connected on either side of this crossing. Once the restored channel is ready to be finalized, this crossing can be updated or removed at the same time. A replaced culvert width should be greater than the width of the bankfull channel.

(Left to right): Stn 9500 looking at erosion on downstream side of road crossing; Stn 9525 looking downstream at 3 CM culverts

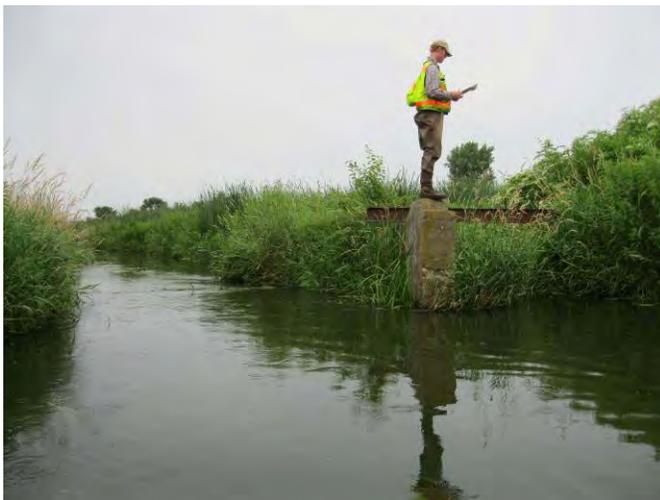
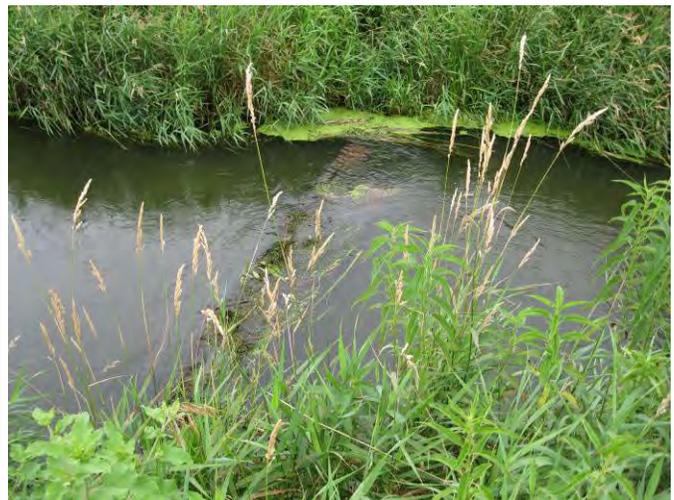
Stream: North Creek, Reach 2	Problem description: An old bridge that consists of 2 abutments and two I-beams remain in the channel. One of the I-beams has fallen and now lies submerged in the water. The earthen berm from the former bridge is cutting off floodplain and wetland connectivity. One I-beam crossing the channel may cause debris to accumulate.
Station: 16500	
Solution: Remove I-beams, concrete abutments and earthen berm.

(Left to right): Stn 16525 looking downstream at abutments; Stn 16500 looking across channel at submerged I-beam

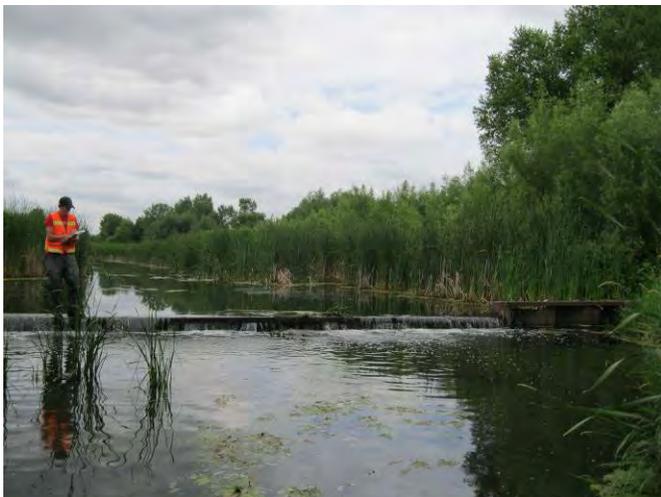
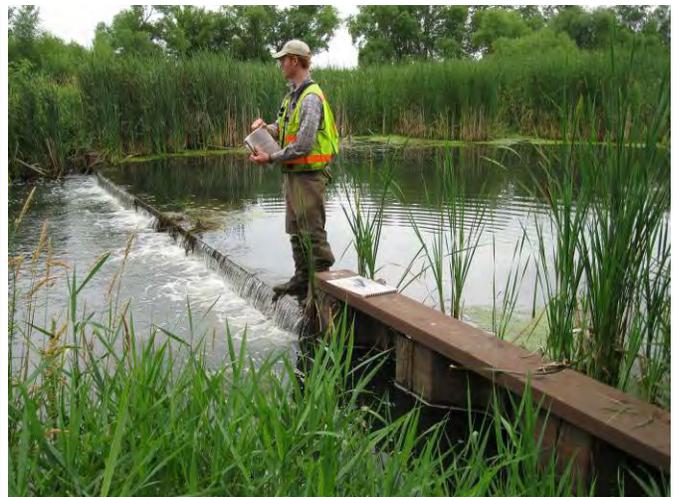
Stream: North Creek, Reach 2	Problem description: 3.5-ft tall, 1-ft wide, 40-ft long metal dam spans the channel creating a long impoundment that is about 40-50 ft wide and 3-5 ft deep. This dam creates a complete fish passage barrier and reduces the transport of sediment downstream.
Station: 20100	
Solution: The purpose of the dam is unknown, but if unnecessary it could be removed. Although active channel restoration could be completed upstream of the dam, the less costly option would be to allow the channel to self-restored. Active wetland planting would help prevent the immediate colonization by reed canary grass and other invasives.

(Left to right): Stn 20075 looking upstream at weir; Stn 20100 looking at weir from left bank

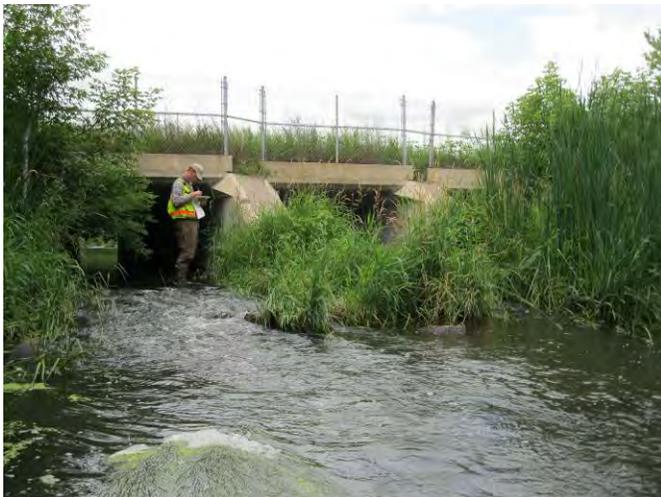
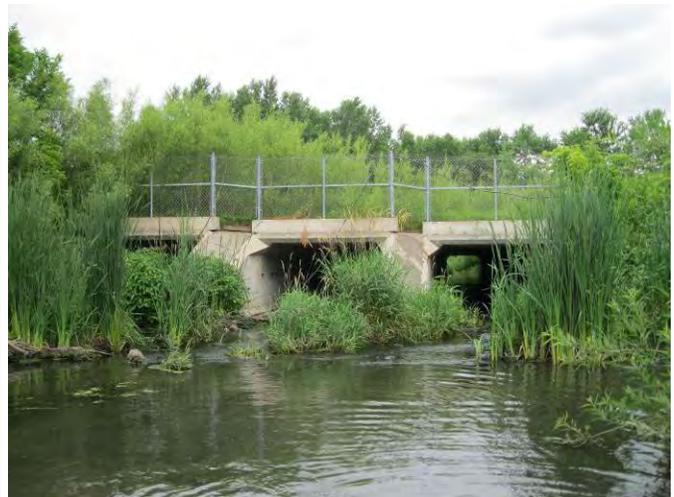
Stream: North Creek, Reach 2	Problem description: 3, 10x6-ft concrete box culverts under Pilot Knob Rd - new culverts in good condition, but the gradient over the riprap is very steep and could present fish passage challenges. No natural habitat or low-flow channel has been provided within the culverts. During low flows, flow depth may not be great enough to provide fish passage. During high flows, velocity may be too high for passage.
Station: 22,200	
Solution: Installing cobbles, boulders and other natural-like substrate could provide better fish-passage opportunities.

(Left to right): Stn 22,050 looking upstream at box culverts; Stn 22,300 looking downstream at box culverts

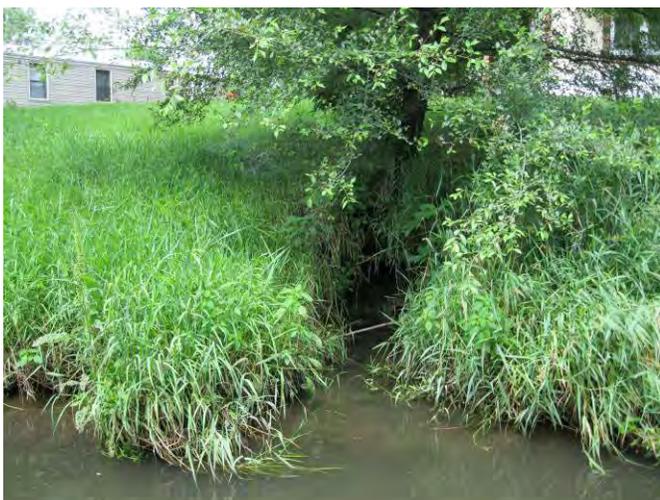
(Left to right): Stn 24,625 looking at the left bank

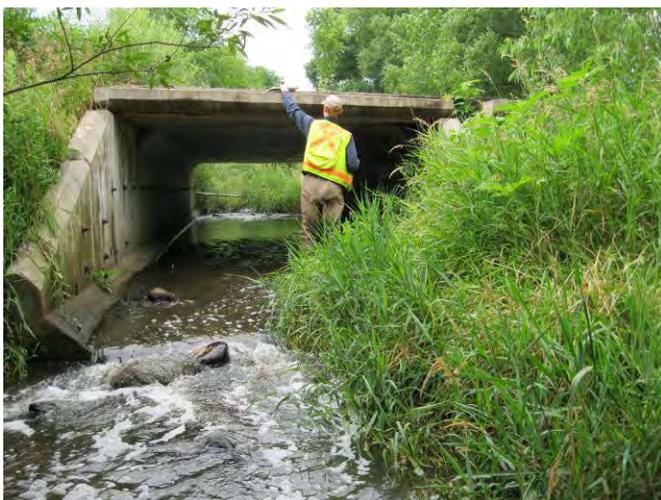
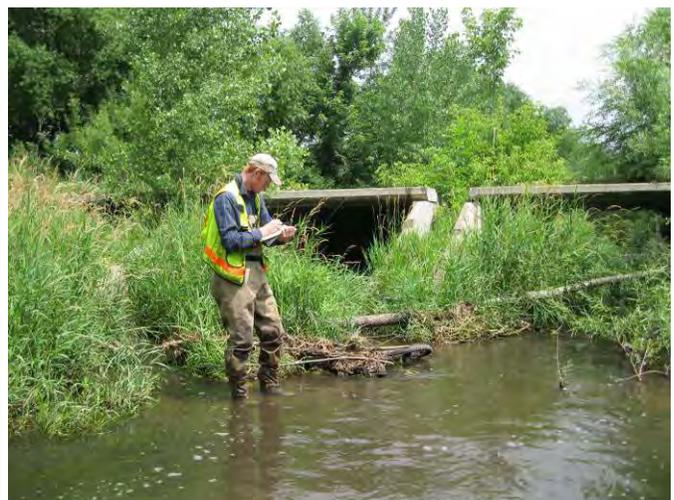
Stream: North Creek, Reach 3	Problem description: 3, 12x6-ft concrete box culverts - flat bottoms may be hard for fish to pass during very low flows
Station: 24,900	
Solution: Creating a low-flow channel by installing cobbles, boulders and other natural-like substrate could provide better fish-passage opportunities at all flow levels.

(Left to right): Stn 24,900 looking upstream at culverts; Stn 24,950 looking downstream at culverts
