Vermillion River Watershed Joint Powers Organization  
**Fluvial Geomorphic Assessment of North Creek and  
Middle Creek, Dakota County, MN: Final Report**

January 6, 2012

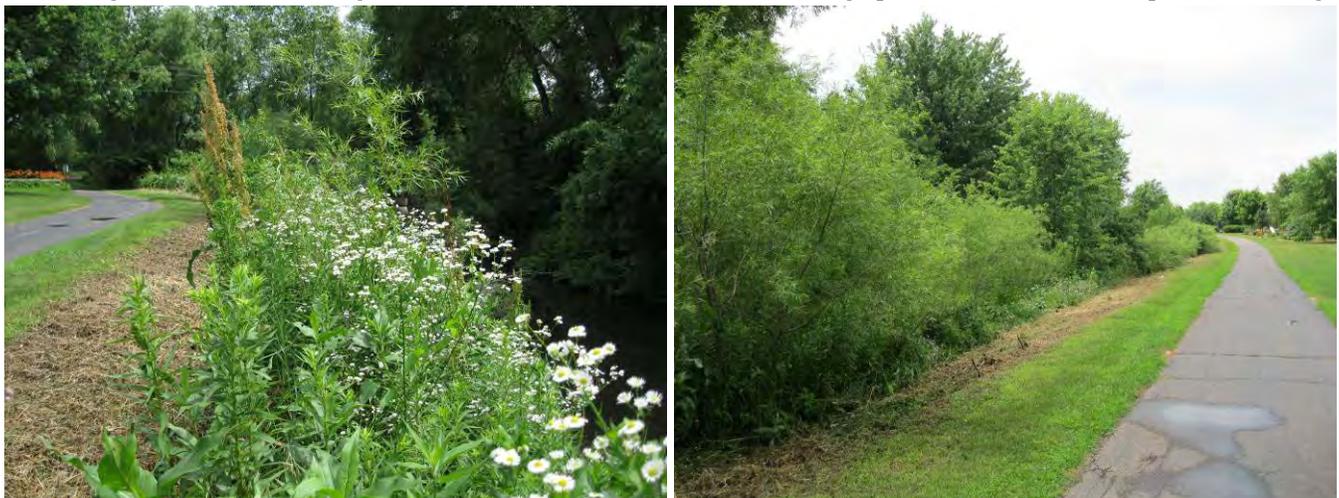
Stream: North Creek, Reach 3	Problem description: mowed to top of bench on left bank. In some locations, saplings on the left slope provide canopy cover and trees on the right floodplain provide additional cover. However, there is little stormwater buffer or opportunity for water flowing off of maintained lawns (potentially with fertilizers, etc) to seep into the ground before entering the channel
Station: 25,100-26,600, mostly left bank	
Solution: Increase buffer by limiting the width of mowed area and planting native riparian vegetation.

(Left to right): Stn 25,300 looking downstream at the buffer: Stn 25,300 looking upstream at the buffer and prox. of mowing

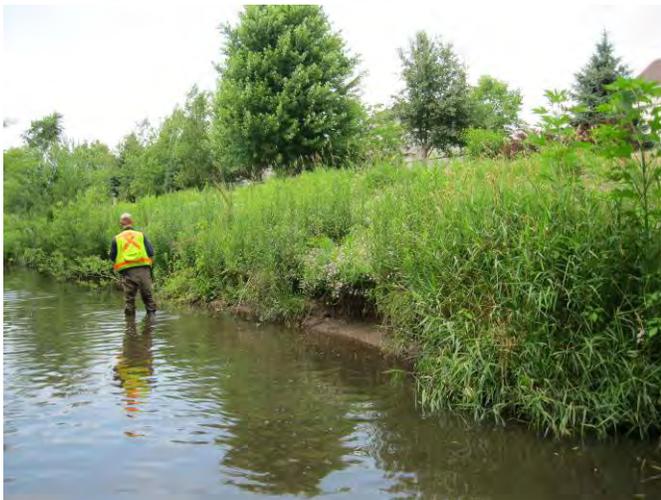
(Left to right): Stn 25,900 looking upstream at left bank erosion

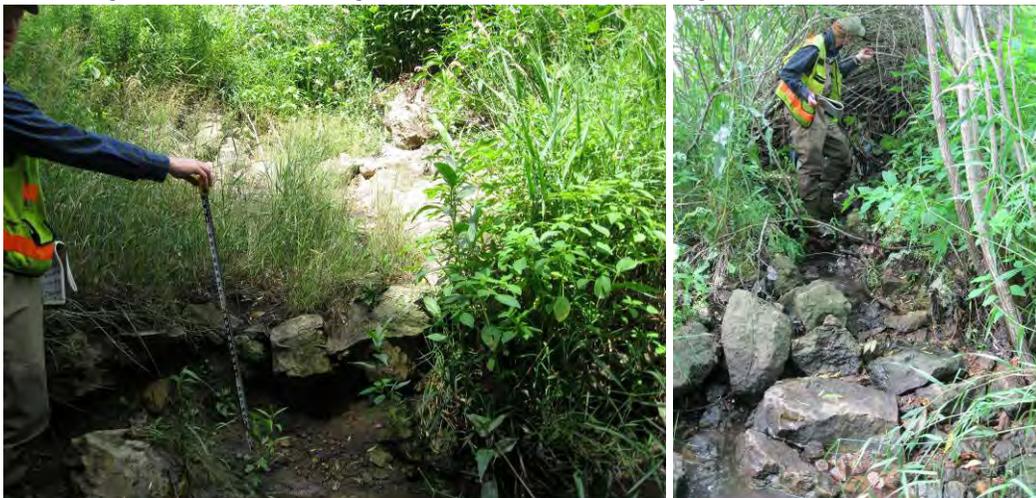
Stream: North Creek, Reach 3	Problem description: 2 pipes (18-inch concrete and 4-ft concrete) drain stormwater from stormwater basin to channel; ~1 ft of incision and erosion is apparent at each even with grouted riprap. Some riprap is falling into channel
Station: 26,400-26,450, left bank	
Solution: Monitor the erosion. If progressing rapidly, replace riprap and concrete with larger stone or lower the pipe elevation to the channel bed elevation.

(Left to right): Stn 26,400 looking at left bank; Stn 26,450 looking at left bank

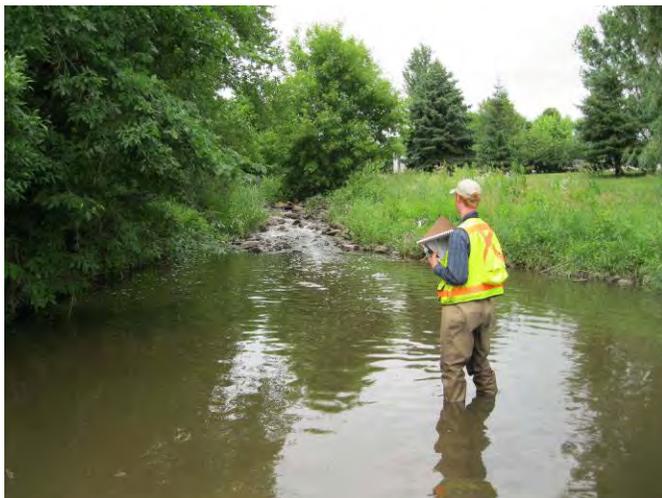
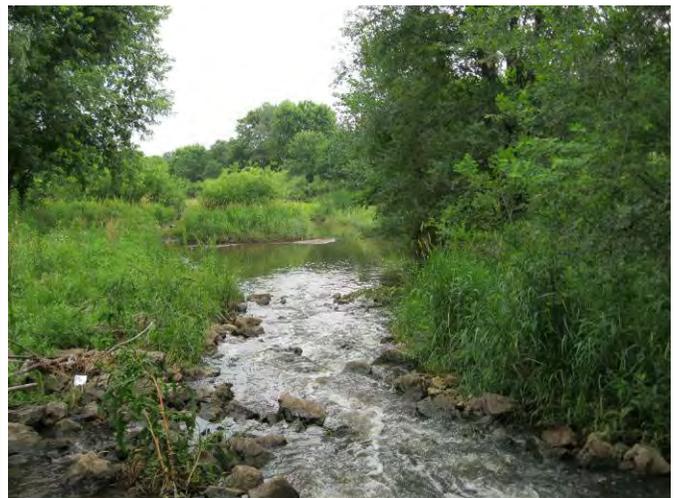
(Left to right): Stn 28,000 looking upstream at the cascades; Stn 28,050 looking downstream at the cascades

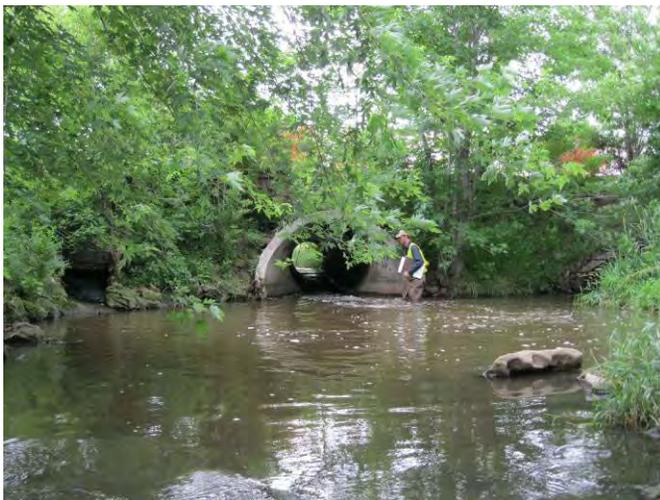
Stream: North Creek, Reach 3	Problem description: 6-ft concrete pipe under Flagstaff Ave is perched about 6 inches above the bed; backwater provides entrance into pipe, but low flows are shallow and all flows are very fast; likely a passage barrier at most flows.
Station: Stn 28,150	
Solution: Increase tailwater elevation to provide backwater through the culvert. When in need of replacement, replace culvert with larger culvert at lower elevation. <i>None of this is necessary unless downstream cascade is shown to pass fish.</i>

(Left to right): Stn 28,050

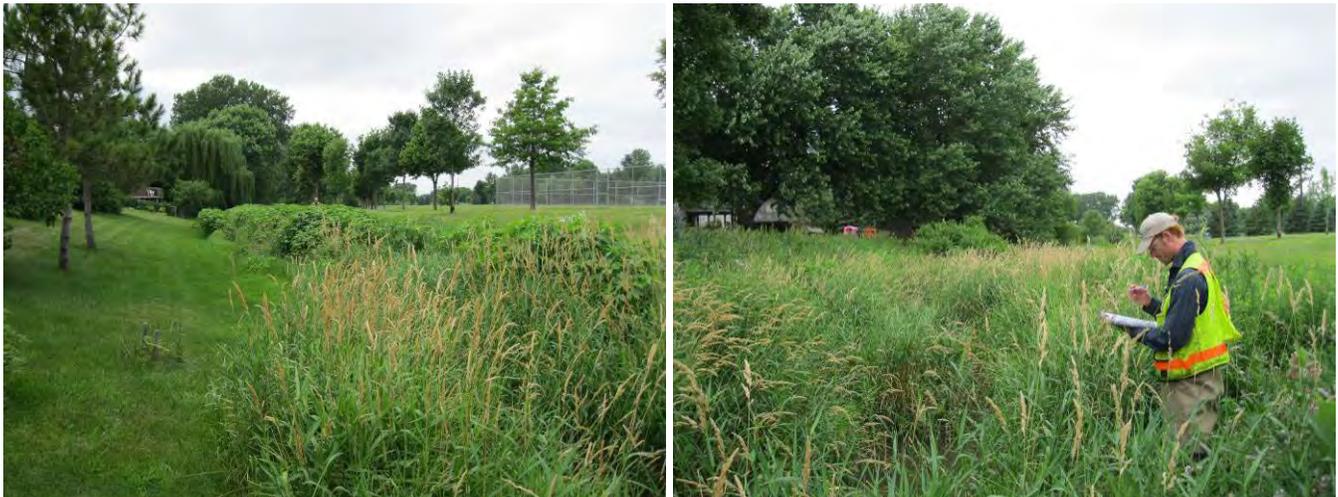
Stream: North Creek, Reach 3	Problem description: The left slope from the edge of water to the top of the bench is vegetated with grasses and wildflowers that provide an 8-ft herbaceous buffer, but there is buffer on the flat bench. Floods do inundate these fields and stormwater does flow off the fields into the channel carrying any pesticides, fertilizers and other chemicals that may have been applied. Larger trees from right side of channel provide some canopy cover; no significant erosion was observed.
Station: 28,200-29,600, left bank	
Solution: Expand riparian buffer onto the flat bench surface and include trees and shrubs in the planting plan to provide more year-round cover and protection.

(Left to right): Stn 28,250 looking upstream - park is in right side of picture; Stn 29,300 looking upstream

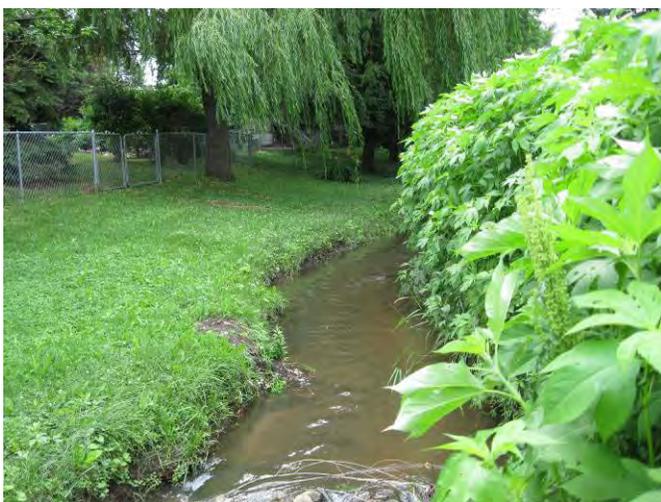
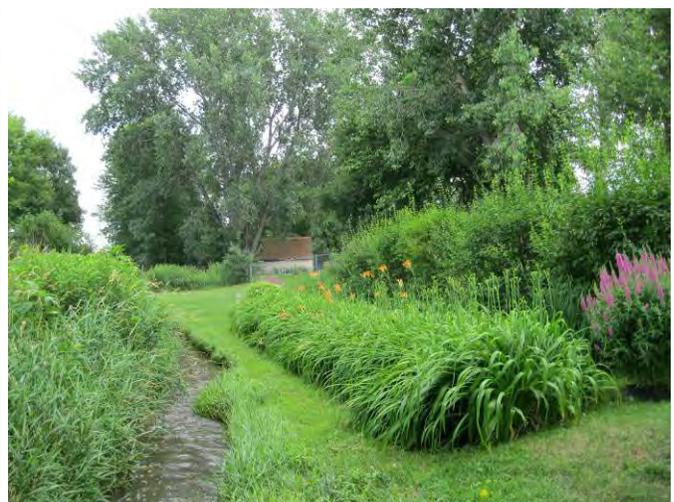
(Left to right): Stn 28,500 looking upstream; Stn 28,900 looking downstream

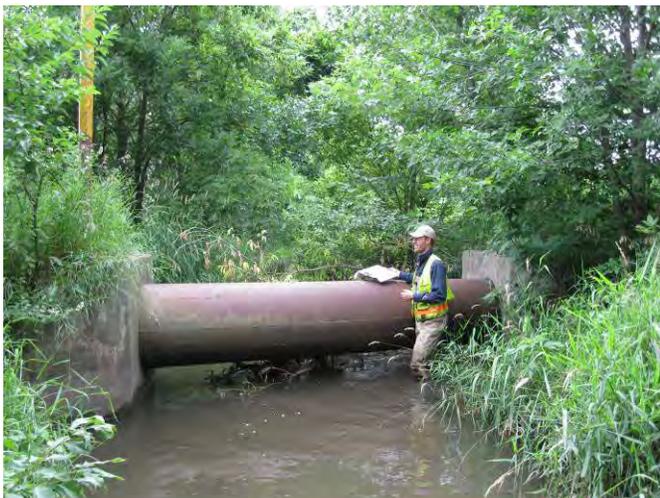
Stream: North Creek, Reach 3	Problem description: 2-ft metal high pressure gas main crosses the channel with concrete abutments on either side of the stream. The pipe is ~2 ft above the channel bed but traps debris on the upstream side and there is some scour occurring around the abutments. The pipe probably causes backwater during floods
Station: 30,550	
Solution: Bury the pipe well under the stream.

(Left to right): Stn 30,550 looking upstream at the sewer pipe

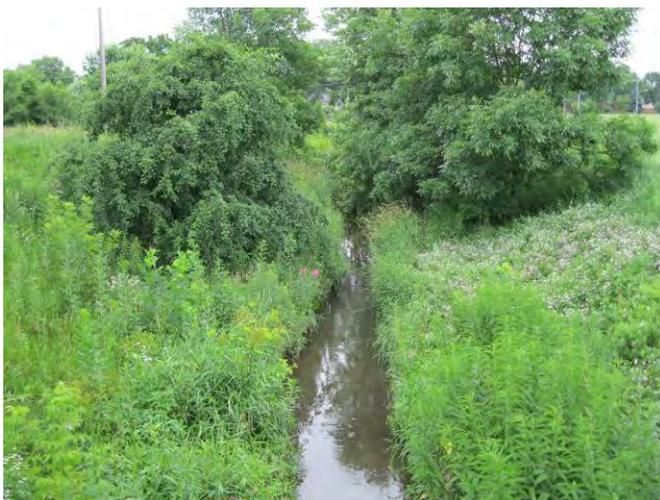
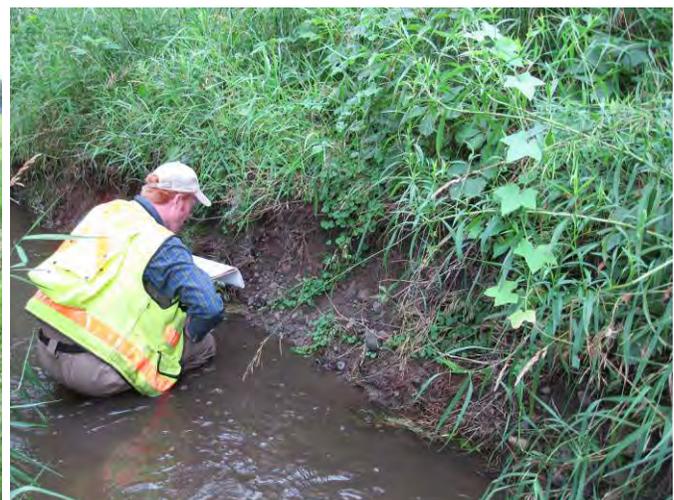
(Left to right): Stn 30,800 looking upstream from footbridge; Stn 31,000 looking at right bank erosion

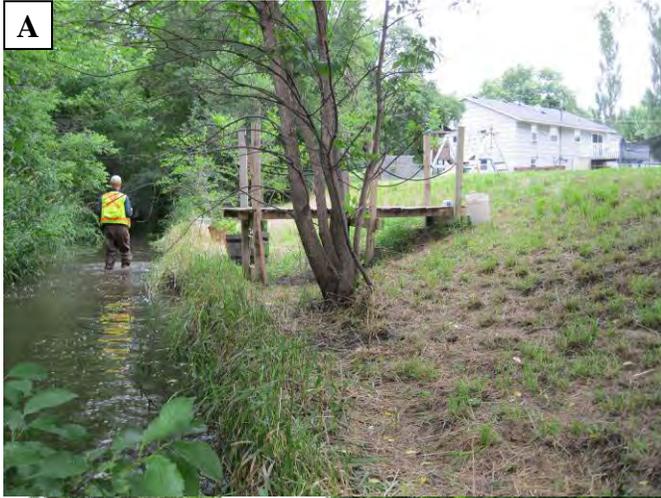
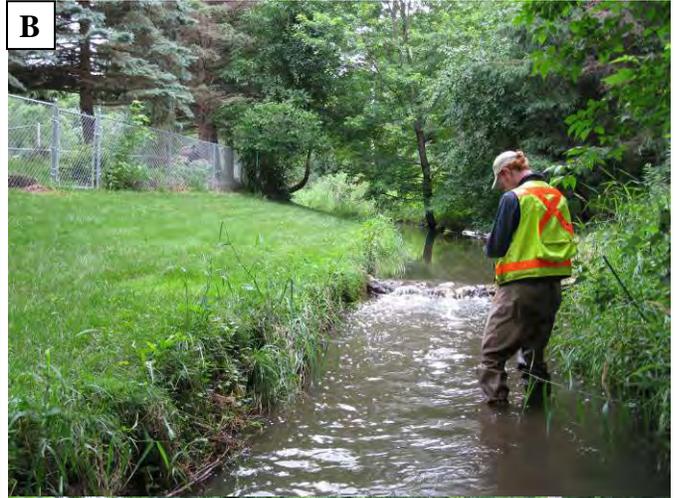
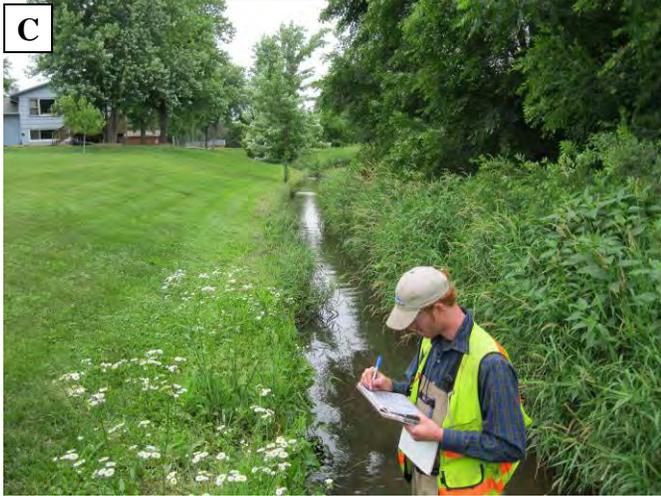
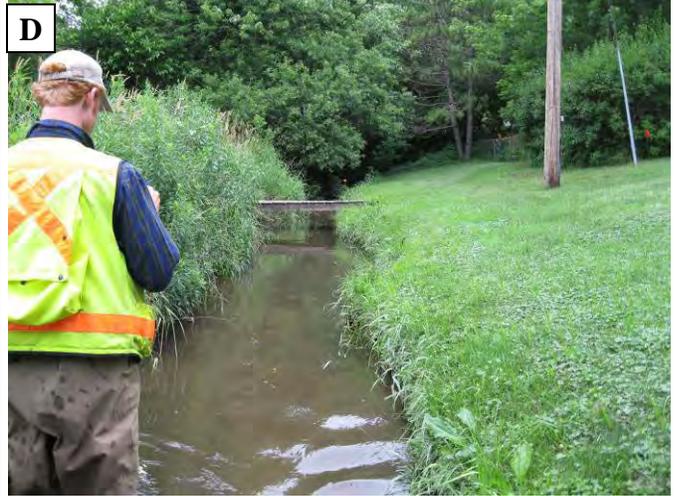
A) Stn 31,200 looking upstream; B) Stn 31,700 looking upstream; C) Stn 32,300 looking upstream; D) Stn 33,400 looking upstream

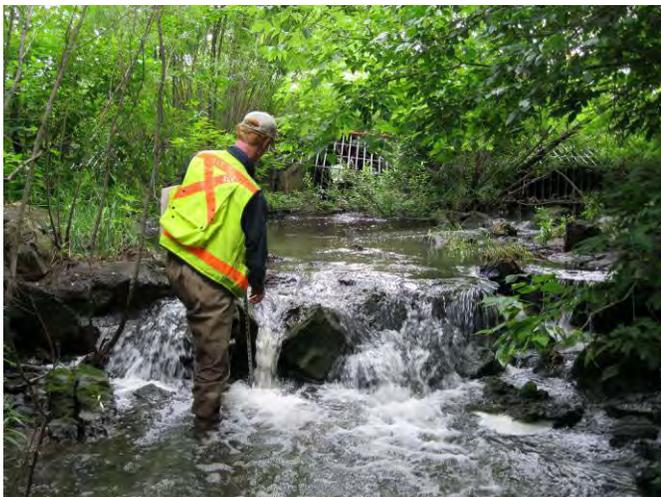
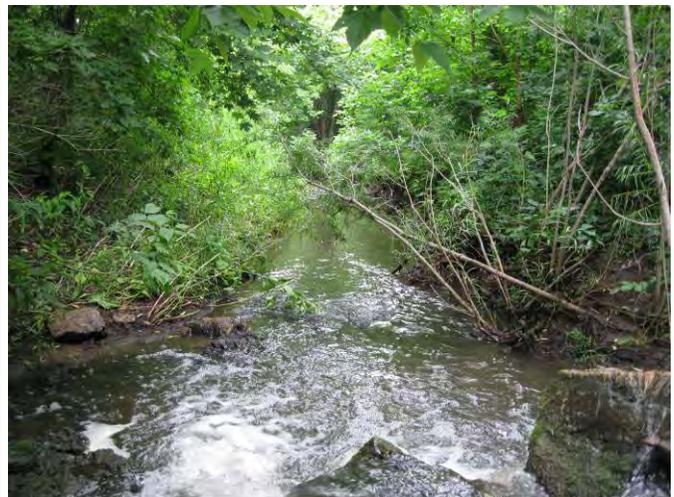
Stream: North Creek, Reach 3	Problem description: 2.5-ft grouted riprap drop provides temporary grade control ~25 ft downstream of Cedar Ave. The drop is a fish passage barrier and some riprap and concrete are falling out as it is being undercut. If the grade control fails, the culvert under Cedar Ave could be compromised.
Station: 34,000	
Solution: Remove grouted riprap and re-grade the channel bed into a series of grade controlling steps and energy-diffusing pools. Only a fish passage problem if downstream barriers are removed and the 1-ft drop in the culvert at the upstream end of Cedar Ave is removed.

(Left to right): Stn 34,000 looking upstream at the drop; Stn 34,000 looking downstream

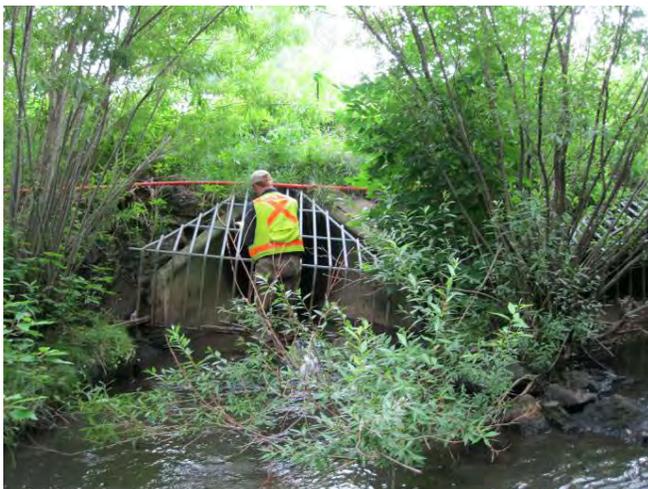
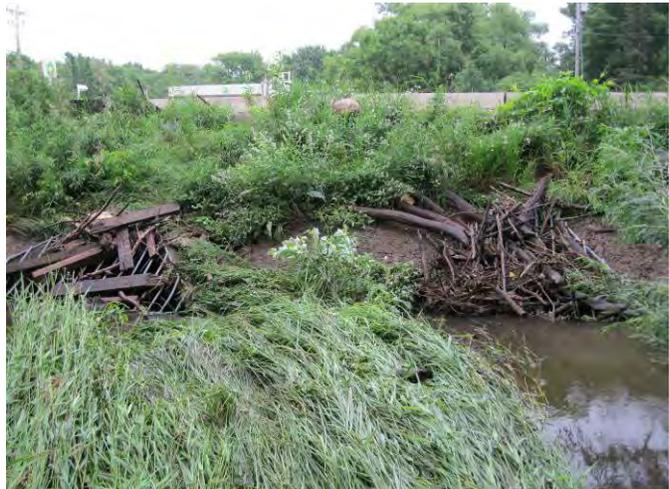
Stream: North Creek, Reach 3	Problem description: 3, 5-ft concrete pipes with trash grates under Cedar Ave. Right pipe is closed with concrete allowing no flow. On upstream end, pipes are designed with a 1-ft drop - this provides grade control and keeps water at certain level upstream, but it is also a complete fish passage barrier
Station: 34,100	
Solution: If fish passage is important at this location, remove the drop (only if downstream barriers are removed); if fish passage is not important, there is no need to change anything. If fish passage and maintaining upstream water levels is important, either 1) remove the drop and build a riffle-pool complex upstream of the road to maintain grade while providing passage or 2) replace culverts and downstream grade control with much wider culverts within which natural substrate provides passage and grade control at the upstream end. With potentially much greater wetland habitat available further upstream, we recommend removing the passage barrier while maintaining the grade control. Because the road surface was recently repaired, the probability of replacing the culvert in the near future is low. Therefore, building a riffle (or step)-pool complex upstream of the culvert to provide passage and grade control is the best option. The scores below reflect this option.

(Left to right): Stn 34,000 looking upstream; Stn 34,250 looking downstream at pipes with debris piled up

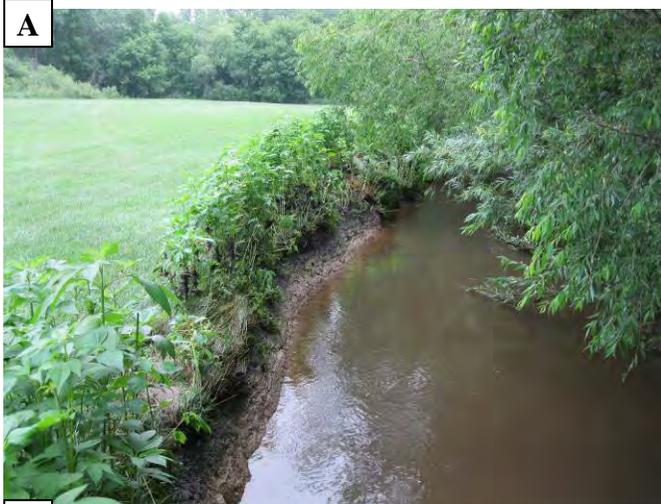
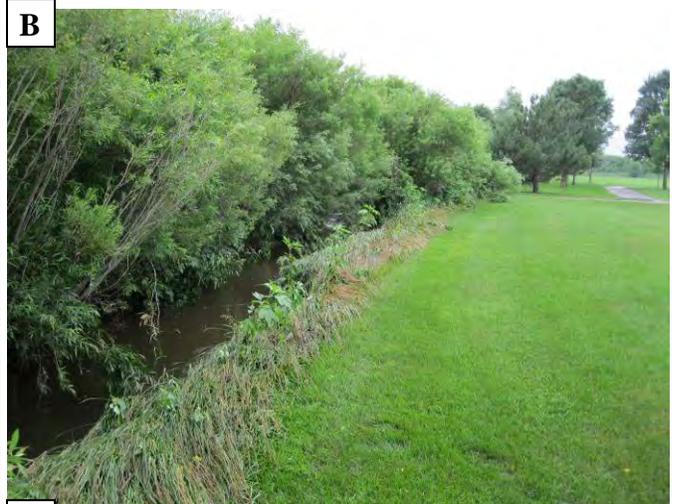
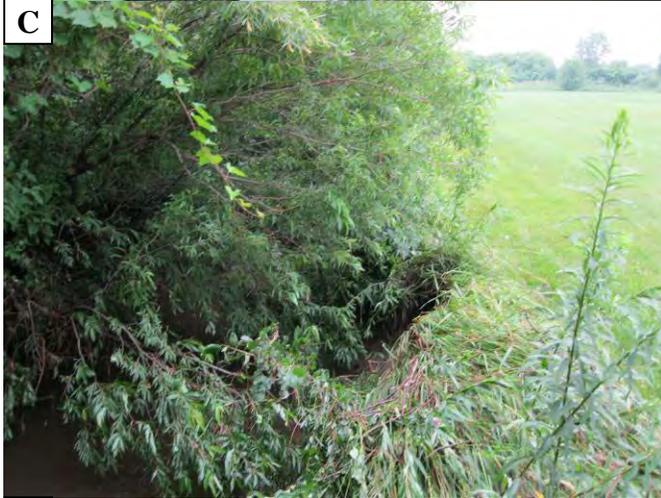
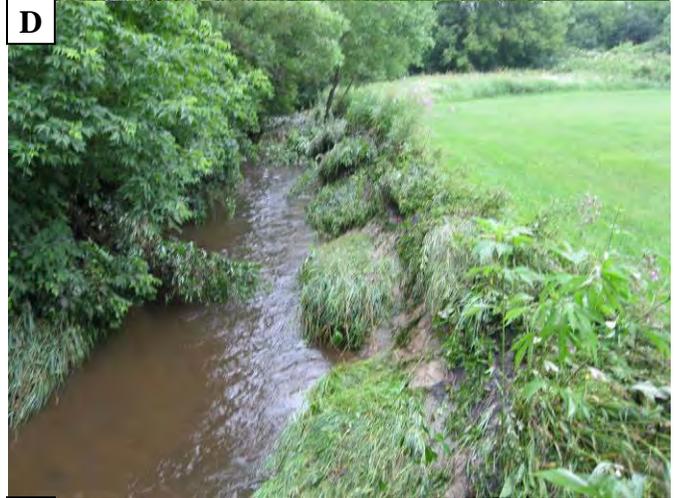
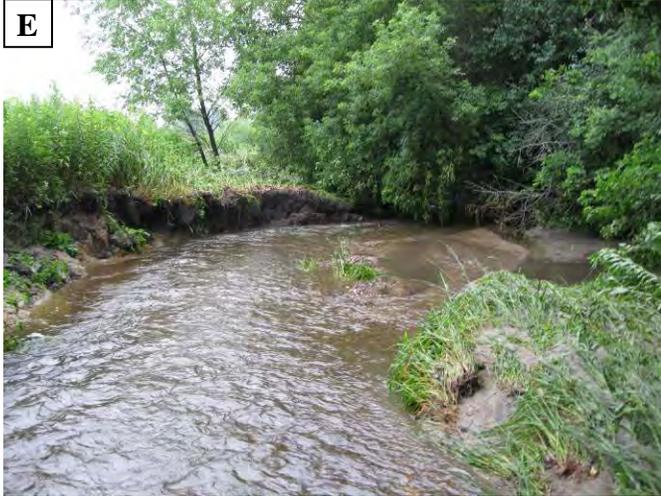
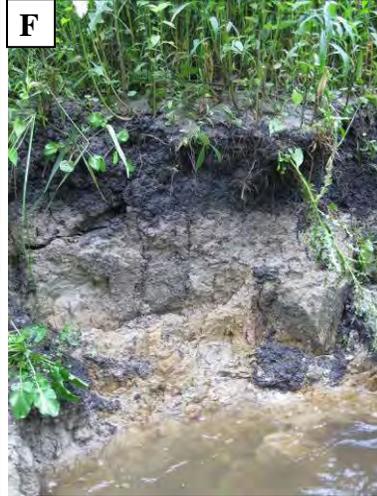
A) Stn 35,700 DS at mowed left edge with some erosion; B) Stn 35,800 looking upstream at mowed left edge; C) Stn 36,350 looking upstream at mowed left edge; D) Stn 36,850 looking upstream at mowed left edge and straight channel; E) Stn 36,950 looking downstream at eroding left bank; F) Stn 36,950 erosion of silt/clay on left bank

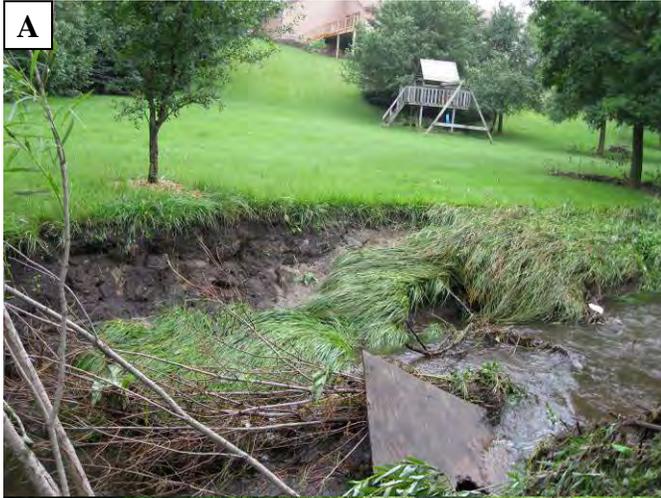
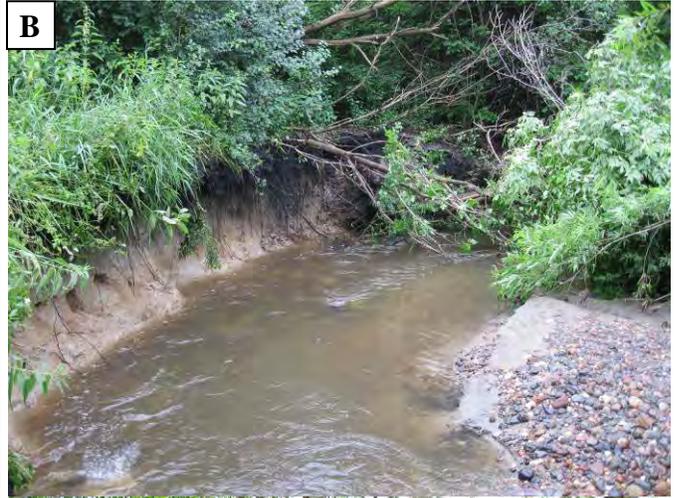
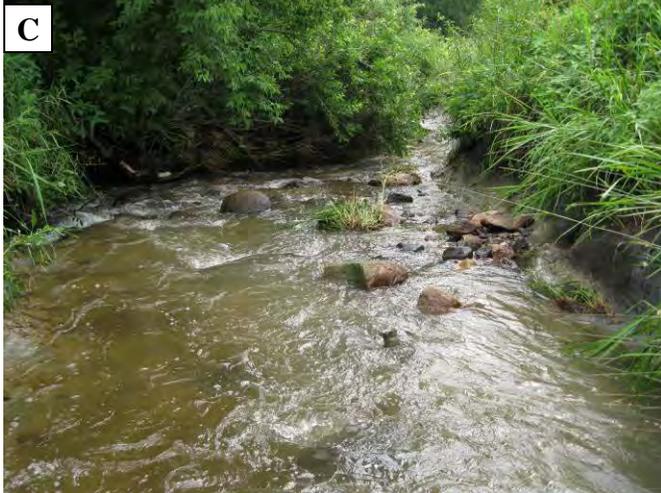
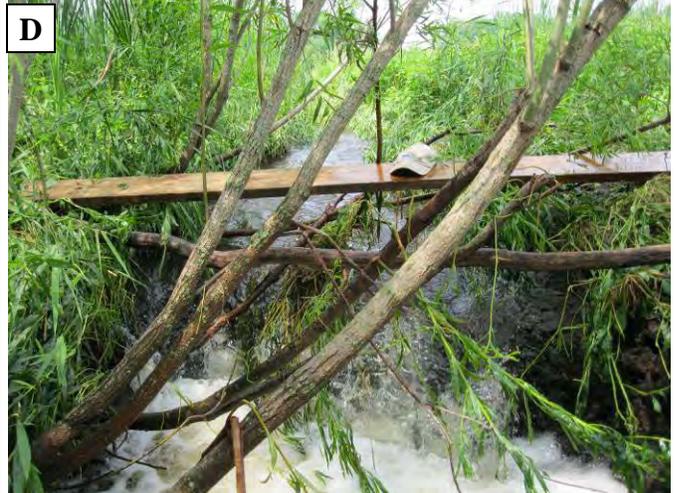
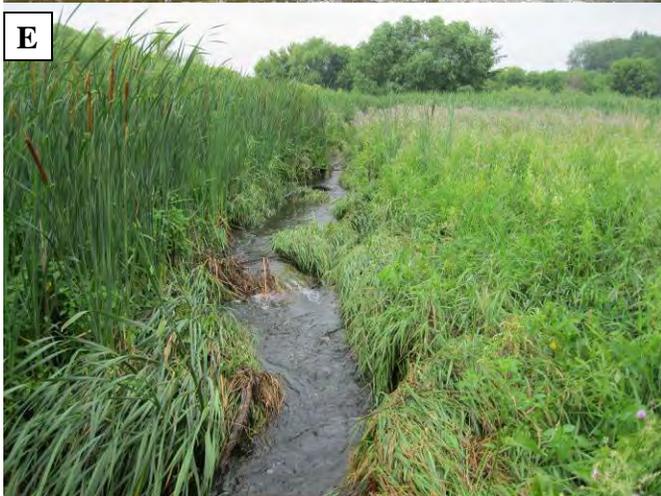
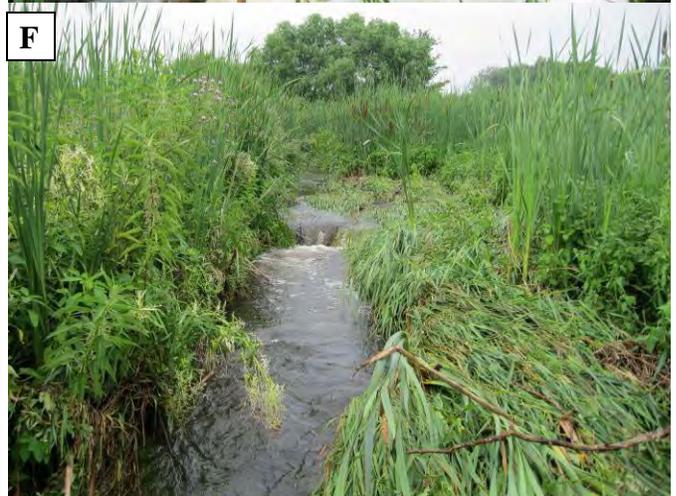
Stream: North Creek, Reach 4	Problem description: Recent incision up to Stn 38,700 is causing bank erosion along nearly the entire length. Between Stn 38,700 and 39,400, 4 knickpoints totaling ~4.5 ft are actively incising - this will in turn result in bank erosion as the channel adjusts. Incision and bank erosion cause excessive sedimentation of the channel and decreased water quality.
Station: 37,000-39,400	
<p>Solution: If this downstream release of turbidity and fine-grained sediment is acceptable, the channel can be allowed to adjust as there is no infrastructure of concern (until the knickpoints reach the bike path and road upstream). However, we believe the turbidity substantially degrades water quality and habitat downstream. To decrease the channel instability and increase wetland functionality and flood storage, we recommend channel reconstruction. The wide wetland complex is owned by the City of Lakeville and there is no infrastructure near the channel. Small drainages and side channels on the wetland surface suggest that the historic channel was not entrenched as it is today. A riffle- or step-pool channel complex could be built at the transition between the downstream park and the wetland. This could be built to bring the channel grade up to less than 2 ft below the wetland surface. A new channel, with channel dimensions to fit the new hydrology, would then be built at a higher elevation and with a more sinuous planform. Side channels, secondary channels, alcoves, off-channel pools could be built to encourage the spread of floodwaters and to provide additional habitat. Flood waters would easily overtop the channel banks and dissipate across the wetland, thus slowing the discharge of water downstream.</p>

A) Stn 37,100 Right bank erosion and mowed to edge; B) Stn 37,425 DS at incision and woody debris; C) Stn 38,800 looking downstream; D) Stn 39,250 looking upstream at 2.5-ft knickpoint; E) Stn 39,300 looking upstream; F) Stn 39,400 looking upstream at 0.5-ft knickpoint

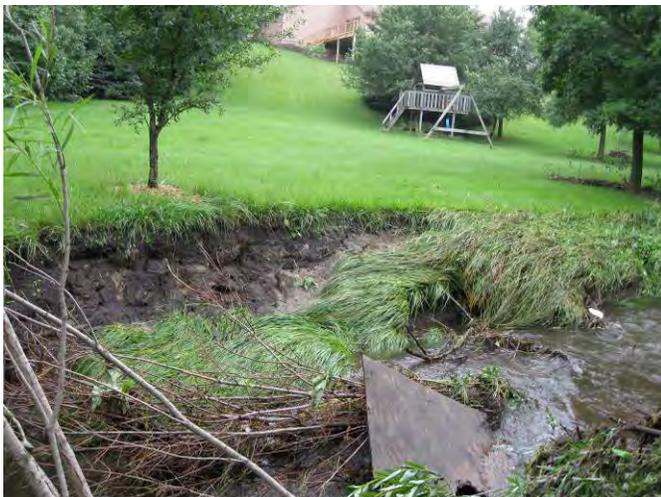
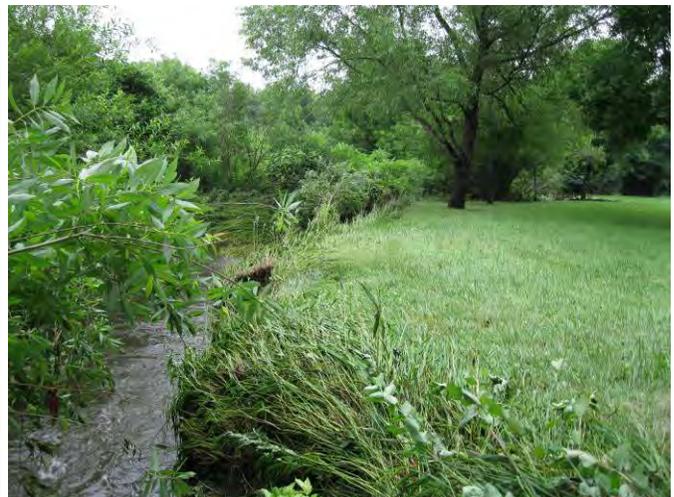
Stream: North Creek, Reach 4	Problem description: Right bank: lawn is mowed to the edge of the bank and the banks are eroding. There is no buffer to provide infiltration or prevent fertilizers or other contaminants from entering the stream.
Station: 37,050-37,350	
Solution: Plant riparian buffer of native trees, shrubs, and forbs.

(Left to right): Stn 37,100 right bank erosion and mowed to edge; Stn 37,300 downstream at mowed left edge with some erosion

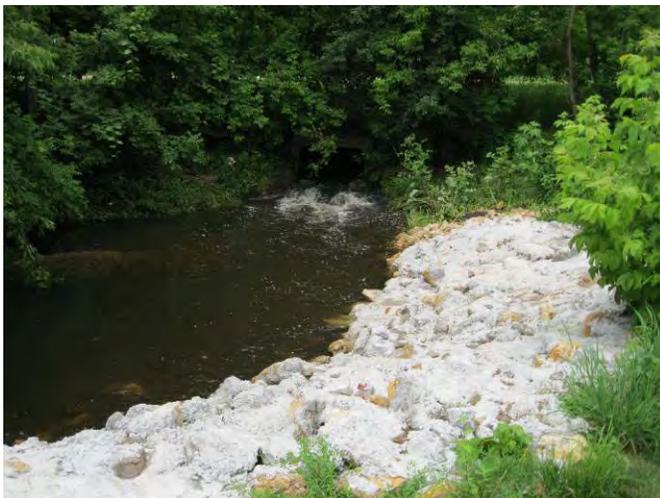
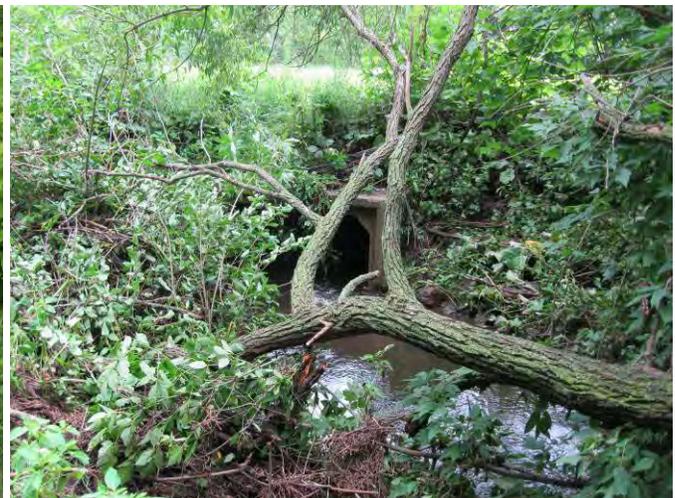
Stream: North Creek, Reach 4	Problem description: 6x3-ft concrete box culvert under Highview Ave is steep and plane bed - partial fish passage barrier at high flows (velocity) and at low flows (depth).
Station: 40,000	
Solution: Replace with larger culvert that allows fish passage during low flows and high flows.

(Left to right): Stn 39,925 looking upstream from bike path at 3x6-ft concrete box culvert under Highview Ave; Stn 40,000 looking downstream at Highview Ave culvert

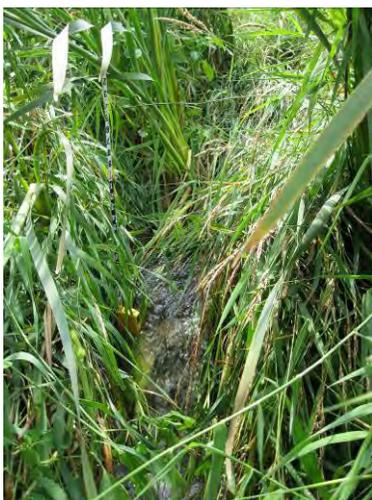
(Left to right): Stn 42,750 looking upstream at 1.5-ft knickpoint

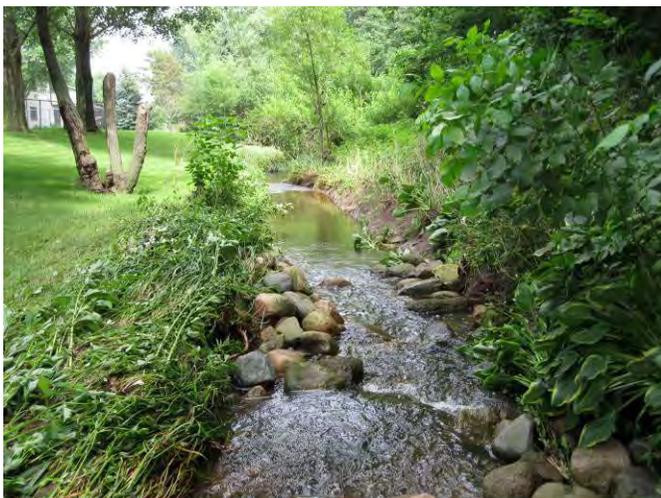
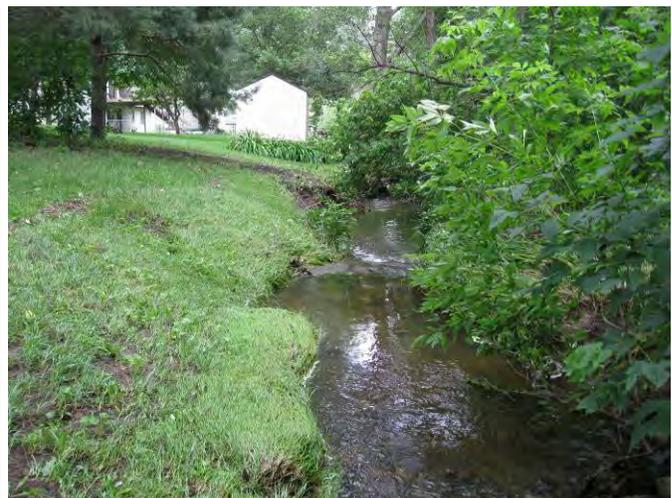
(Left to right): Stn 45,850 looking downstream at mowed left edge; Stn 45,900 looking downstream at mowed left edge

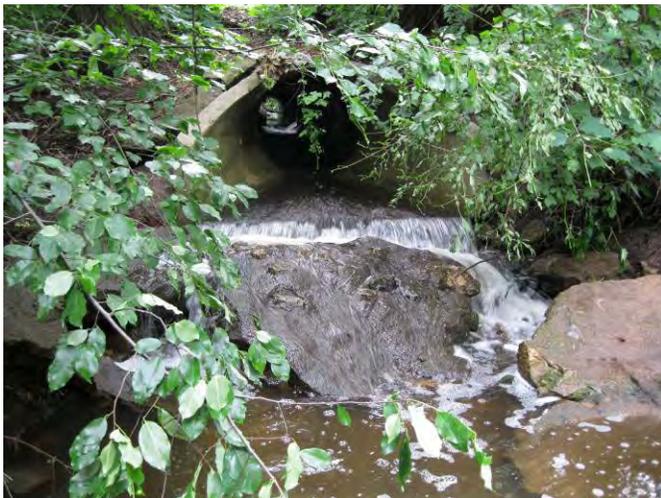
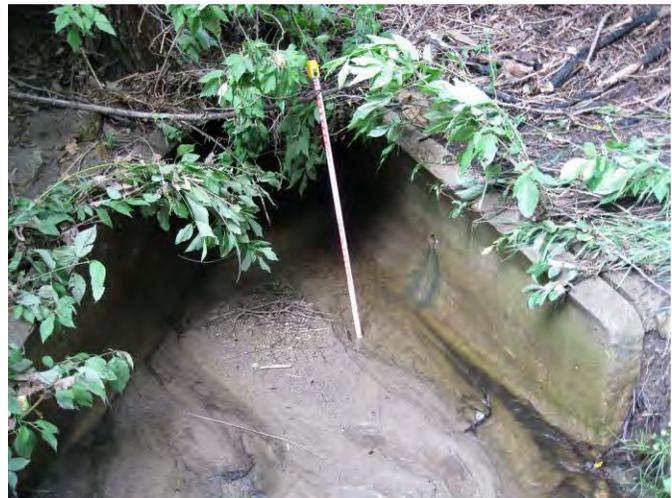
Stream: North Creek, Reach 5	Problem description: 3.5-ft flared concrete pipe under Icon Trail is perched 2 ft on the downstream end. The grouted riprap apron and banks have failed and are now broken in the channel
Station: 46,000	
Solution: Place rock at mouth to protect culvert. No habitat is available upstream, so fish passage is not a concern.

(Left to right): Stn 45,900 looking upstream at 3.5-ft concrete pipe perched 2 ft under Icon Trail; Stn 46,000 looking downstream at 3.5-ft concrete pipe under Icon Trail

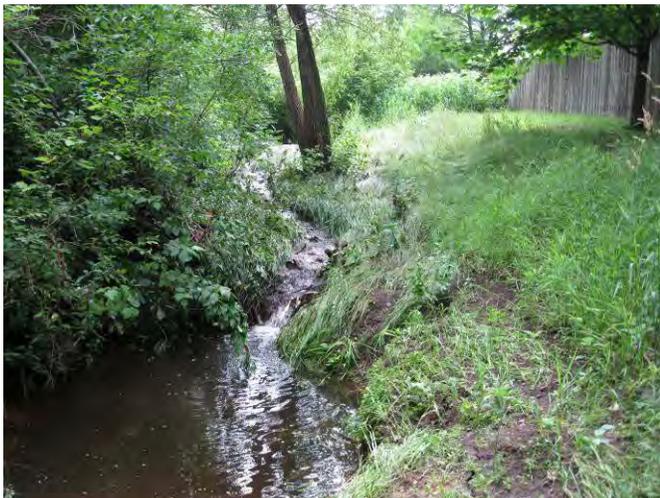
(Left to right): Stn 46,550 looking upstream at 2-ft knickpoint

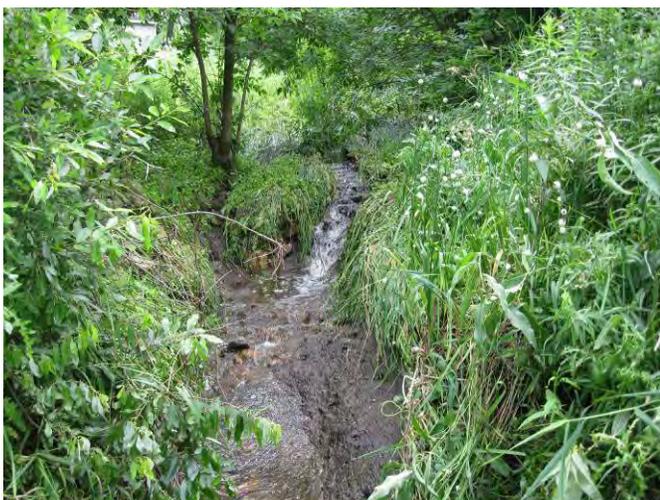
(Left to right): Stn 46,700 looking upstream at 2-ft knickpoint

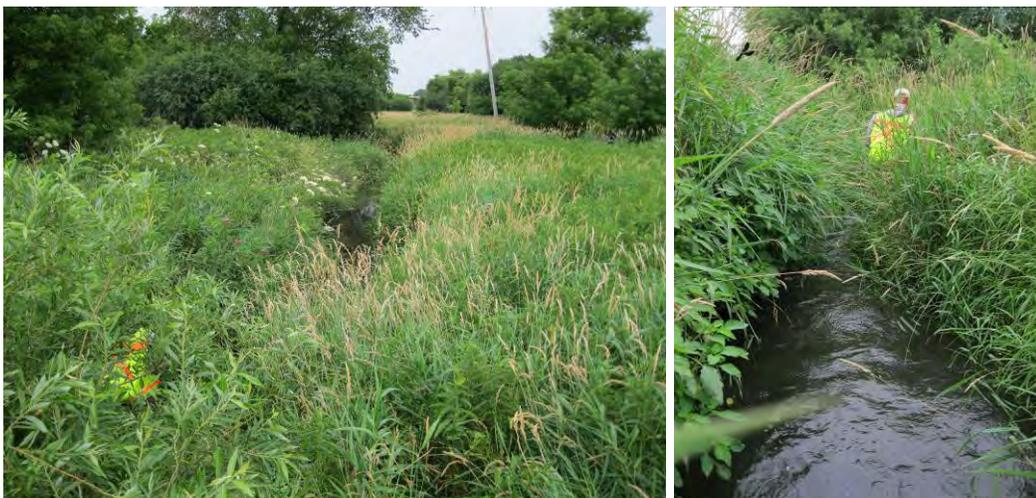
(Left to right): Stn 200 looking downstream; Stn 250 looking upstream

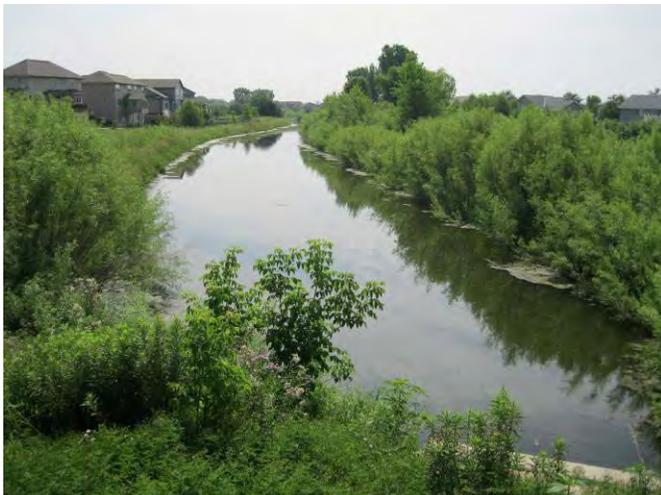
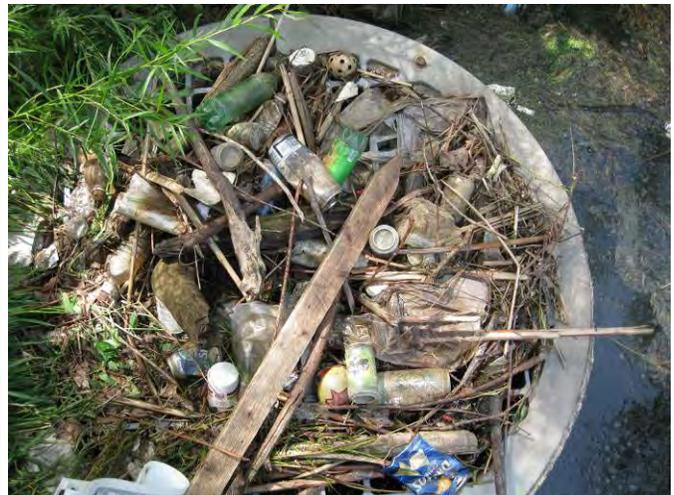
Stream: North Creek Trib 1, Reach 2	Problem description: System of in-stream stormwater basins causes water to warm to more than 80°F in the summer, providing a source of warm water to North Creek. Maintaining stormwater basins is beneficial in reducing the volume of water entering the channels downstream, but the over-heated water does not help the water quality.
Station: 1900-7200 (entire reach)	
Solution: Although changing conditions here is unlikely as this development is relatively new, the vertical pipe at Stn 5050 could be retained and everything upstream of that retained as a stormwater pond (could the pipe be raised so water only discharges downstream during large rain events?). Downstream of that vertical pipe, a narrow and more natural creek with floodplain could be built between levees that contain stormwater basins to either side of the stream. The stream would have riparian vegetation to provide cover.

(Left to right): Stn 4450 downstream from Dylan Drive; Stn 5050 looking down at debris on top of vertical storm water pipe inlet

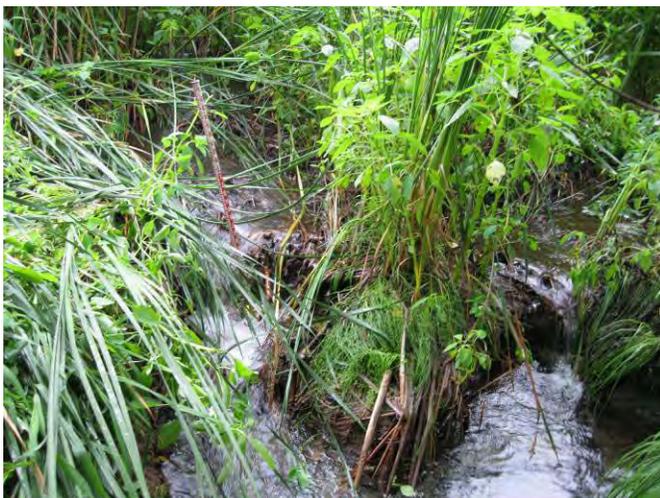
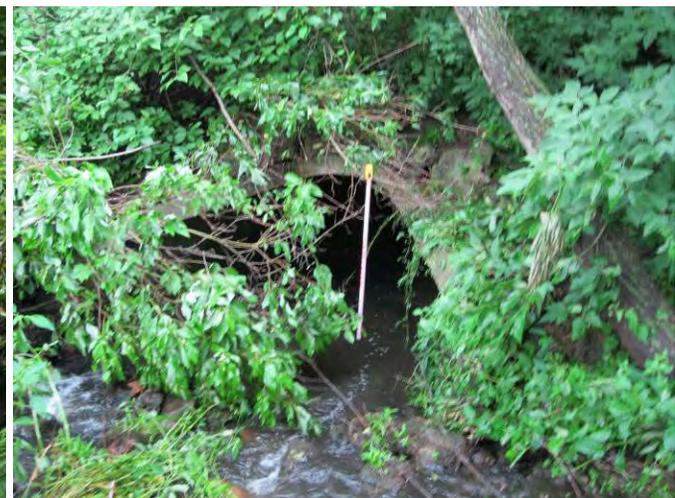
(Left to right): Stn 1800 looking upstream at multiple channels with 0.5-ft knickpoints through clay; Stn 1750 looking downstream at 3.2x4-ft concrete pipe under Hamilton Dr.

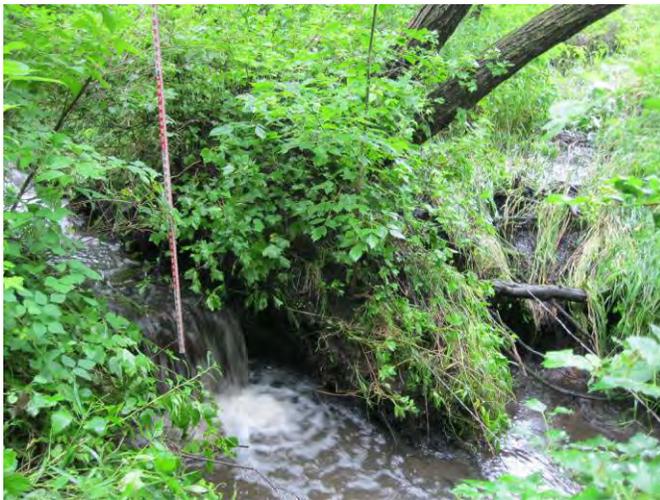
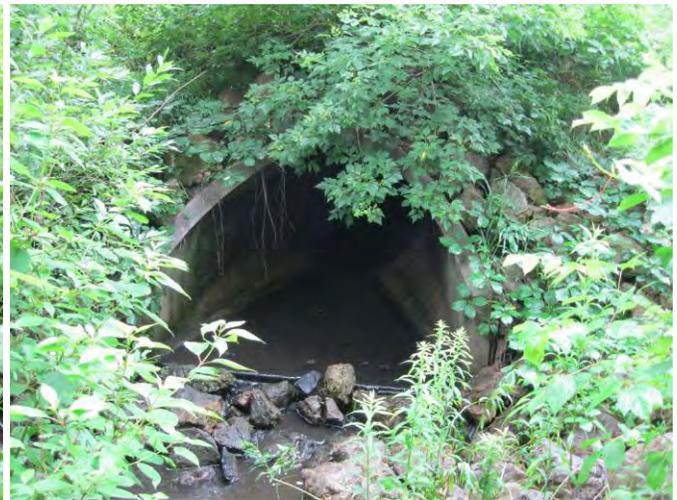
(Left to right): Stn 4000 looking upstream at 2.5-ft knickpoint halted at tree root; Stn 4500 looking upstream at cascade into 5-ft concrete pipe under Highview Ave

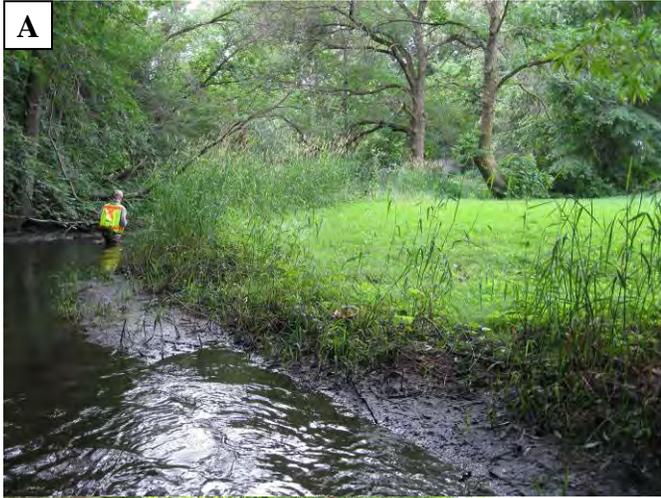
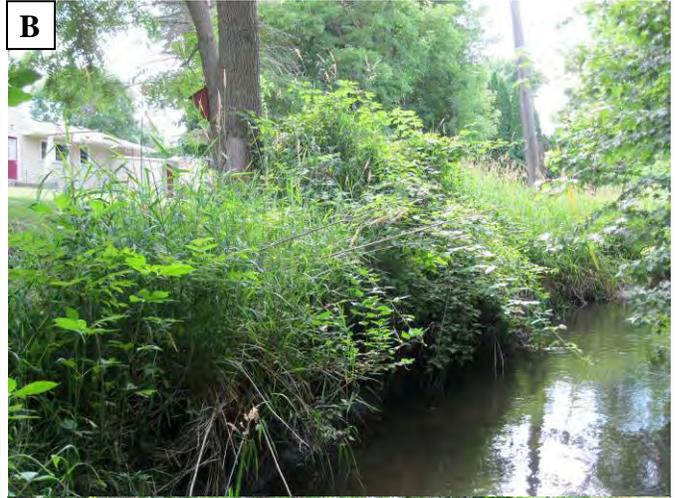
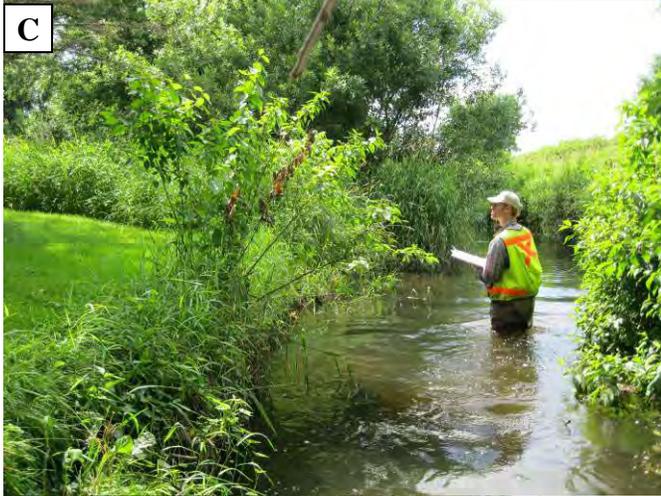
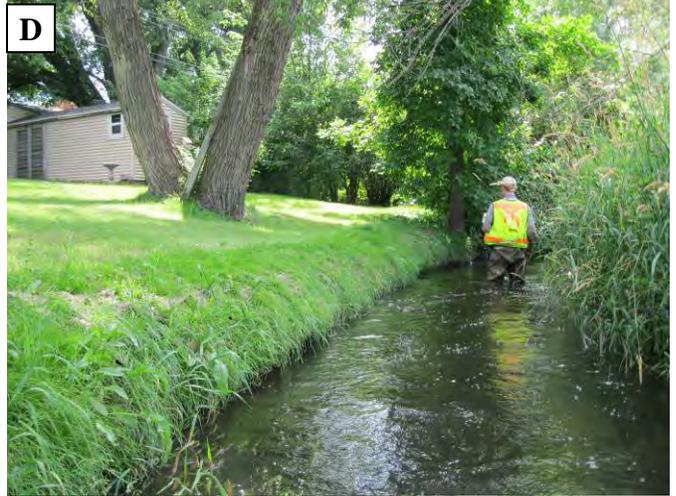
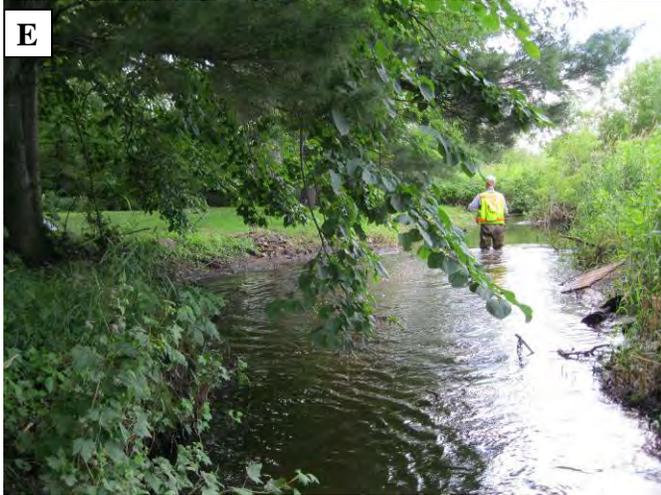
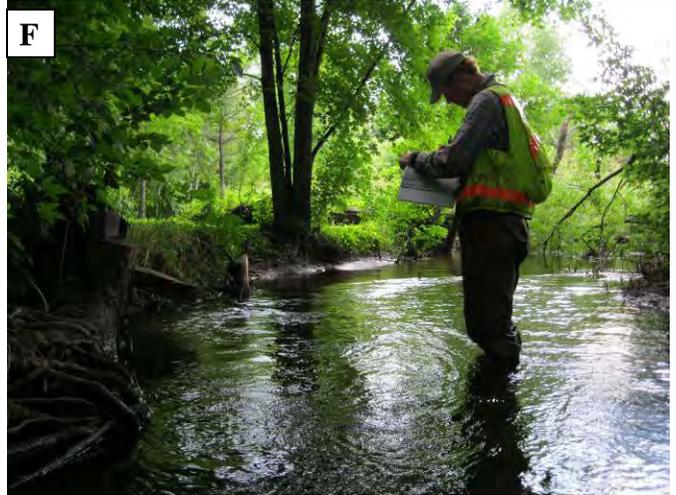
A) Stn 100 looking upstream; B) Stn 1150 looking upstream; C) Stn 1300 looking upstream; D) Stn 1400 looking upstream; E) Stn 1700 looking upstream; F) Stn 1850 looking upstream
