Vermillion River Watershed Joint Powers Organization  
**Fluvial Geomorphic Assessment of North Creek and  
Middle Creek, Dakota County, MN: Final Report**

January 6, 2012

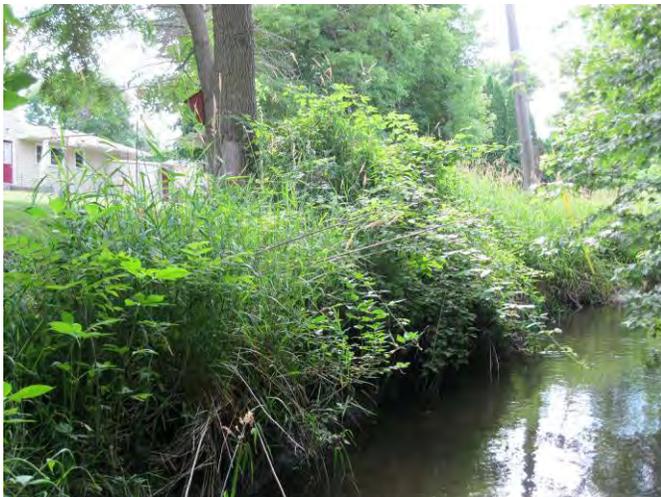
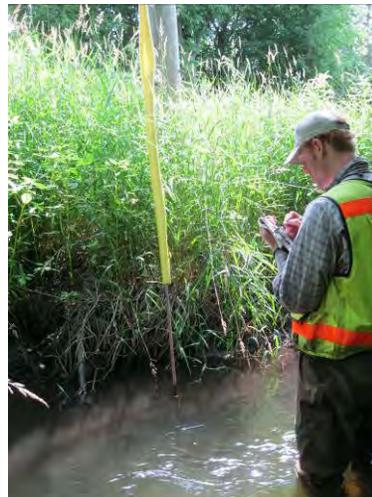
Stream: Middle Creek, Reach 1	Problem description: right bank: utility pole is 4 ft from the channel and a support cable is in the water and is loose; potential infrastructure and health hazard.
Station: 1200	
Solution: Move pole and cable away from bank and future bank erosion.

(Left to right): Stn 1150 looking upstream at the telephone pole; Stn 1200 looking at the telephone pole support cable in the water

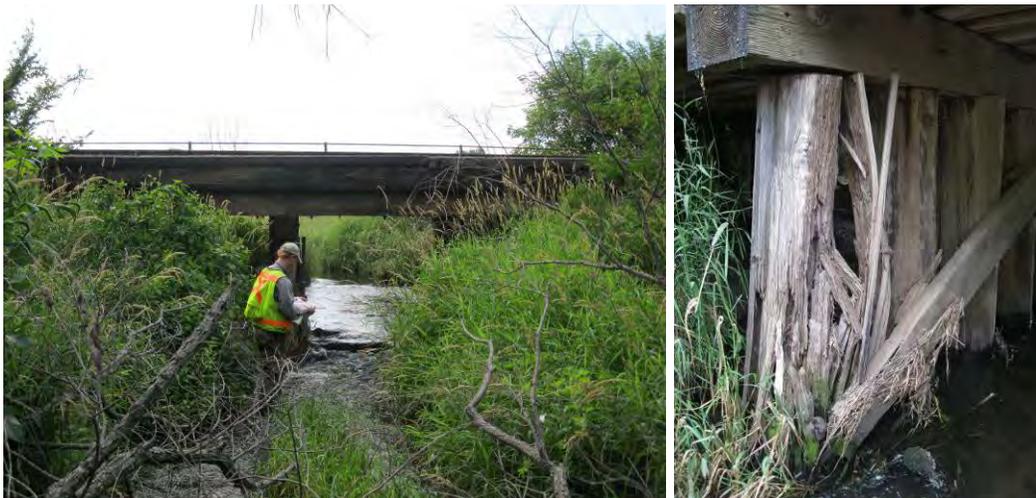
Stream: Middle Creek, Reach 1	Problem description: Downstream piling of right pier under railroad bridge is broken.
Station: 1950	
Solution: Monitor and evaluate remainder of bridge to ensure it is stable.

(Left to right): Stn 1900 looking upstream at the RR bridge; Stn 1950 view of failed RR bridge support.

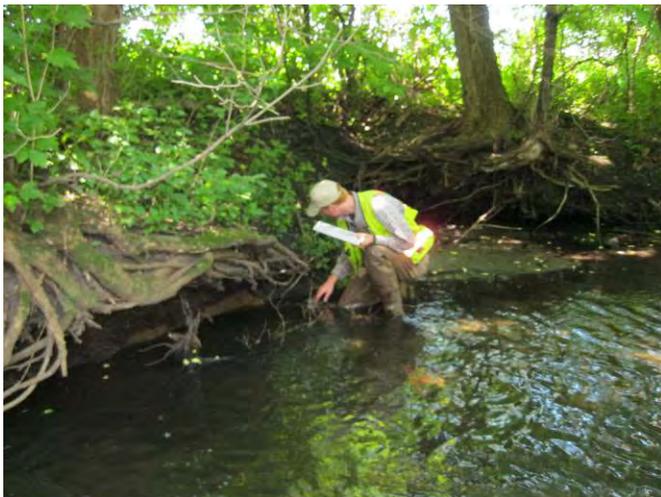
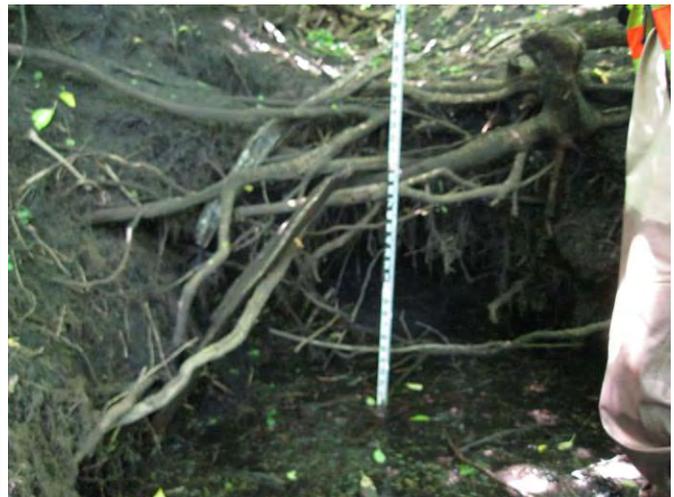
(Left to right): Stn 8800 erosion from field runoff on right bank; Stn 8800 erosion from field runoff on right bank

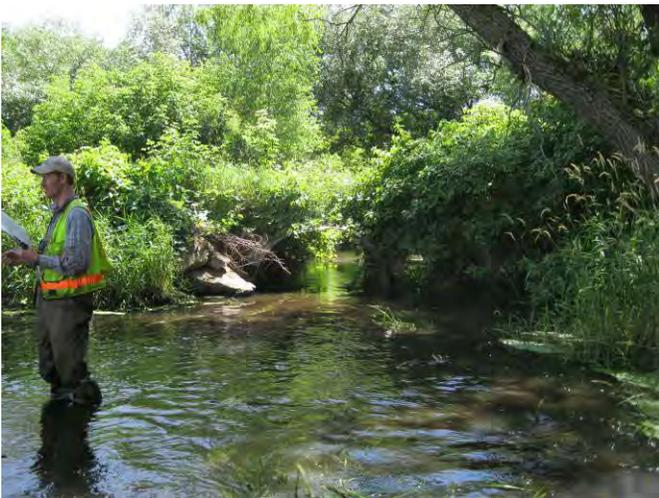
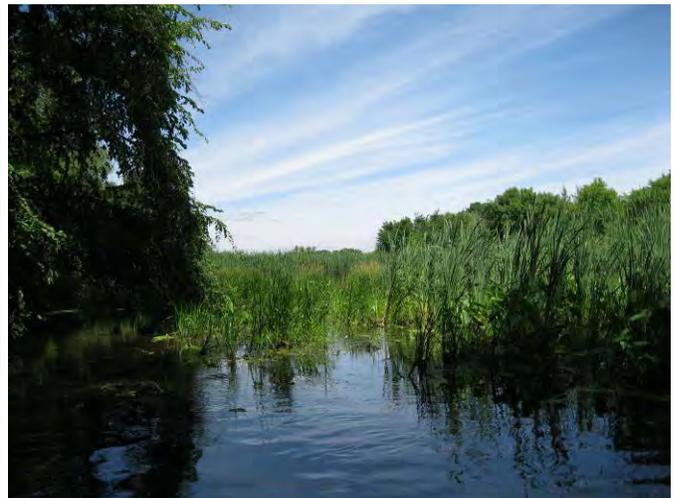
(Left to right): Stn 10,050 looking downstream at the two culverts, the right culvert is hidden by significant vegetation; Stn 10,050 looking upstream at the wetland

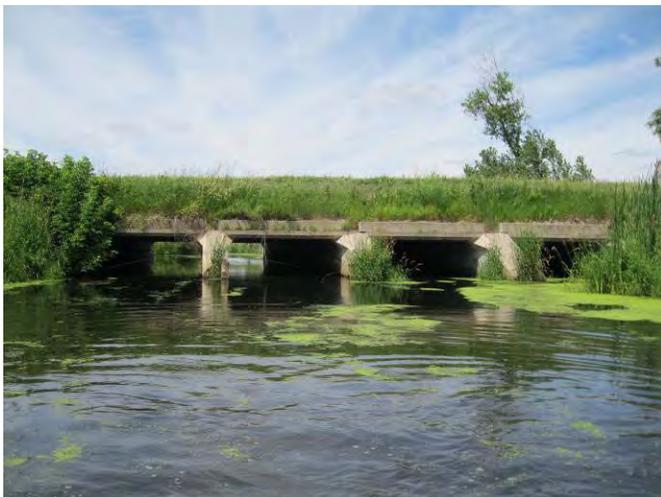
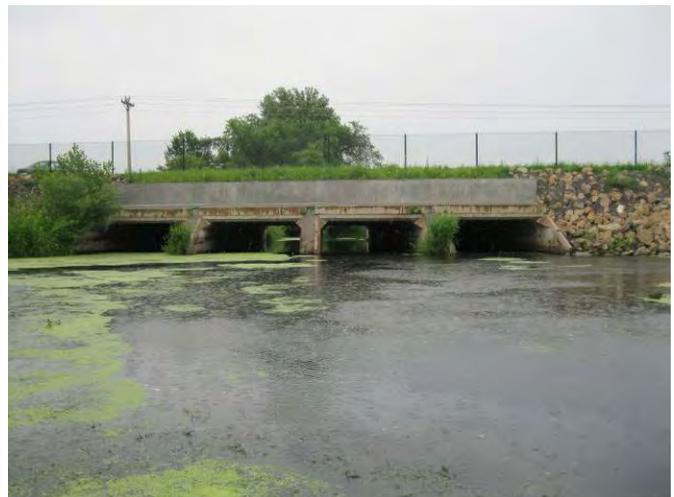
Stream: Middle Creek, Reach 2	Problem description: 4, 12x5-ft concrete box culverts under Pilot Knob Rd are in good condition but no low channels were provided. At very low flows, water depth may become a fish passage barrier.
Station: 13,050	
Solution: Study hydrology - if water depths remain sufficient throughout the year, do nothing. If depths decrease substantially during portions of the year, block low flows with stone in all but one culvert; in remaining culvert, build low flow channel with stone throughout culvert. Scores assume hydrology is sufficient, and only monitoring is necessary.

(Left to right): Stn 12,925 looking upstream at 4 box culverts under Pilot Knob Rd; Stn 13,200 looking downstream at 4 box culverts under Pilot Knob Rd.

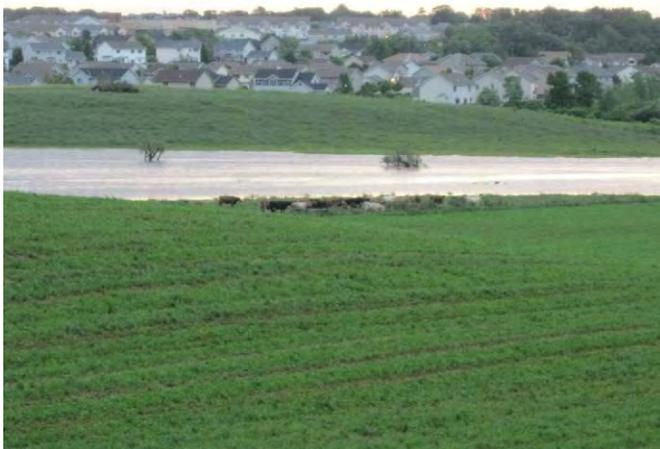
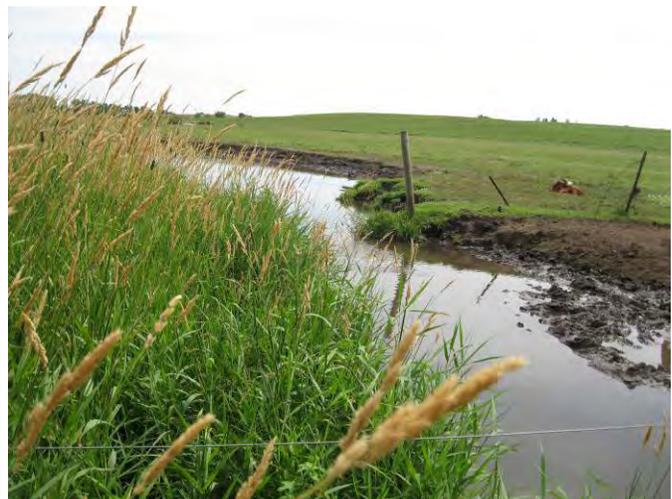
Stream: Middle Creek, Reach 2	Problem description: No restrictions on livestock grazing has resulted in eroding banks, which likely cause a decrease in water quality.
Station: 16,700-19,800	
Solution: Fencing could help keep livestock away from channel banks. A riparian buffer within the fencing would help stabilize the banks, provide infiltration for livestock waste, and provide instream cover and habitat.

(Left to right): Stn 19,000 looking at flooding from Flagstaff Ave; Bob Donnelly's property; closeup of cows; Stn 19,850 looking downstream at right bank erosion due to open grazing

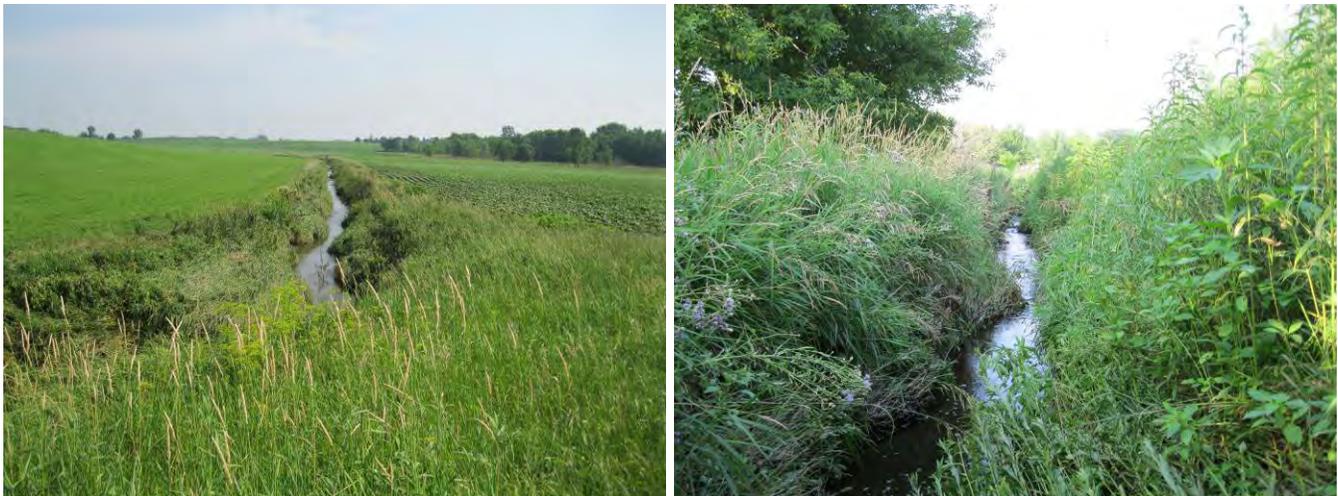
(Left to right): Stn 22,600 looking upstream at straightened channel; Stn 47,900 looking downstream at straightened channel

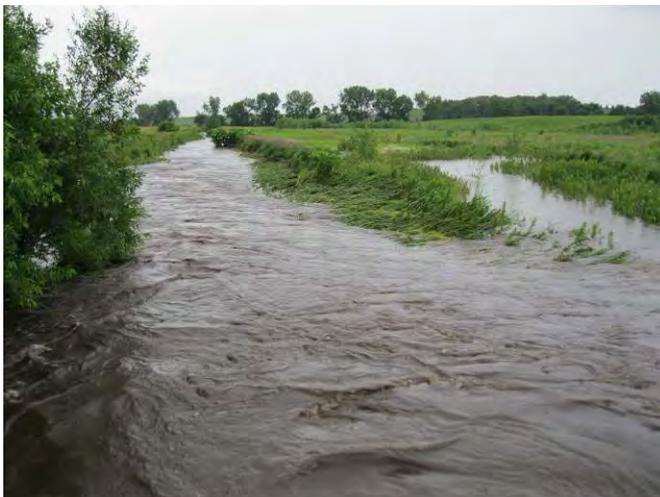
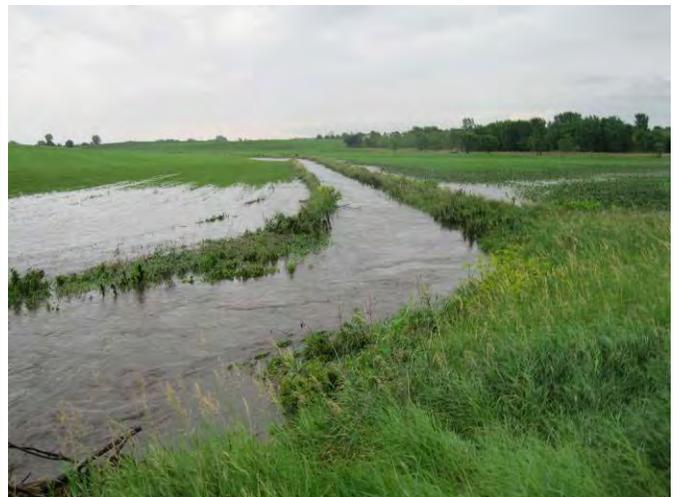
(Left to right): Stn 22,500 looking downstream during flood, the left stretch is the main channel; Stn 22,600 looking upstream during flood

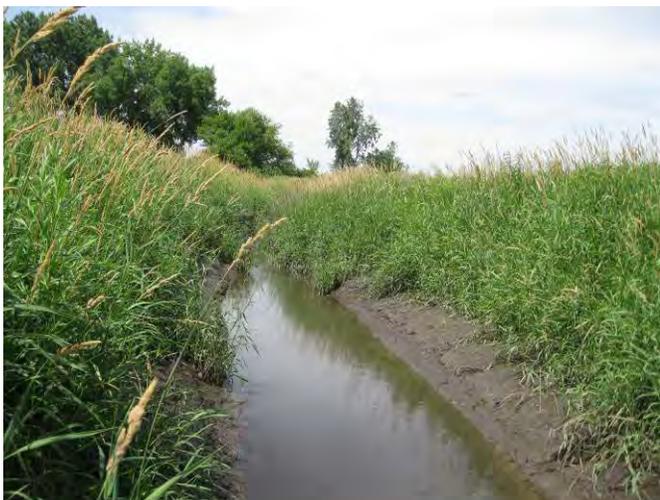
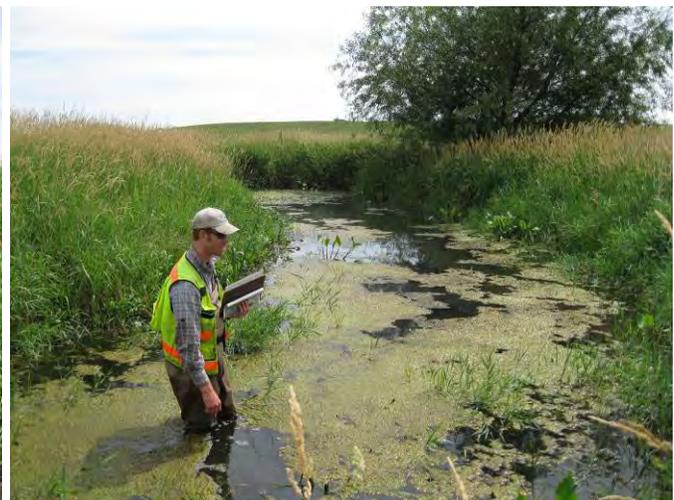
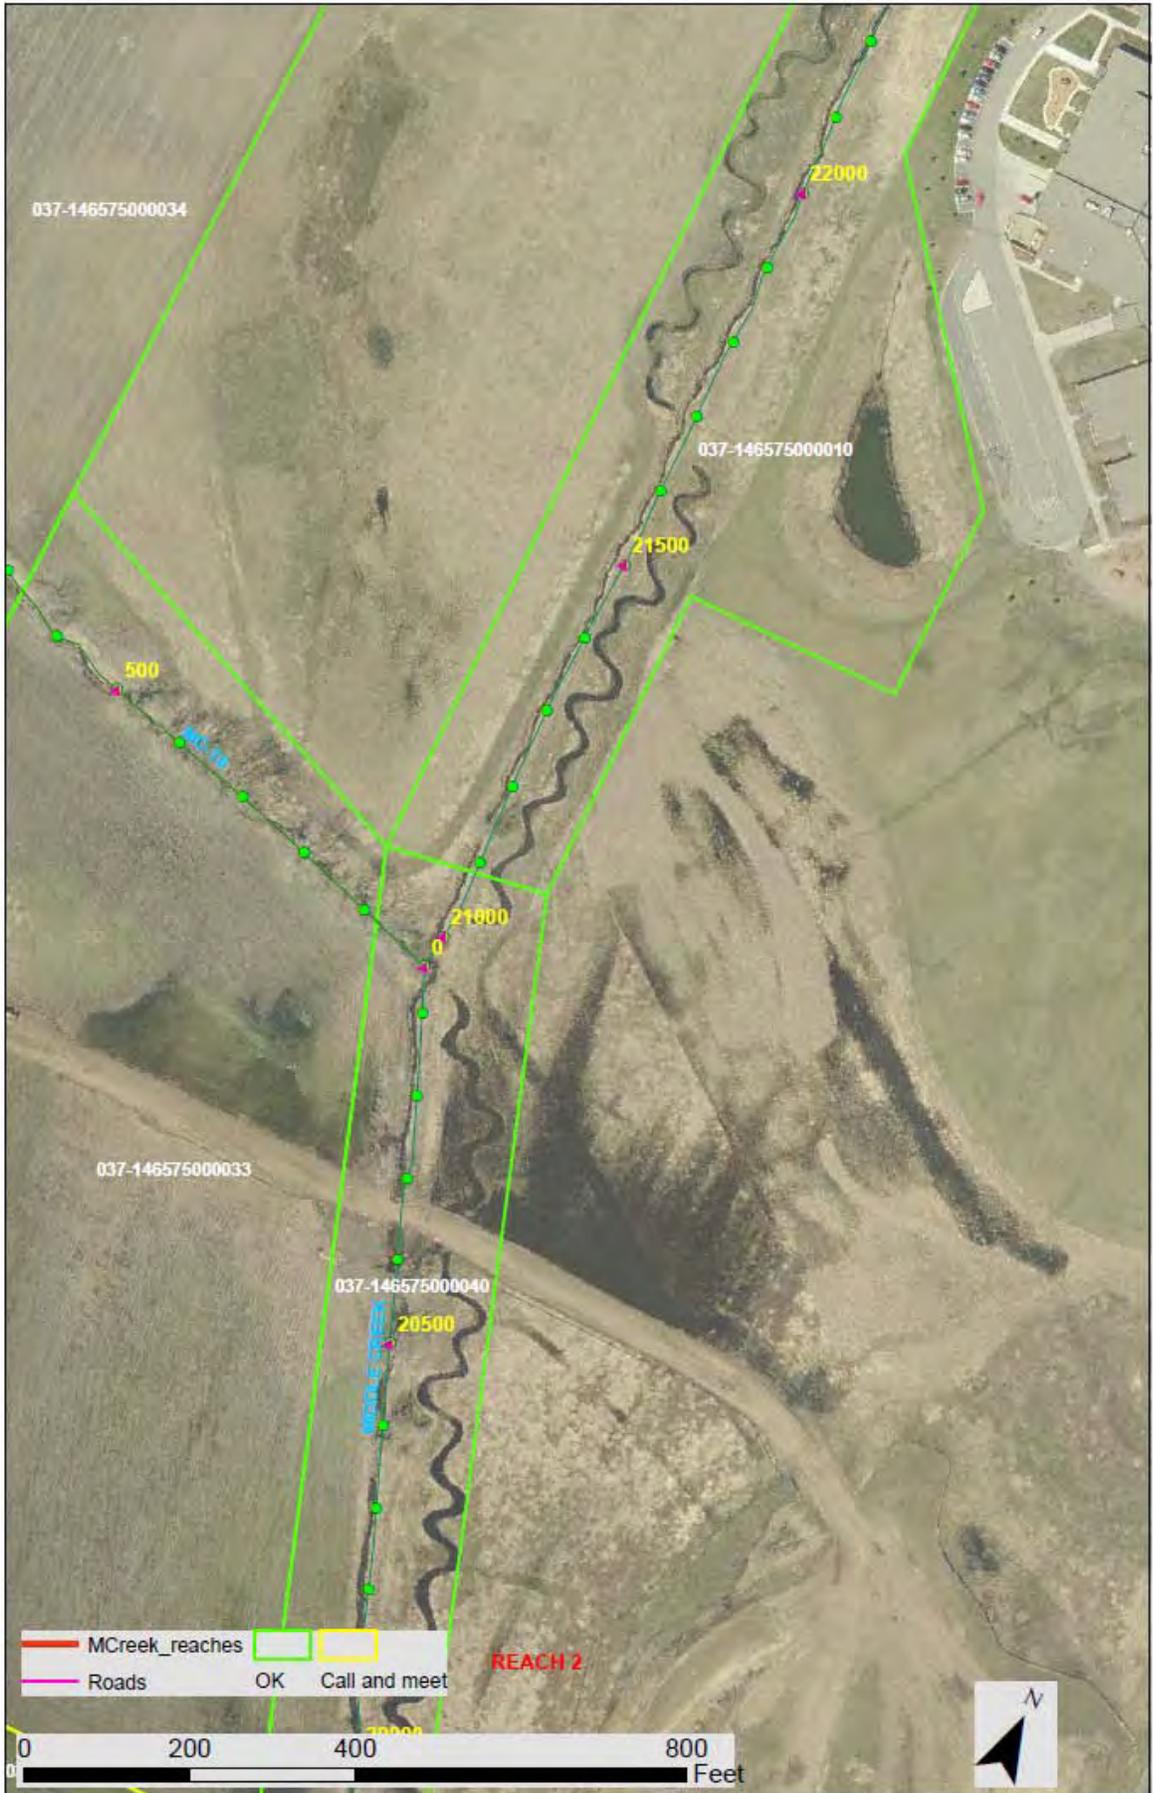
(Left to right): Stn 20,600 looking upstream straight channel; Stn 19,950 looking downstream sinous side channel; See next page for aerial view of two separate channels

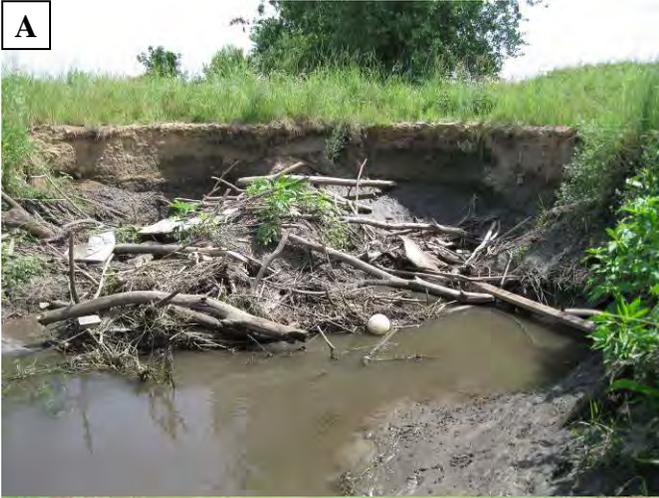
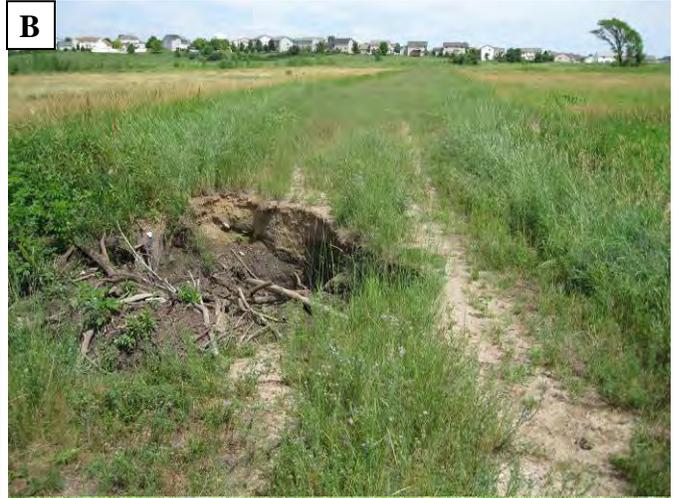
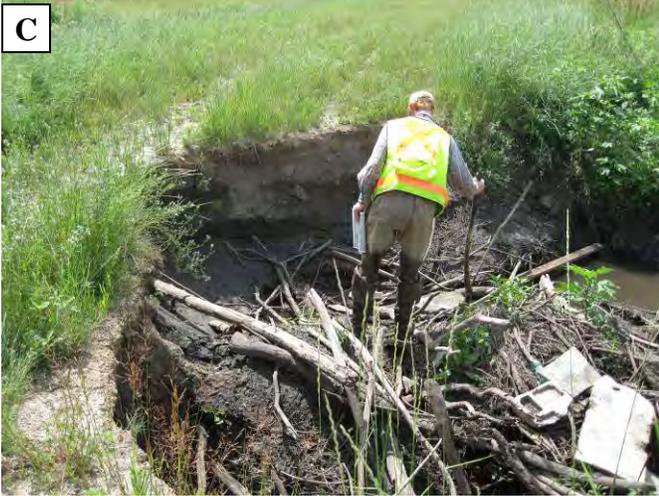
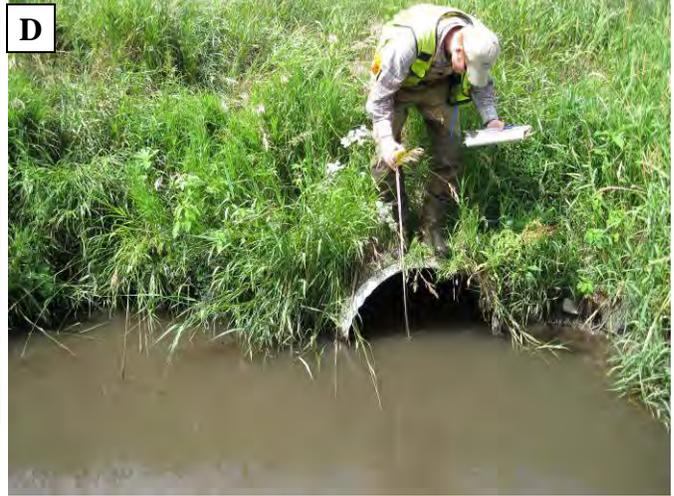
Stream: Middle Creek, Reach 3	Problem description: Half of this dirt farm road is washed out on the upstream side with 4.5 ft of bank erosion. The culverts are partially or fully blocked with debris. Additional scour has occurred on the downstream side.
Station: 20,650	
Solution: Eliminate crossing if road is no longer necessary; replace culverts with larger culverts and rebuild road if the road is necessary. If restored channel is connected, new culverts will need to be built under the road anyway.

A) Stn 20,650 looking downstream at road crossing; B) Stn 20,650 looking across channel showing severity of erosion to farm road; C) Stn 20650 looking across channel; D) Stn 20675 looking upstream at culvert outlet.

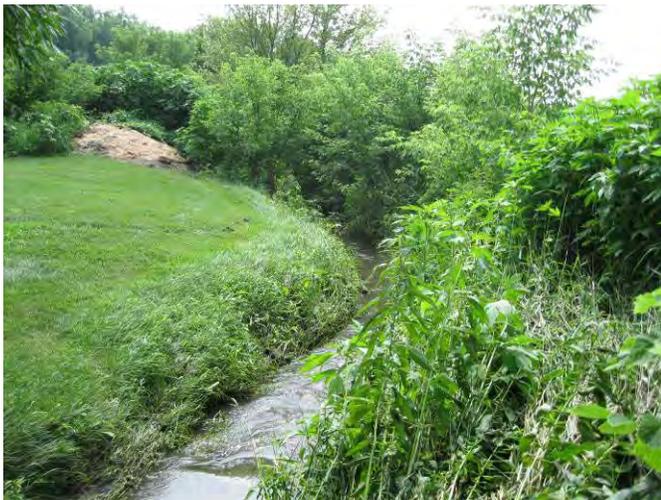
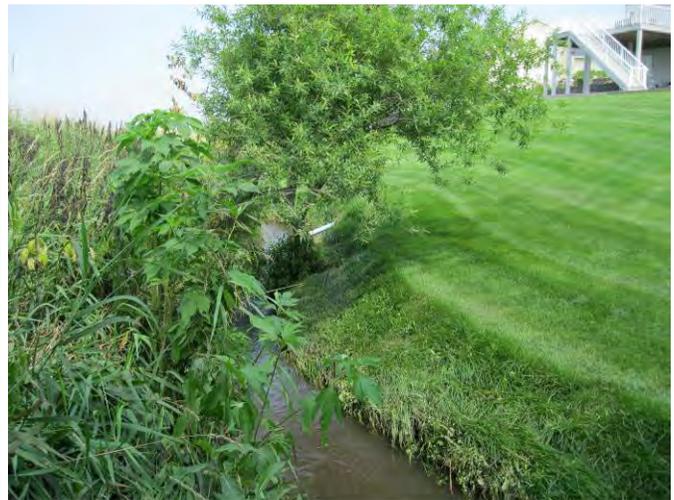
(Left to right): Stn 28,550 looking downstream; Stn 28,550 looking upstream

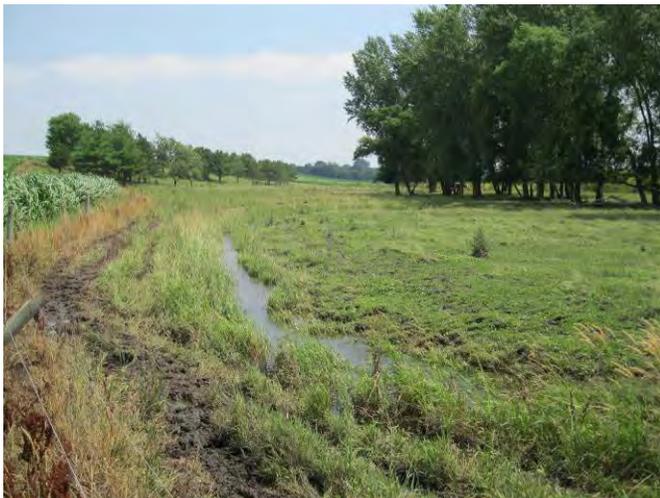
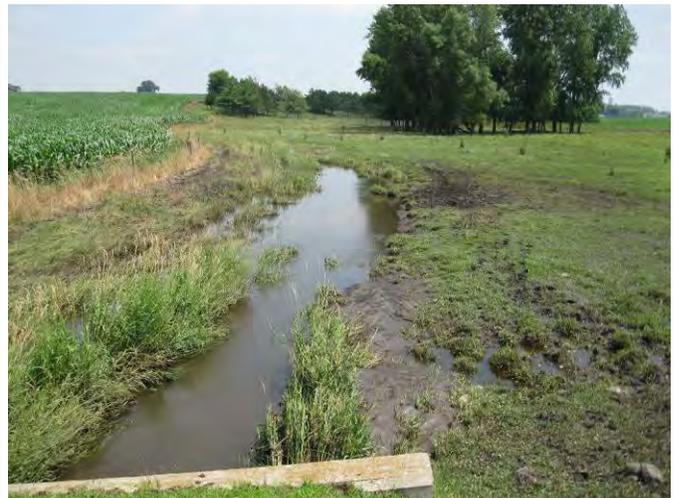
(Left to right): Stn 32,100 looking downstream at cow pasture; Stn 32,500 looking downstream from Flagstaff Ave

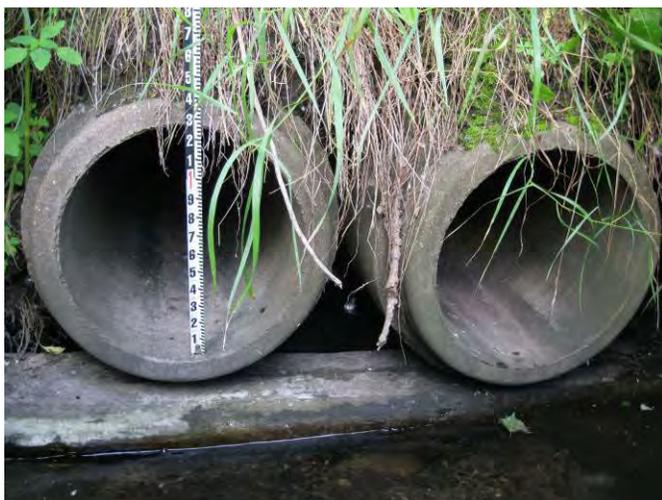
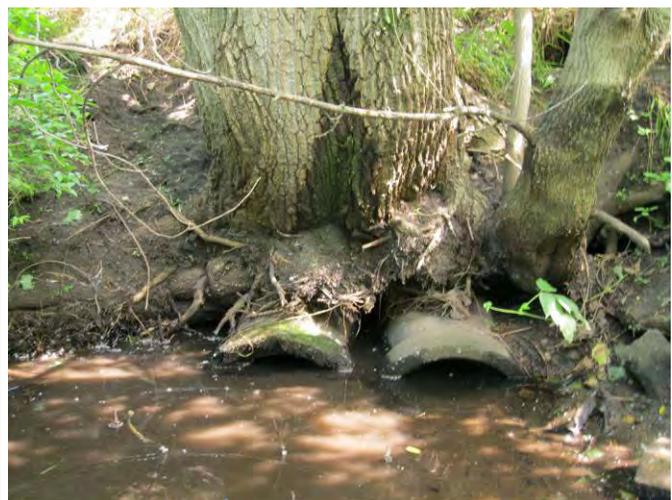
Stream: Middle Creek Trib 1, Reach 1	Problem description: 2, 14-inch concrete pipes under farm road are perched, undersized, and not fully functional as low flows go underneath the pipes.
Station: 600	
Solution: Culverts should be replaced with large culverts if the road is still necessary. A stabilized gravel/cobble ford or bridge could also replace the culverts. Scores reflect replacing with a stabilized gravel/cobble ford.

(Left to right): Stn 600 looking upstream at culverts; Stn 600 looking downstream at culverts

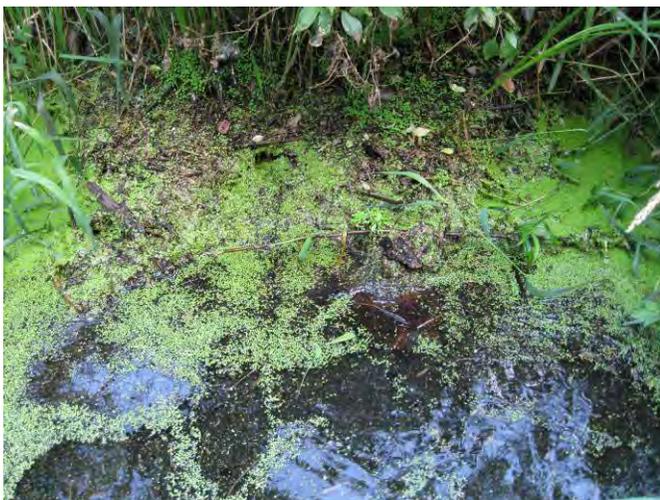
(Left to right): Stn 850 looking downstream at culverts

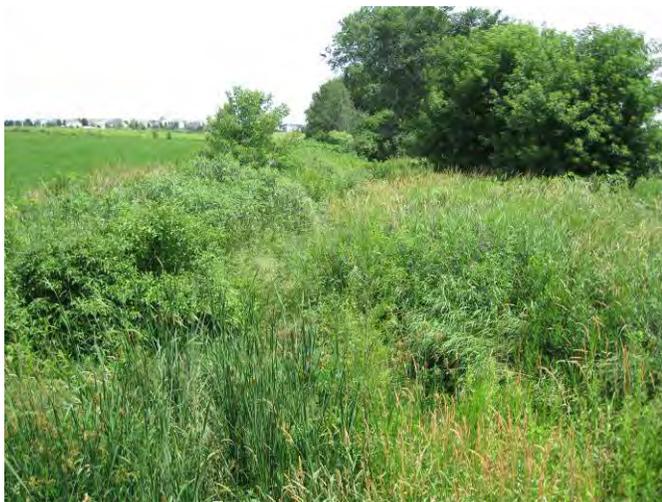
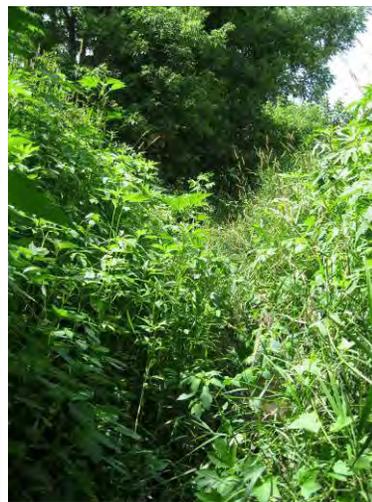
Stream: Middle Creek Trib 6, Reach 1	Problem description: Portions of this reach have little canopy cover, though grasses provide some in-channel shade. Trees planted on small benches between the channel and the ditch walls would provide stability, canopy cover, and geomorphic/habitat complexity as is found in a few locations with trees in this reach.
Station: 500-1200	
Solution: Plant native riparian trees and shrubs both within the ditch and between the row crops and the ditch.

(Left to right): Stn 1250 looking downstream from Flagstaff Ave; Stn 700 looking upstream

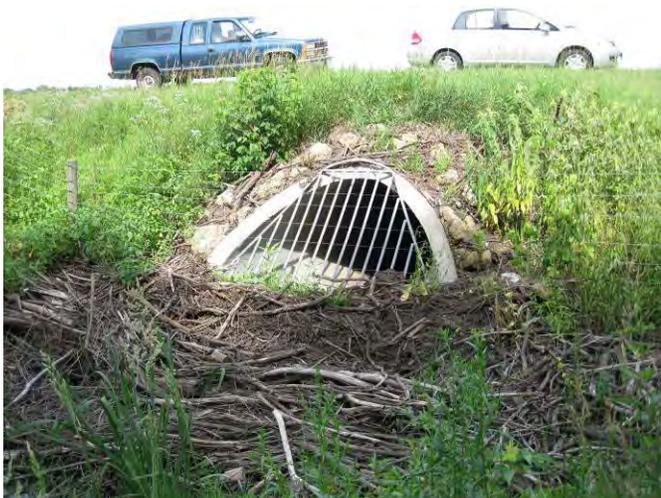
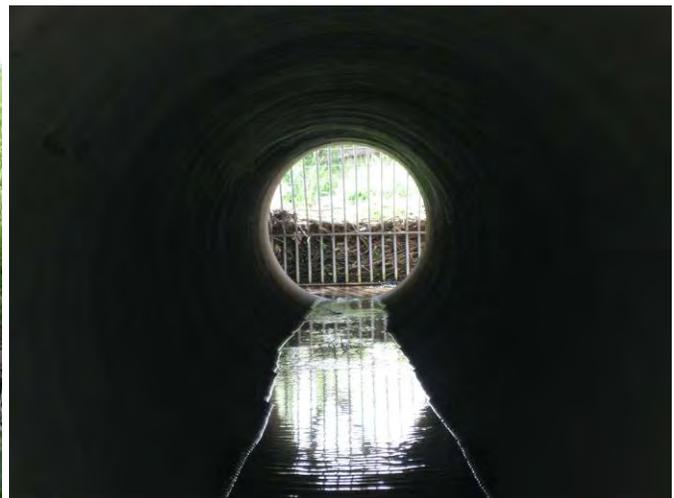
Stream: Middle Creek Trib 6, Reach 1	Problem description: 6-ft flared concrete pipe with trash grates under Flagstaff Ave is a fish passage barrier due to debris piled up multiple feet on both ends.
Station: 1300	
Solution: Clean trash grates regularly, especially after flood events. <i>Only complete if downstream passage barriers are removed and habitat upstream is improved and found to be viable for fish species.</i>

(Left to right): Stn 1400 looking downstream at culvert below Flagstaff Rd; Stn 1250 looking upstream through culvert

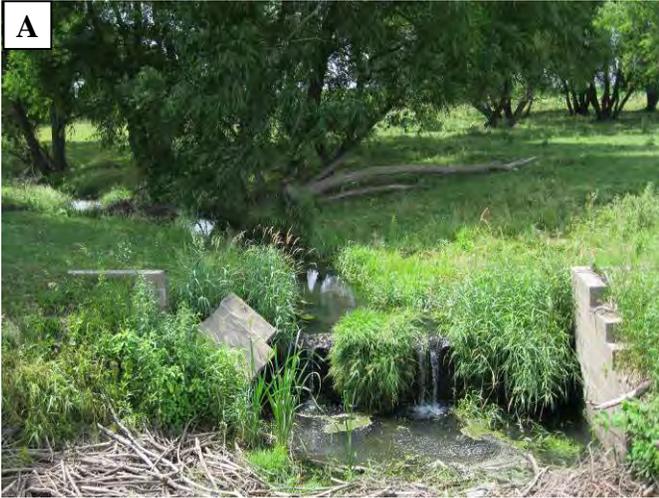
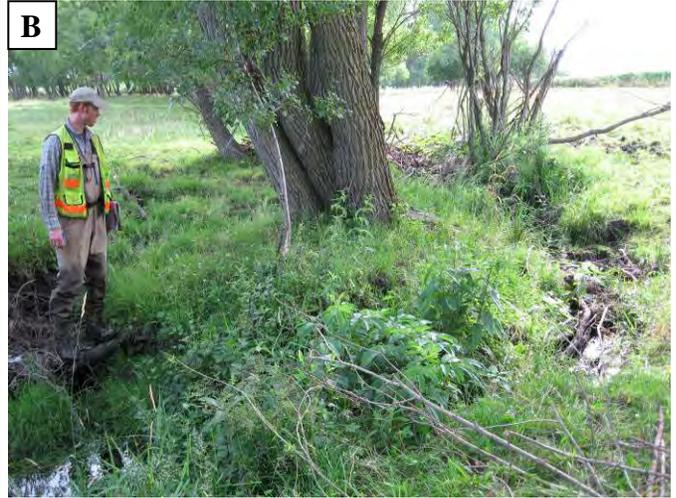
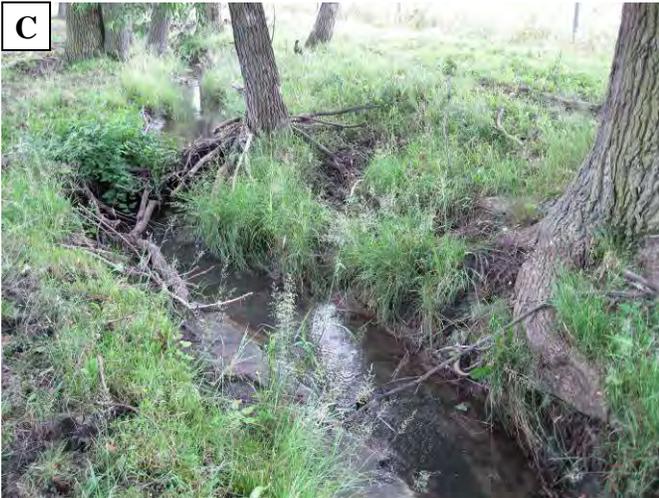
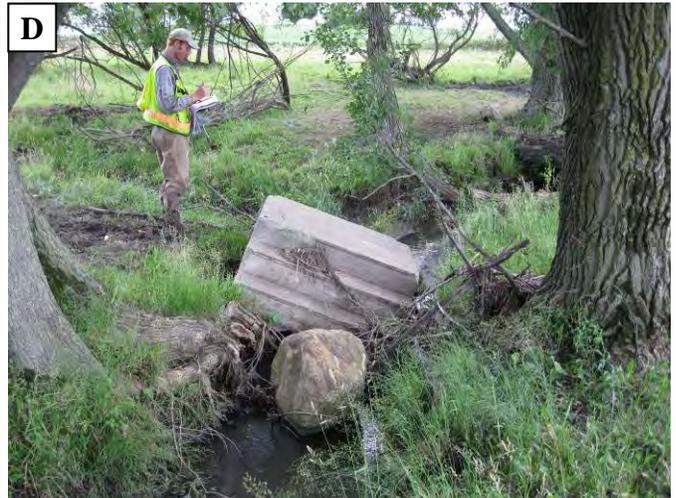
Stream: Middle Creek Trib 6, Reach 1	Problem description: Multiple knickpoints, a dam, and trash suggest active channel incision and all present fish passage barriers:
Station: 1400-2500	<ul style="list-style-type: none"> <li>• Stn 1400: 3.2-ft high concrete dam/weir is about 12 ft long across the channel. Part of the dam has broken and fallen into the stream. The dam provides grade control to prevent further knickpoint migration, but it is also a fish passage barrier.</li> <li>• Stn 1600: 2-knickpoint stopped at willow roots</li> <li>• Stns 2150, 2300, 2425: 0.5-ft knickpoints stopped at willows</li> <li>• Stn 2400: Concrete steps in channel block flows</li> </ul>
Solution: If fish passage becomes important in this tributary, the dam and the concrete steps should be removed and the channel rebuilt with a riffle-pool structure that provides grade control and habitat. If fish passage is not a concern, monitor the knickpoints - if incision and downstream sediment release becomes a problem, rebuild channel to fit new hydrology and provide grade control. Scores reflect monitoring.

A) Stn 1350 looking upstream at concrete weir; B) Stn 1550 looking upstream at knickpoint; C) Stn 2300 looking upstream at knickpoint; D) Stn 2400 looking upstream at concrete steps

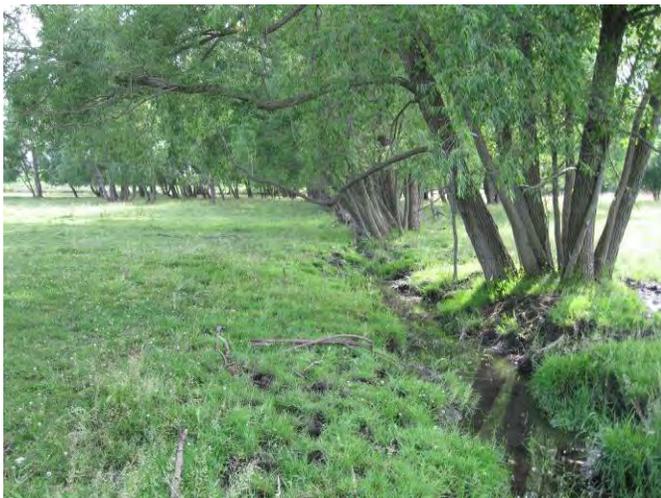
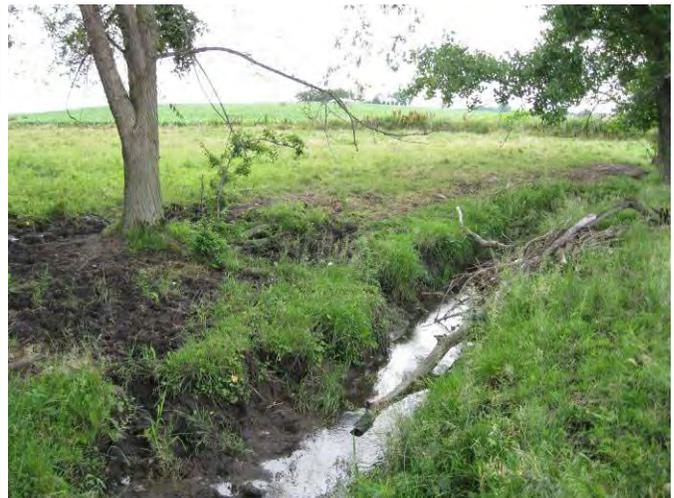
Stream: Middle Creek Trib 6, Reach 1	Problem description: Unrestricted cattle grazing causing some bank erosion and poor water quality.
Station: 1400-2500	
Solution: Cold water was observed emerging from seeps near the channel, suggesting that this tributary could be a good source of cold, clean water to downstream reaches with better habitat. Provide a buffer of at least 15 ft on either side of the channel with one or two stabilized crossings for the cattle. Plant native understory species within these fences to provide a buffer between waste runoff and the channel.

(Left to right): Stn 1550 looking upstream at open grazing; Stn 2450 looking upstream at open grazing

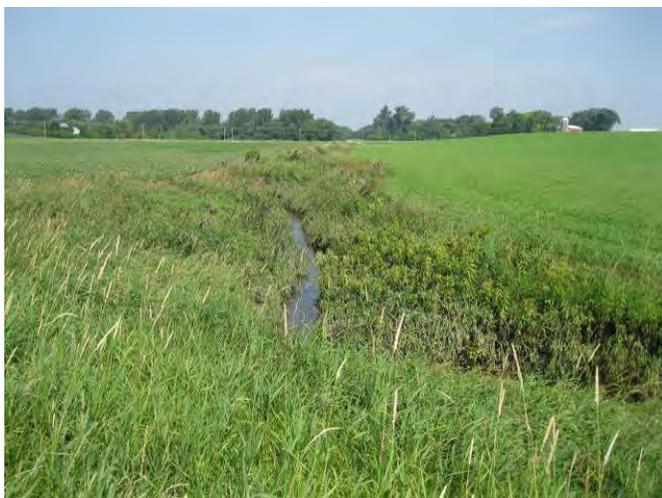
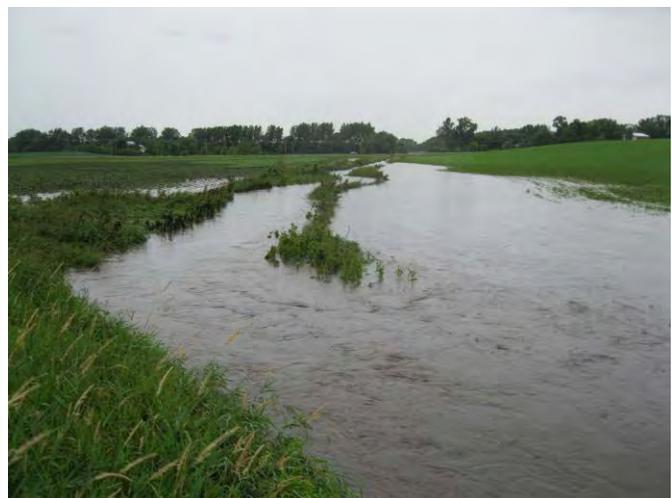
Stream: Middle Creek Trib 7, Reach 1	Problem description: Entire reach has been straightened into a ditch historically - little opportunity for geomorphic or habitat complexity. During large rain events, portions of the fields flood, introducing sediment and any chemicals and fertilizers applied on the fields to the channel. Excessive suspended sediment and introduced chemicals and fertilizers can degrade water quality and in-stream habitat.
Station: 0-1500	
Solution: Increase riparian buffer to encompass the extent of overbank flooding. With riparian buffer, build more sinuous channel with wider floodplains. Plant native riparian trees, shrubs and forbs throughout.

(Left to right): Stn 50 looking upstream; Stn 50 looking upstream during flood.

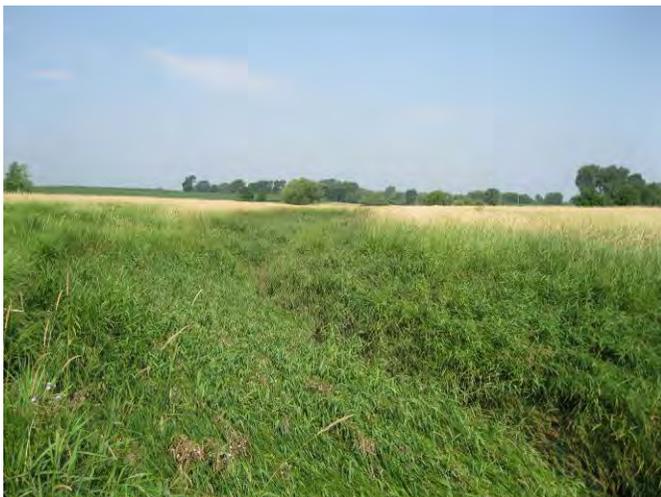
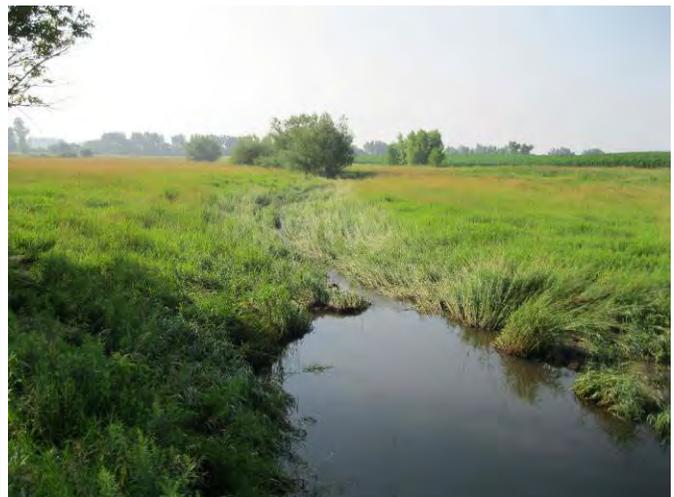
(Left to right): Stn 2700 looking upstream; Stn 4550 looking downstream from 190<sup>th</sup> St. W

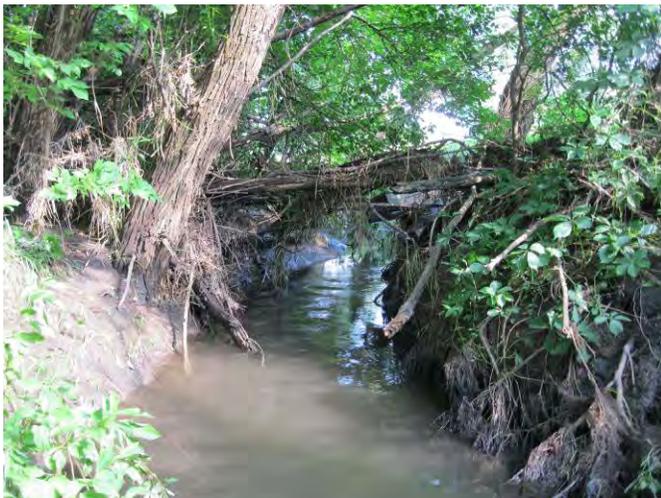
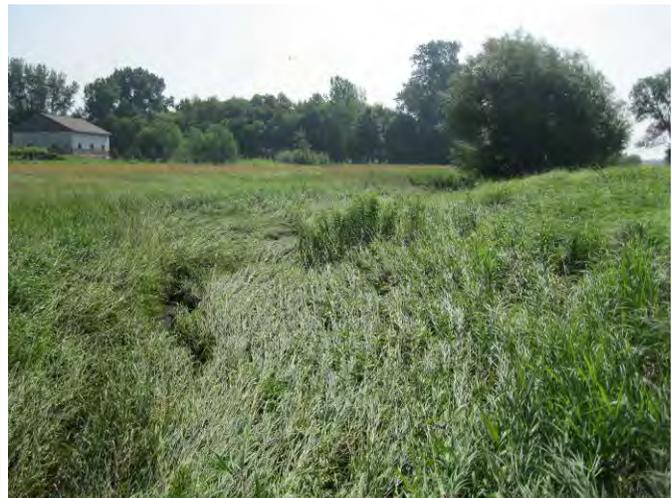
(Left to right): Stn 1800 looking upstream at incised channel and flood debris; Stn 2700 looking downstream

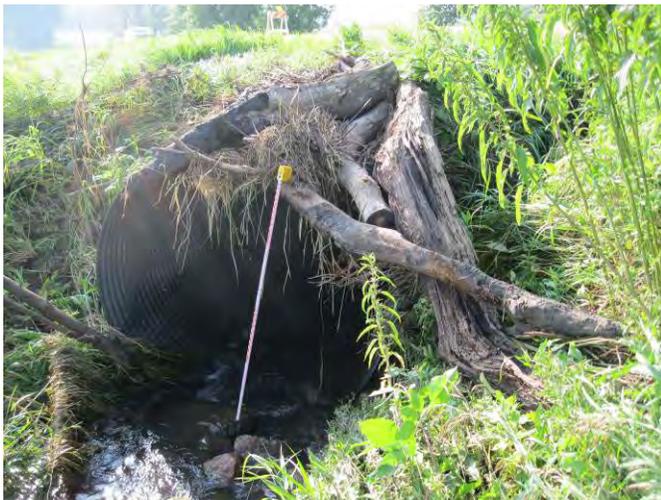
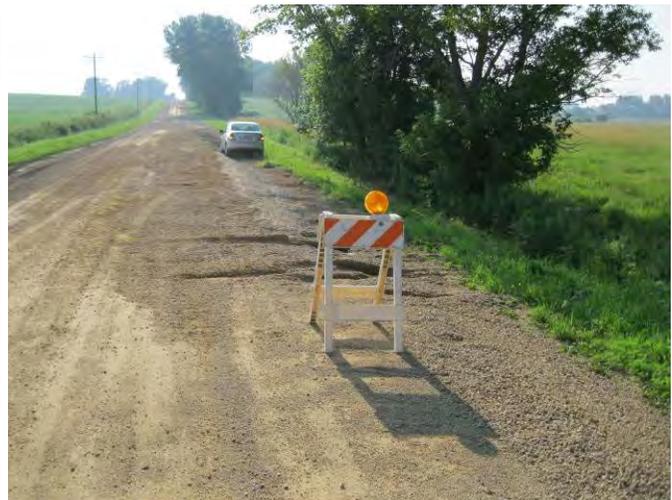
Stream: Middle Creek Trib 7, Reach 2	Problem description: 6-ft corrugated metal pipe is undersized and has resulted in overtopping the dirt road leading to rilling and erosion.
Station: 4550	
Solution: Replace culvert with a larger bottomless arch or box culvert and re-grade to allow appropriate fish passage.

(Left to right): Stn 4600 at corrugated metal pipe; Stn 4550 looking east along 190<sup>th</sup> St. W showing evidence of recent overtopping of road

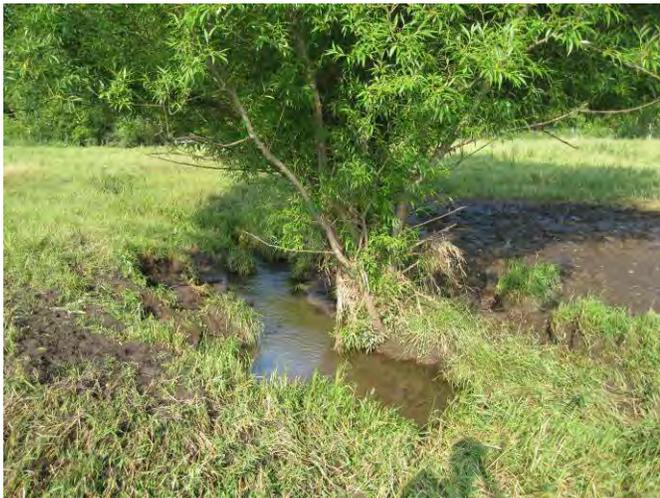
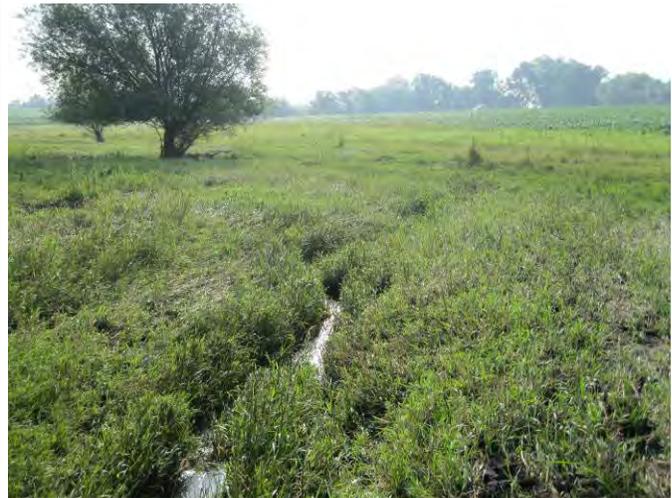
Stream: Middle Creek Trib 7, Reach 2	Problem description: Open grazing through channel and wetland decreases water quality and increases bank erosion.
Station: 5500-6600	
Solution: Develop buffer with fencing to keep cows out except at certain crossings. Plant native riparian vegetation within fencing to help infiltrate waste runoff before it reaches the channel.

(Left to right): Stn 6400 looking upstream; Stn 6550 looking downstream at pasture

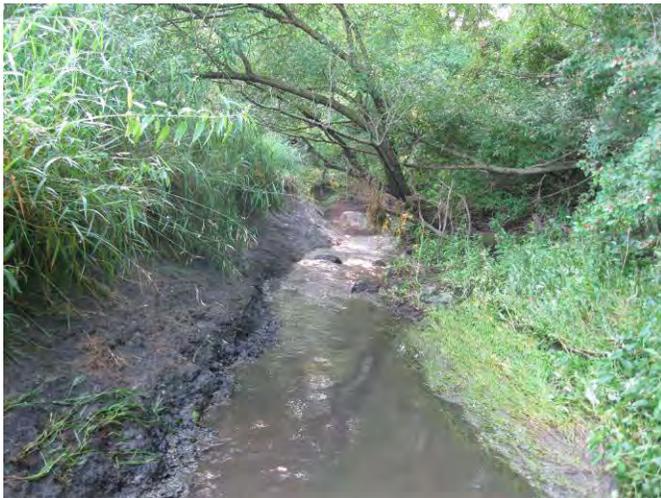
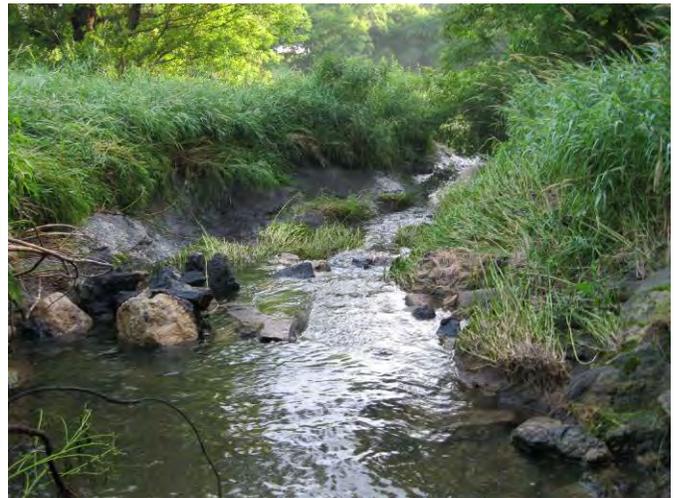
Stream: Middle Creek Trib 7, Reach 2	Problem description: Excessive incision up to 5 ft has occurred. There is a 2-ft knickpoint at ~Stn 7600 about 100 ft downstream of the 190th St W crossing. This knickpoint is where grouted riprap failed and has piled up downstream from its intended location.
Station: 6800-7600	
Solution: Raise and widen the channel through this area to accommodate larger flows. Install grade controls to prevent further incision.

(Left to right): Stn 7550 looking downstream at incision; Stn 7650 looking downstream at incision

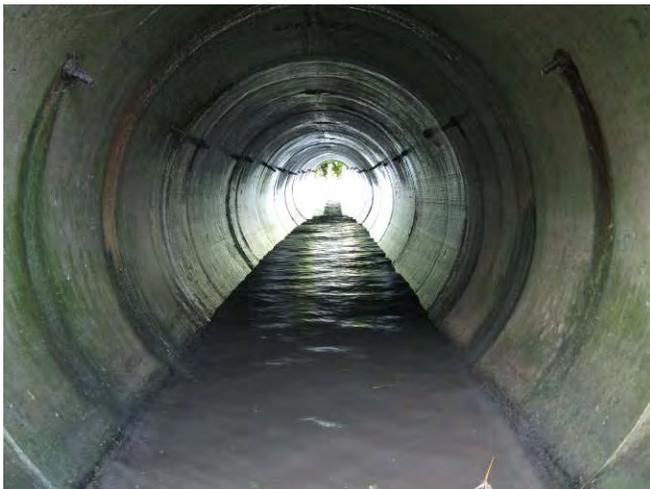
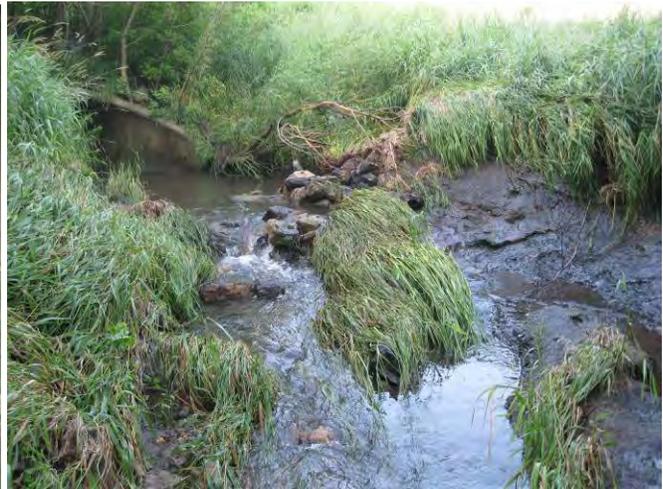
Stream: Middle Creek Trib 7, Reach 2	Problem description: 6-ft concrete pipe under 190th St W is steep on the upstream end of the culvert. This is likely a partial fish passage barrier.
Station: 7750	
Solution: If culvert is not being replaced in near future, install natural bed material on base of culvert to provide refuge and resting places as fish navigate the culvert. Fish were observed at the downstream end of the culvert.

(Left to right): Stn 7700 looking upstream inside culvert; Stn 7650 looking upstream at outlet of culvert

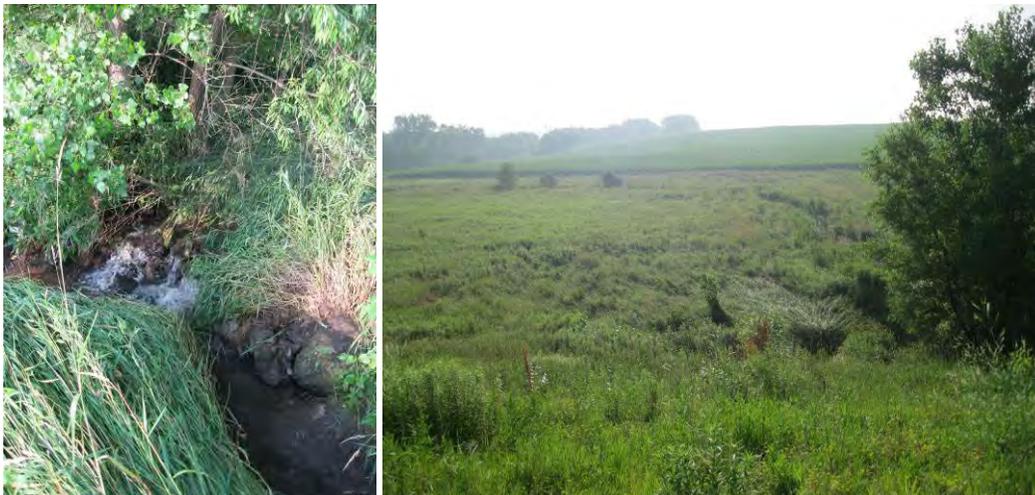
Stream: Middle Creek Trib 7, Reach 3	Problem description: 2, 4-ft concrete pipes under Cedar Ave. A 2-ft knickpoint on the downstream end as water flows over riprap and a 2-ft knickpoint on the upstream end at the edge of the field suggest some active vertical instability. Below the culvert the channel is deeply incised (4-5 ft).
Station: 8550	
Solution: Because fish passage here would not open up a large amount of high quality habitat, the area between Stn 7750 and 8400 could be converted into a stormwater basin if the landowner is willing. This would limit the impact of the downstream knickpoint and provide some storage. On the upstream end, regrading and the potential creation of an actual channel may improve conditions.

(Left to right): Stn 8300 looking upstream at 2-ft knickpoint over riprap; Stn 8400 looking downstream from Cedar Ave.
