Vermillion River Watershed Joint Powers Organization  
**Fluvial Geomorphic Assessment of North Creek and  
Middle Creek, Dakota County, MN: Final Report**

January 6, 2012

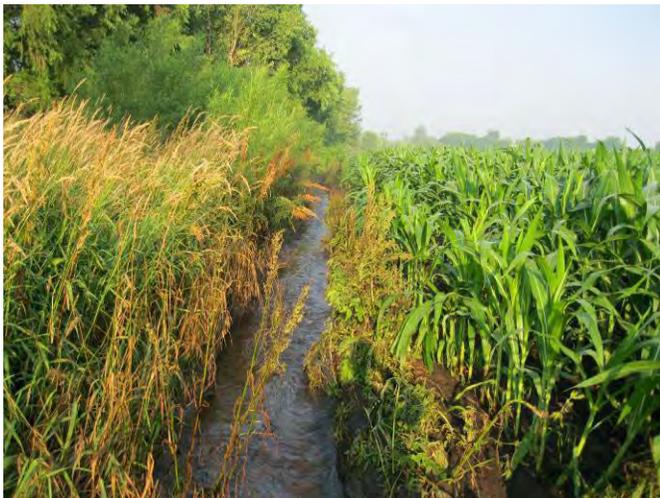
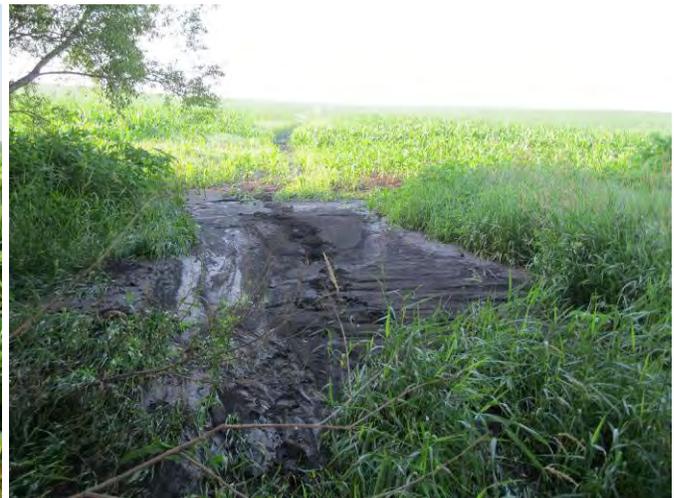
Stream: Middle Creek Trib 7, Reach 3	Problem description: Channel has moved into the corn field and out of the wide riparian area. The channel is a trench between corn rows negatively impacting crops and introducing excessive quantities of sediment and contaminants to the channel downstream.
Station: 10,450-11,500	
Solution: Either increase buffer or redirect water back into channel and recreate channel to keep it in the preferred location. A small drainage from the south at Stn 11,550 has deposited a lobe of fines that has likely pushed the channel into the fields downstream. Could heavily vegetate that drainage so the soils are not as easily washed away.

(Left to right): Stn 11,400 looking upstream at channel formed in cornfield; Stn 11,550 looking South across channel at deposition from drainage off of fields

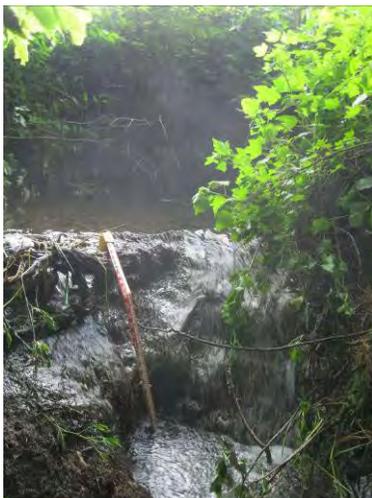
(Left to right): Stn 13,950 looking upstream at 2-ft knickpoint

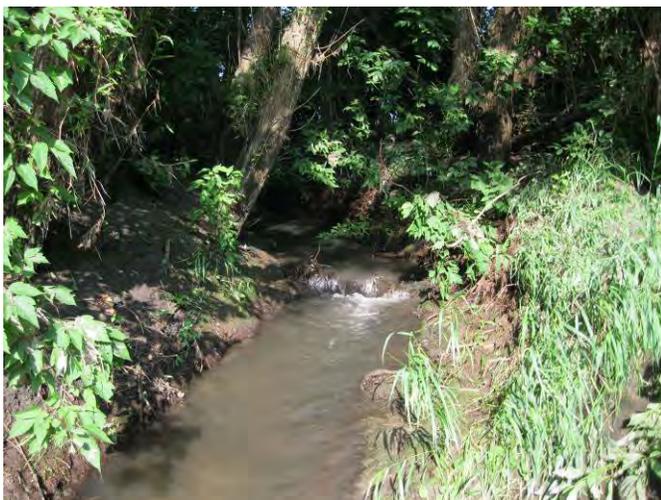
(Left to right): Stn 0 looking upstream from confluence at small knickpoint

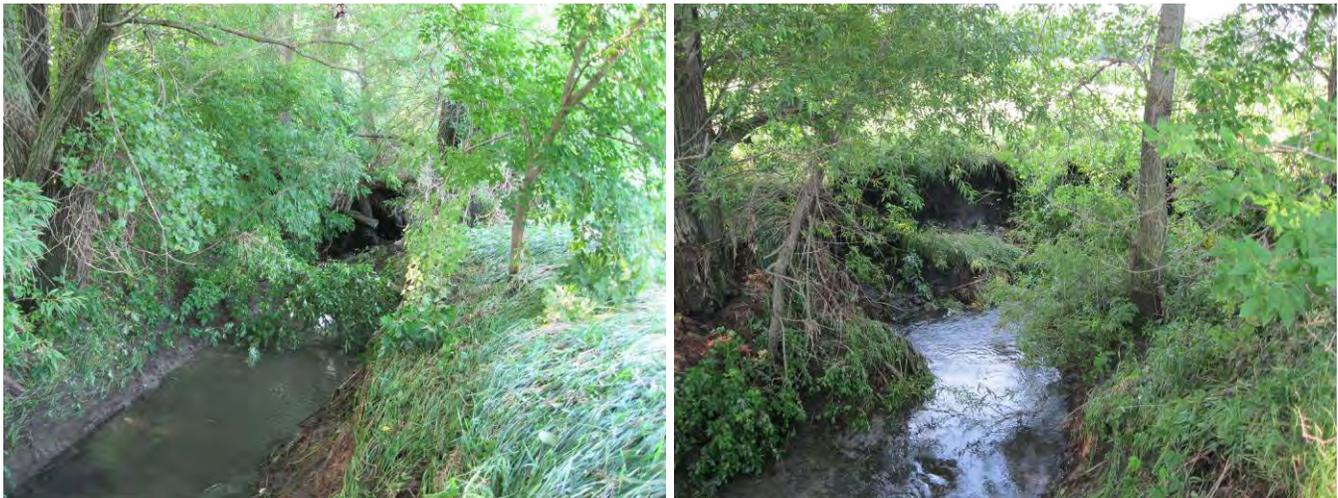
Stream: Middle Creek Trib 7A, Reach 1	Problem description: Historically straightened and deepened channel is now a ditch. The historic and ongoing incision results in excessive bank erosion through much of this section.
Station: 0-2100	
Solution: The cool water, canopy cover, and wide buffer from the fields presents an opportunity to complete full channel restoration with grade controls, riffles and pools, wider floodplains, and increased sinuosity.

(Left to right): Stn 650 looking upstream at incised channel; Stn 1100 looking upstream at eroded bank

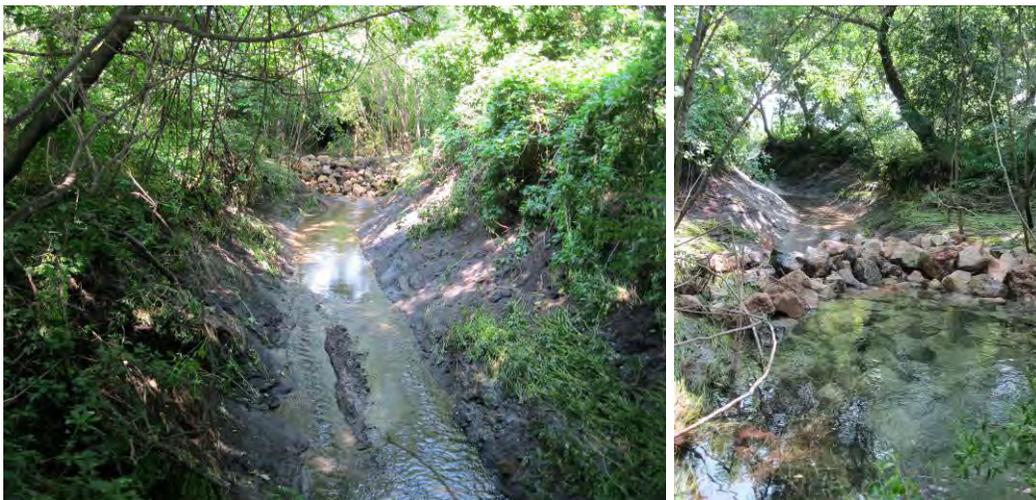
Stream: Middle Creek Trib 7A, Reach 1	Problem description: Incision has resulted in bank erosion and channel widening. Incision is continuing in drainages from fields and may impact field conditions in the future.
Station: 5750-5900	
Solution: Provide toe stabilization and grade control where necessary. Could be incorporated into downstream restoration. Monitor the incision near the fields.

(Left to right): Stn 5800 looking upstream at incision and pile of riprap below culvert; Stn 5950 looking downstream at incision

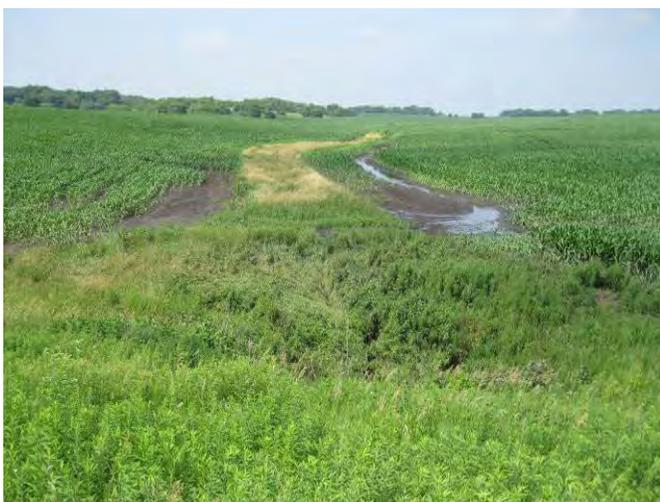
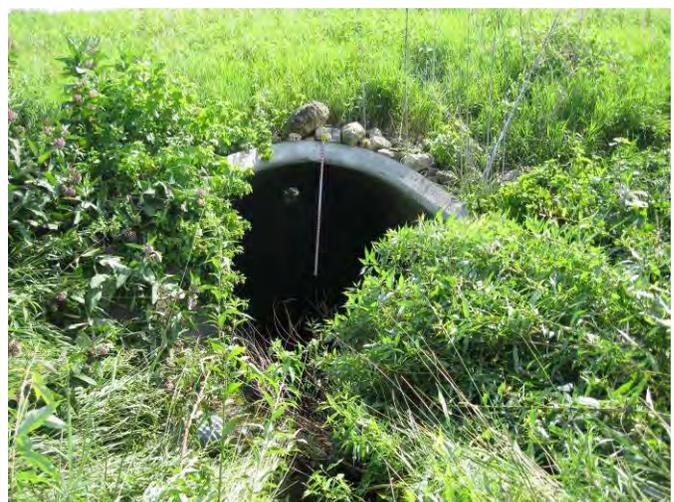
(Left to right): Stn 6150 looking upstream at swale between corn fields; Stn 6200 looking downstream at 6.5-ft concrete pipe under Cedar Ave

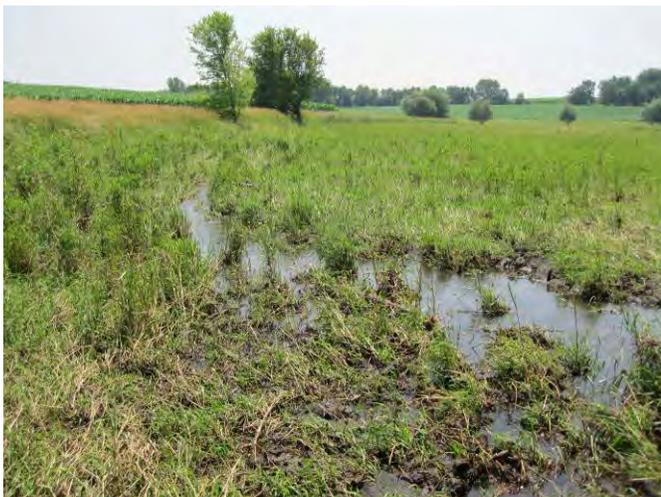
Stream: Middle Creek Trib 7B, Reach 1	Problem description: Open grazing through channel with no canopy cover. Grazing has resulted in bank erosion and a diffuse channel as well as decreased water quality.
Station: 0-700	
Solution: Prevent livestock from grazing within a specific buffer width. Plant native riparian trees, shrubs, and forbs within fence to provide shading and improve infiltration of waste from livestock before it enters the channel. High-quality, cold-water aquatic habitat with wide riparian buffer is upstream of this section.

(Left to right): Stn 650 looking downstream at pasture

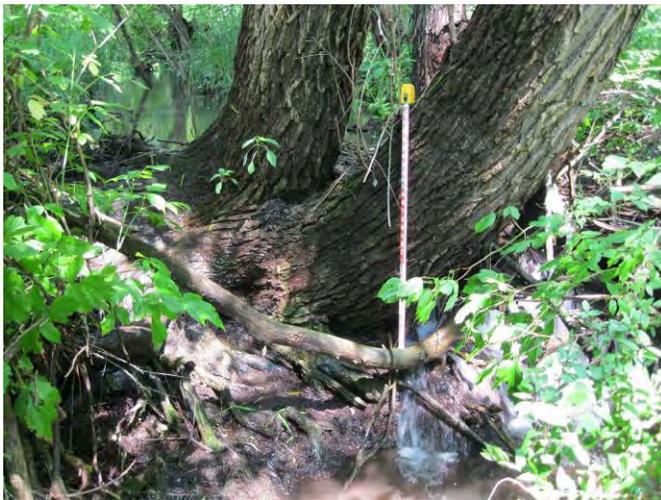
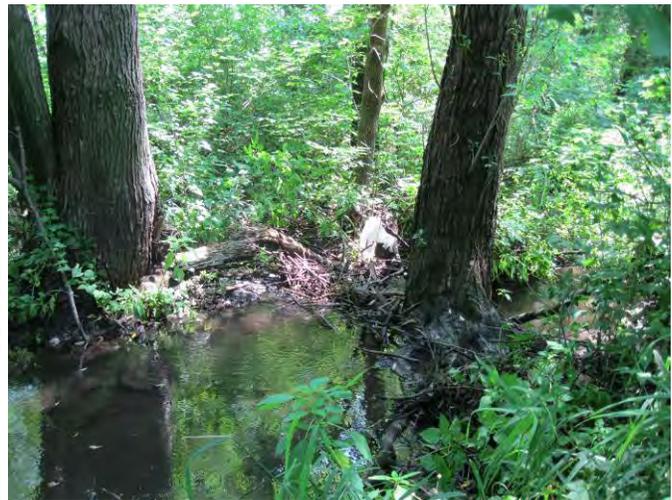
Stream: Middle Creek Trib 7B, Reach 1	Problem description: 3.5-ft knickpoint is currently stopped at tree roots, but is likely to continue if it works through the roots. If allowed to continue, this migrating knickpoint will continue to increase sediment loads downstream and could eventually impact the Cedar Ave crossing.
Station: 1350	
Solution: Build grade-controlling riffle.

(Left to right): Stn 1300 looking upstream at willow halting 3.5-ft knickpoint; Stn 1350 looking towards left bank at top of 3.5-ft knickpoint

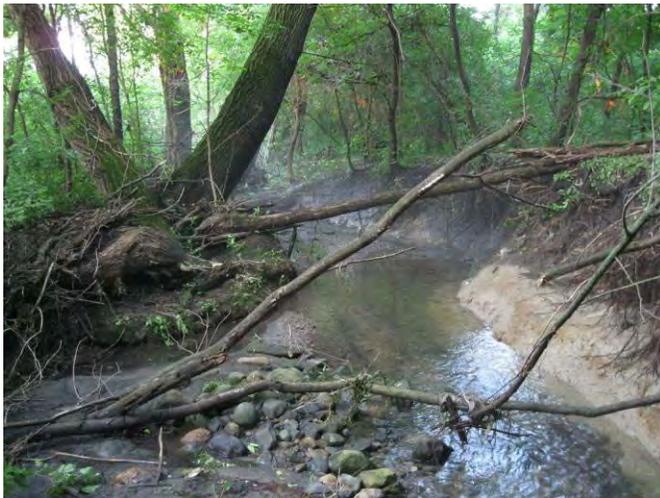
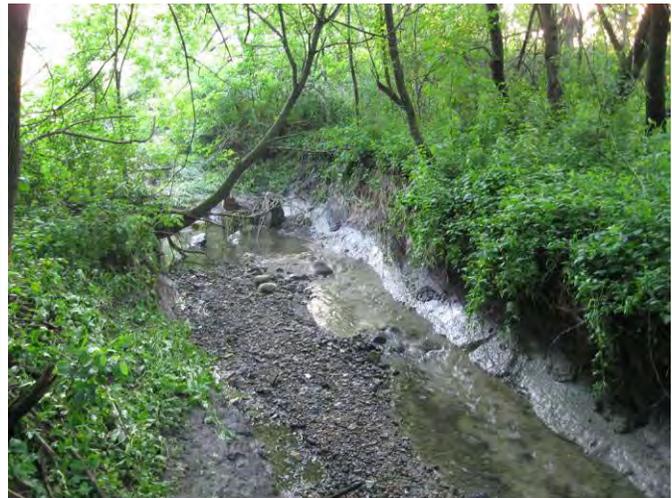
(Left to right): Stn 2350 looking downstream at incision and erosion; Stn 2450 looking downstream at incision

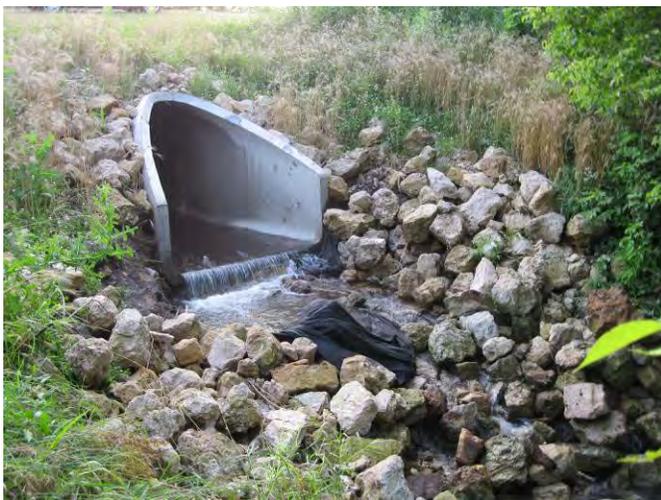
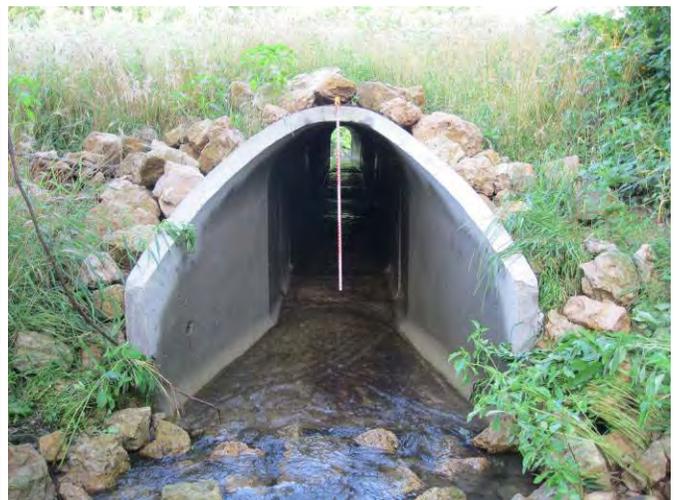
(Left to right): Stn 2500 looking upstream at slightly perched culvert under Highview Ave; Stn 2600 looking downstream at 6X4 culvert under Highview Ave

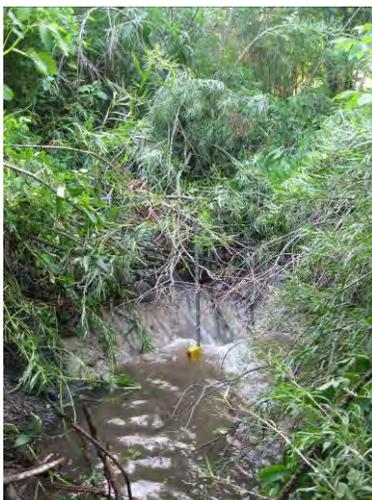
(Left to right): Stn 2700 looking upstream at 3-ft knickpoint through clay

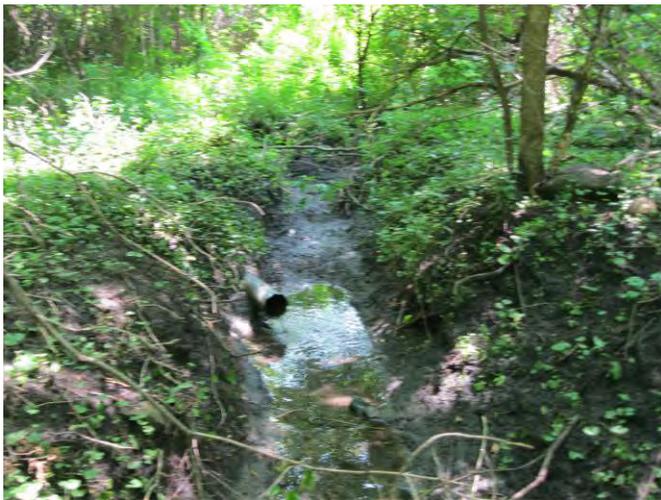
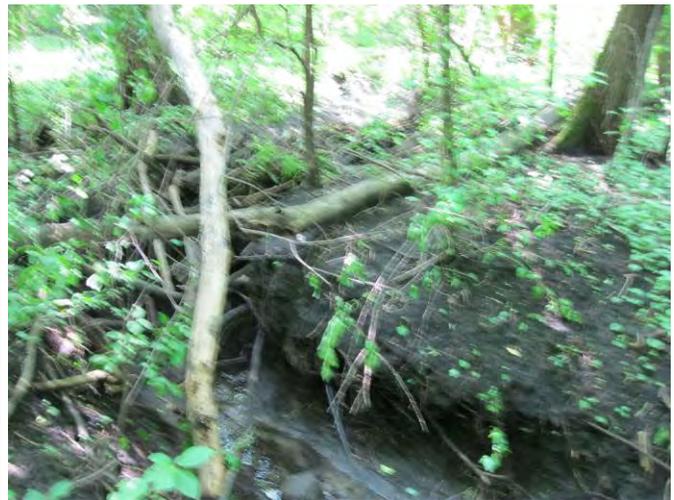
(Left to right): Stn 5550 looking South at 6-in tiling draining from field about 100-ft south of Tributary 9; Stn 5550 looking South at incision due to tiling

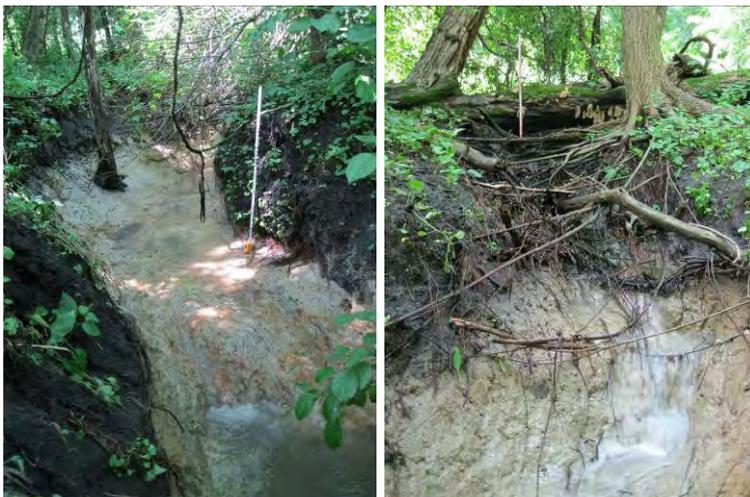
(Left to right): Stn 5825 looking upstream at a knickpoint; Stn 5850 looking upstream at knickpoint
