Vermillion River Watershed Joint Powers Organization
**South Creek Subwatershed Fluvial Geomorphic
Assessment Report**

January 15, 2010

1. Introduction

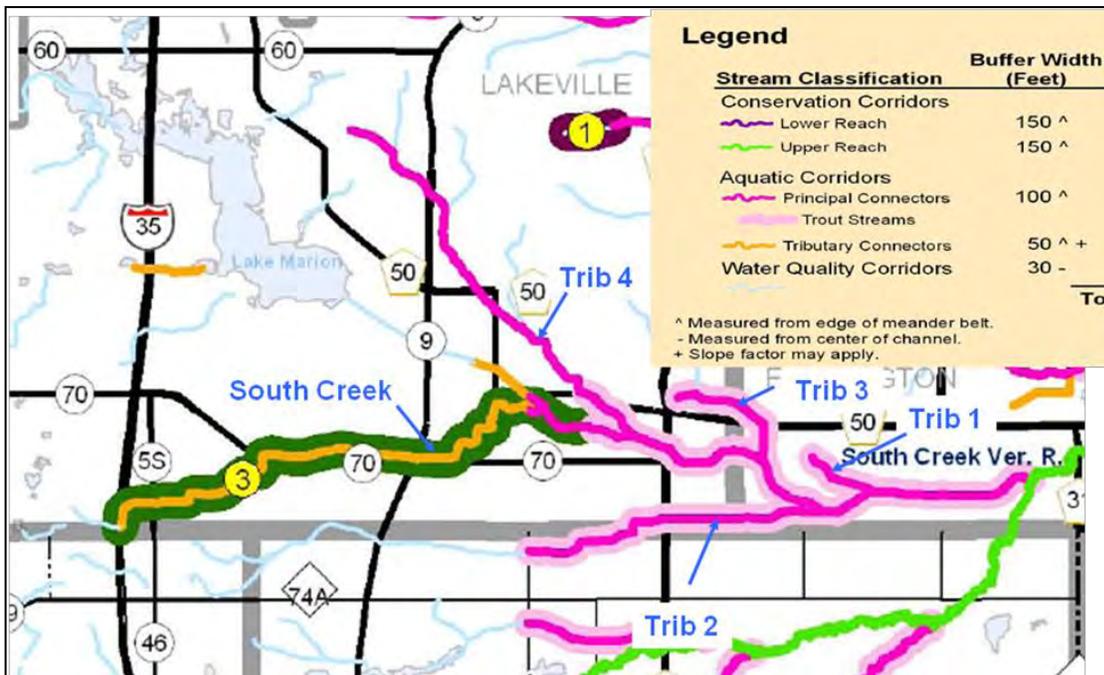
continuous flow through most of the year are classified as trout stream Principal Connectors; elsewhere, the channels are principal or tributary connectors (Figure 1).

Figure 1: Stream classification and buffer width standards for South Creek and the four tributaries surveyed in this study (modified from VRWJPO, 2006).

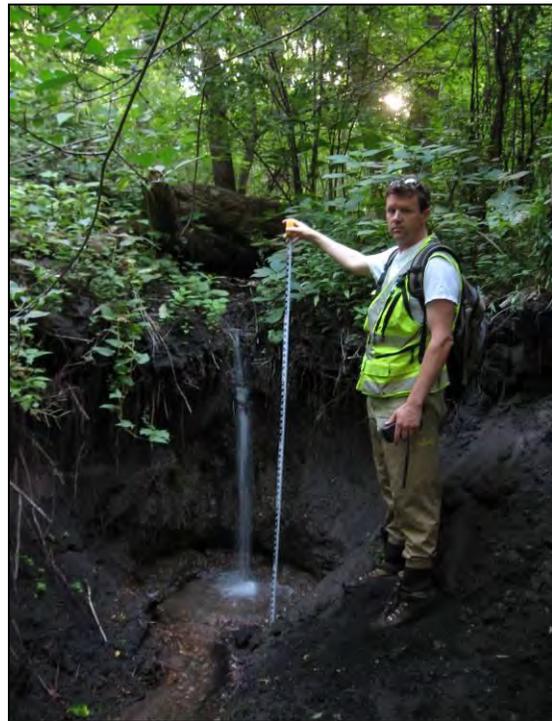
Figure 3: A headcut and incised channel on a small stream in Scott County.

waterfall would be an extreme example of a knickpoint in bedrock. As a headcut moves upstream, the stream becomes more incised and the flood energy increases as more and more volume is confined to an incised or *entrenched* channel (Figure 3). Whereas prior to incision, the stream was able to dissipate its energy over a wide floodplain, after incision this energy is concentrated. Following incision, the stream typically begins to erode laterally with the end result being new floodplain formation at a lower grade. The Schumm channel evolution model demonstrates how a headcut creates an incised channel that becomes laterally unstable and eventually forms a new stable channel at a lower elevation (Figure 4).

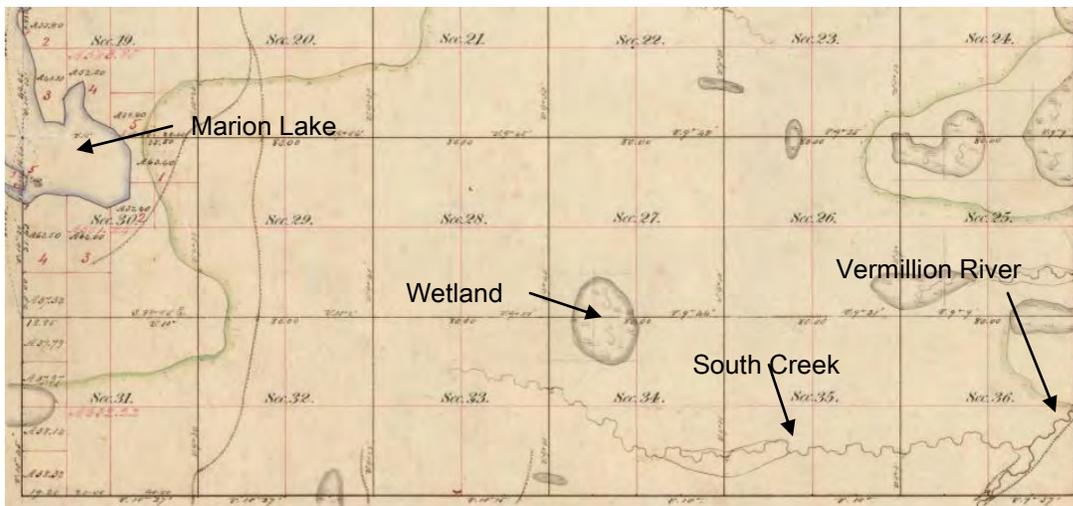
The first land surveys in Dakota County resulted in plat maps from 1855. These maps indicate an active sinuous channel in the current location of South Creek from the Vermillion River to between Flagstaff Avenue and Cedar Avenue (Figure 5). There is no record of the channel continuing upstream in the watershed and no record of tributaries that are currently active in the South Creek watershed (Figure 1). There is a small wetland indicated on the map in the approximate location of the upstream portion of Tributary 1; there is currently an active pumpkin farm at this location and no indication of a wetland (Appendix A and B). These maps are not comprehensive and are not exact representations of the conditions in 1855, but they do offer insight into the likely planform of South Creek and conditions in the watershed. In 1855, South Creek was a relatively short creek that was very sinuous. There were no major wetland areas located in the watershed and there was not enough water to warrant mapping tributaries if they were present.

Figure 5: 1855 plat map showing South Creek flowing into the Vermillion River.

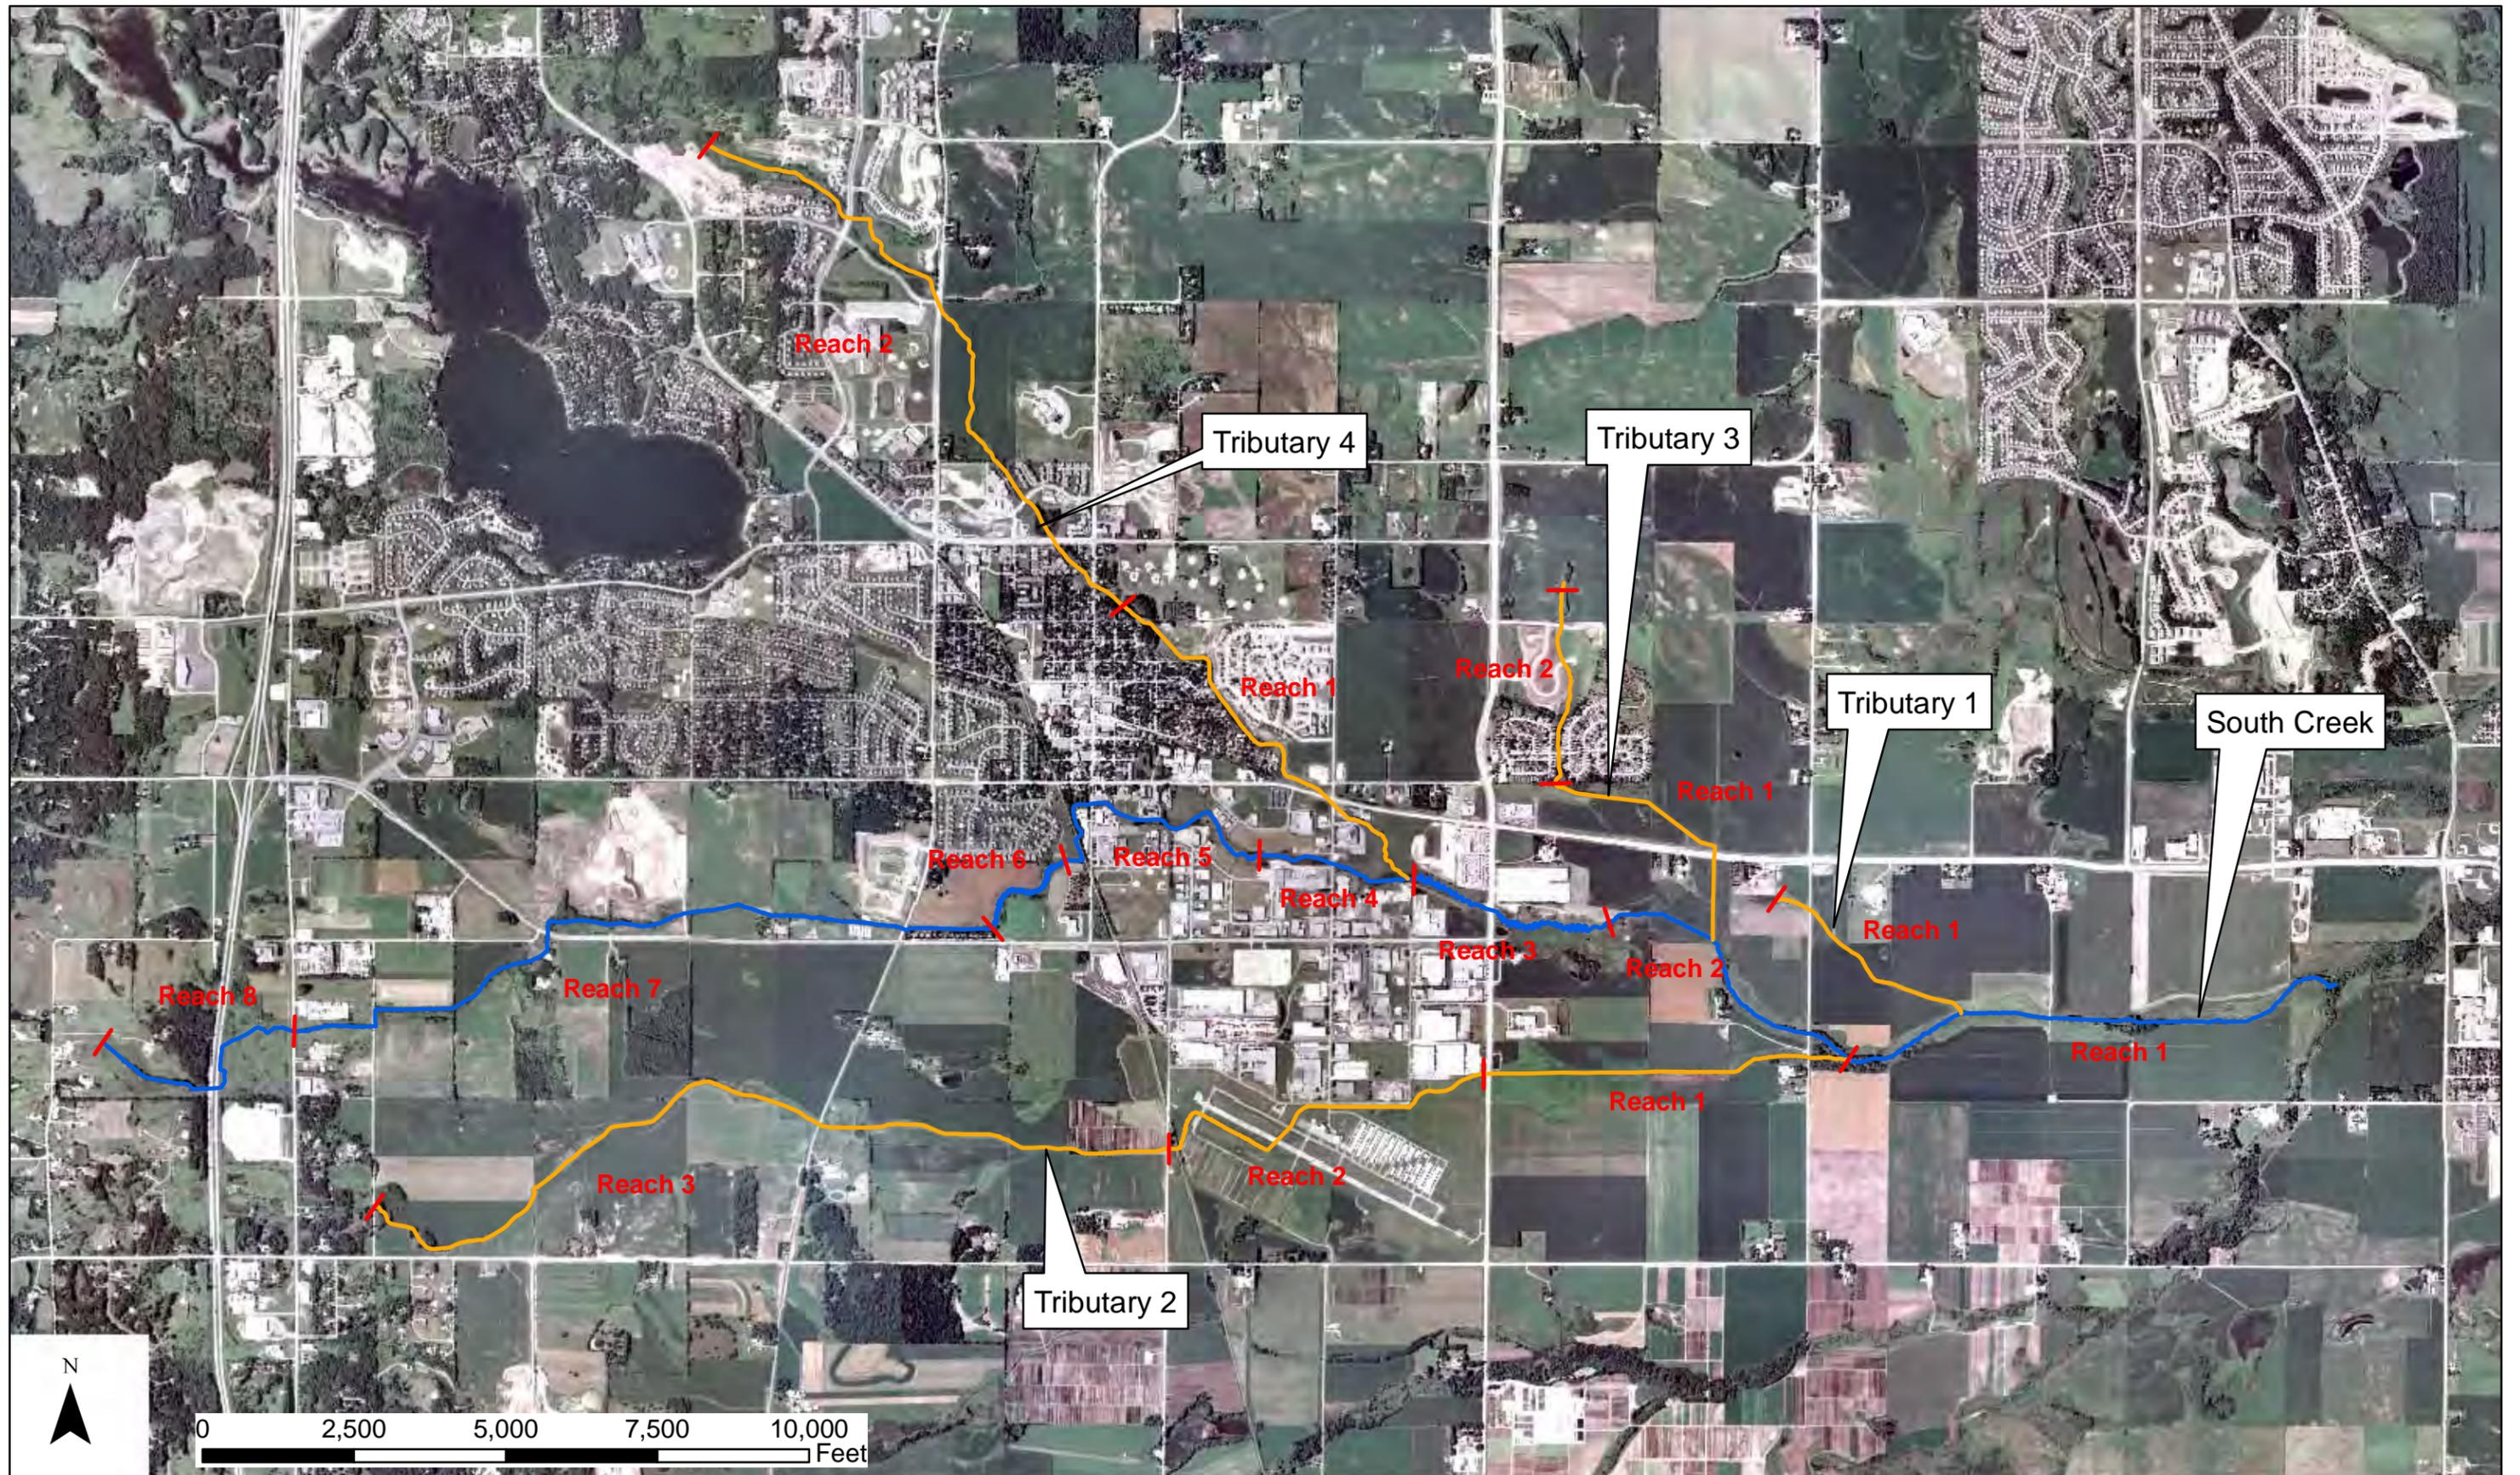
Appendix A: South Creek and its tributaries with the reach boundaries indicated.
