Vermillion River Watershed Joint Powers Organization
**South Creek Subwatershed Fluvial Geomorphic
Assessment Report**

January 15, 2010

1. Introduction

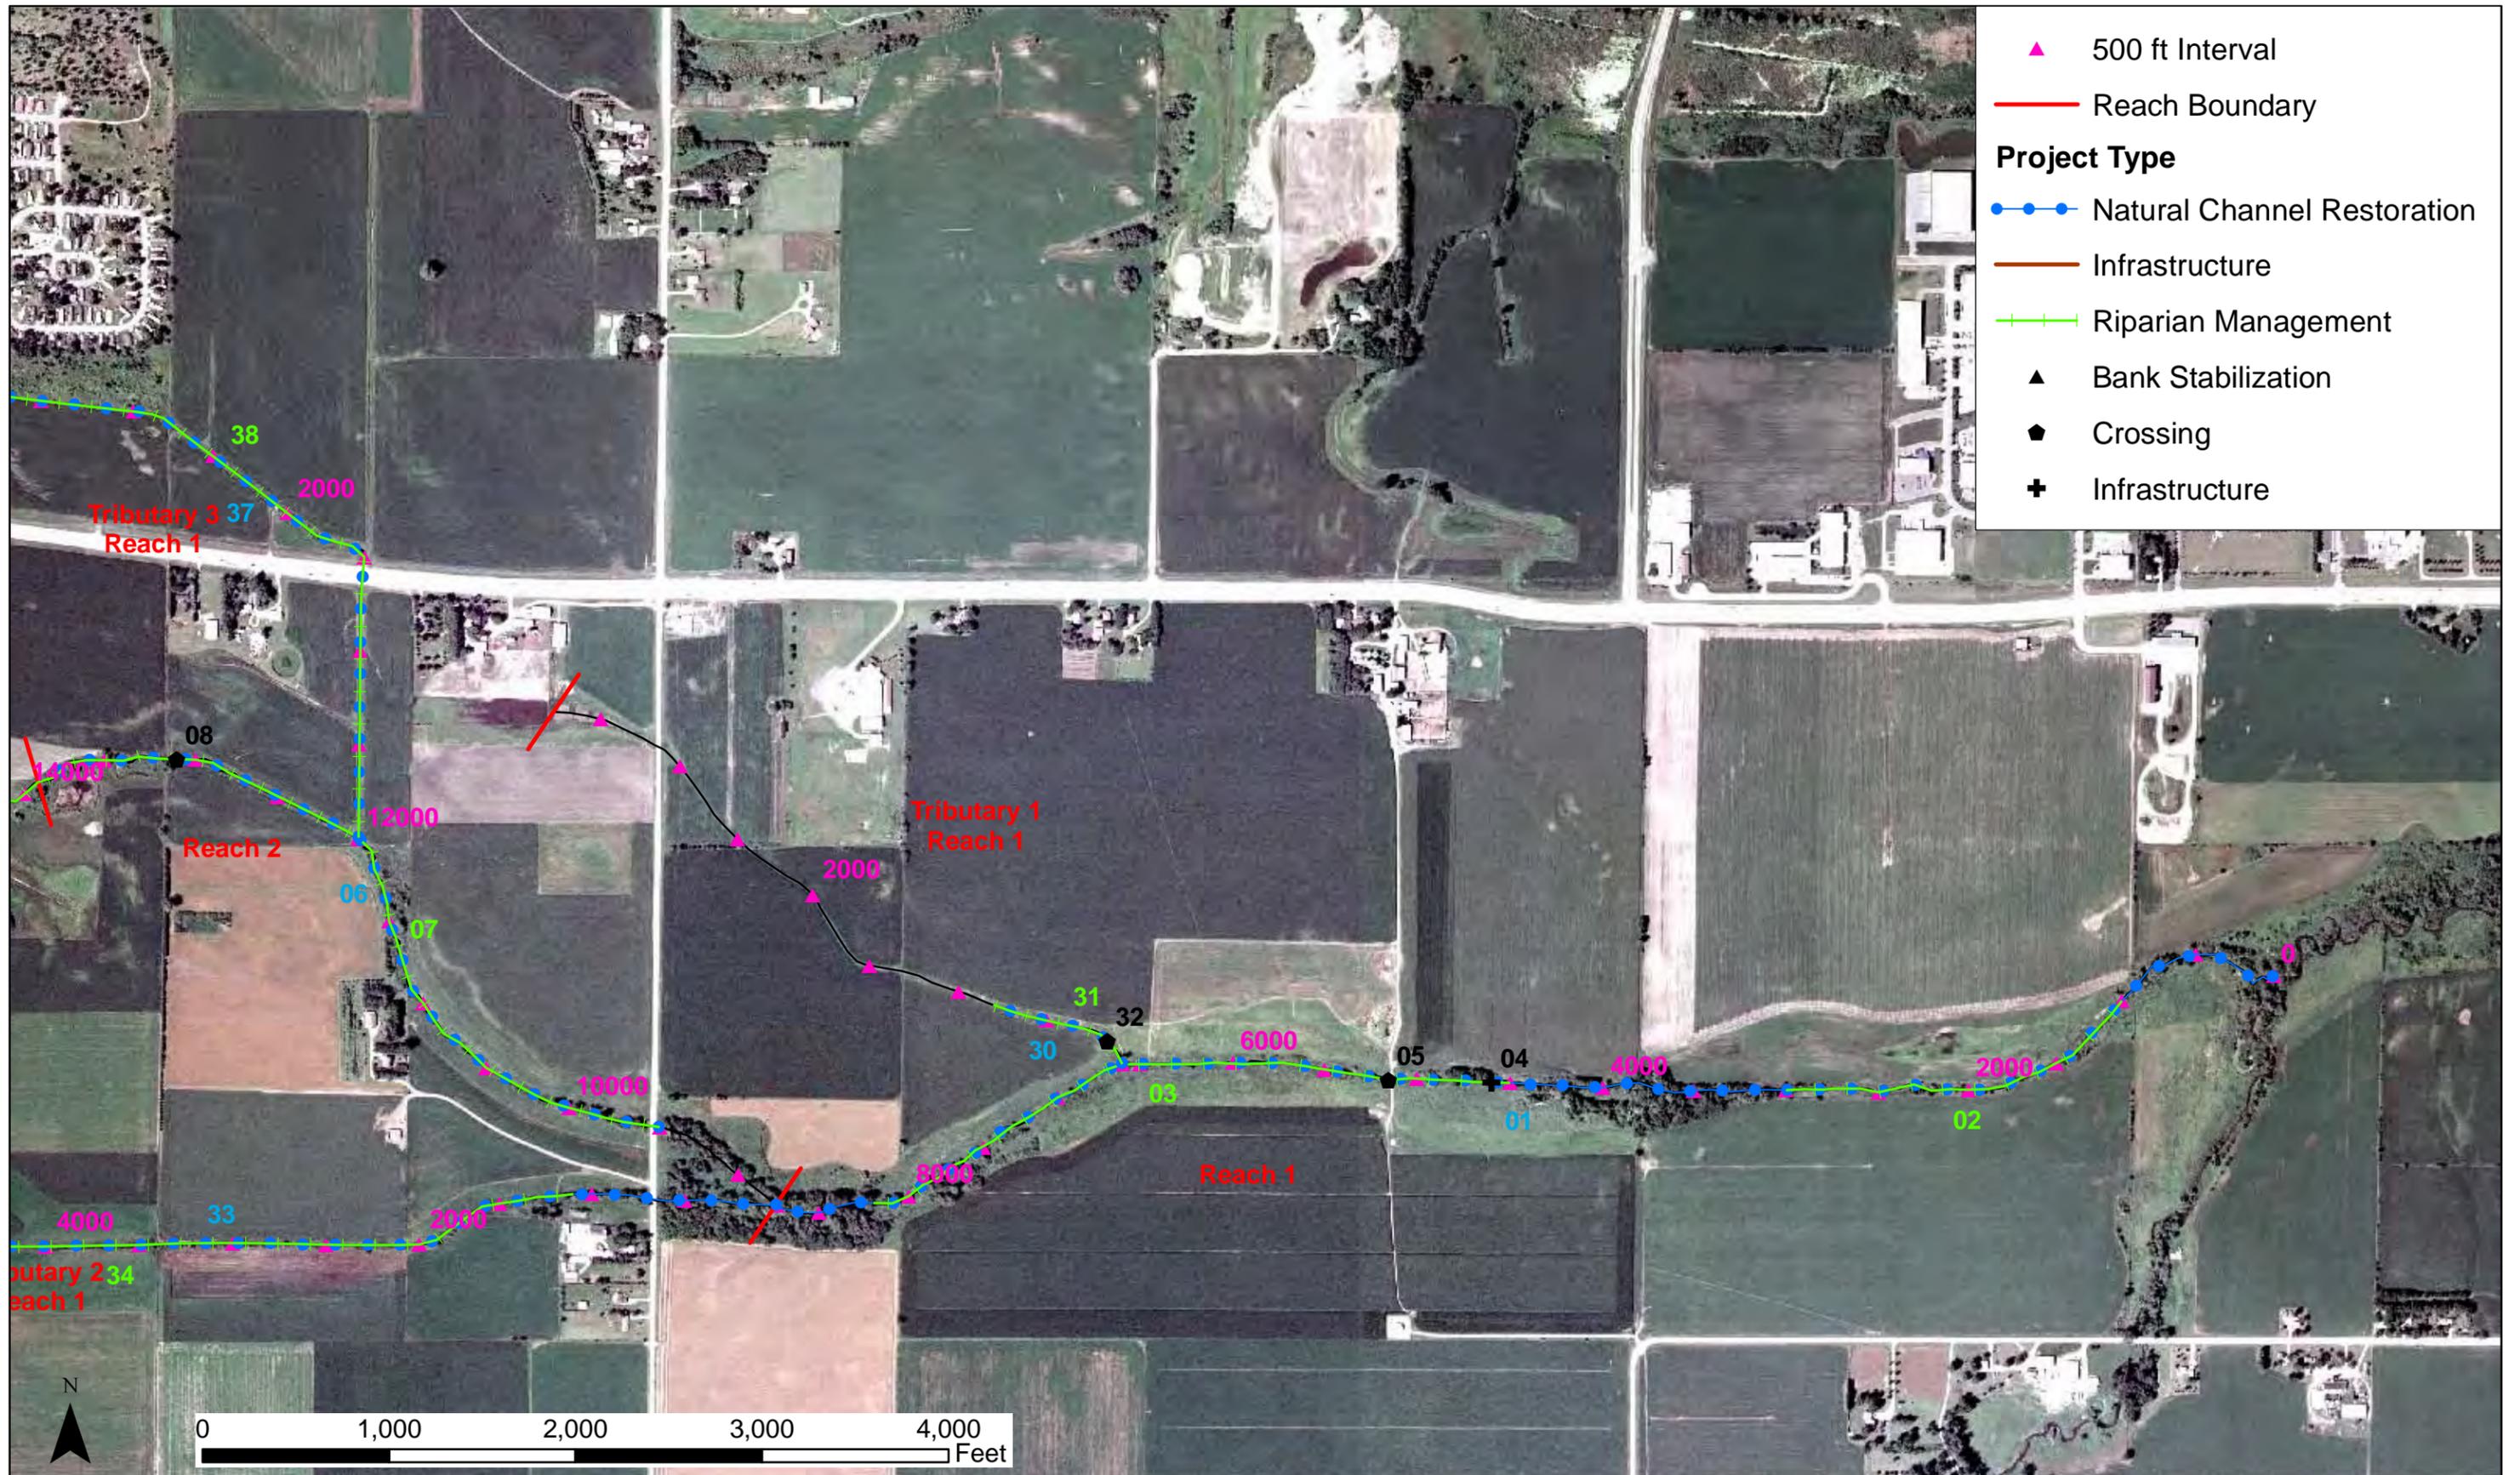
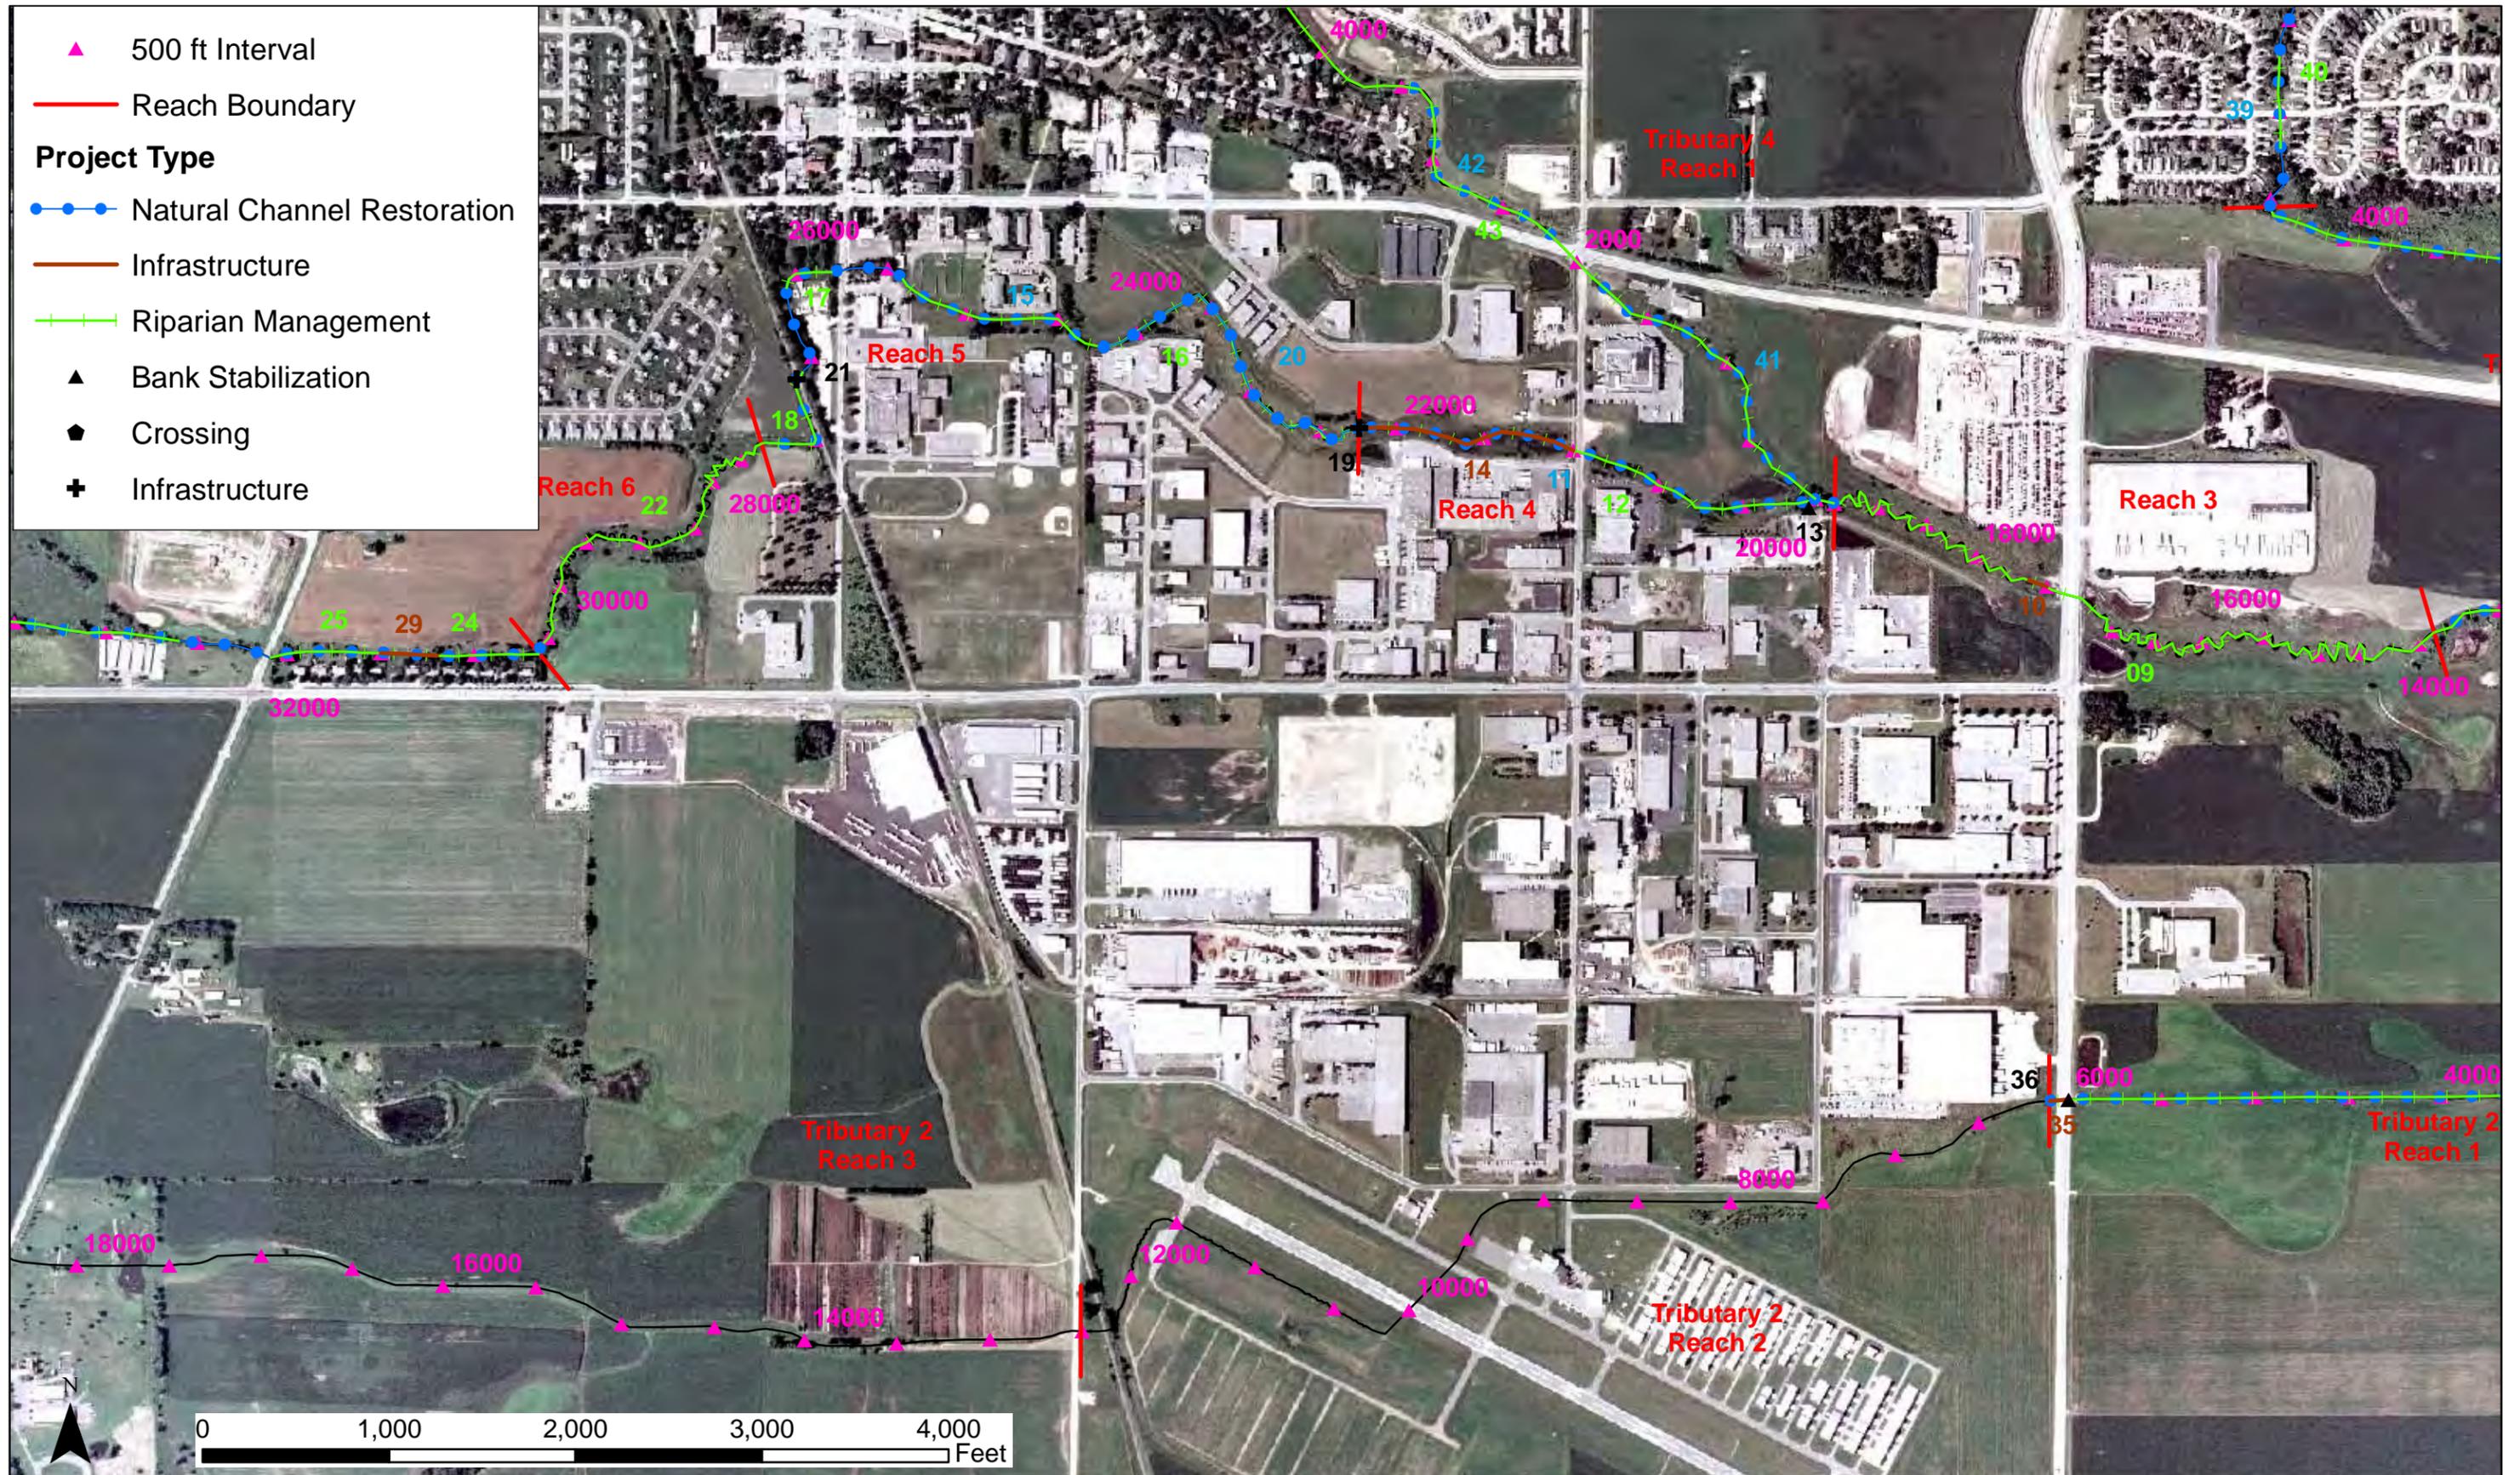
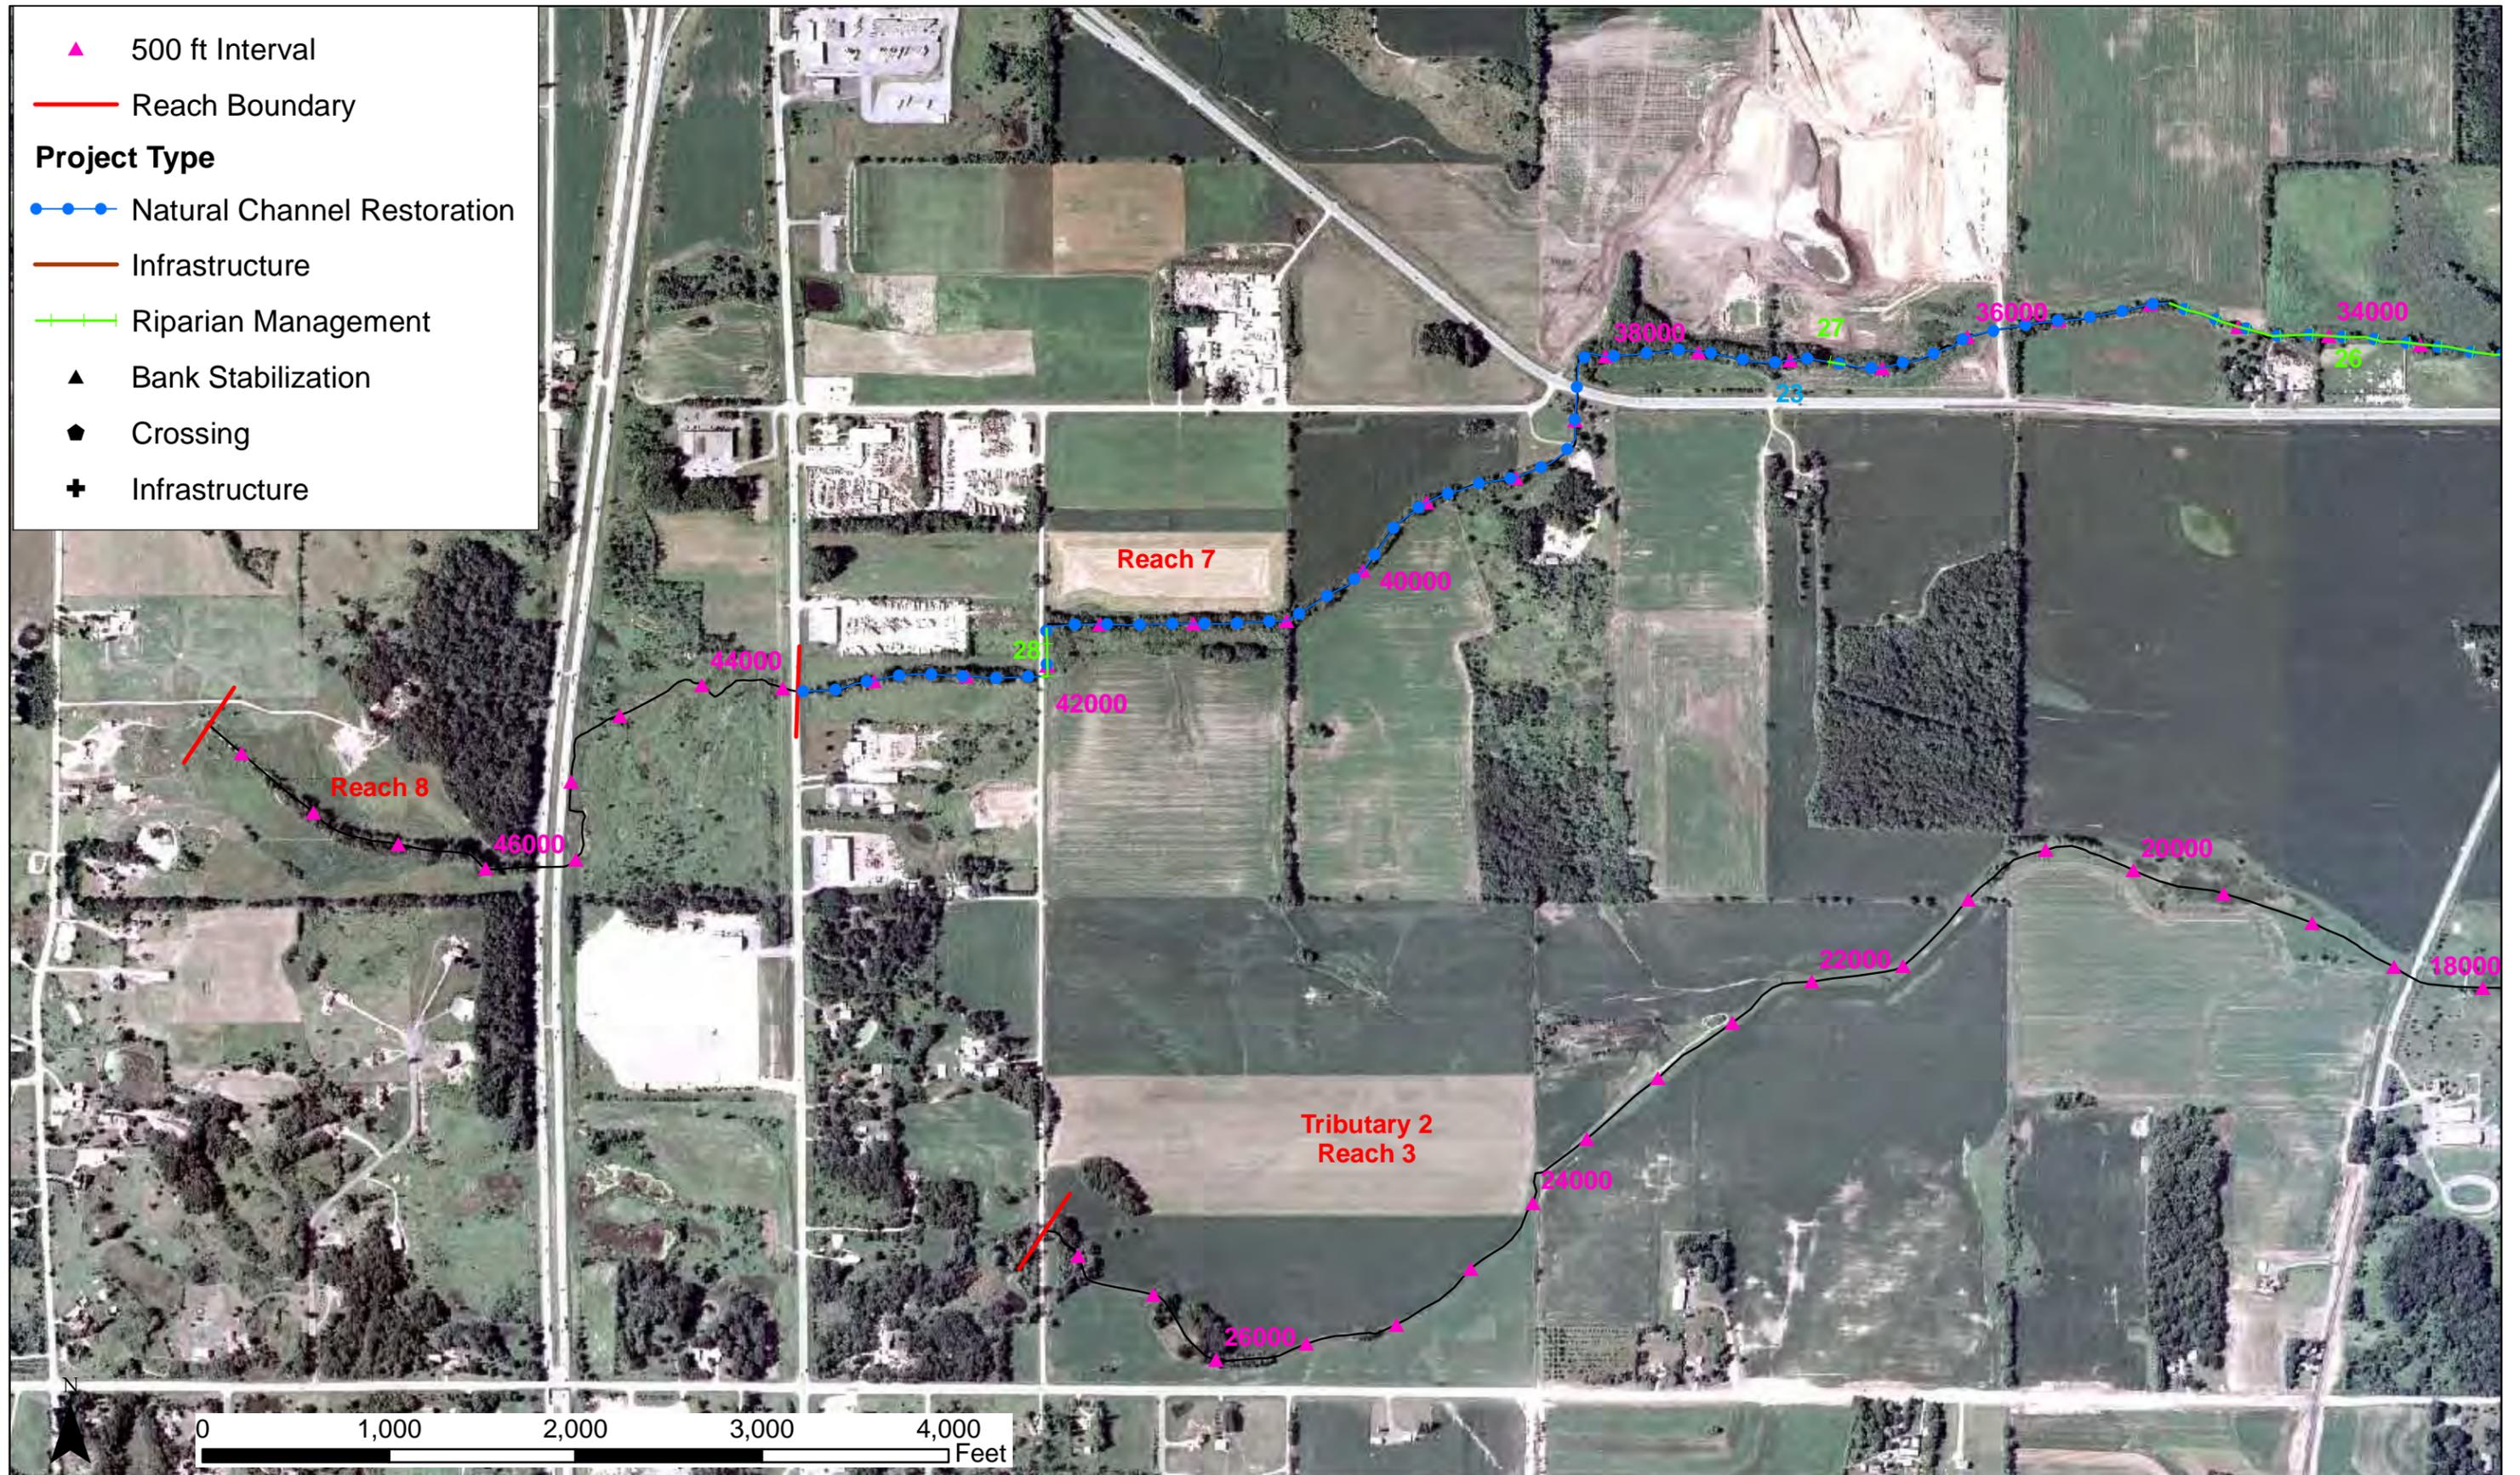
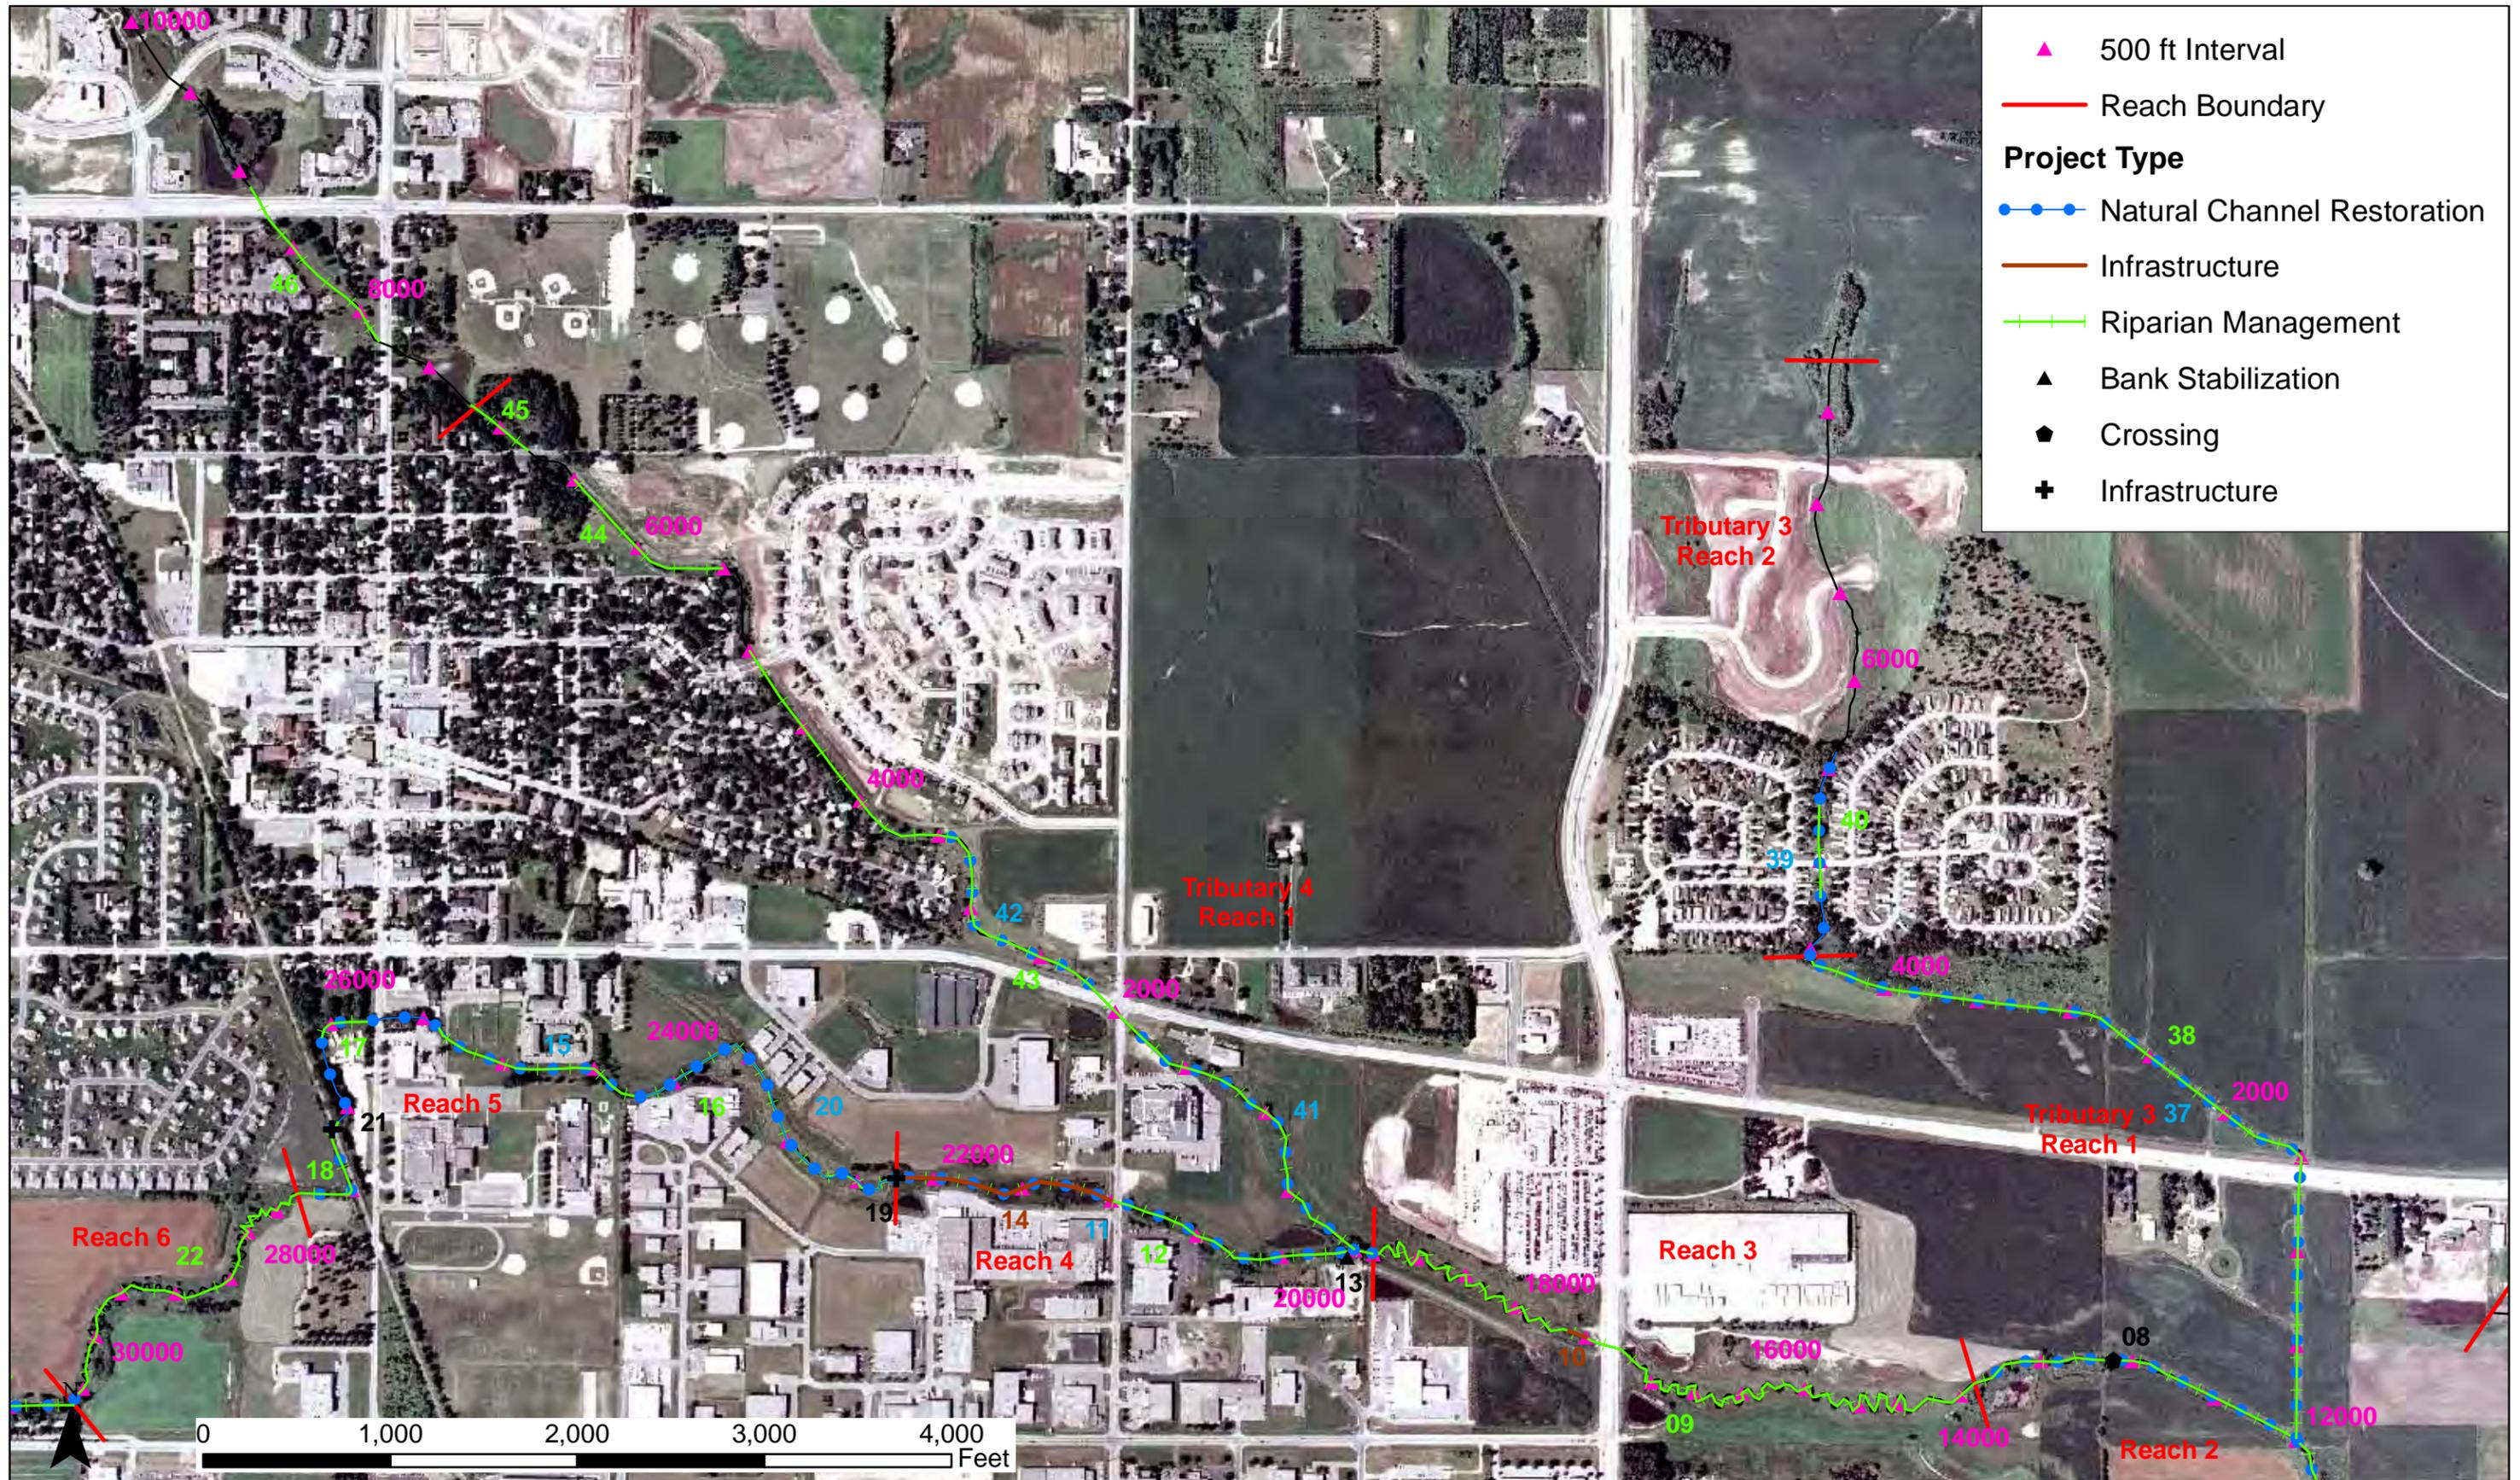
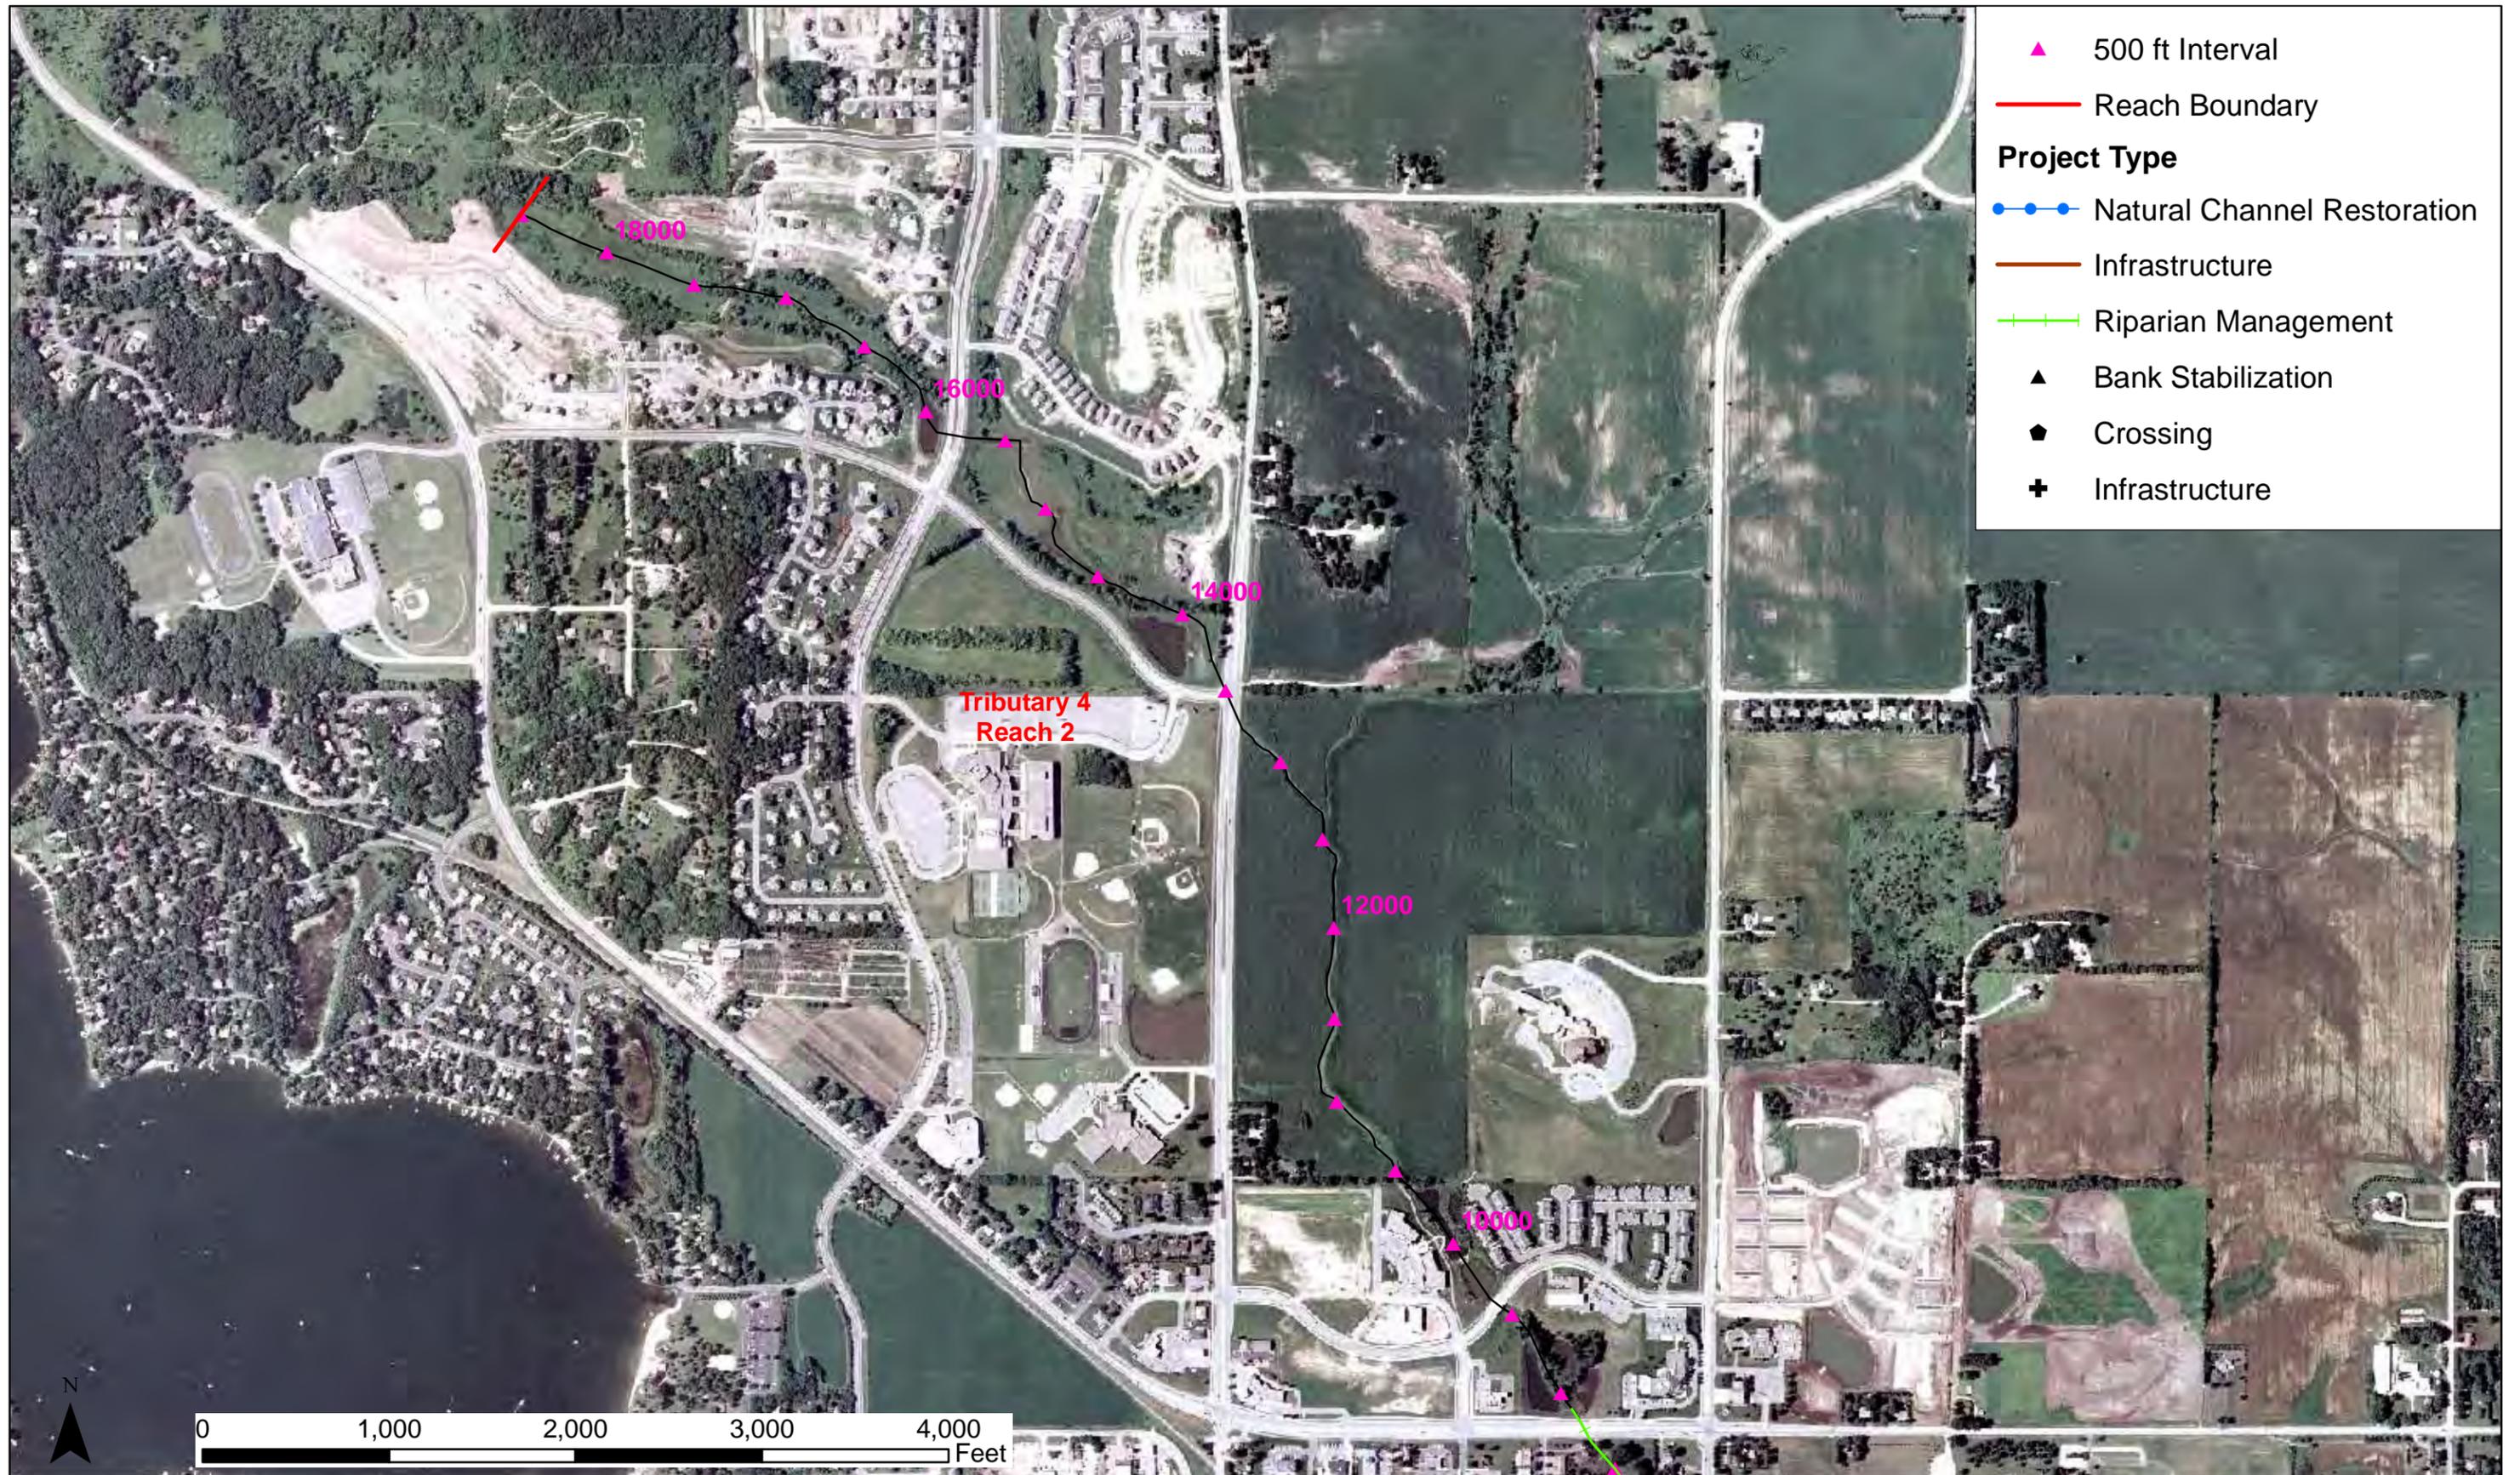
Appendix B: South Creek and its tributaries with the potential restoration projects indicated. Pink numbers are channel centerline station numbers; other numbers reference potential restoration projects.
