October 24, 2018

CENTURY RIDGE TOWNHOME ASSOCIATION

STAGE II IRRIGATION AUDIT REPORT

WATER IN MOTION, INC.

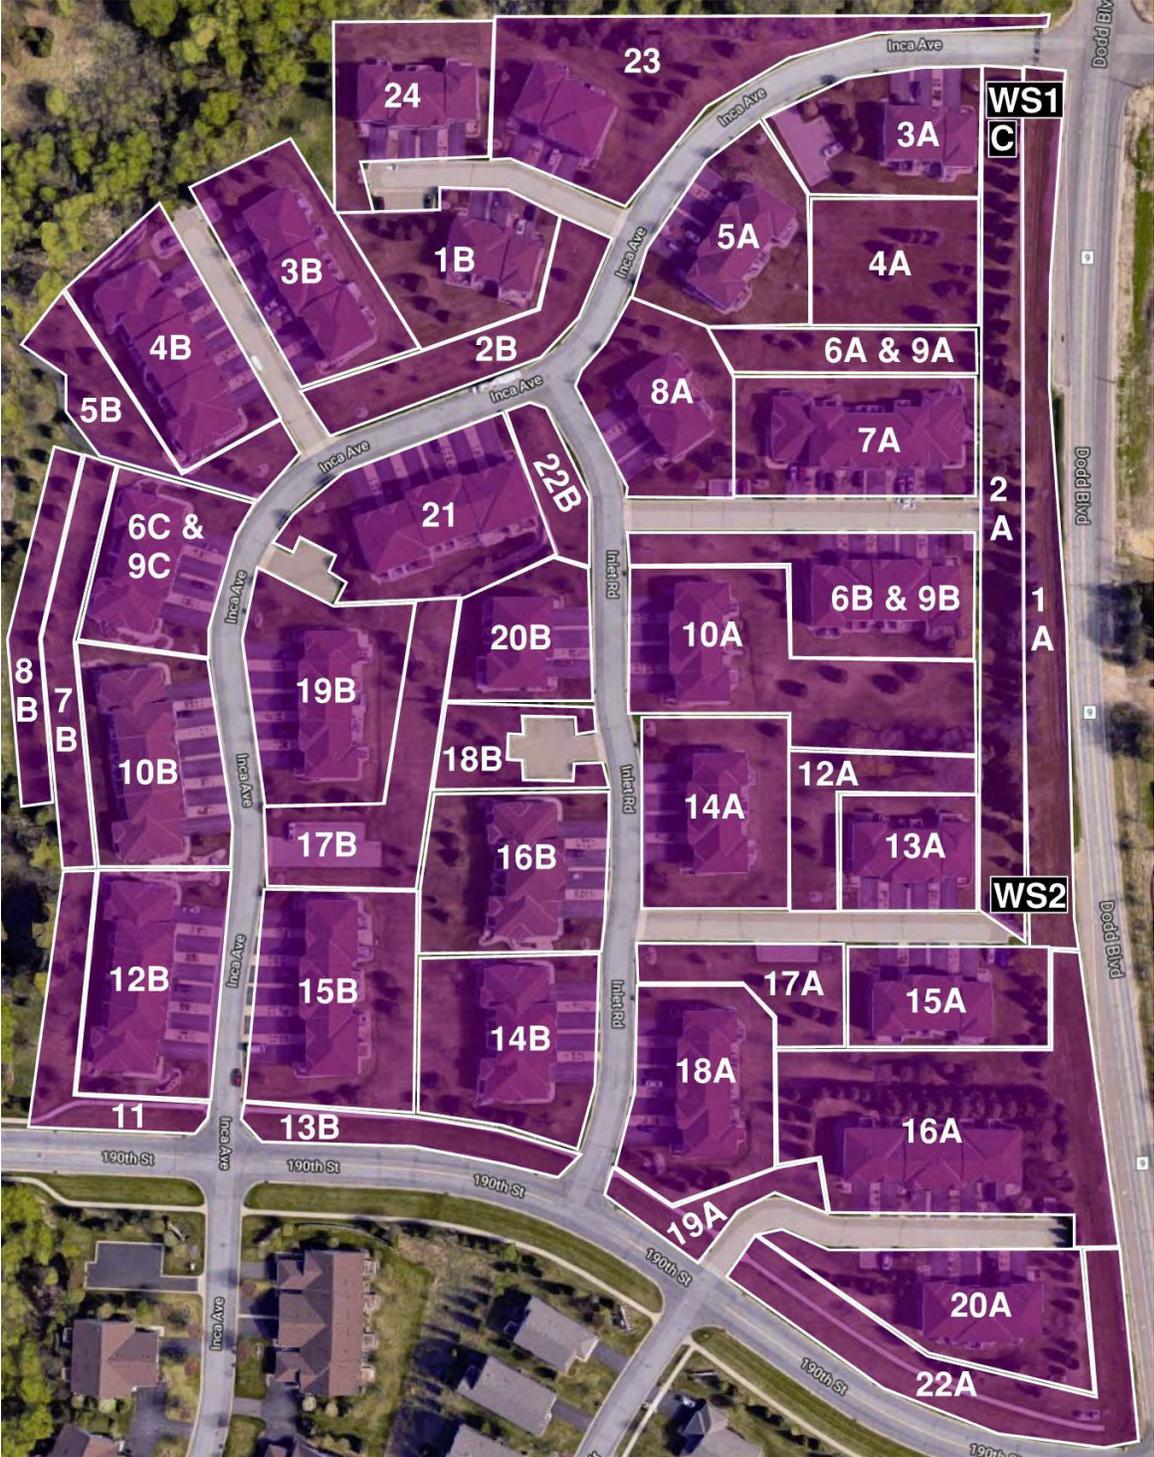
STATION MAP

On output ports of the irrigation controller where best practice is to hardwire a single station of irrigation, WiM found multiple stations of irrigation operating. The station map below indicates which stations operate together, indicated by "A", "B", and "C".

| F | High | Rewire controller to operate the 43 valves present on the site separately. Currently at Century Ridge there are stations operating alongside one or two other stations. WiM recommends installing two 12 station modules in the ESP-LX Basic controller. The 43 stations can then be operated separately after rewiring. | \$350 - \$450 | Assuming there are no field wiring issues |
