Lower Vermillion River Geomorphic Assessment

FINAL SUBMITTAL
December 2018

Vermillion River Watershed Joint Powers Organization
14955 Galaxie Ave.
Apple Valley, MN 55124

Inter-Fluve, Inc.
2121 Randolph Ave, Suite 200
St. Paul, MN 55105

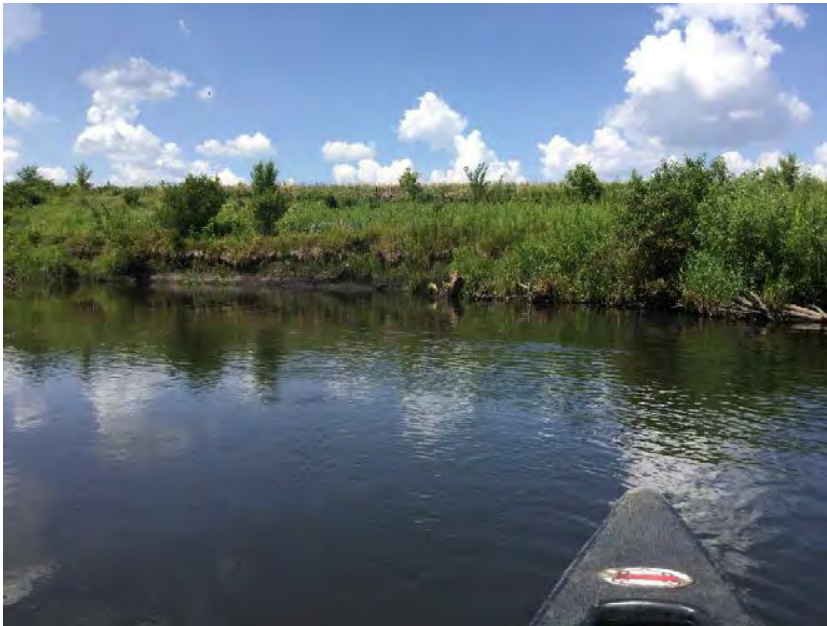
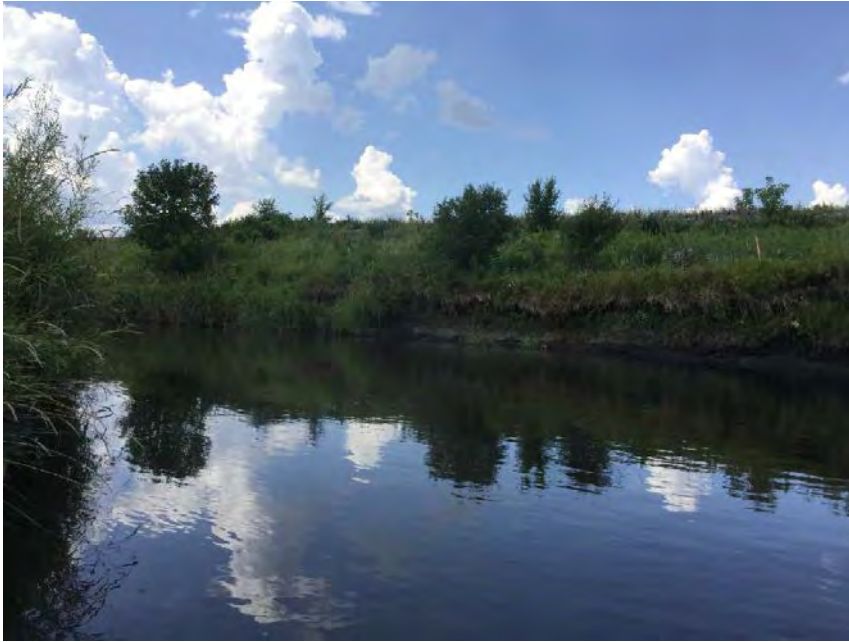
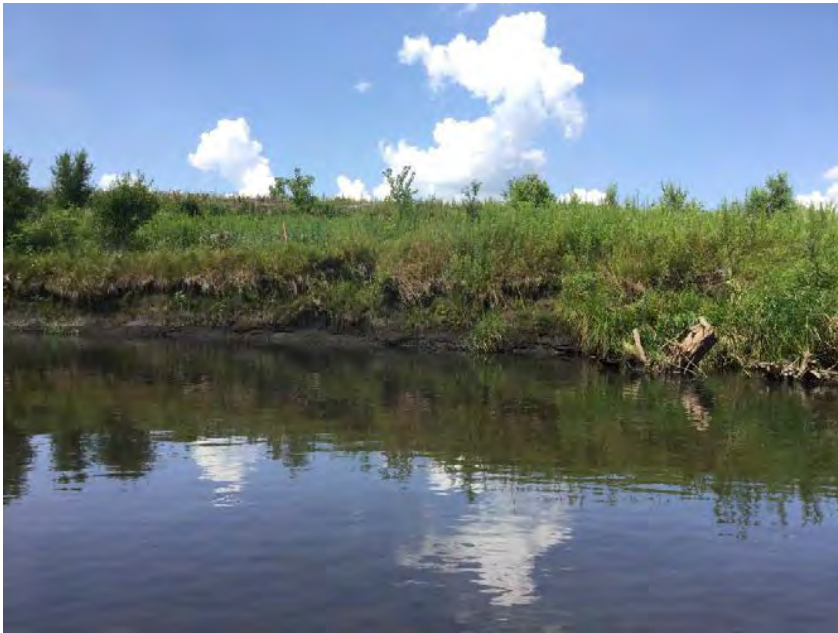
PP03

Stream: Lower Vermillion River	Problem description: Narrow riparian corridor between farm and channel. Past bank work used angular boulders that may not be serving the original intended purpose as well as plastic fabric that is still exposed. In addition, minor bank erosion was observed along 120 ft of bank with 4 ft bank heights.
Station: 59500-60000, right bank Reach: 6	
Solution: Widen riparian corridor. Remove plastic where exposed. Large wood could be used to stabilize the bank and replace the angular boulders, but the erosion is not extensive.

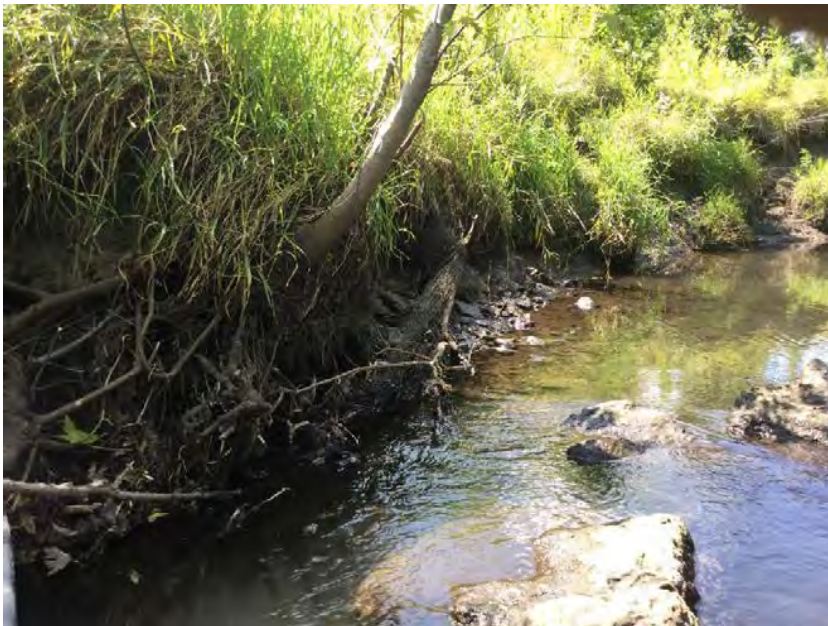
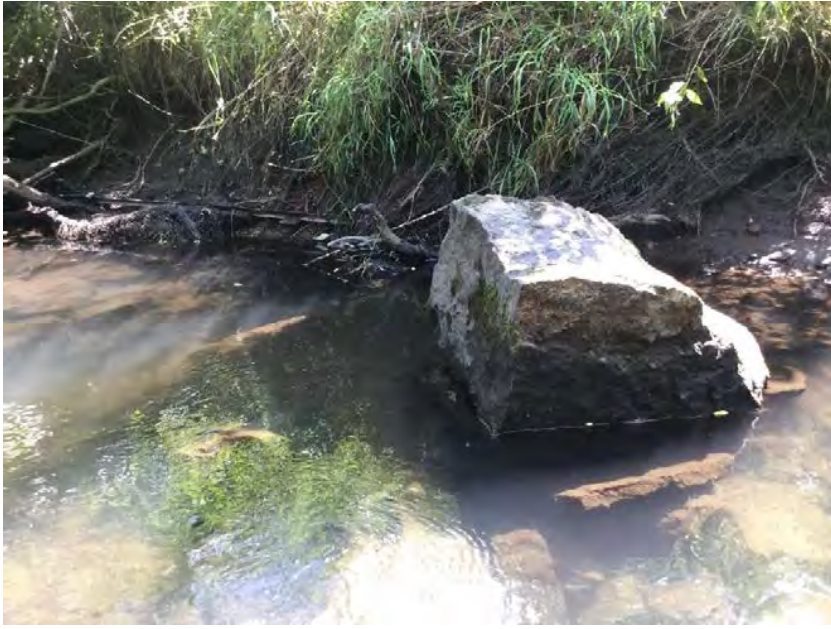
PP04

Score	Notes
Pollutant loading	7	Pipe drains agricultural field and bank erosion
In-stream ecological benefit	5	Increase canopy cover
Project cost	3	Requires engineering design
Fish passage	1	NA
Riparian ecological benefit	5	Widen riparian zone
Infrastructure risk	1	NA; power poles are not at edge of the river
Project complexity	3	Requires engineering design
Aesthetic impact	3	Improved aesthetic for paddlers
Property ownership	1	Private, though maybe an easement for the utility
Public education	1	NA

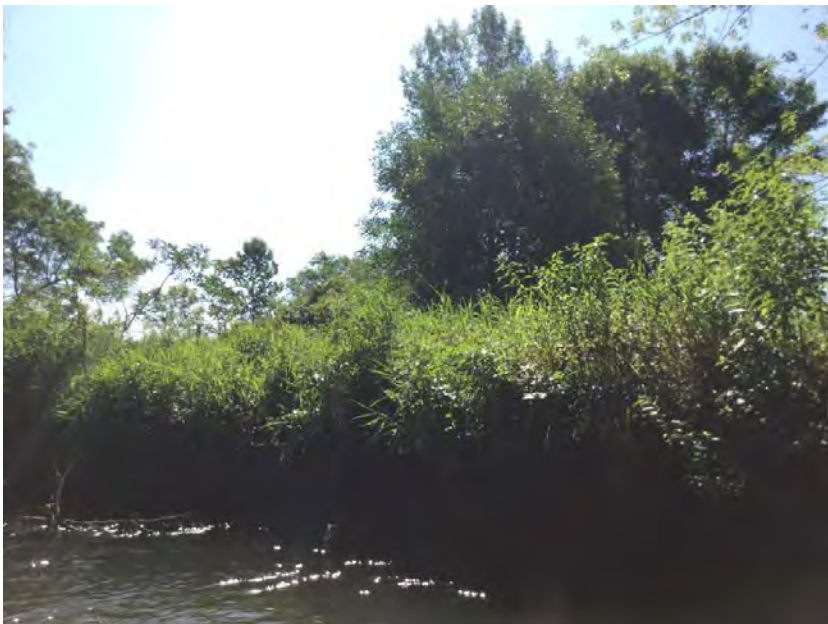
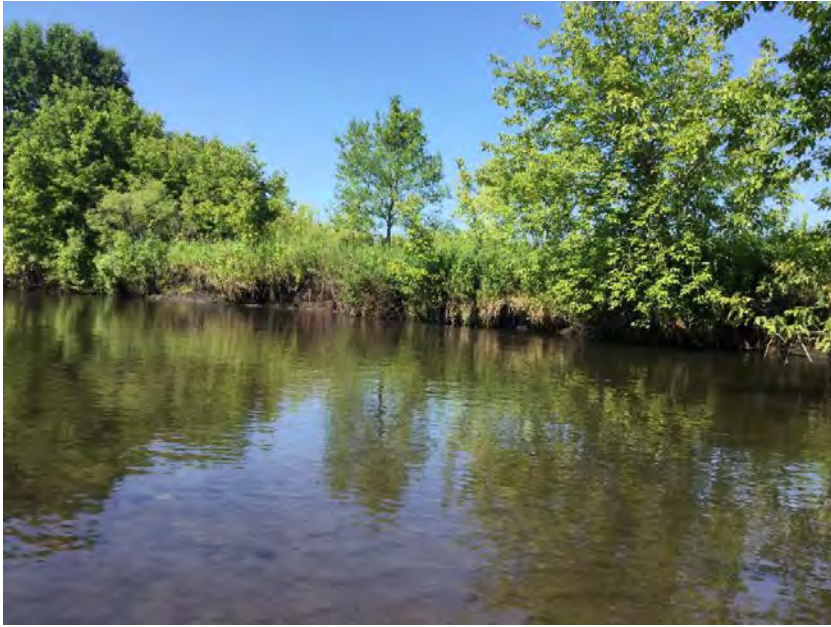
PP16

Score	Notes
Pollutant loading	3	Minor erosion
In-stream ecological benefit	3	Increase canopy cover
Project cost	7	Planting
Fish passage	1	NA
Riparian ecological benefit	3	Small site
Infrastructure risk	1	NA
Project complexity	7	Planting
Aesthetic impact	1	No impact
Property ownership	1	Private
Public education	5	Close to neighborhoods and an easy project for public participation

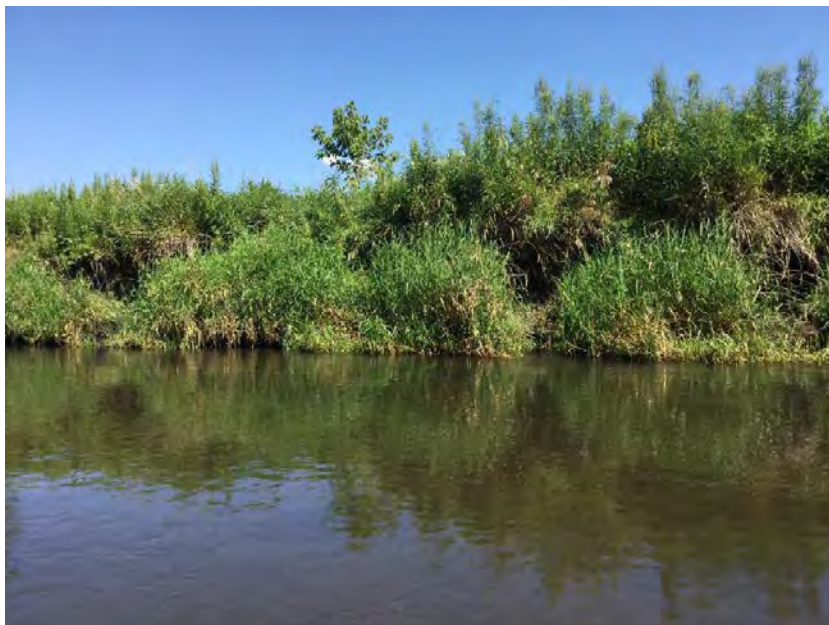
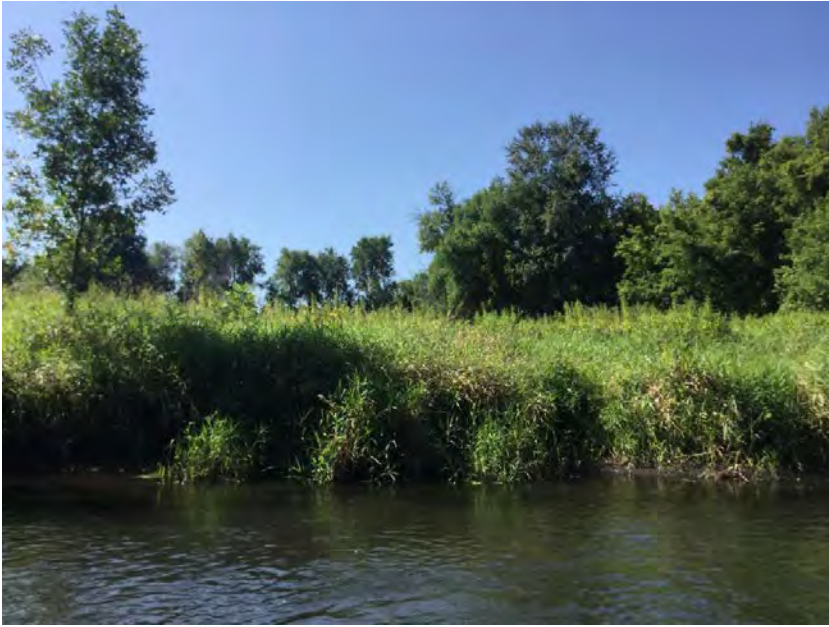
PP17

Stream: Lower Vermillion River	Problem description: Little riparian tree cover; minor bank erosion; little in stream habitat
Station: 42700-43100, left bank 43200-43600, right bank Reach: 4	
Solution: Plant expanded riparian zone with native trees and shrubs. Could actively stabilize banks, but we recommend expanded the riparian zone with plantings first and monitoring.

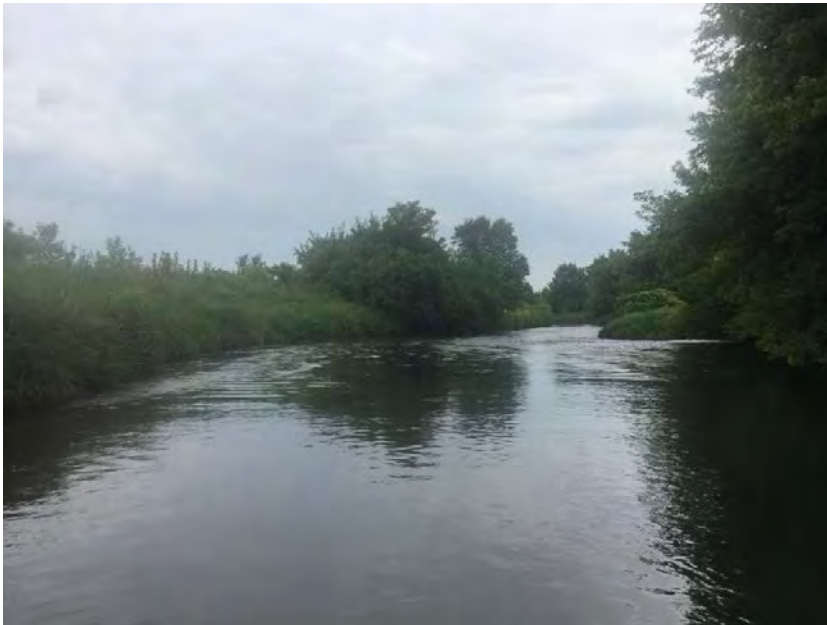
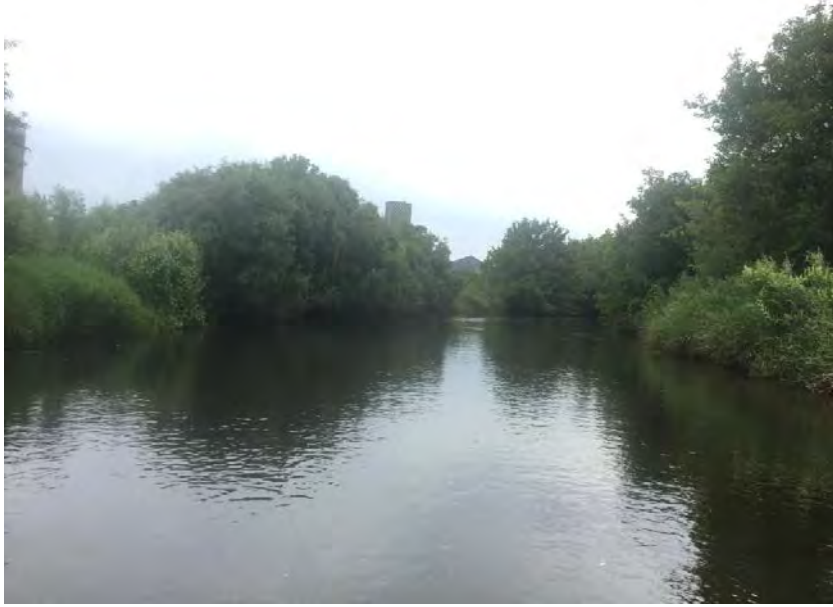
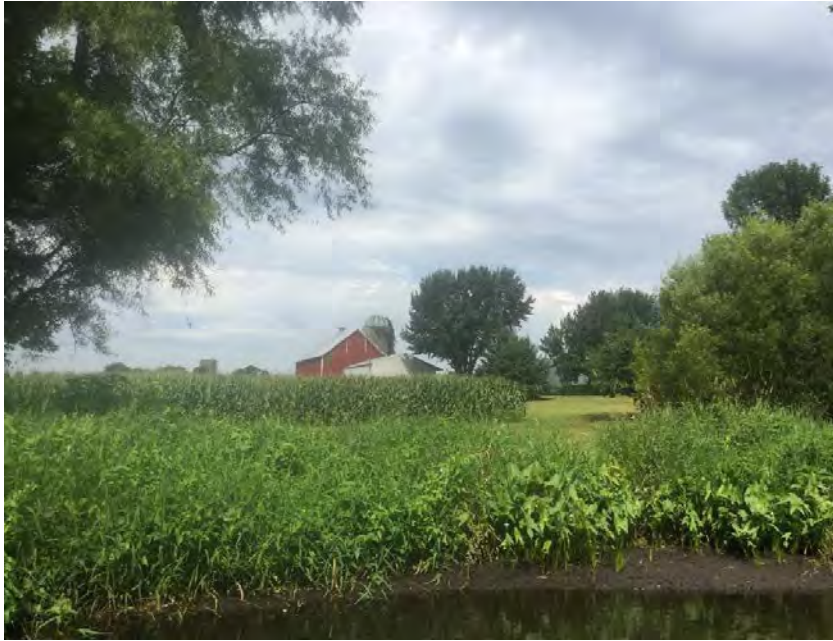
PP24

Stream: Lower Vermillion River	Problem description:
Station: 23000-24400, both banks 22600-22700, right bank Reach: 3	Few riparian trees No large wood habitat in channel Bridge is undersized bottomless arch with no riparian passage Plastic and concrete in channel from historic bank stabilization project
Solution: Plant riparian zone with trees. Install large wood to provide in-stream habitat. Replace bridge with one that can pass revised flood flows and provide terrestrial passage.

Score	Notes
Pollutant loading	3	Minor erosion
In-stream ecological benefit	3	
Project cost	1	Without the bridge work, this would receive a score of 5.
Fish passage	3	NA
Riparian ecological benefit	3	
Infrastructure risk	3	Undersized crossing – it is not in imminent danger, but it appears to be undersized so that large floods put added pressure on the bridge infrastructure.
Project complexity	3	Bridge designs and large wood designs needed
Aesthetic impact	3	Remove past project materials
Property ownership	1	Private
Public education	5	Easily accessible
