Commercial  
Site  
Assessment™  
Tier II

**Claret Springs**

15115 Cimarron Court  
Rosemount, MN 55068

## **Commercial Site Assessment™**

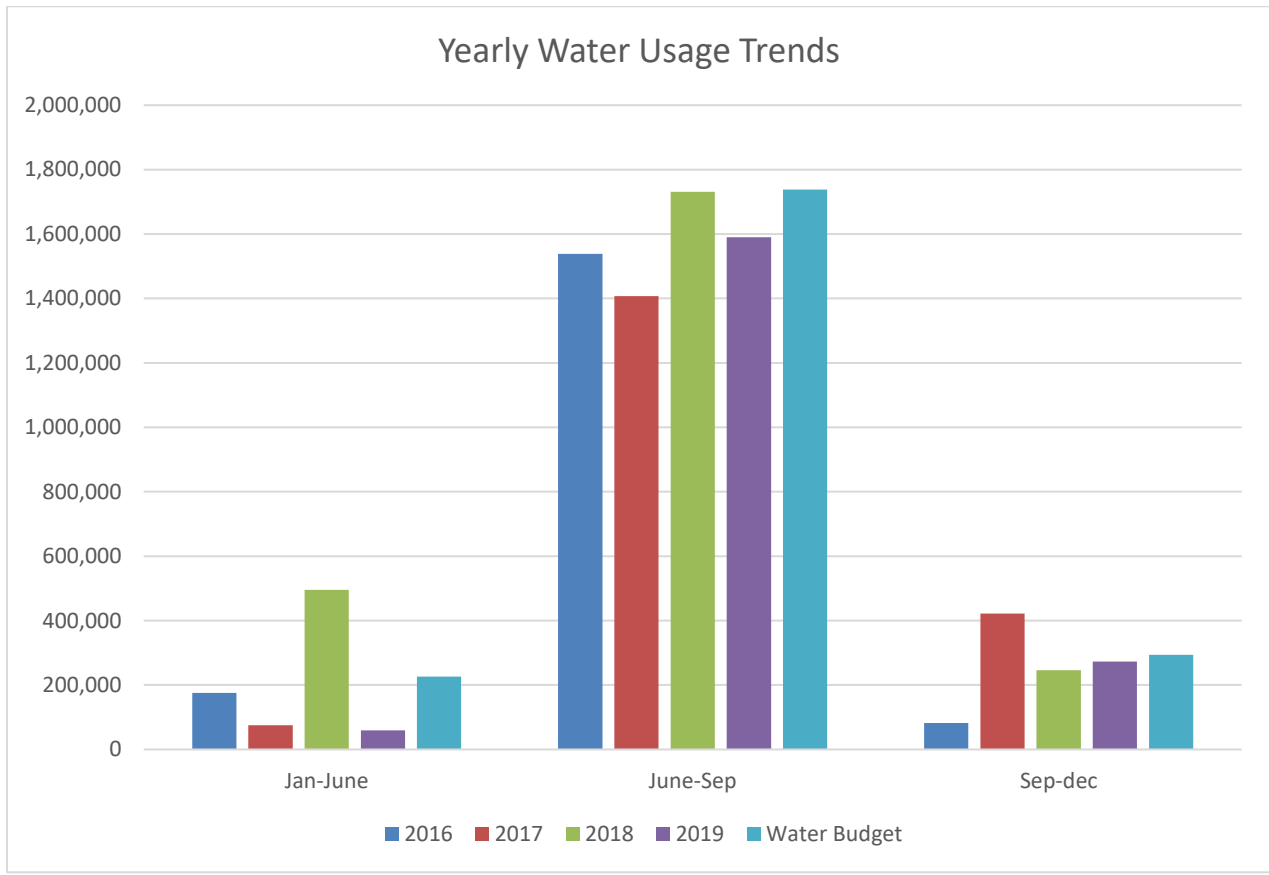
## Water Budgeting

Month	2016 Usage	2017 Usage	2018 Usage	2019 Usage	Avg Usage	Water Budget
Jan-June	175,000	75,000	495,000	59,000	201,000	225,668
June-Sep	1,538,000	1,407,000	1,731,000	1,590,000	1,566,500	1,737,646
Sep-Dec	82,000	422,000	246,000	273,000	255,750	293,369
<b>Total(gal)</b>	<b>1,795,000</b>	<b>1,904,000</b>	<b>2,472,000</b>	<b>1,922,000</b>	<b>2,023,250</b>	<b>2,256,683</b>

Water use seems to be consistent around 1,900,000 to 2,000,000 gallons for the last four years. The grass root profile and health are doing well with this amount of watering. This is likely thanks to the smart control system. Though, as mentioned in the previous page, there is still room for improvement.
