Commercial  
Site  
Assessment™  
Tier II

Stone

Borough HOA

### **Commercial Site Assessment™**

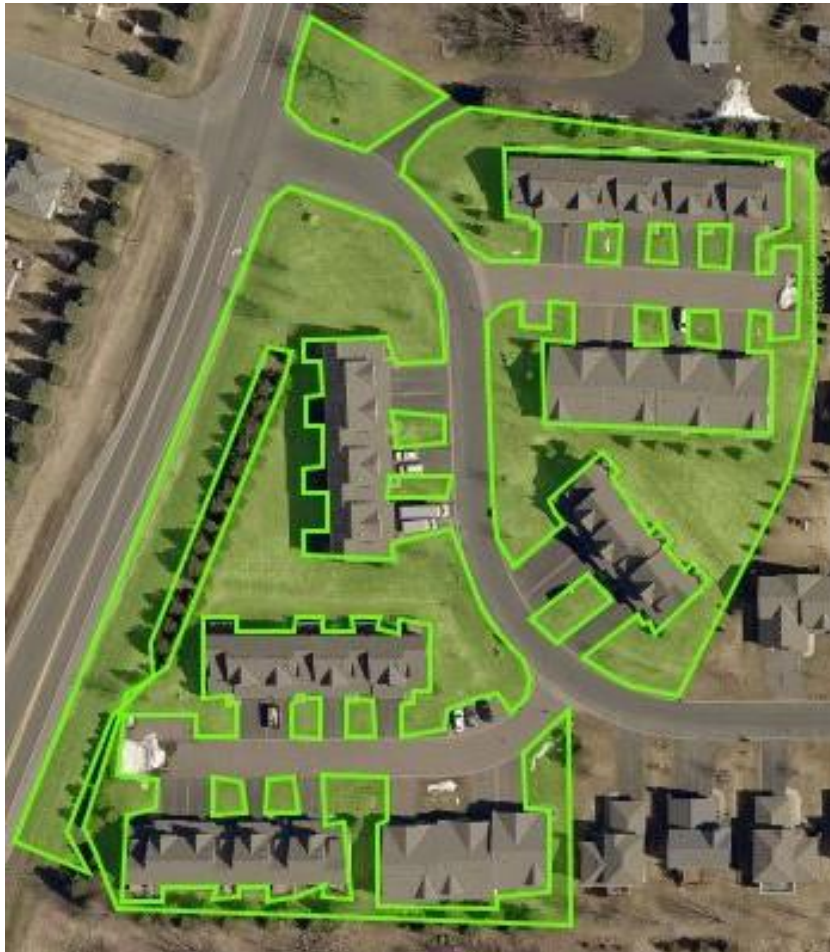
## Irrigated Area

Irrigated Acres: 2.49

Irrigated *ft*<sup>2</sup>: 108,707 *ft*<sup>2</sup>

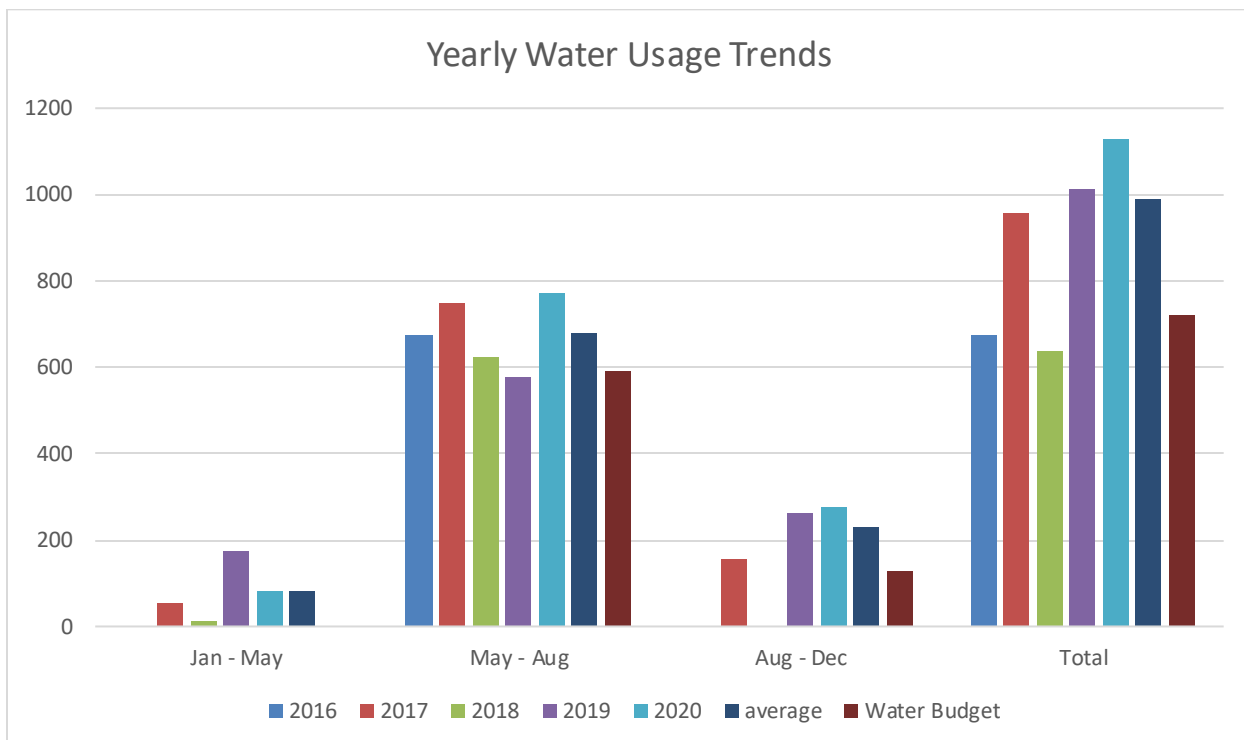
## Water Budgeting

2016	2017	2018	2019	2020	average	Water Budget
Jan - May	0	54	14	173	80	80.25	0.00
June - Aug	676	749	625	578	773	680.2	590.06
Sept - Dec	0	154	0	263	276	231	130.21
<b>Total</b>	676	957	639	1014	1129	991.45	720.28
