Commercial  
Site  
Assessment™  
Tier II

Harmony East  
Condo Assoc.

**Commercial Site Assessment™**

## Harmony East Condo Assoc Audit Observations

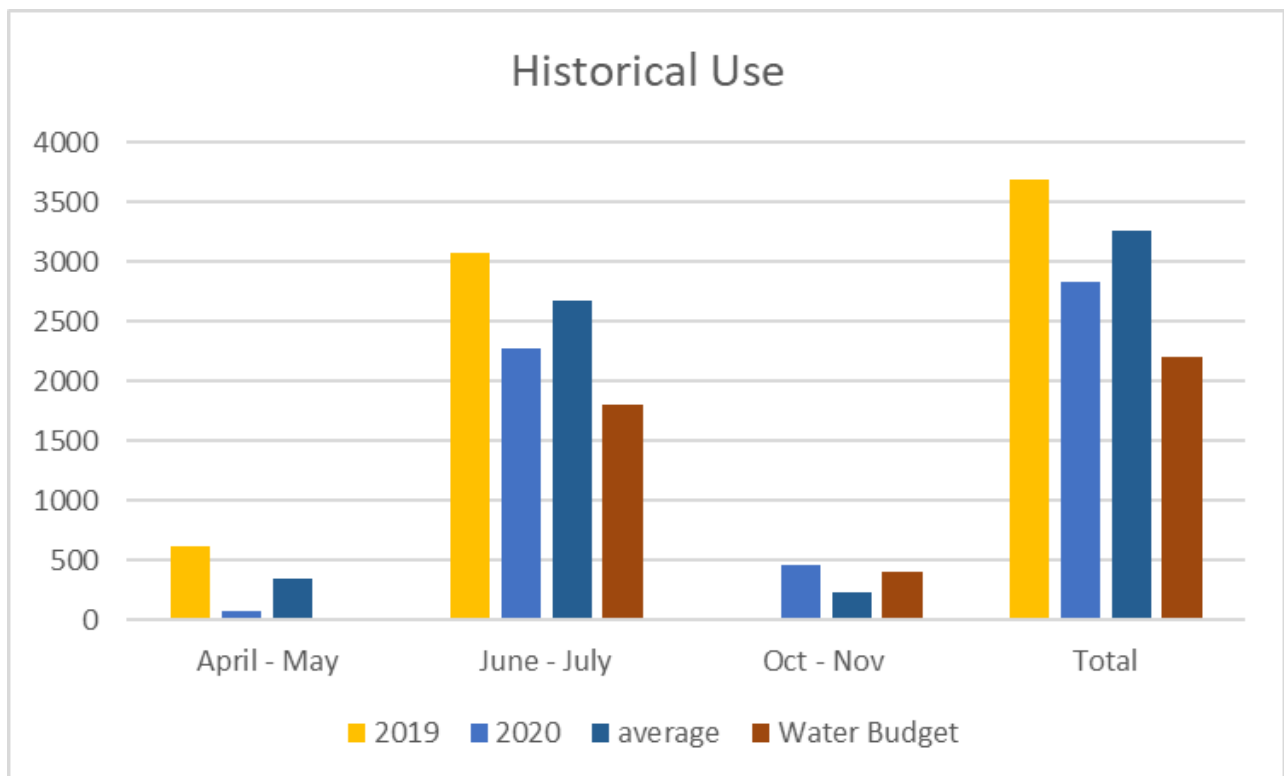
Month	April-May Reading	June-July Reading	Oct-Nov Reading	Total(gal)
2020 Usage	81,000	2,276,000	470,000	<b>2,827,000</b>
2019 Usage	614,000	3,075,000	0	<b>3,689,000</b>
Avg Usage	<b>347,500</b>	<b>2,675,500</b>	<b>235,000</b>	<b>3,158,000</b>
Water Budget	<b>0</b>	<b>1,811,590</b>	<b>399,770</b>	<b>2,211,365</b>

*Eff* = 75% : 2,211,365 gallons used at an annual cost of **\$8,403**
