Commercial
Site
Assessment™
Tier II

Woodhill

HOA

Commercial Site Assessment™

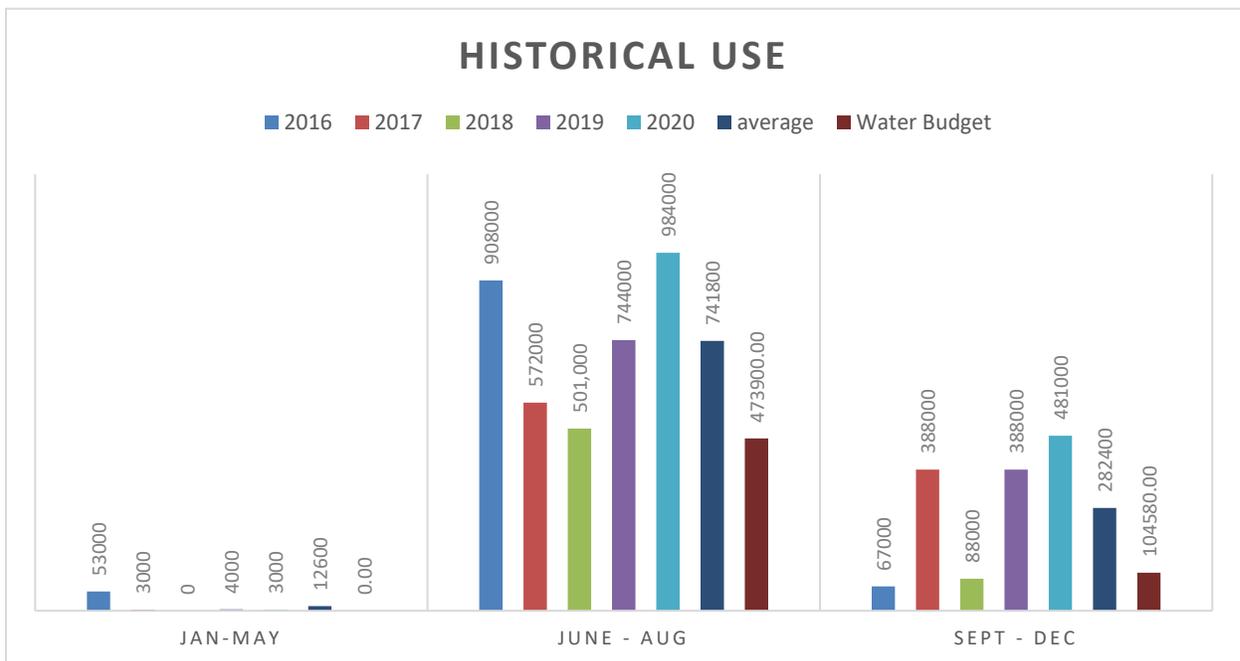
Month	April-May Reading	June-July Reading	Oct-Nov Reading	Total(gal)
2020 Usage	3,000	984,000	481,000	1,468,000
2019 Usage	4,000	744,000	388,000	1,136,000
2018 Usage	0	501,000	88,000	589,000
2017 Usage	3,000	572,000	388,000	963,000
2016 Usage	53,000	908,000	67,000	1,028,000
Avg Usage	12,600	741,800	282,400	1,036,800
Water Budget	0	473,900	104,580	578,480

Eff = 75% : 578,480 gallons used at an annual cost of **\$3,827**
