# Commercial Site Assessment™ Tier II

# Prepared for: **Prairie of Village Creek**

20620 Harrow Ct. Lakeville, MN 55044

2021 Season

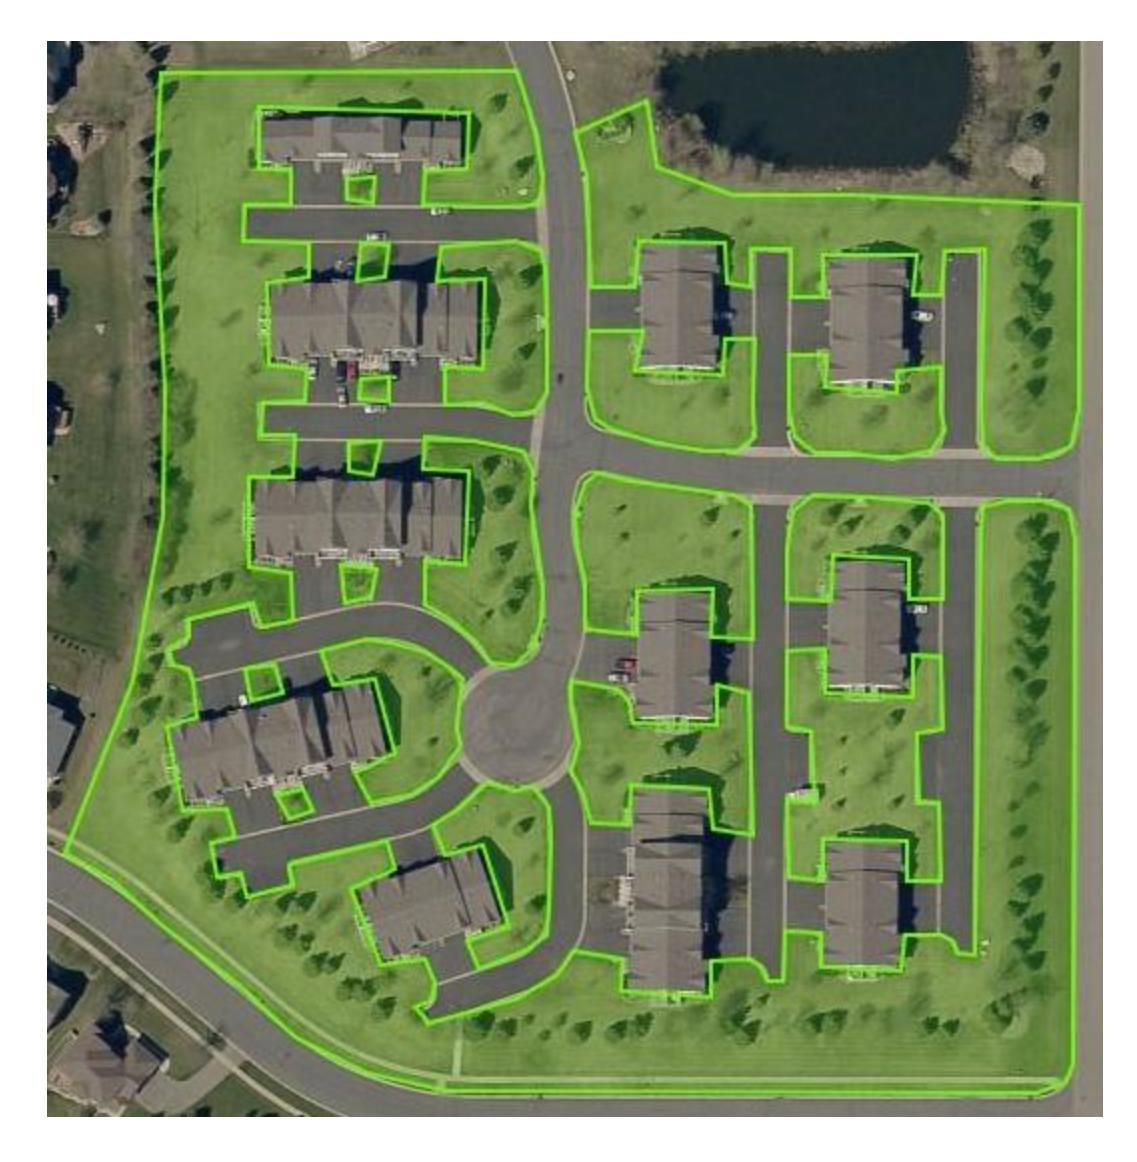
### Irrigated Area

Date of Tier I CSA:	October 30, 2021
Certified Technician:	Jake Mathre CLIA, CIC, CIT
Date of Tier II CSA:	June 30, 2021
Certified Technician:	Jake Mathre CLIA, CIC, CIT
Irrigated Acres: Irrigated $ft^2$ :	5.92 258,033 ft <sup>2</sup>

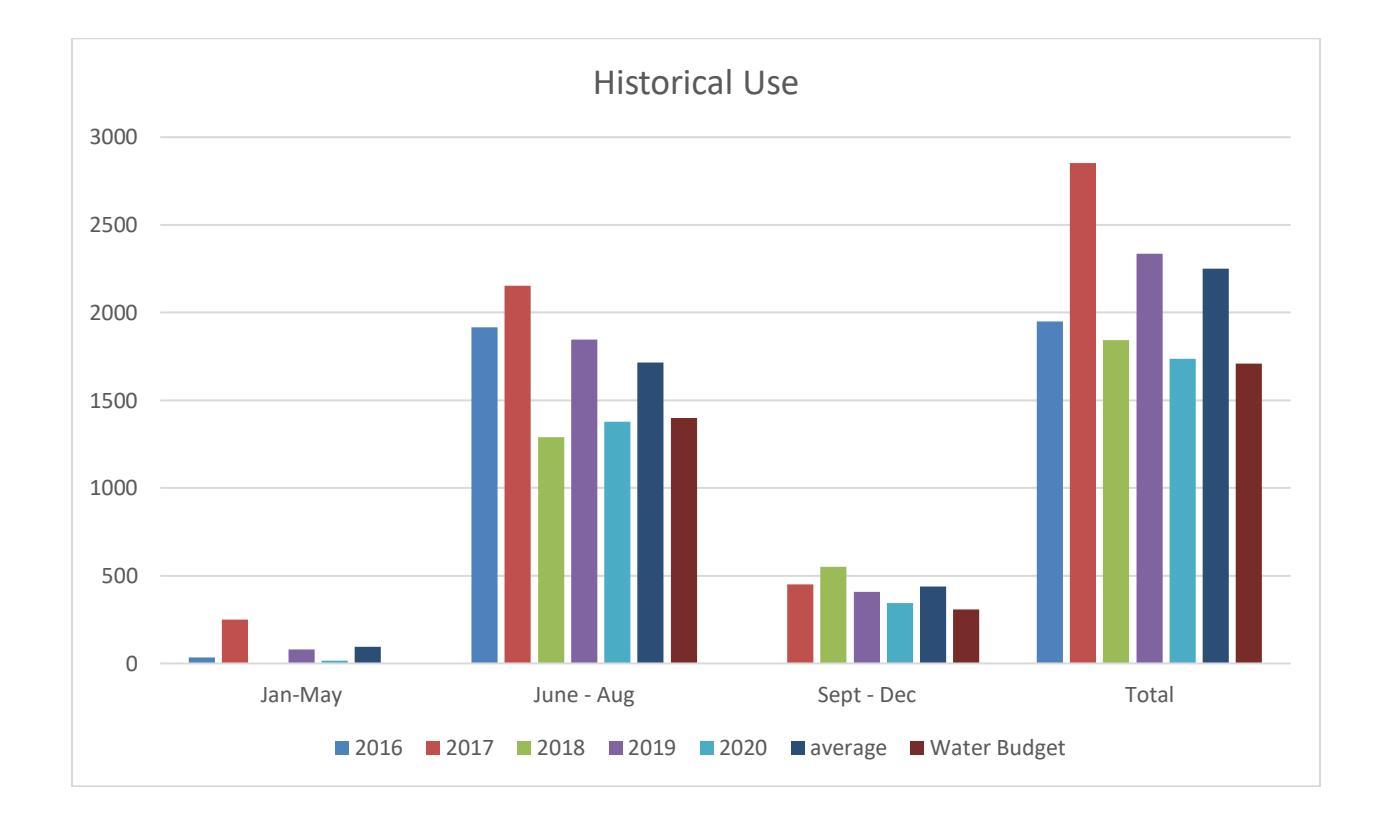
### Water Budgeting

2016	2017	2018	2019	2020	average	Water Budget
Jan-May	34	251	0	81	15	95.25	0.00
June - Aug	1916	2153	1291	1845	1377	1716.4	1400.60
Sept - Dec	0	450	552	409	345	439	309.08
Total	1950	2854	1843	2335	1737	2250.65	1709.68
