Lakeville: 205th Street Channel Stabilization

Protecting Lake Marion

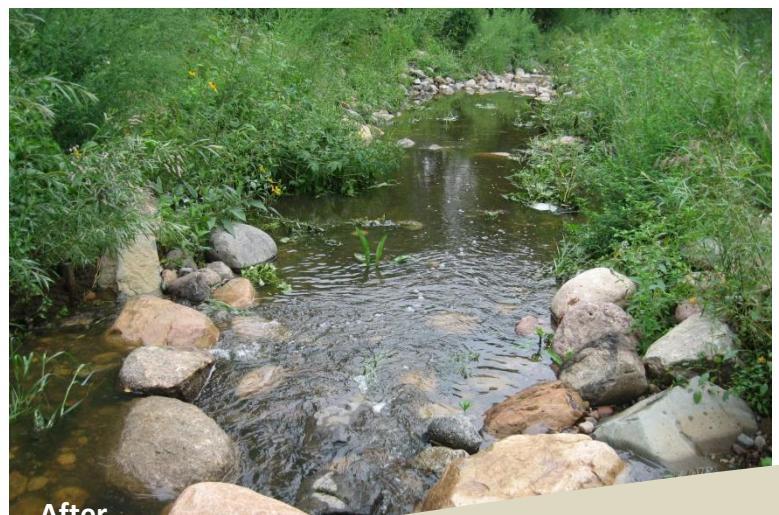
After

The 205th Street channel in the City of Lakeville was re-graded, stabilized using erosion-control features, and planted with native species.

Cost-share funding from the Vermillion River Watershed Joint Powers Organization enabled the City of Lakeville to stabilize the channel, prevent erosion, and reduce sediment and nutrients running into Lake Marion. The bottom of the channel was lined with rocks to slow the water flow, and the sides were stabilized with native plants, rocks, and

special erosion control fabric.

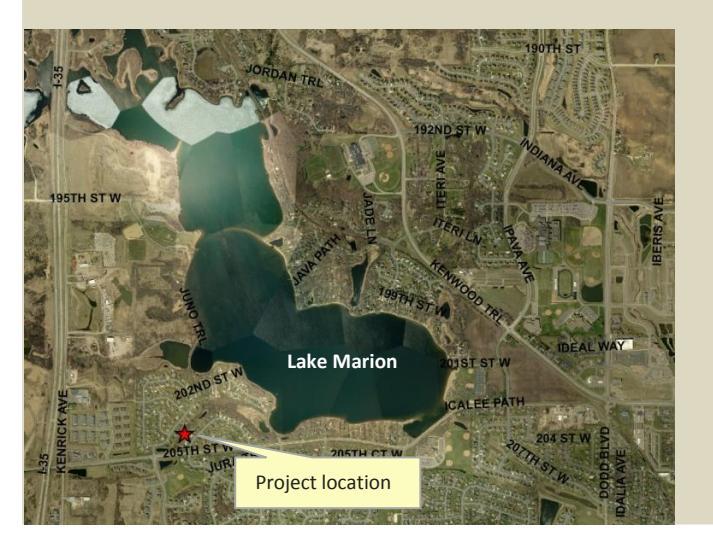
Stormwater flow caused erosion and bank failure, and carved a six to eight foot deep ravine in the 600-foot long drainage channel at 205th Street in Lakeville. Sediment- and nutrient-laden waters drained into Lake Marion and created several water quality issues, such as cloudy water, algae blooms, and low dissolved oxygen.
