Connemara Crossings Homeowner Association Rosemount, MN

Landscape Irrigation Assessment Report & Recommendations

Water in Motion, Inc. Authored by: Timothy Malooly, CLIA, US EPA WaterSense Partner

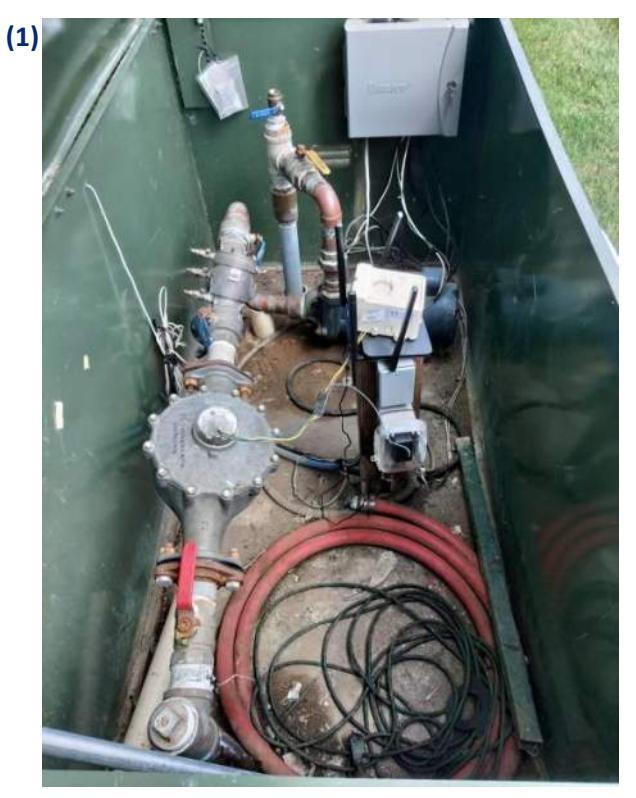
Plumbing is all metal to below grade. 2" Service, meter & Wilkins backflow prevention assembly.

Flint & Walling booster pump w/Munro Start relay w/out pump protection.

- A. Test, tag and furnish required paperwork for the backflow assembly, per local code.
- B. Add support posts and brace brackets under the plumbing equipment to relieve stress on fittings

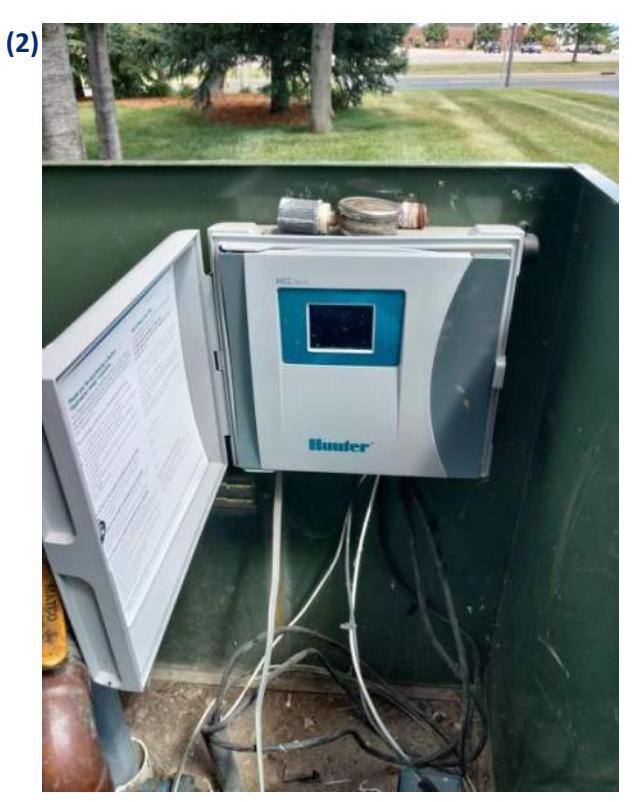
Hunter HCC Hydrawise wifi controller connected to wifi. Not very accessible to perform maintenance. Monthly seasonal scheduling adjustment is in place.

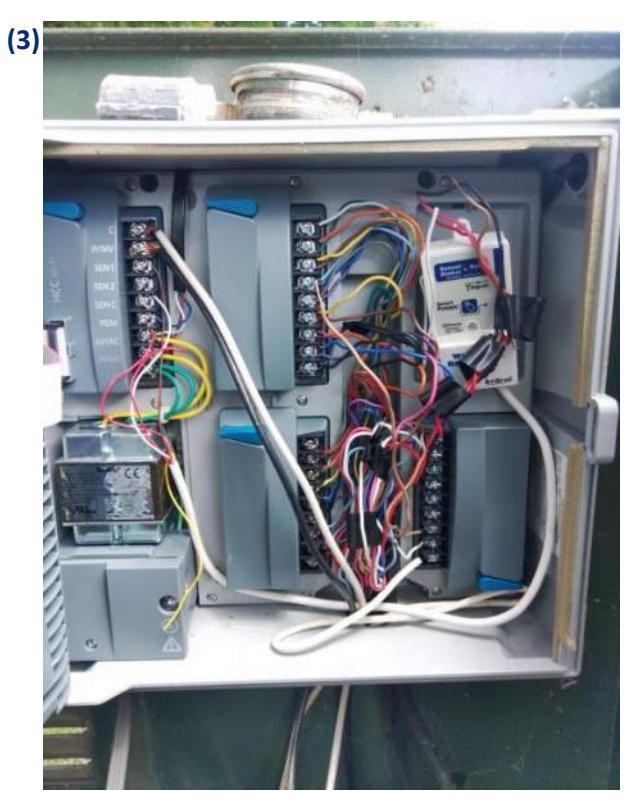
18 stations of sprinklers, multi strand field wire, heavy gauge pump start wire. Irritrol basic wireless basic rain sensor appears to be in service.

- A. Replace the basic rain sensor with an advanced model with programmable delays after rain events
- B. Calculate, document and input station runtimes based on soil, sun, plant type
- C. Employ and document cycle-and-soak operation to reduce runoff and waste
- D. Consider adding flow sensing to enable action and reporting of malfunctions

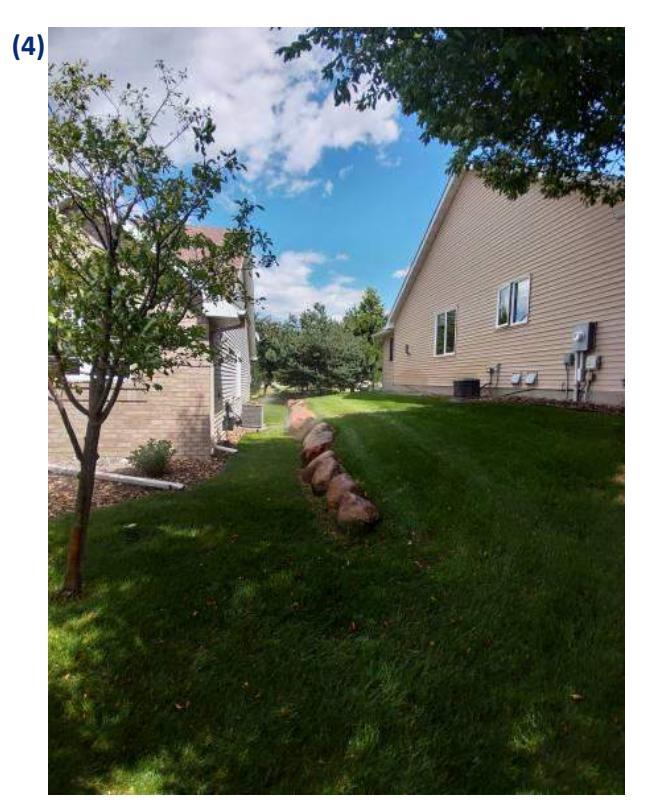
Station 2 between 13890 & 13882 Blanca. 1 rotor sprinkler not turning. Recommend changing to multi-stream, multi-trajectory (MSMT) sprinklers between homes to reduce overwatering.

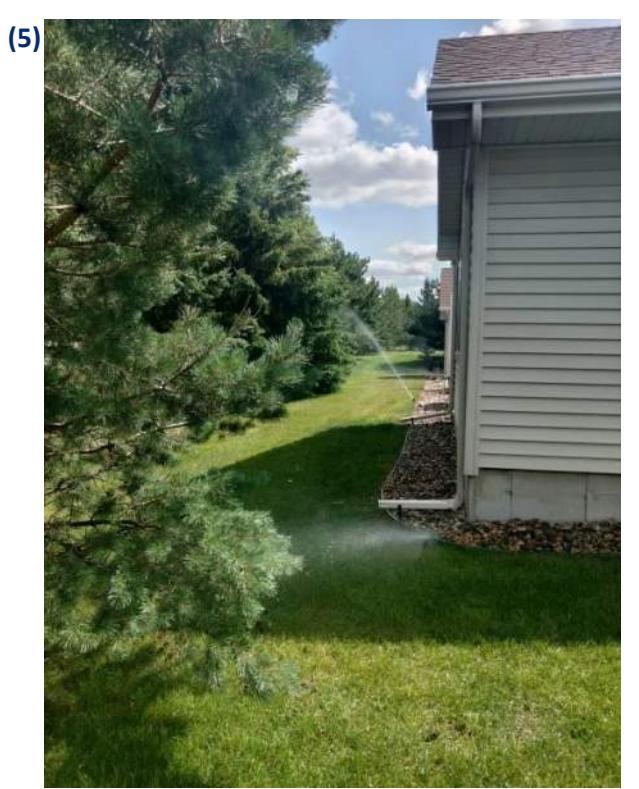
Station 2 backs of homes recommend changing to MSMT sprinklers to reduce overwatering and reduce direct spray into mature trees.

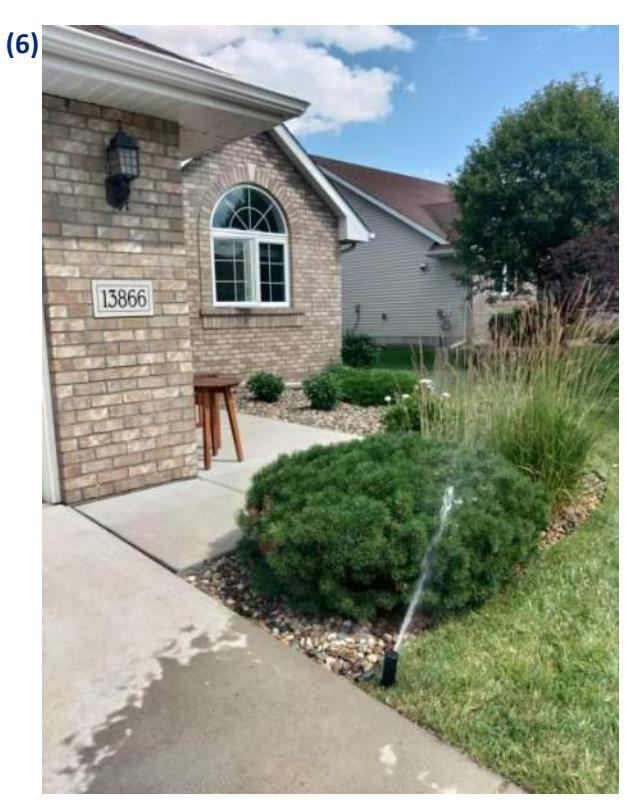
Station 3 - sample of need to move or change to high-rise sprinklers to accommodate landscape growth.

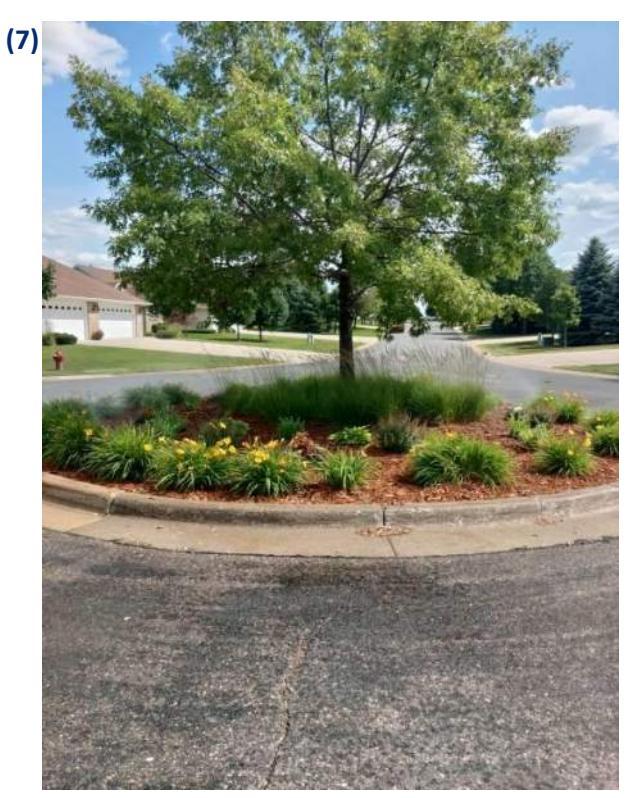
Station 4 - 2 rotor sprinklers to cover the entire teardrop planting bed. Recommend changing to several 12" pop-up MSMTs placed for efficient coverage and reduced waste onto the road.

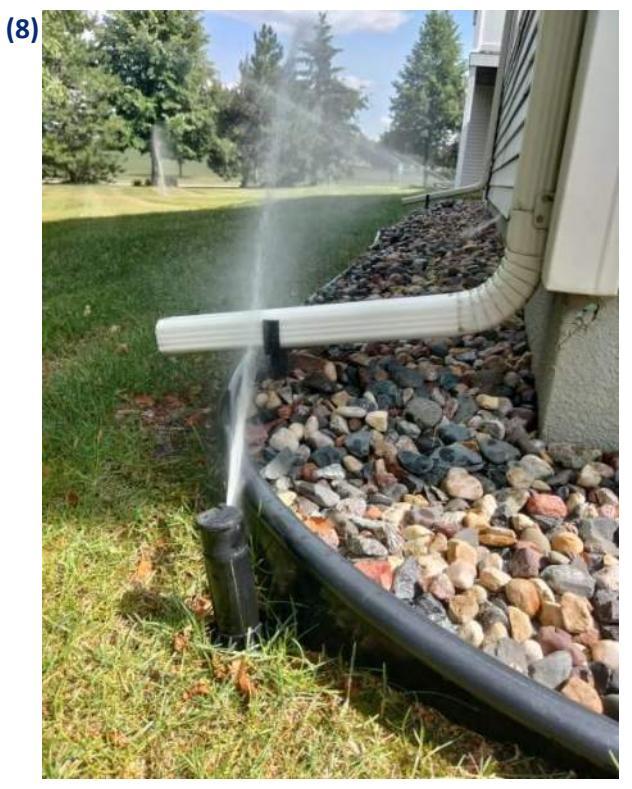
Station 4 - example of need to move or change to 12" pop-up sprinkler to overcome obstacles.

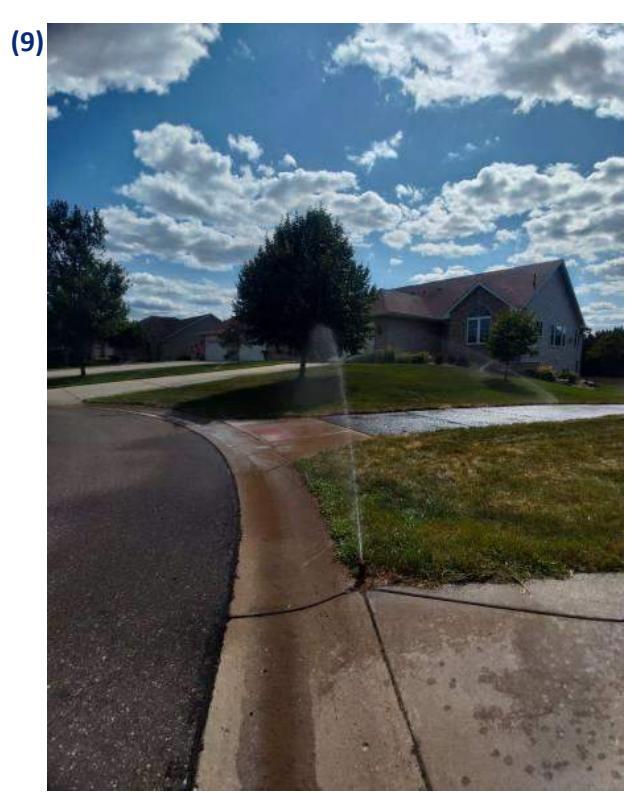
Station 5 - throwing over walk path. Spacing is beyond manufacturer recommendations. Recommend adding sprinklers where needed to avoid throwing over walks. Recommend matched application rate nozzles for improved efficiency.

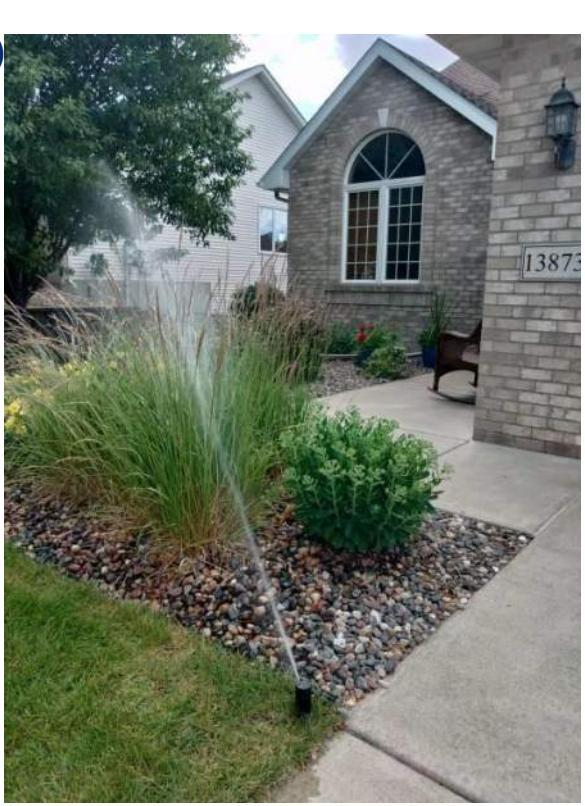
Station 6 - another example of need to move or change to high popup sprinklers to accommodate landscape growth.

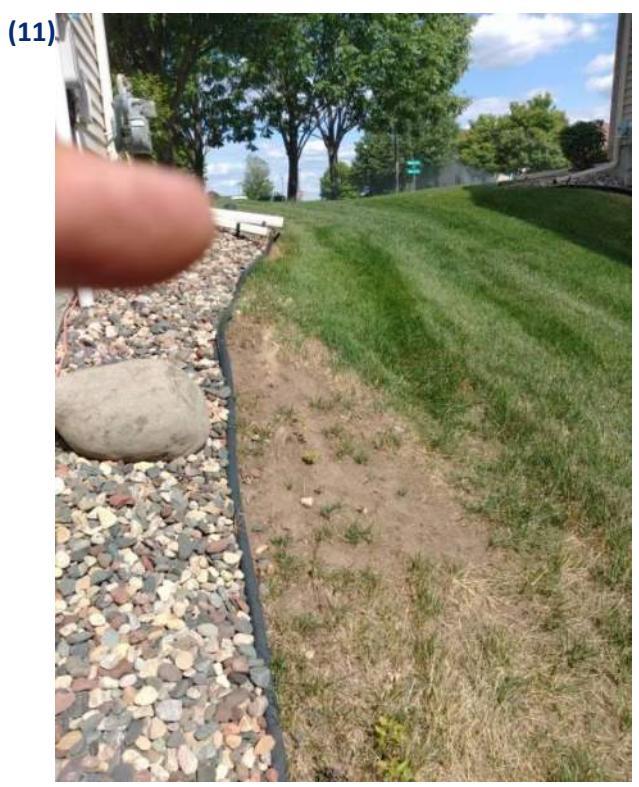
Station 7 - pointing to a severely pitched sprinkler resulting in water waste and surrounding dry area from resultant lack of coverage.

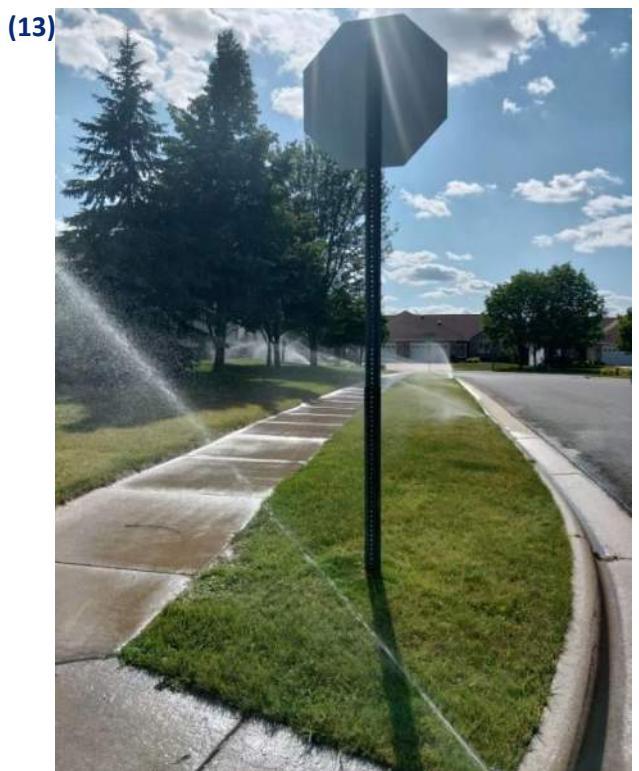
Station 9 - sprinklers throwing over walks along 139th.

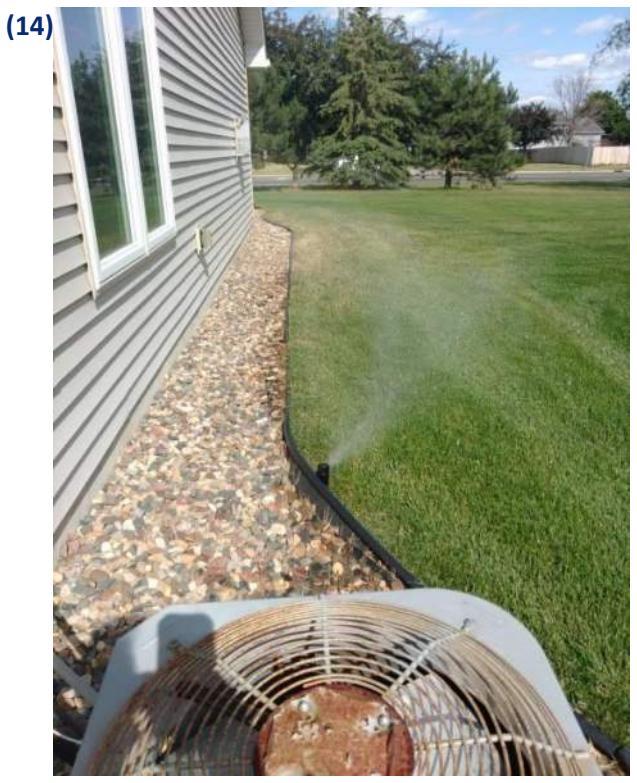
Station 10 - side of 13972 sprinkler is significantly cut down and tilted resulting in ineffective coverage, water waste and resultant dry area.

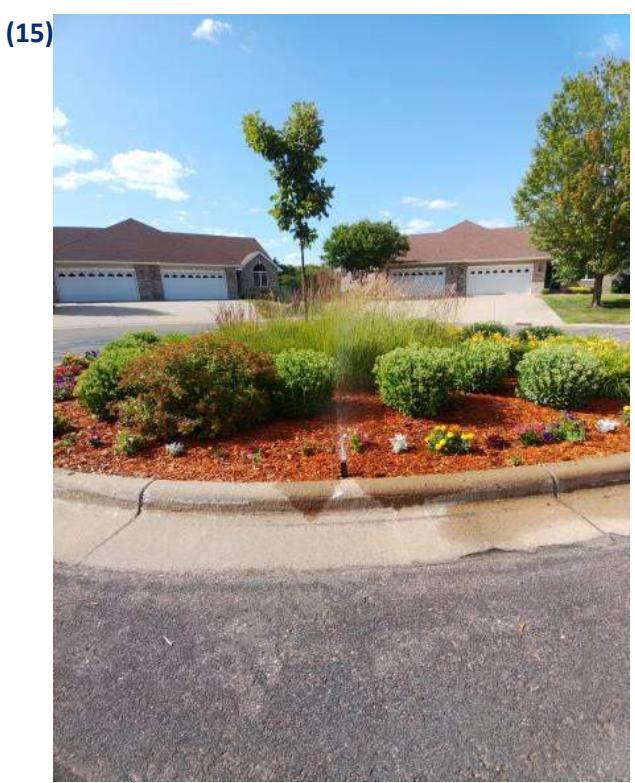
Station 13 – center island planter with the same poor configuration as the station 4 planter. Recommend reconstructing w/12" popup sprinklers spaced appropriately.

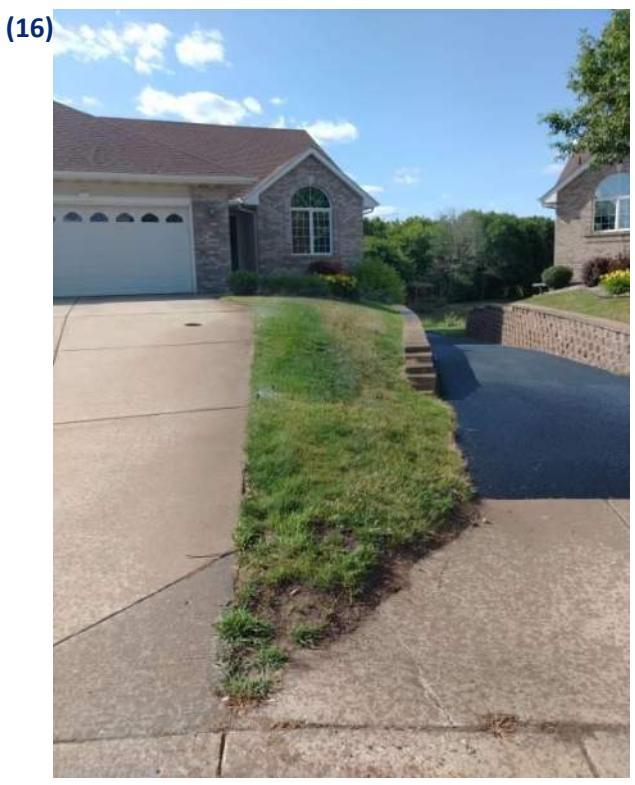
Station 14- right side of 13985. Sprinkler placement and nozzle selection is largely ineffective. Recommend adding opposing MSMTs as needed for improved coverage and re-nozzle sprinklers to avoid throwing over the walk path.

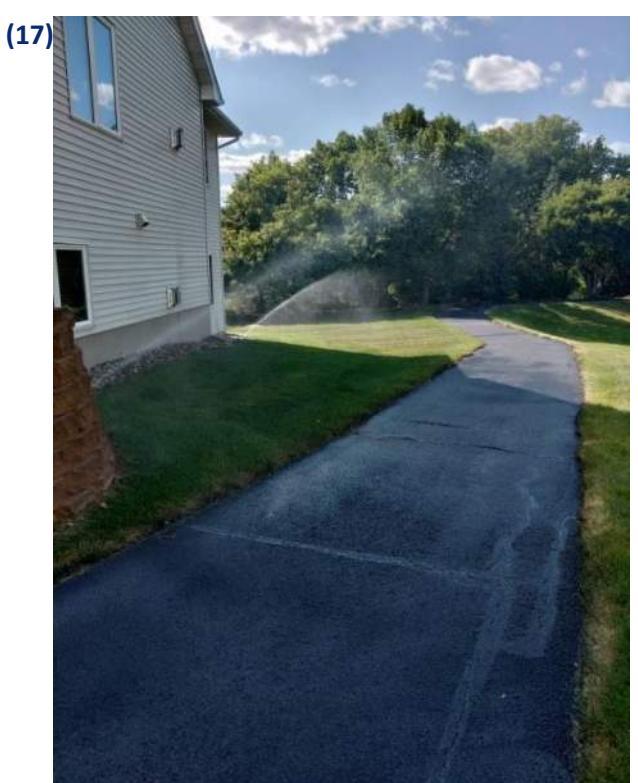
Station 14 – right side of 13985. Adjust sprinklers to avoid throwing over the walk and add sprinklers as needed for proper coverage.

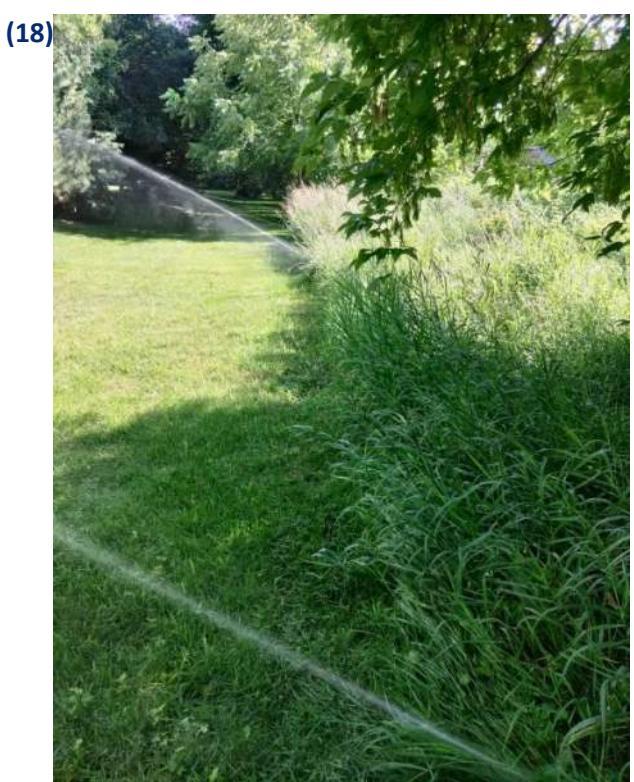
Station 18 - several sprinklers behind grassline. Heavy shade for much of the station. Recommend moving blocked sprinklers, add matched application rate nozzles and adjust runtimes accordingly.
