Vermillion River Monitoring Network

2018 Annual Report

*Prepared for the Vermillion River Watershed Joint Powers Organization
by the Dakota County Soil and Water Conservation District*

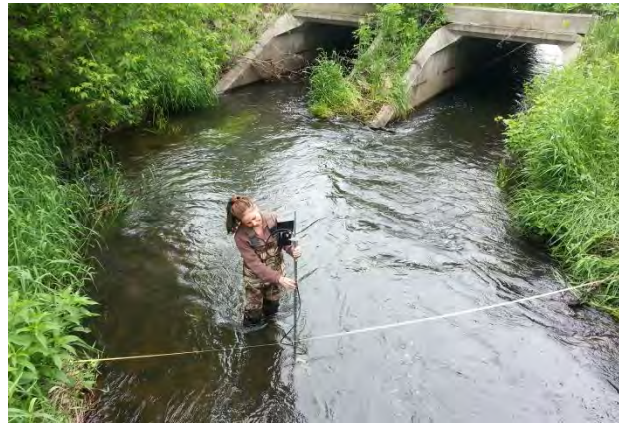
Flow is typically measured manually five to seven times per season at each site over a variety of flow regimes to develop a mathematical relationship in which flow can be estimated at any river level (stage). In doing so, DCSWCD staff follows United States Geological Survey (USGS) established protocols for measuring flow (Buchanan, 1969). Additionally, each station is equipped with automated data loggers which record continuous stage at fifteen minute intervals. With these two approaches, it is possible to get an accurate discharge rate at any water level.

DCSWCD staff measuring flow at the NC808 monitoring site
Photo Credit – J. Van Der Werff Wilson

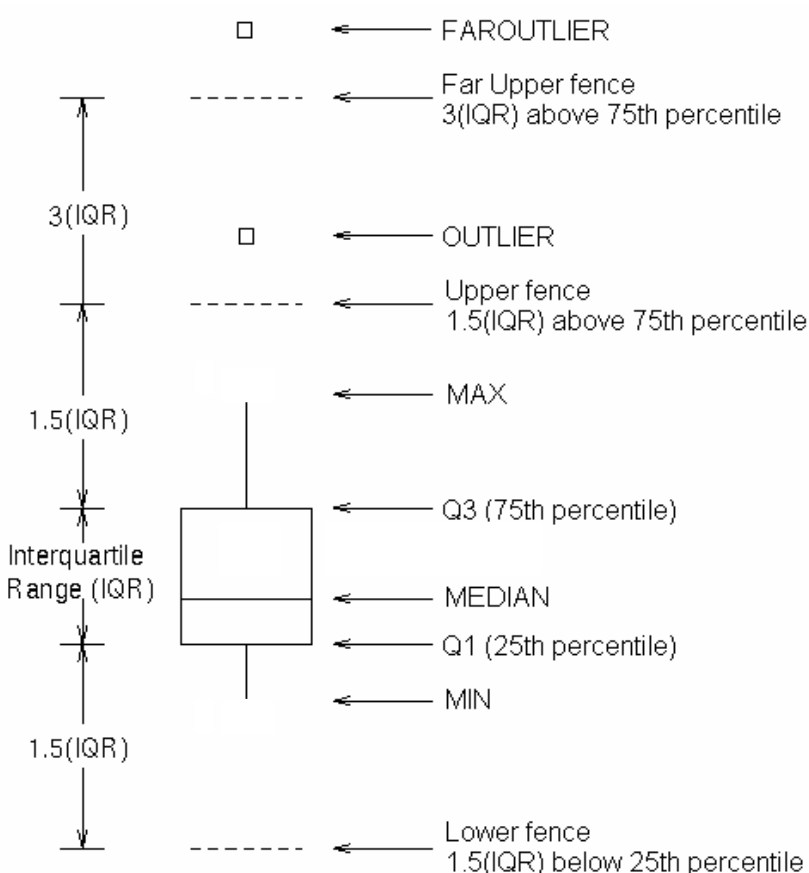
JMP 11 software was used to plot field and laboratory data. An explanation of box plot figures is shown in Figure 2. In the event that outliers exist, lines are not drawn to the minimum and maximum but instead are drawn to 1.5 times the interquartile range (IQR) and outliers are shown as dots. The IQR effectively trims the highest and lowest 25% of values, and represents the middle 50%. The median represents the value lying at the midpoint with an equal number of observed values above and below. N indicates sample size.

Figure 2. Vertical boxplot display key.

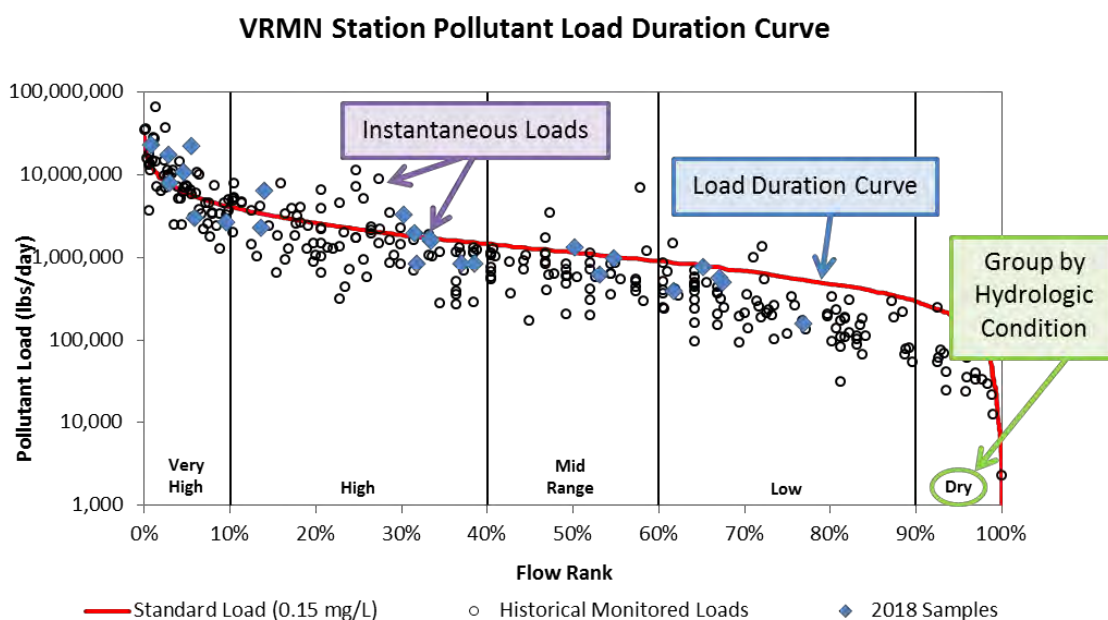
Loads that display on the graph above the curve (calculated using the state standard) indicate a violation of the water quality standard, while those plotting below the load duration curve indicate that the standard is being met for that monitoring event.

Figure 3. Example of a load duration curve.

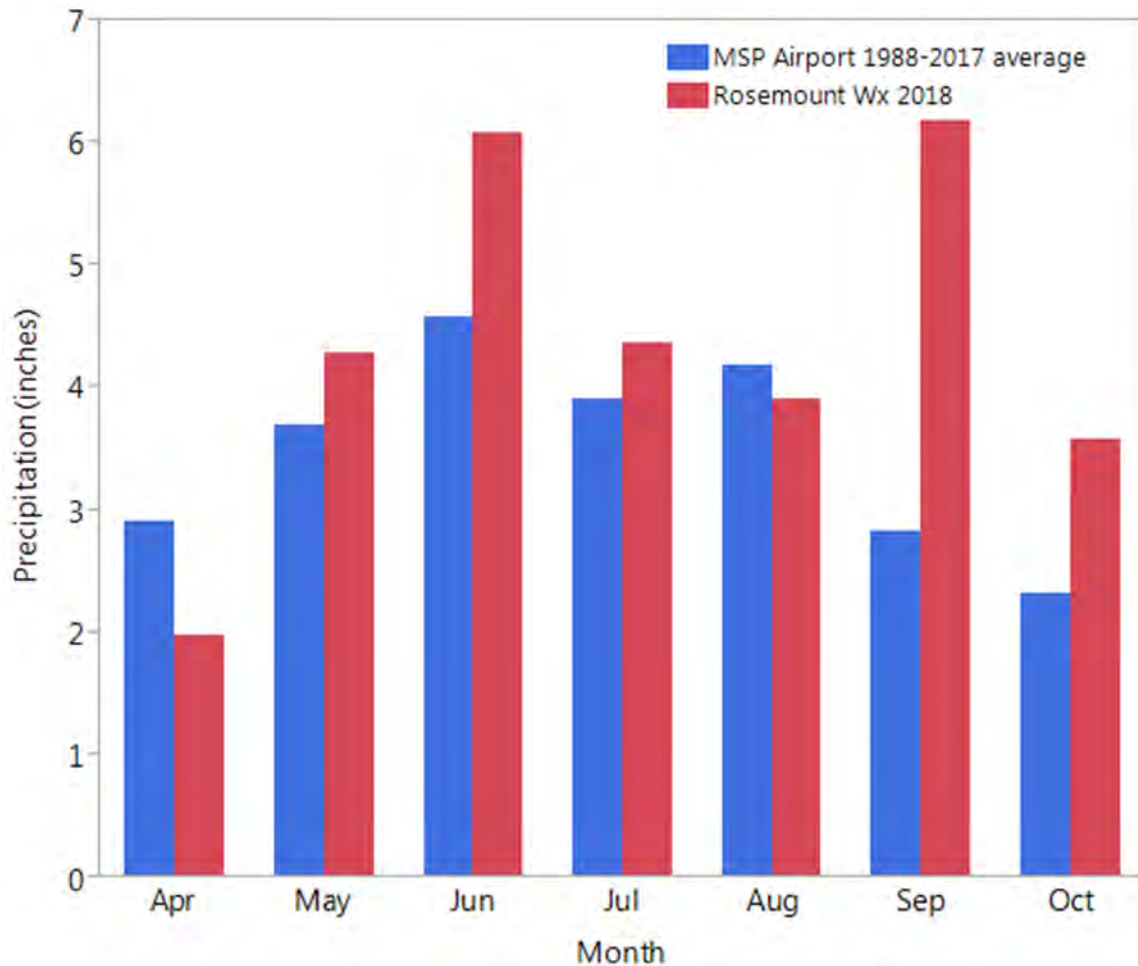
Precipitation records for the Minneapolis-St. Paul (MSP) airport were obtained from the Minnesota Climatology Working Group website (climate.umn.edu/) and serve as a benchmark to observe the deviation from normal precipitation for the current year. Monthly averages for the last 30 years were calculated and shown along with the precipitation data from the University of Minnesota weather station in Rosemount, Minnesota from April through October (Figure 4).

Figure 4. 30-year monthly average (1988-2017) precipitation at Minneapolis-St. Paul airport and 2018 monthly precipitation measured at the Rosemount weather station from April through October.

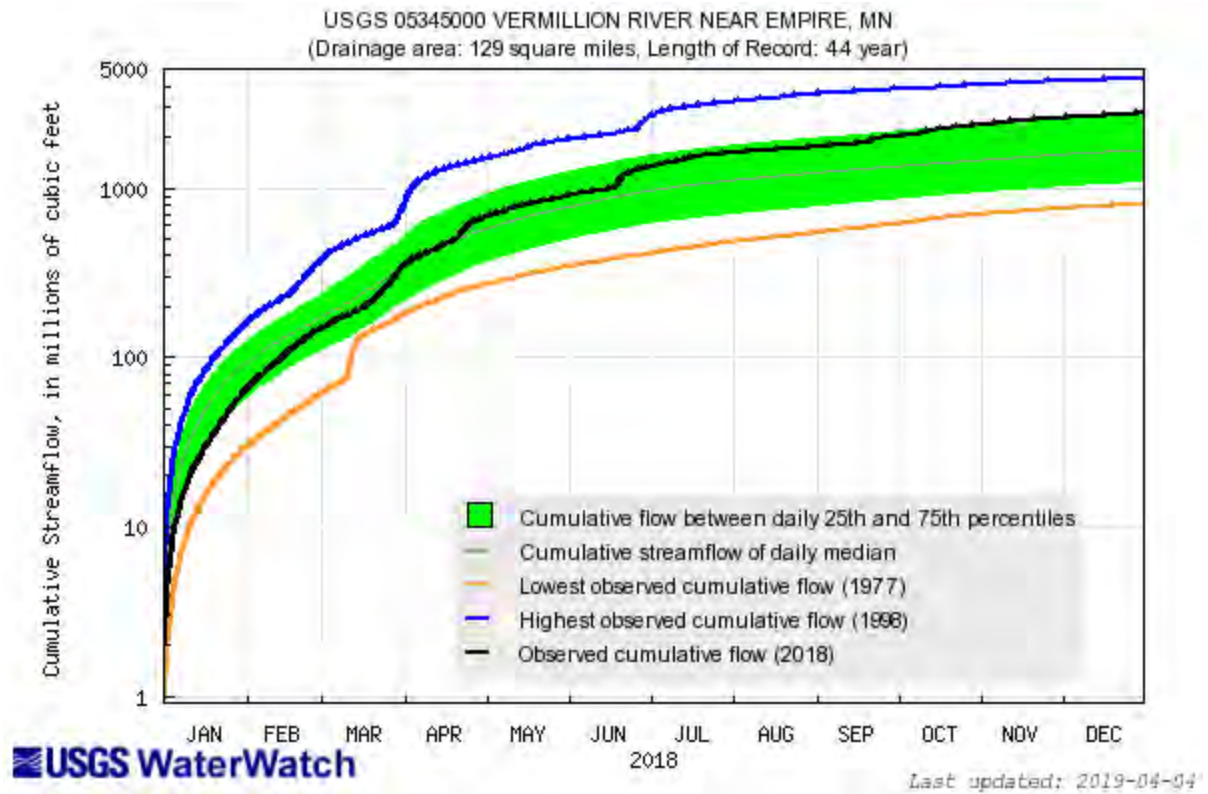
The cumulative flow of the Vermillion River for 2018 was within the normal range for most of the monitoring season. Stream discharge was at baseflow levels at the beginning of the year, with elevated levels in March and April due to multiple snowmelt events. Occasional heavy rainfall began in April and continued through July, resulting in short term spikes. Following September storms, elevated discharge levels continued through the remainder of the year, skirting the 75th percentile October through December (Figure 6, courtesy of USGS).

Figure 6. Cumulative flow for the USGS station at Blaine Avenue in 2018.

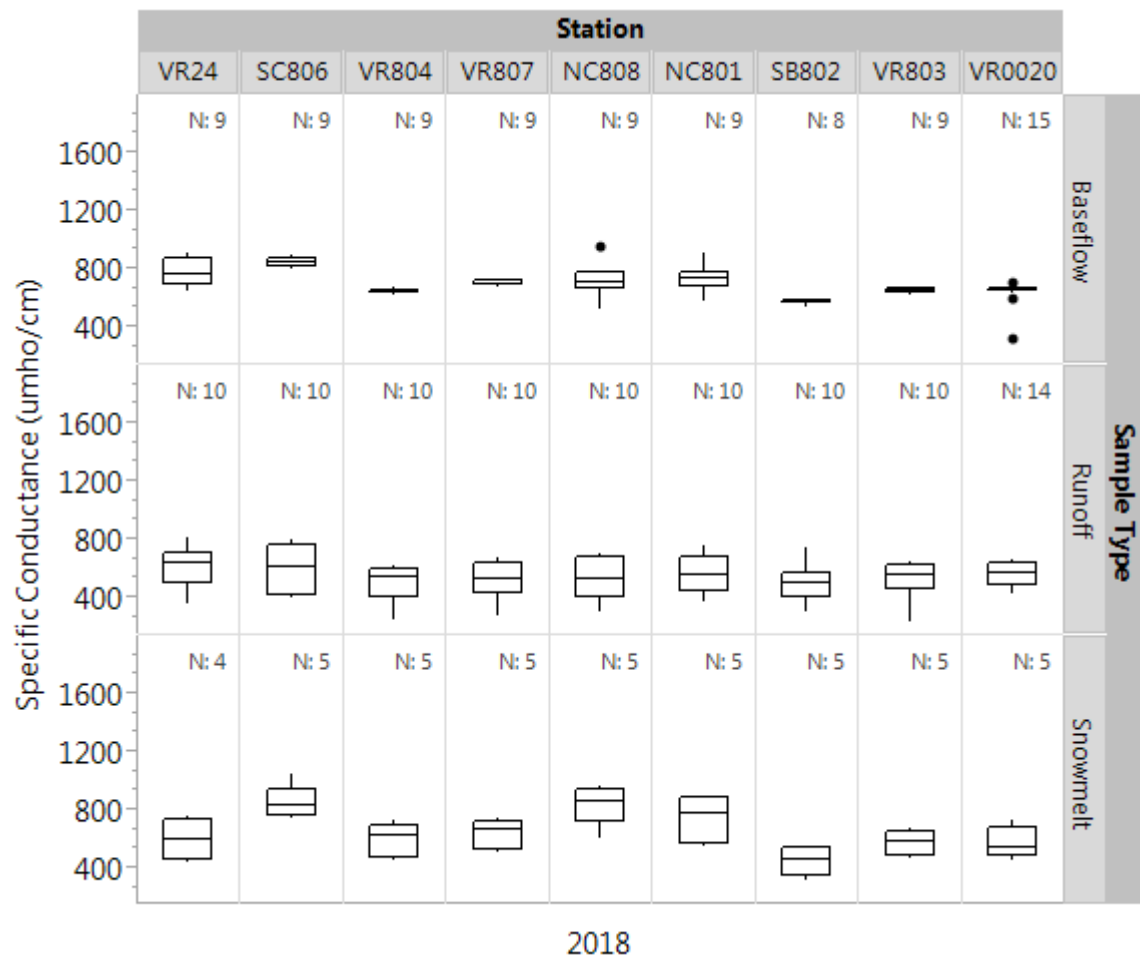
In 2018, baseflow conductivity is higher than conductivity measurements collected during runoff events at all sites (Figure 7). Groundwater tends to have more dissolved ions from geologic sources and rain water tends to have lower conductivity. Additionally, fields are often irrigated with groundwater during dry conditions. This high conductivity water then enters surface water through shallow groundwater discharge.

There do not appear to be major differences between stations with regards to specific conductance in 2018; median levels appear to be about the same throughout the watershed during baseflow and runoff conditions. Conductivity concentrations following snowmelt events show increased variability at SC806, NC801, and NC808 – the more urban tributaries in the watershed.

Figure 7. Specific conductance for each station, categorized by sample type, for 2018.

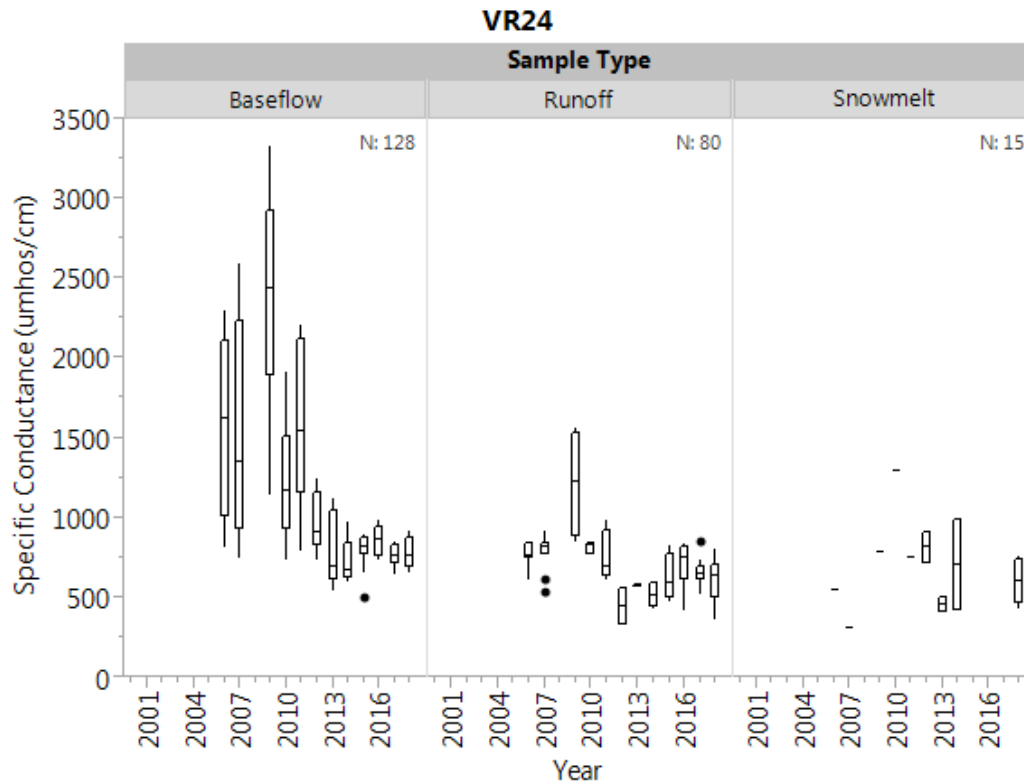
Station VR24 has much higher conductivity values compared to other stations in the network (take note of scale, Figures 9a-i). Conductivity tends to be higher downstream of WWTPs; a pattern that can be seen at VR24 and VR803 (Ort, 2008). Following the WWTP upstream of VR24 being redirected to the Empire WWTP in 2012, a decrease in conductivity has been observed and is expected to continue to decrease in the future. Additionally, a portion of the land use upstream of VR24 is sod farming, where the land is drained via tile and ditches as well as irrigated with groundwater, which may be contributing to the elevated conductivity values. After the Empire WWTP was rerouted to the Mississippi River, the conductivity measured at VR803 showed a noticeable decrease in both the baseflow and runoff values.

Figure 9a. Historical specific conductance by sample type at VR24. **Note the scale difference between VR24 and other monitoring sites.

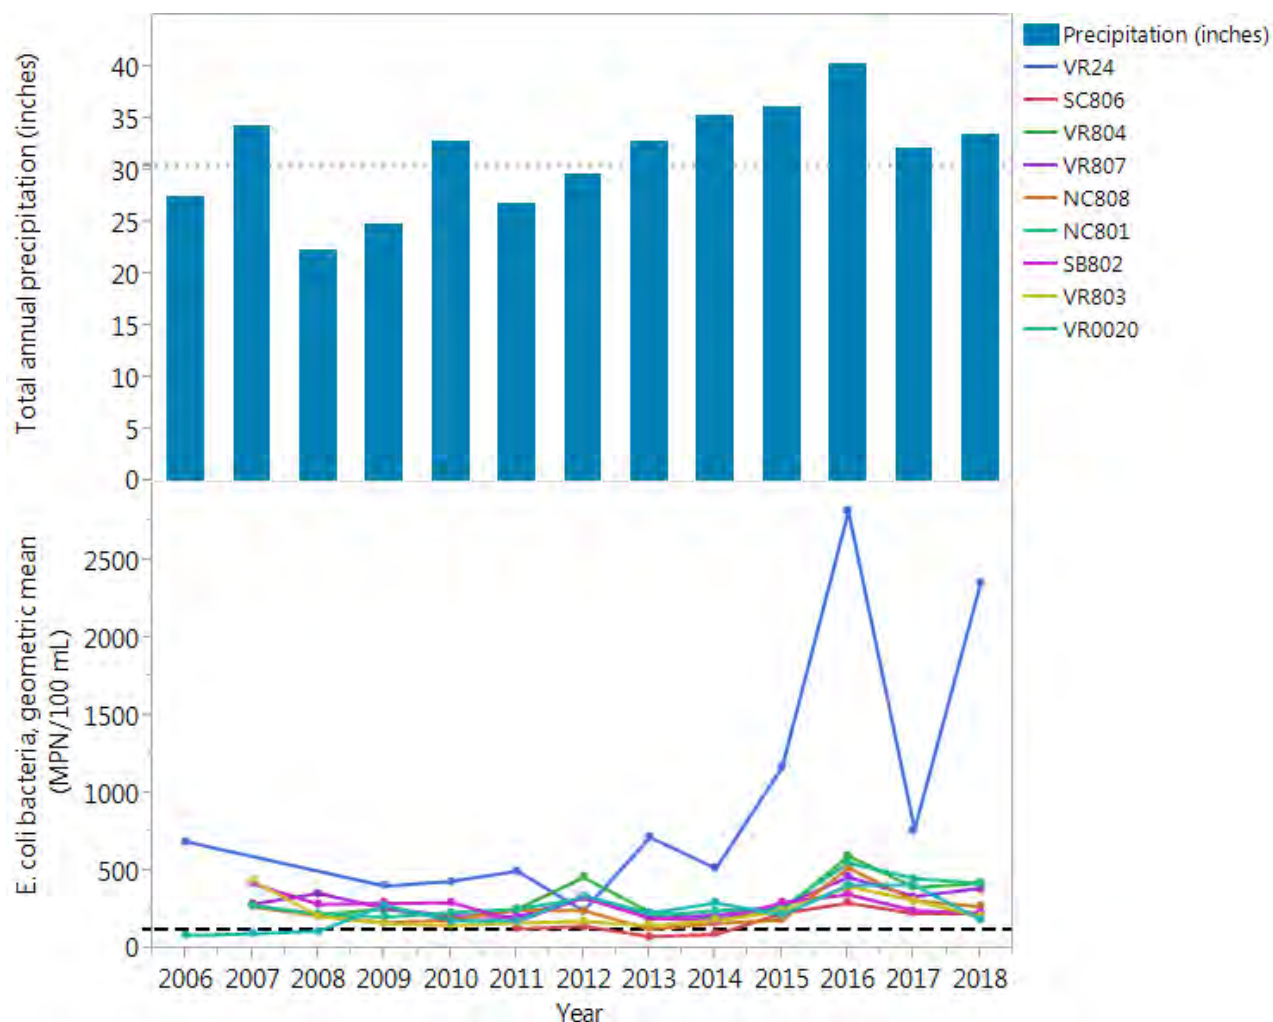
Figure 12. Annual geometric mean of *Escherichia coli* (*E. coli*) bacteria for all stations by year. MPN stands for most probable number of organisms. Black dashed line indicates the 30-day geometric mean standard (for data collected April through October) of ≤ 126 MPN/100 mL. Bars represent total annual precipitation for each year. Gray dotted line indicates the 30 year (1988-2017) total annual average precipitation at the Minneapolis – St. Paul airport weather station of 24.46 inches.

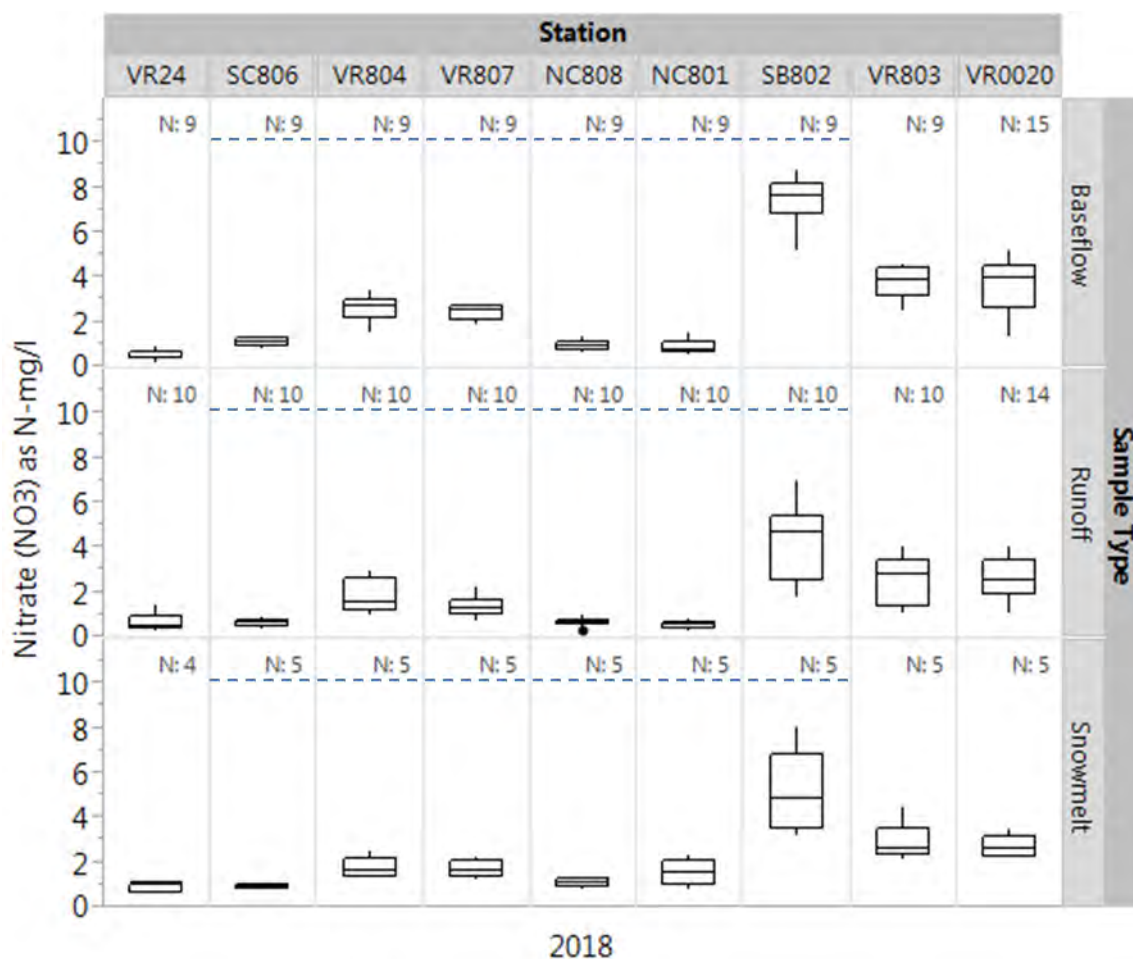
Figure 14. Nitrate nitrogen for each station, categorized by sample type, for 2018. Blue dashed line represents the domestic consumption state standard (≤ 10 mg/L).

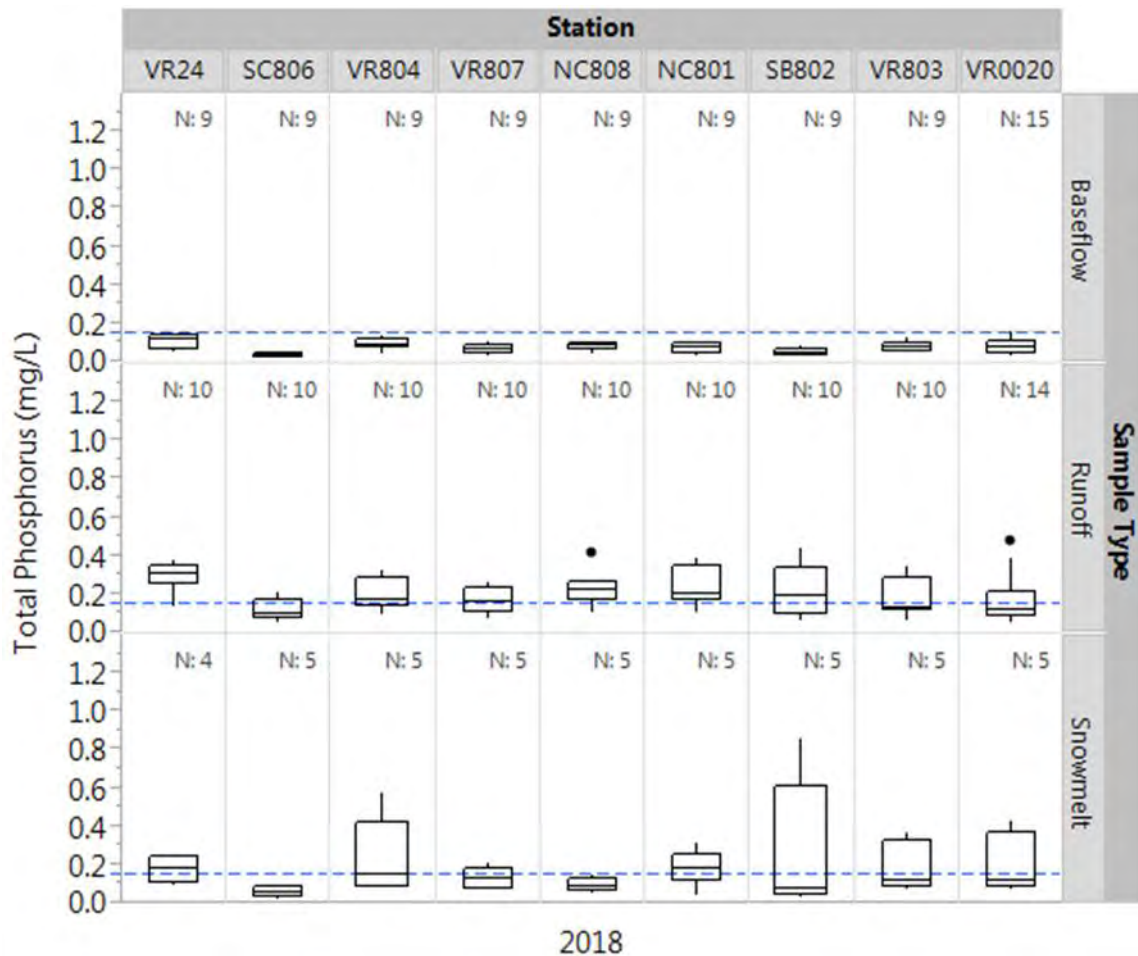
Figure 16 shows total phosphorus (TP) for each station categorized by sample type. All stations had a median baseflow TP concentration below the state standard of 0.15mg/L. The median for runoff samples was above the standard at the majority of monitoring sites. Individual samples exceeded the standard at all of the monitoring sites during runoff conditions. Phosphorus levels during snowmelt events varied, with the median phosphorus level below the standard in seven of the nine monitoring sites in the watershed.

Figure 16. Total phosphorus (TP) for each station, categorized by sample type, for 2018. Blue dashed line represents the state standard for total phosphorus, ≤ 0.15 mg/L.

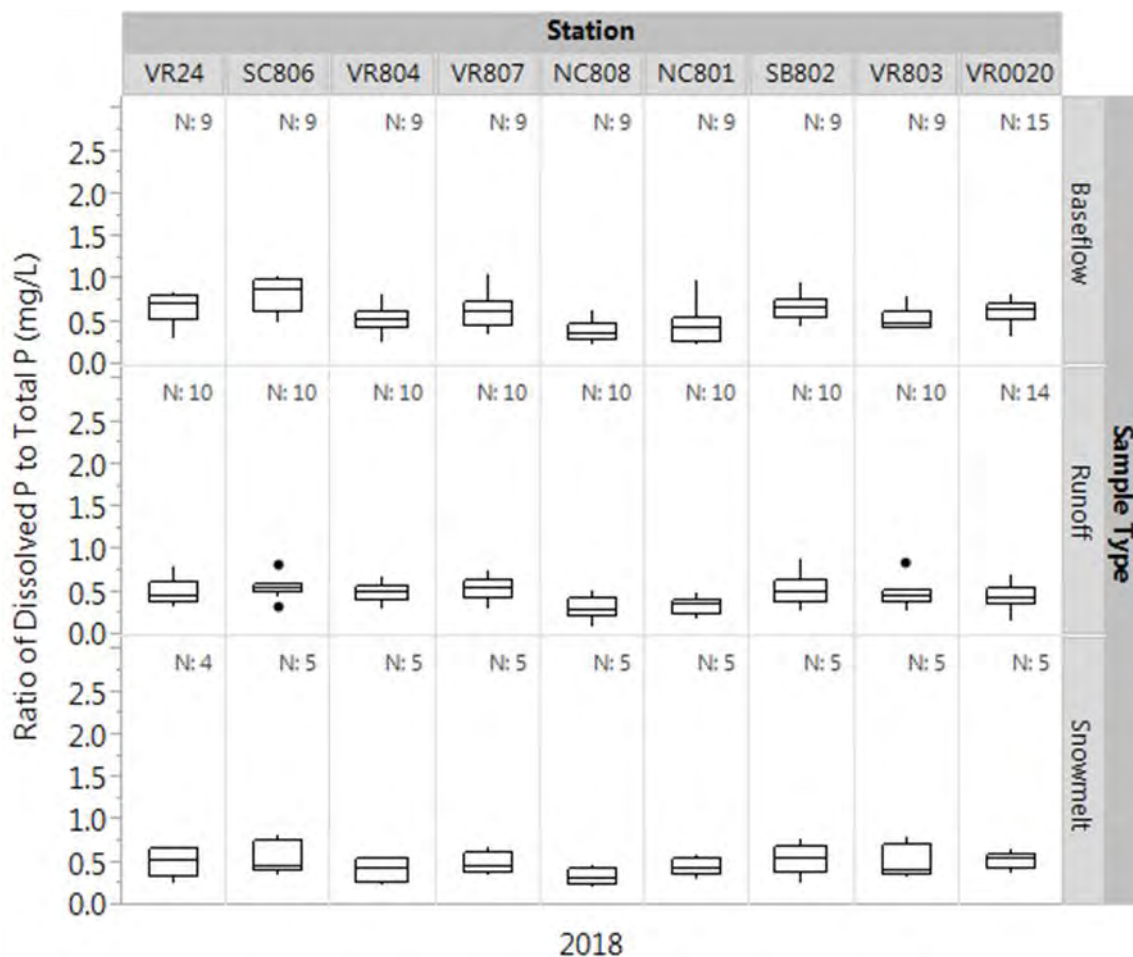
Figure 18. Ratio of dissolved phosphorus (TDP) to total phosphorus (TP) for each station, categorized by sample type, for 2018.

During baseflow conditions, the TDP:TP ratio at VR803 had decreased about the time that wastewater treatment upgrades were implemented in 2006. Discharges from the wastewater treatment plant were likely the source of the TDP fraction; organic phosphorus excreted by organisms (including humans) would be dissolved, as opposed to particulate. WWTP upgrades in 2006 were important in reducing TDP levels at VR803 and significant reductions were apparent by 2007.

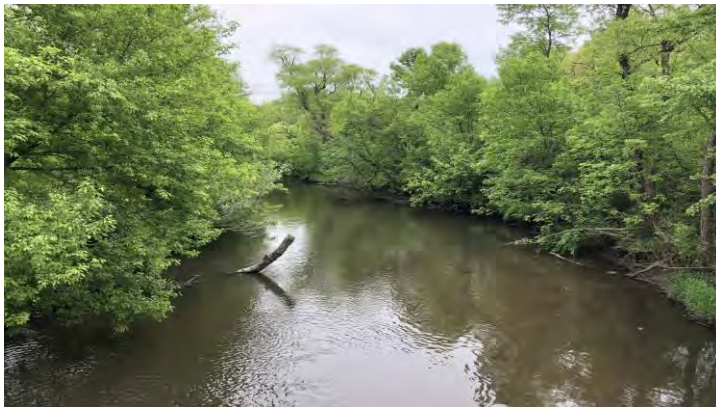
VR803 at *baseflow* conditions.
Small amount of suspended particles
being transported downstream.
Water transparency is high.

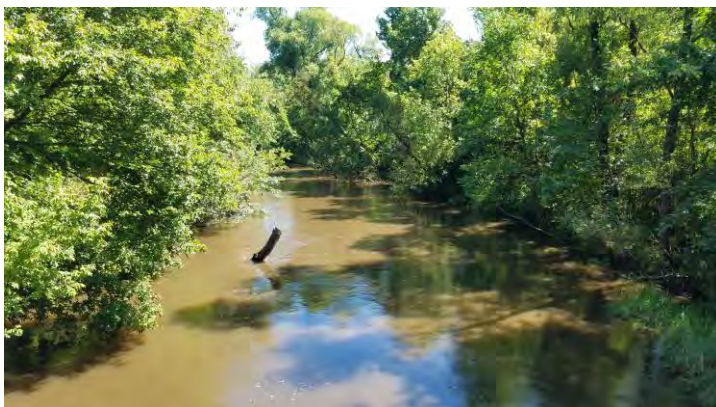
VR803 under *runoff* conditions.
Water is murky and there is a high level
of suspended sediment in the water.
Water transparency is low.

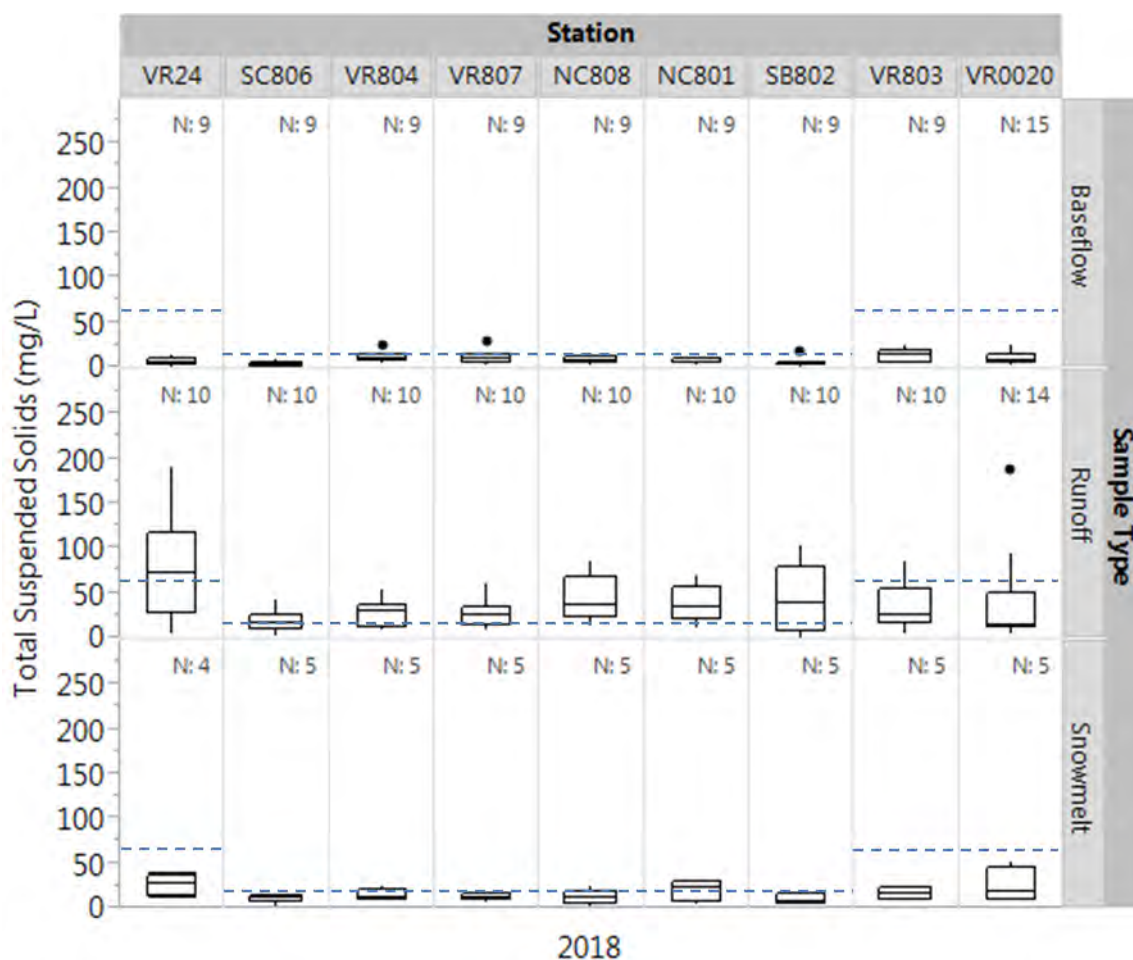
State standards were recently developed for TSS. For cold water (2A) streams the standard is ≤ 10 mg/L and for warm water (2B) streams the standard is ≤ 65 mg/L. These standards apply from April through September; however, data shown here includes the entire monitoring season which goes from snowmelt (mid-March) through November 1st. Sample medians were below the state standard at all stations during baseflow conditions, whereas sample medians for the six cold water monitoring sites were at or above the standard (as was the sample median for VR24 (warmwater)) during runoff monitoring (Figure 20).

Figure 20. Total suspended solids categorized by sample type for 2018. Blue dashed line represents the state standard for cold 2A (≤ 10 mg/L) and warm 2B (≤ 65 mg/L) waters.

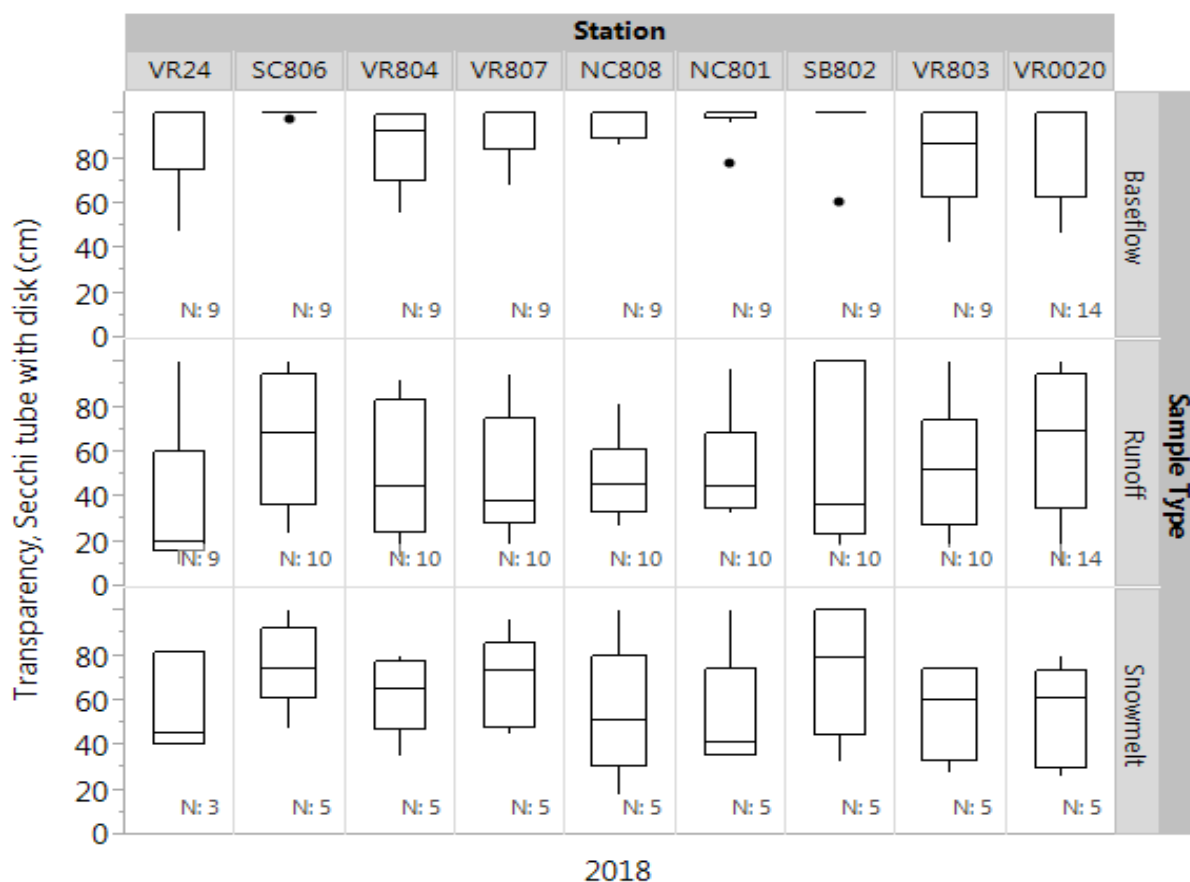
Water is relatively clear during baseflow conditions at all stations, often exceeding the measurement limit of 100 cm (Figure 22). Station VR804 has the poorest baseflow sample medians relative to the other monitoring sites in the watershed. Sandy soils dominate the area and the stream bed contains a lot of sand. Sandy substrate is easily suspended in the water column, making the water cloudy.

Figure 22. Transparency, categorized by sample type, for 2018.
