## Capital Improvement Project Lakeville: Phosphorous Treatment Enhancements at County Road 50

### Vermillion River Watershed Joint Powers Organization

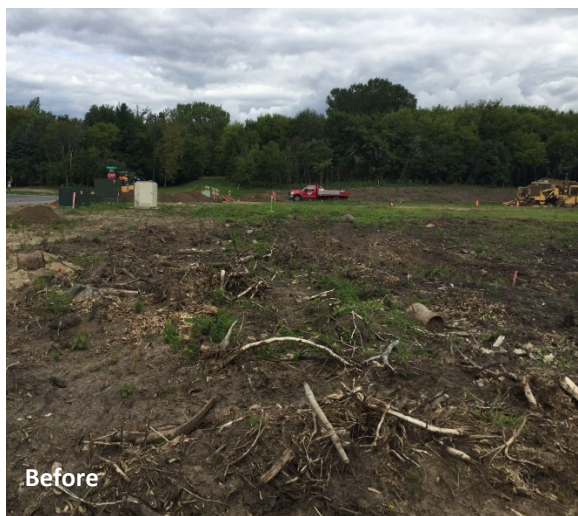
A treatment train of bioretention and an iron-enhanced sand filter allows for the capture of particulate bound and dissolved phosphorus, helping to improve water quality.

Bioretention works to filter out particulate-bound phosphorus. Iron-enhanced sand filters use iron filings mixed with sand to act as a natural magnet trapping both dissolved phosphorus and particulate-bound phosphorus. Less phosphorous entering Lake Marion results in less algae.
