Capital Improvement Project Lakeville: South Creek at Hamburg Avenue Stream Restoration

Restoring a trout stream

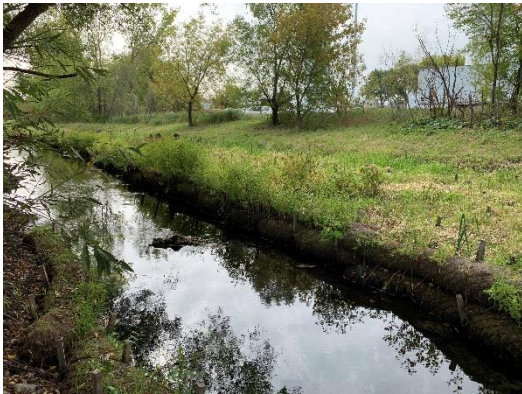
Stream restoration included installing numerous in-stream habitat features, narrowing portions of the channel that are over-widened, stabilizing the bank, and improving riparian conditions to limit sedimentation and improve wildlife habitat.
