Capital Improvement Project

Lakeville: Middle Creek at Dodd Boulevard Channel Restoration

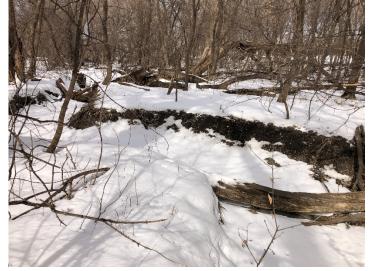
Figure 2. Pre-project, northern channel with bank erosion and 3-5 Figure 3. Restored Middle Creek channel, fall 2023. feet of downcutting.
